February 20, 2020

Re: Pikeview Quarry, Permit No. M-1977-211; Fourth Adequacy Review for 112 Construction Materials Reclamation Permit Amendment Application (AM-04)

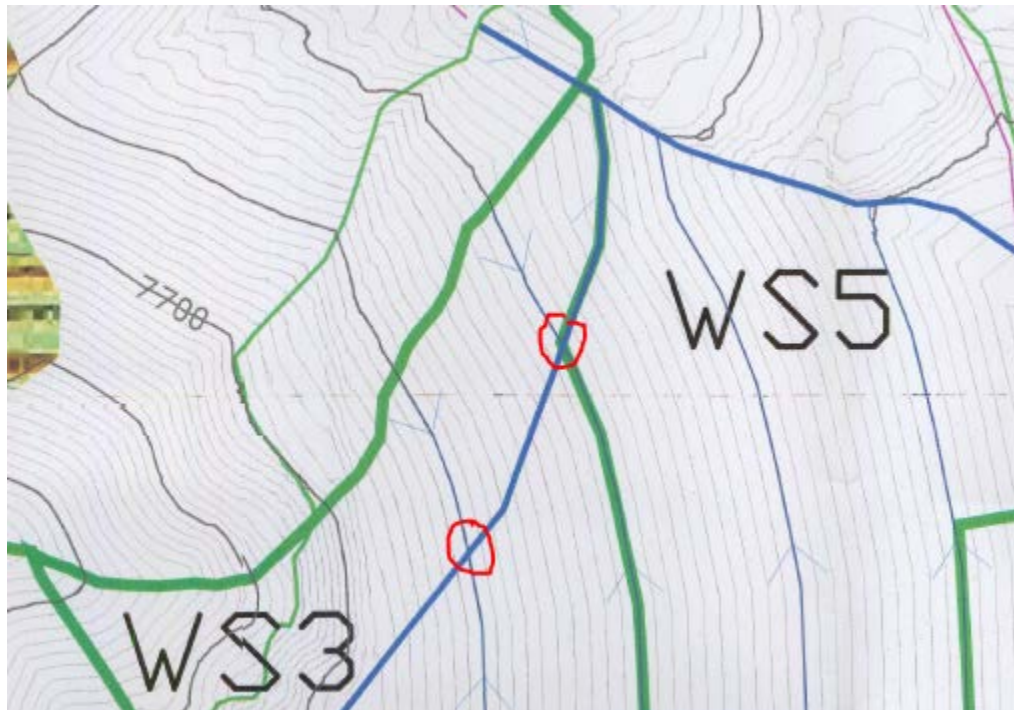
33. Stormwater management: Please provide the following:
- a. Freeboard clarification: The response is adequate.
 - b. Table G-3: The response is not adequate, additional information is required. Please address the following:
 - i. The Lower South Channel, WS-9 should be 20 ft wide to be consistent with the SEDCAD model output in the response.
 - ii. Based on the channel profiles on Exhibit G-3, there are four engineered channel segment not addressed: 1) WS-4 at 2% slope, 2) Outlet Channel WS-11 at 7% slope, 3) Upper most WS-3 cross channel (WS-1 flows?) at 6% slope, 4) lower WS-3 cross channel at 2% slope. Please include these in Table G-3.
 - c. Channel Transition Design: The response is not adequate. The comment was misunderstood. The comment is meant to address the cross channel intersection with south-flowing terrace channels (see below), not the intersection with WS-4.

The hydraulic performance at the intersection of the WS-3 Cross Channel and south flowing terrace channel is of concern to the DRMS. Higher flows and velocity in the cross channel may cause interference/backwater/reverse flow conditions in the terrace channel at these junctions, leading to overtopping and/or potential for significant erosion and significant water infiltration. Please provide design details for these critical junctions.
