April 23, 2020

**Re: Project, Permit No. M-1980-244;  
Stormwater Preliminary Adequacy Review, Amendment Application (AM-13)**

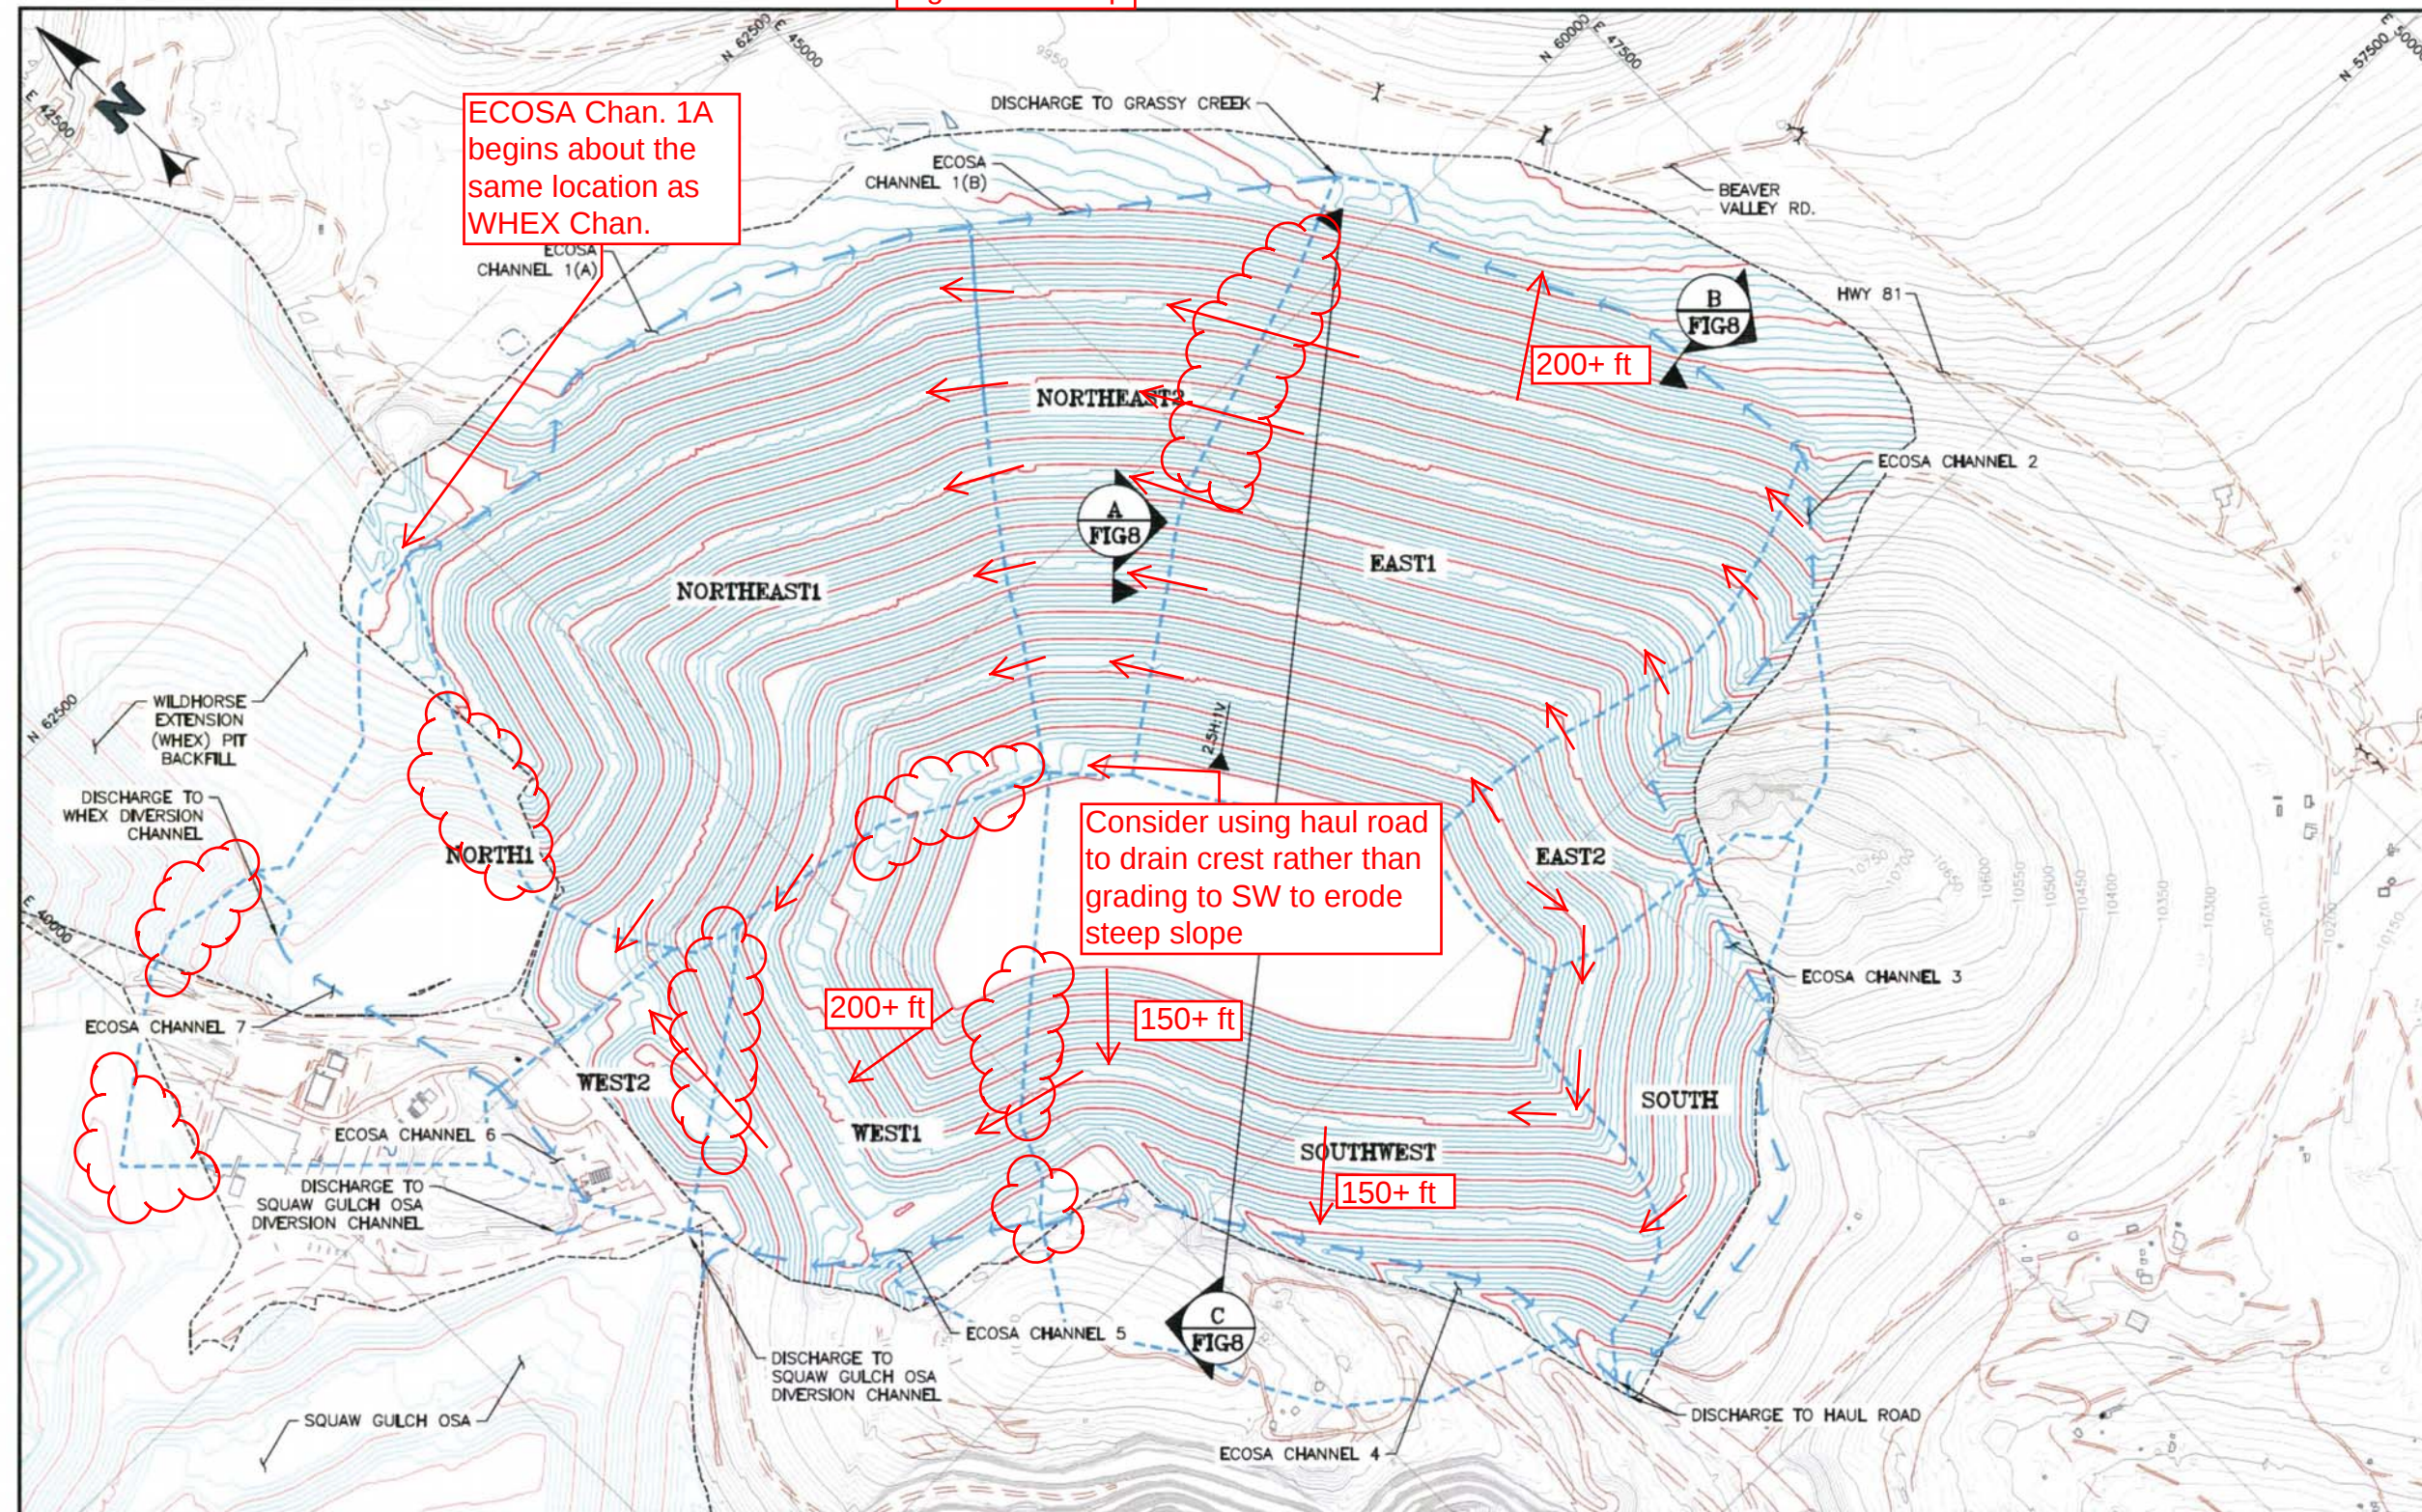
- J. Figure 2. Section 2.1 of the text indicates the ECOSA top will be graded at 1.5% towards the southwest to limit runoff to Grassy Valley. No such indication is shown on Figure 2. Two proposed diversion channels merge on the south end of the ECOSA and Altman backfill area, with a note indicating a “Discharge to Haul Road”. Please address the following:

- c. The 1.5% grade to drain on the crest of the ECOSA appears to significantly expand the contributing area to the “Haul Road” channel. Has the increased peak flow been

checked with respect to the design capacity and stability of the “Haul Road” channel?

There are several apparent errors on Figure 2 related to the subbasin delineation and the grading plan. Several subbasin boundaries are skewed from the expected orientation perpendicular to contour lines. Furthermore, the second and third bullets in Paragraph 2 (p. 1) state benches are to exist every 150 vertical feet and Section A on Figure 8 is called out on Figure 2, implying bench channels are planned for each bench. These planned bench channels contradict the watershed boundaries delineated on Figure 2. Please reference the enclosed Figure 2 Markup and address the following:

- a. Watershed delineation labels need to be added to the legend,
- b. Bench Channels should be corrected to be no more than 150 feet apart (vertically),
- c. Watershed delineations are inconsistent with the grading plan,
- d. Consider grading the crest towards the remnant haul road and using the haul road to convey runoff away from Grassy Valley, rather than grading the crest to southwest where it would erode the steep slope in the Southwest watershed.
- e. ECOSA Channel 1A (on Figure 2) and the WHEX Channel on Figure 3 appear to have an upstream beginning in very close to the same place. How is runoff from the north end of watershed Northeast1 and all of watershed North1 directed to ECOSA Channel 1A and not the WHEX Channel?

- Subbasin delineation not perpendicular to contours
- Figure 8, Section A channel contradicting overall subbasin delineation
- Distance between benches > 150 ft (vertical)

- a. Watershed delineation labels need to be added to the legend,
  - b. Add a note or grading direction indicator on the crest of the ECOSA showing a 1.5% slope to the southwest

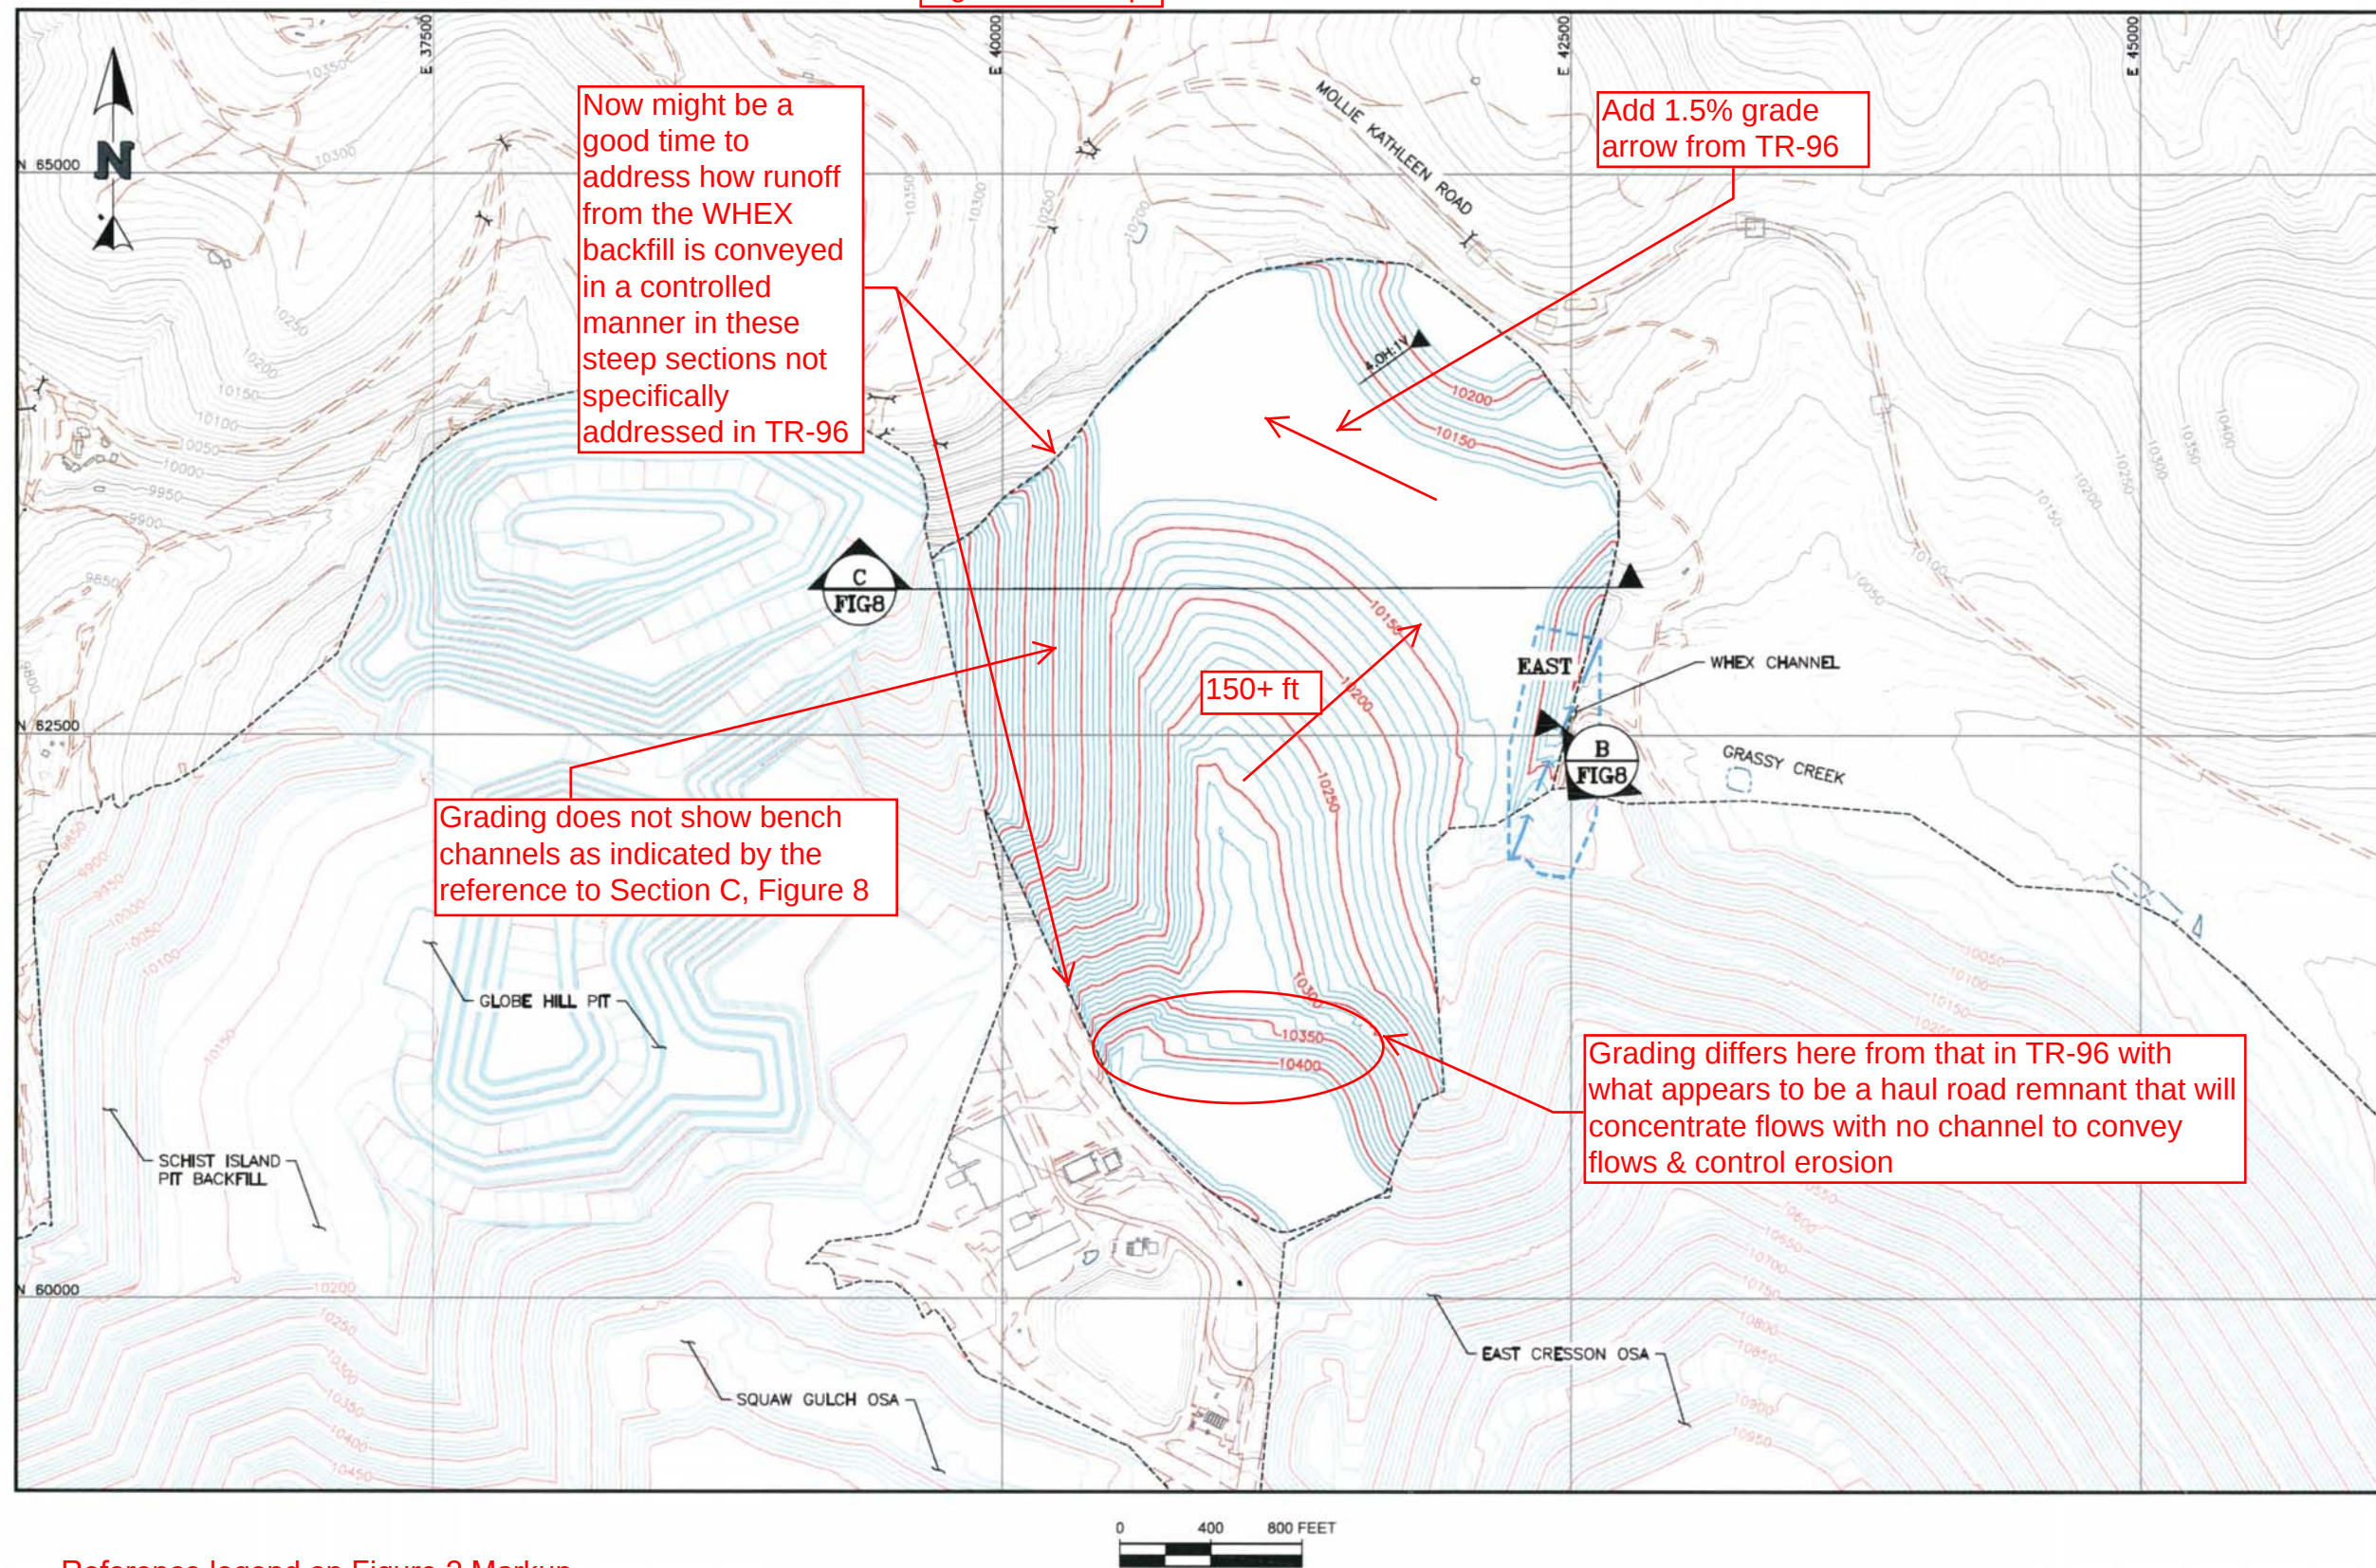
Figure 3 Markup

- a. Watershed delineation labels need to be added to the legend,
- b. Bench Channels should be corrected to be no more than 150 feet apart (vertically) and shown in grading plan,
- c. Steep channels on the west side of the WHEX backfill not addressed specifically in TR-96, and
- d. Grading difference with respect to a remnant haul road on the south end of the WHEX backfill

Now might be a good time to address how runoff from the WHEX backfill is conveyed in a controlled manner in these steep sections not specifically addressed in TR-96

Grading does not show bench channels as indicated by the reference to Section C, Figure 8

150+ ft

Grading differs here from that in TR-96 with what appears to be a haul road remnant that will concentrate flows with no channel to convey flows & control erosion

Add 1.5% grade arrow from TR-96

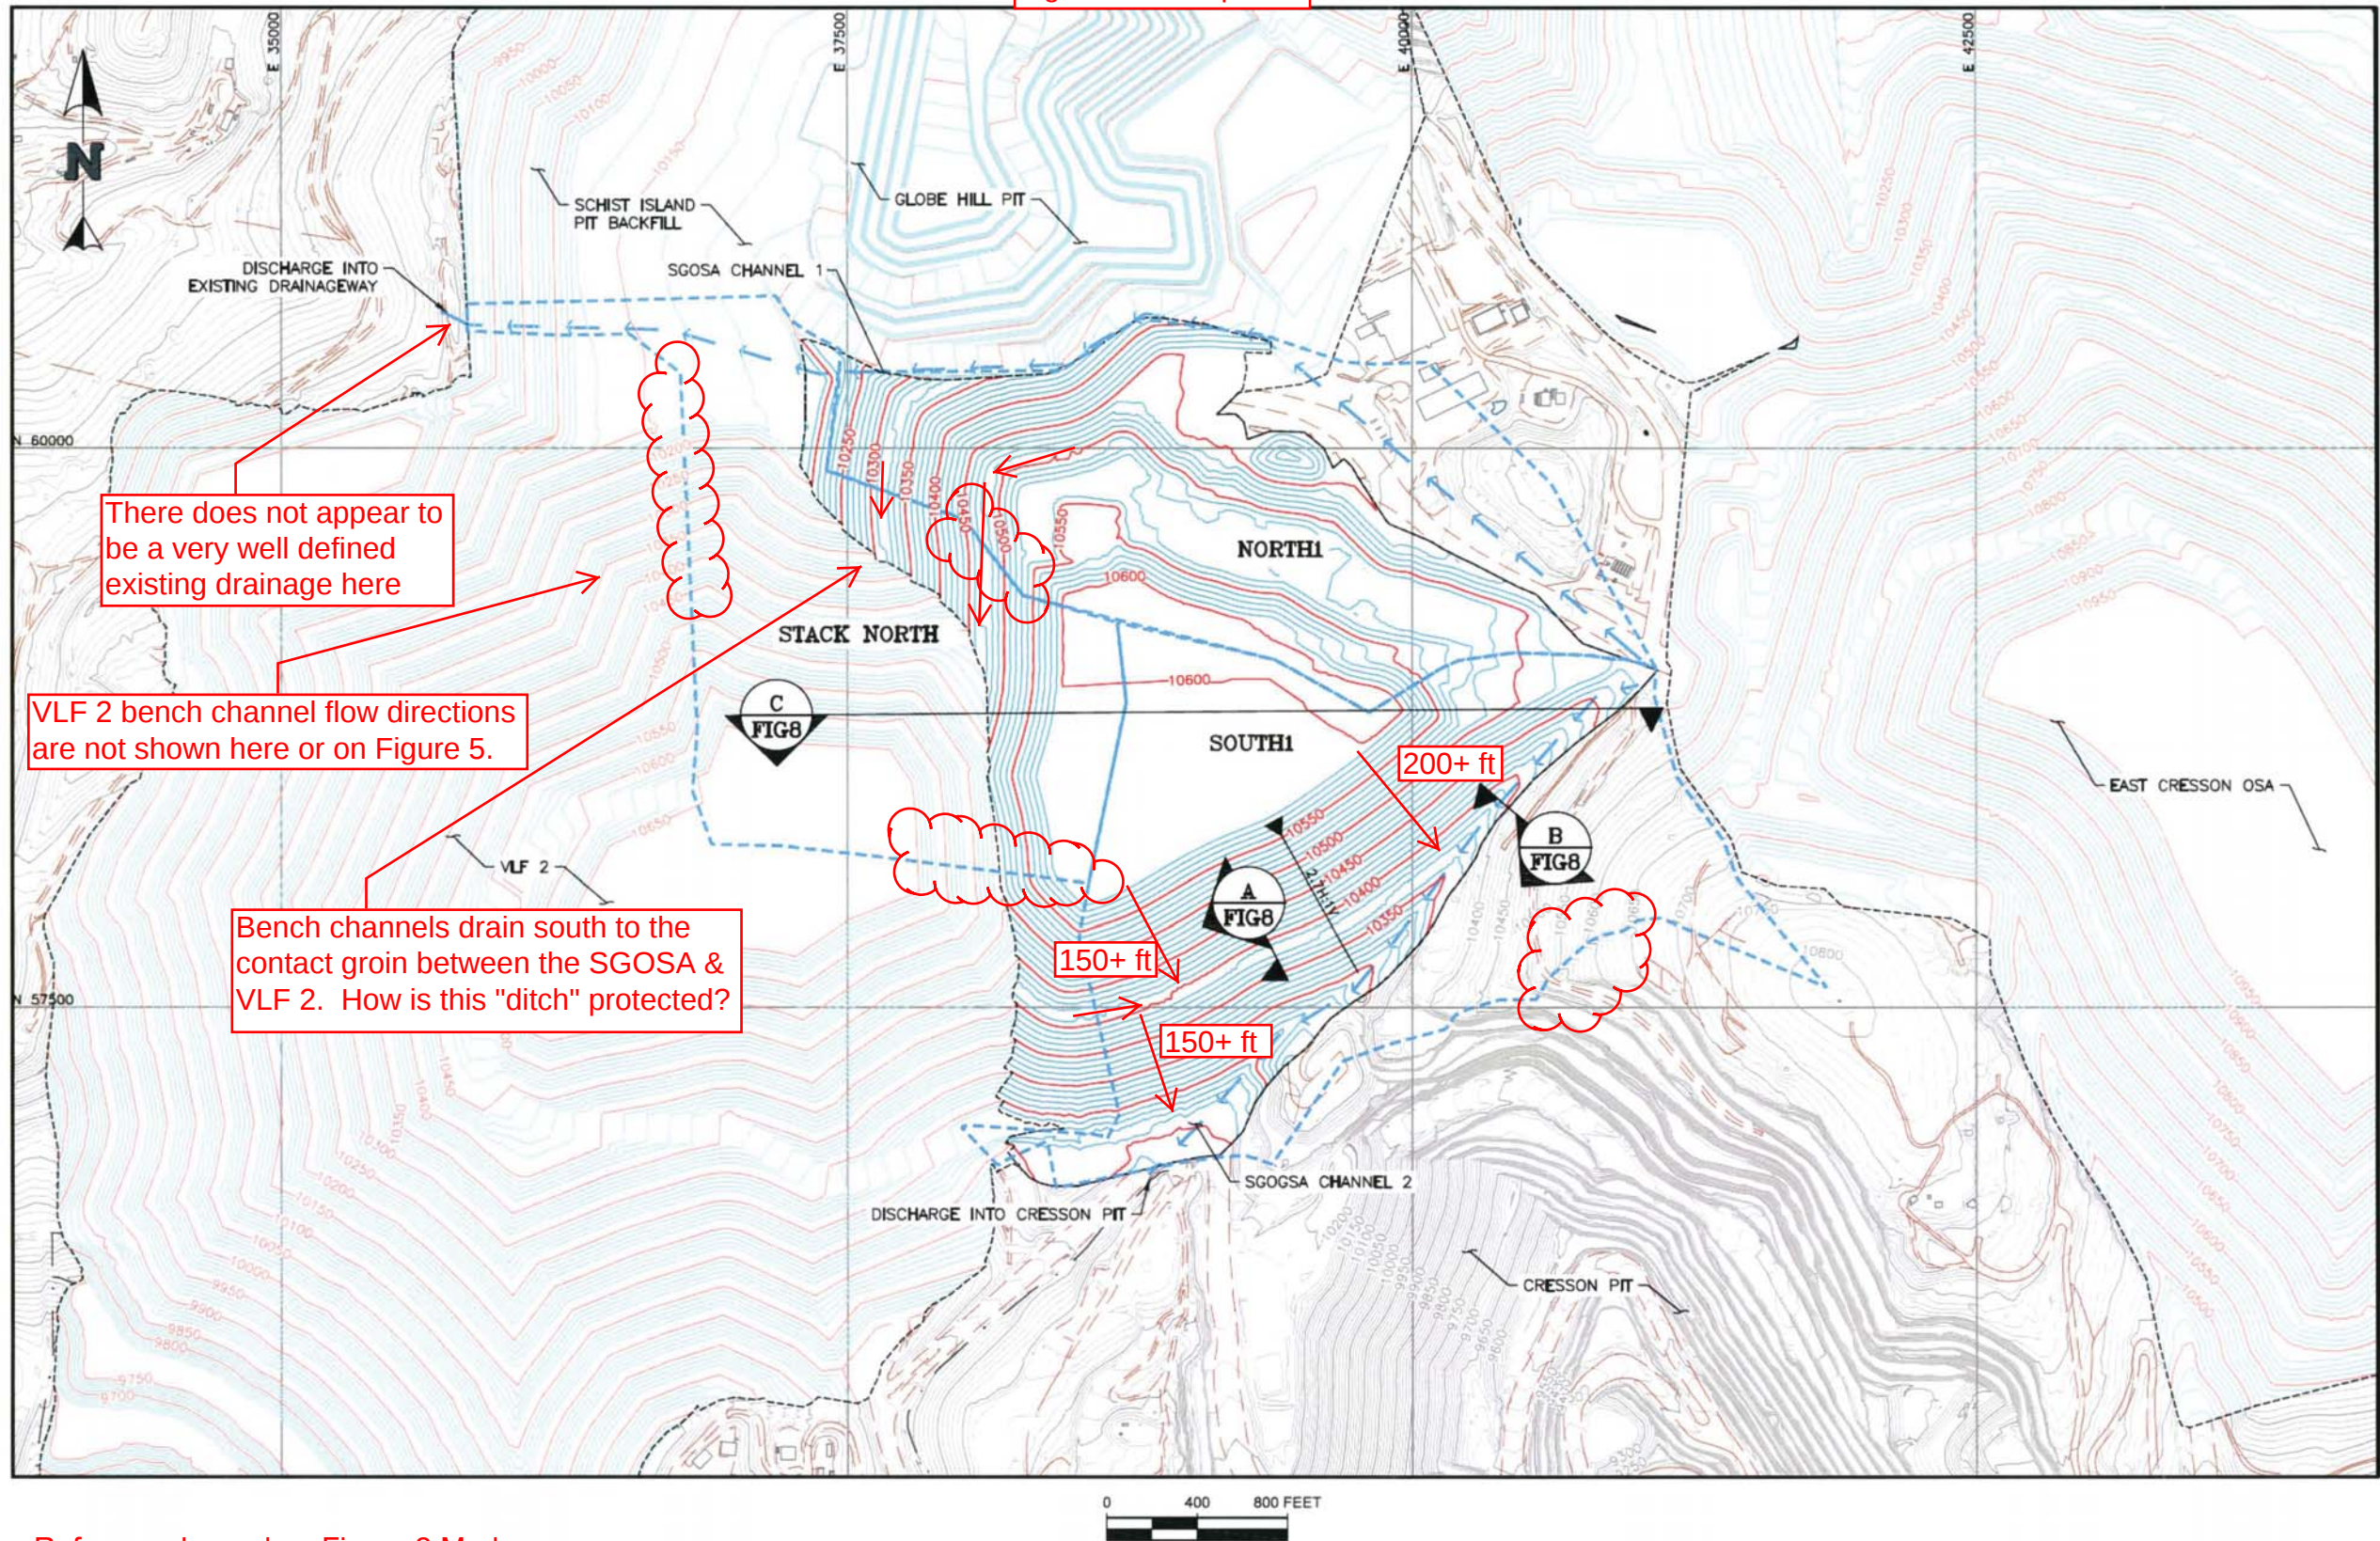
Figure 4 Markup

- a. Watershed delineation labels need to be added to the legend,
- b. Bench Channels should be corrected to be no more than 150 feet apart (vertically) and shown in grading plan,
- c. Watershed delineations are inconsistent with the grading plan,

- d. The steep contact channel on the north side of the contact between VLF 2 and the SGOSA does not appear to be designed, and
- e. The discharge to the existing drainage way on the west appears to be into swale rather than an incised drainage. This will likely lead to significant head cutting. How will head cutting be avoided?

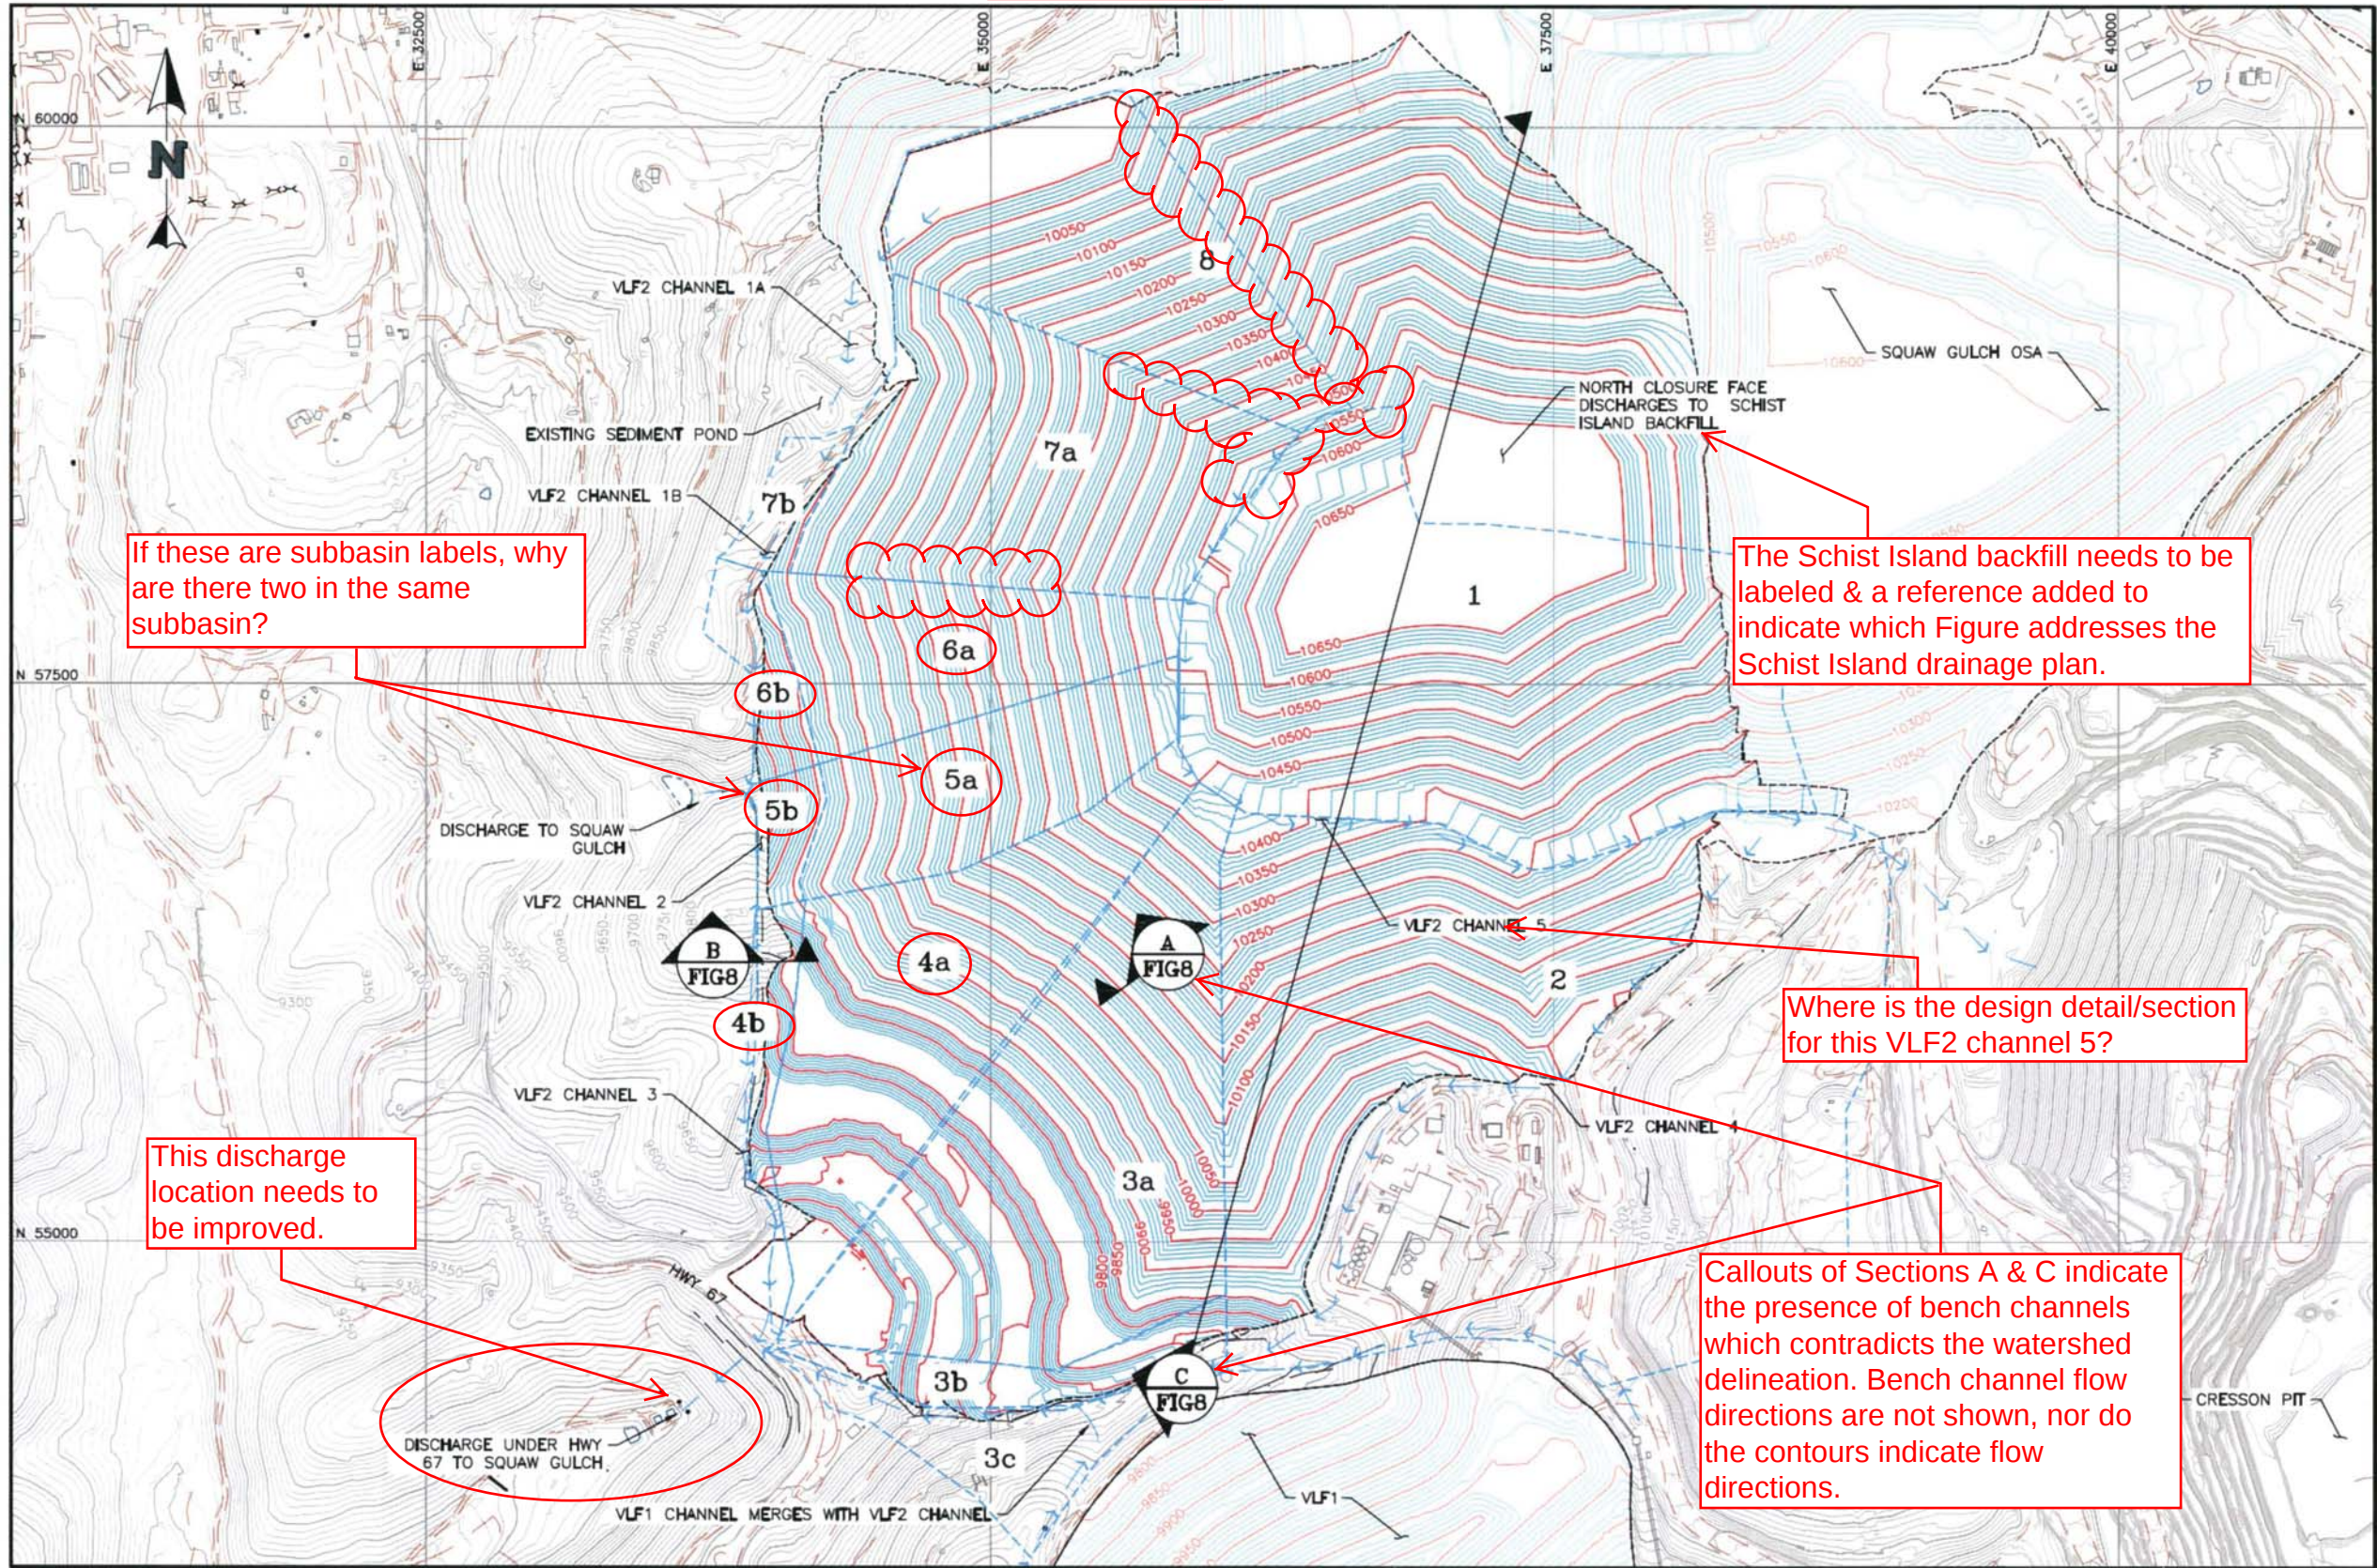
Figure 5 Markup

- a. Watershed delineation labels need to be added to the legend,
- b. Watershed delineations appear to be inconsistent with the grading plan,
- c. There is no design detail/section for the haul road channel (VLF2 channel 5),
- d. Bench channel flow directions need to be shown.
- e. The ultimate discharge location appears to be down the steep face of the VLF2/SGVLF toe berm on the SW side of Hwy 67. There is no defined or established drainage here. Some means of controlling discharge to the existing Squaw Gulch drainage needs to be presented that will not result in excessive scour.

If these are subbasin labels, why are there two in the same subbasin?

The Schist Island backfill needs to be labeled & a reference added to indicate which Figure addresses the Schist Island drainage plan.

Where is the design detail/section for this VLF2 channel 5?

This discharge location needs to be improved.

Callouts of Sections A & C indicate the presence of bench channels which contradicts the watershed delineation. Bench channel flow directions are not shown, nor do the contours indicate flow directions.

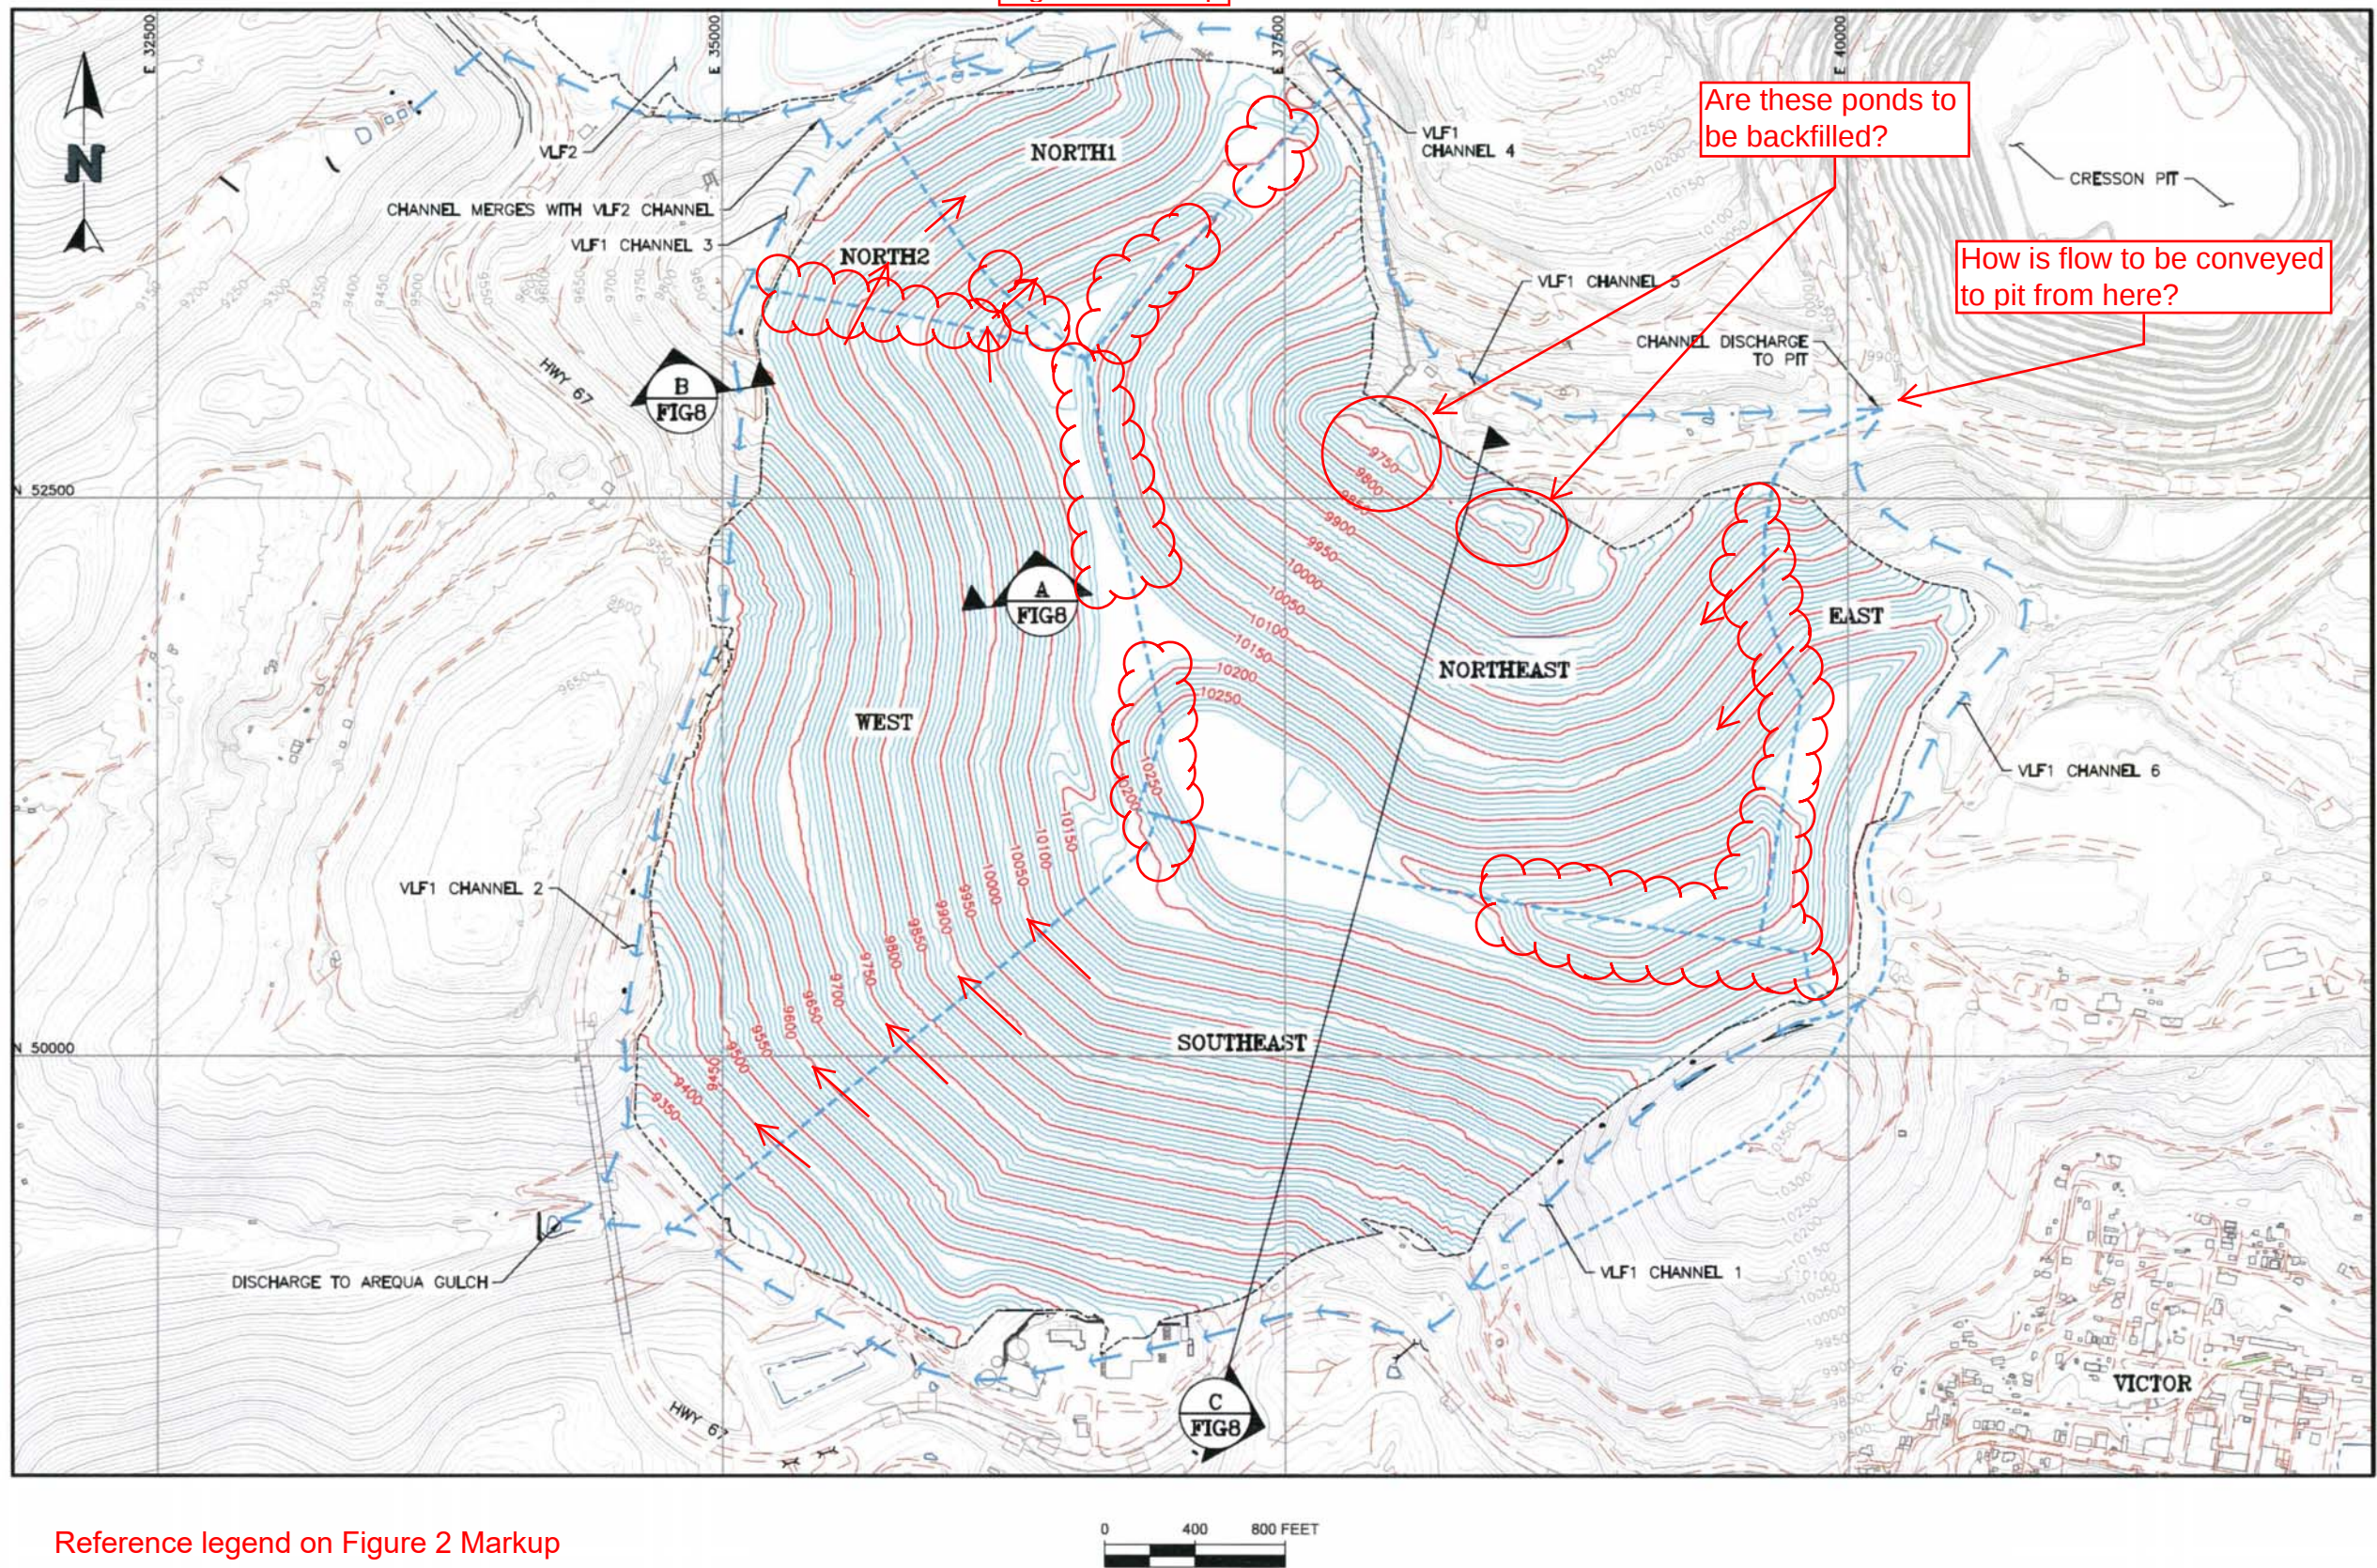
Figure 6 Markup

- a. Watershed delineation labels need to be added to the legend,
- b. Watershed delineations are inconsistent with the grading plan,
- c. How is runoff conveyed from the termination of the VLF1 Channels 5 and 6 to the Cresson Pit?
