April 23, 2020

**Re: Project, Permit No. M-1980-244;  
Stormwater Preliminary Adequacy Review, Amendment Application (AM-13)**

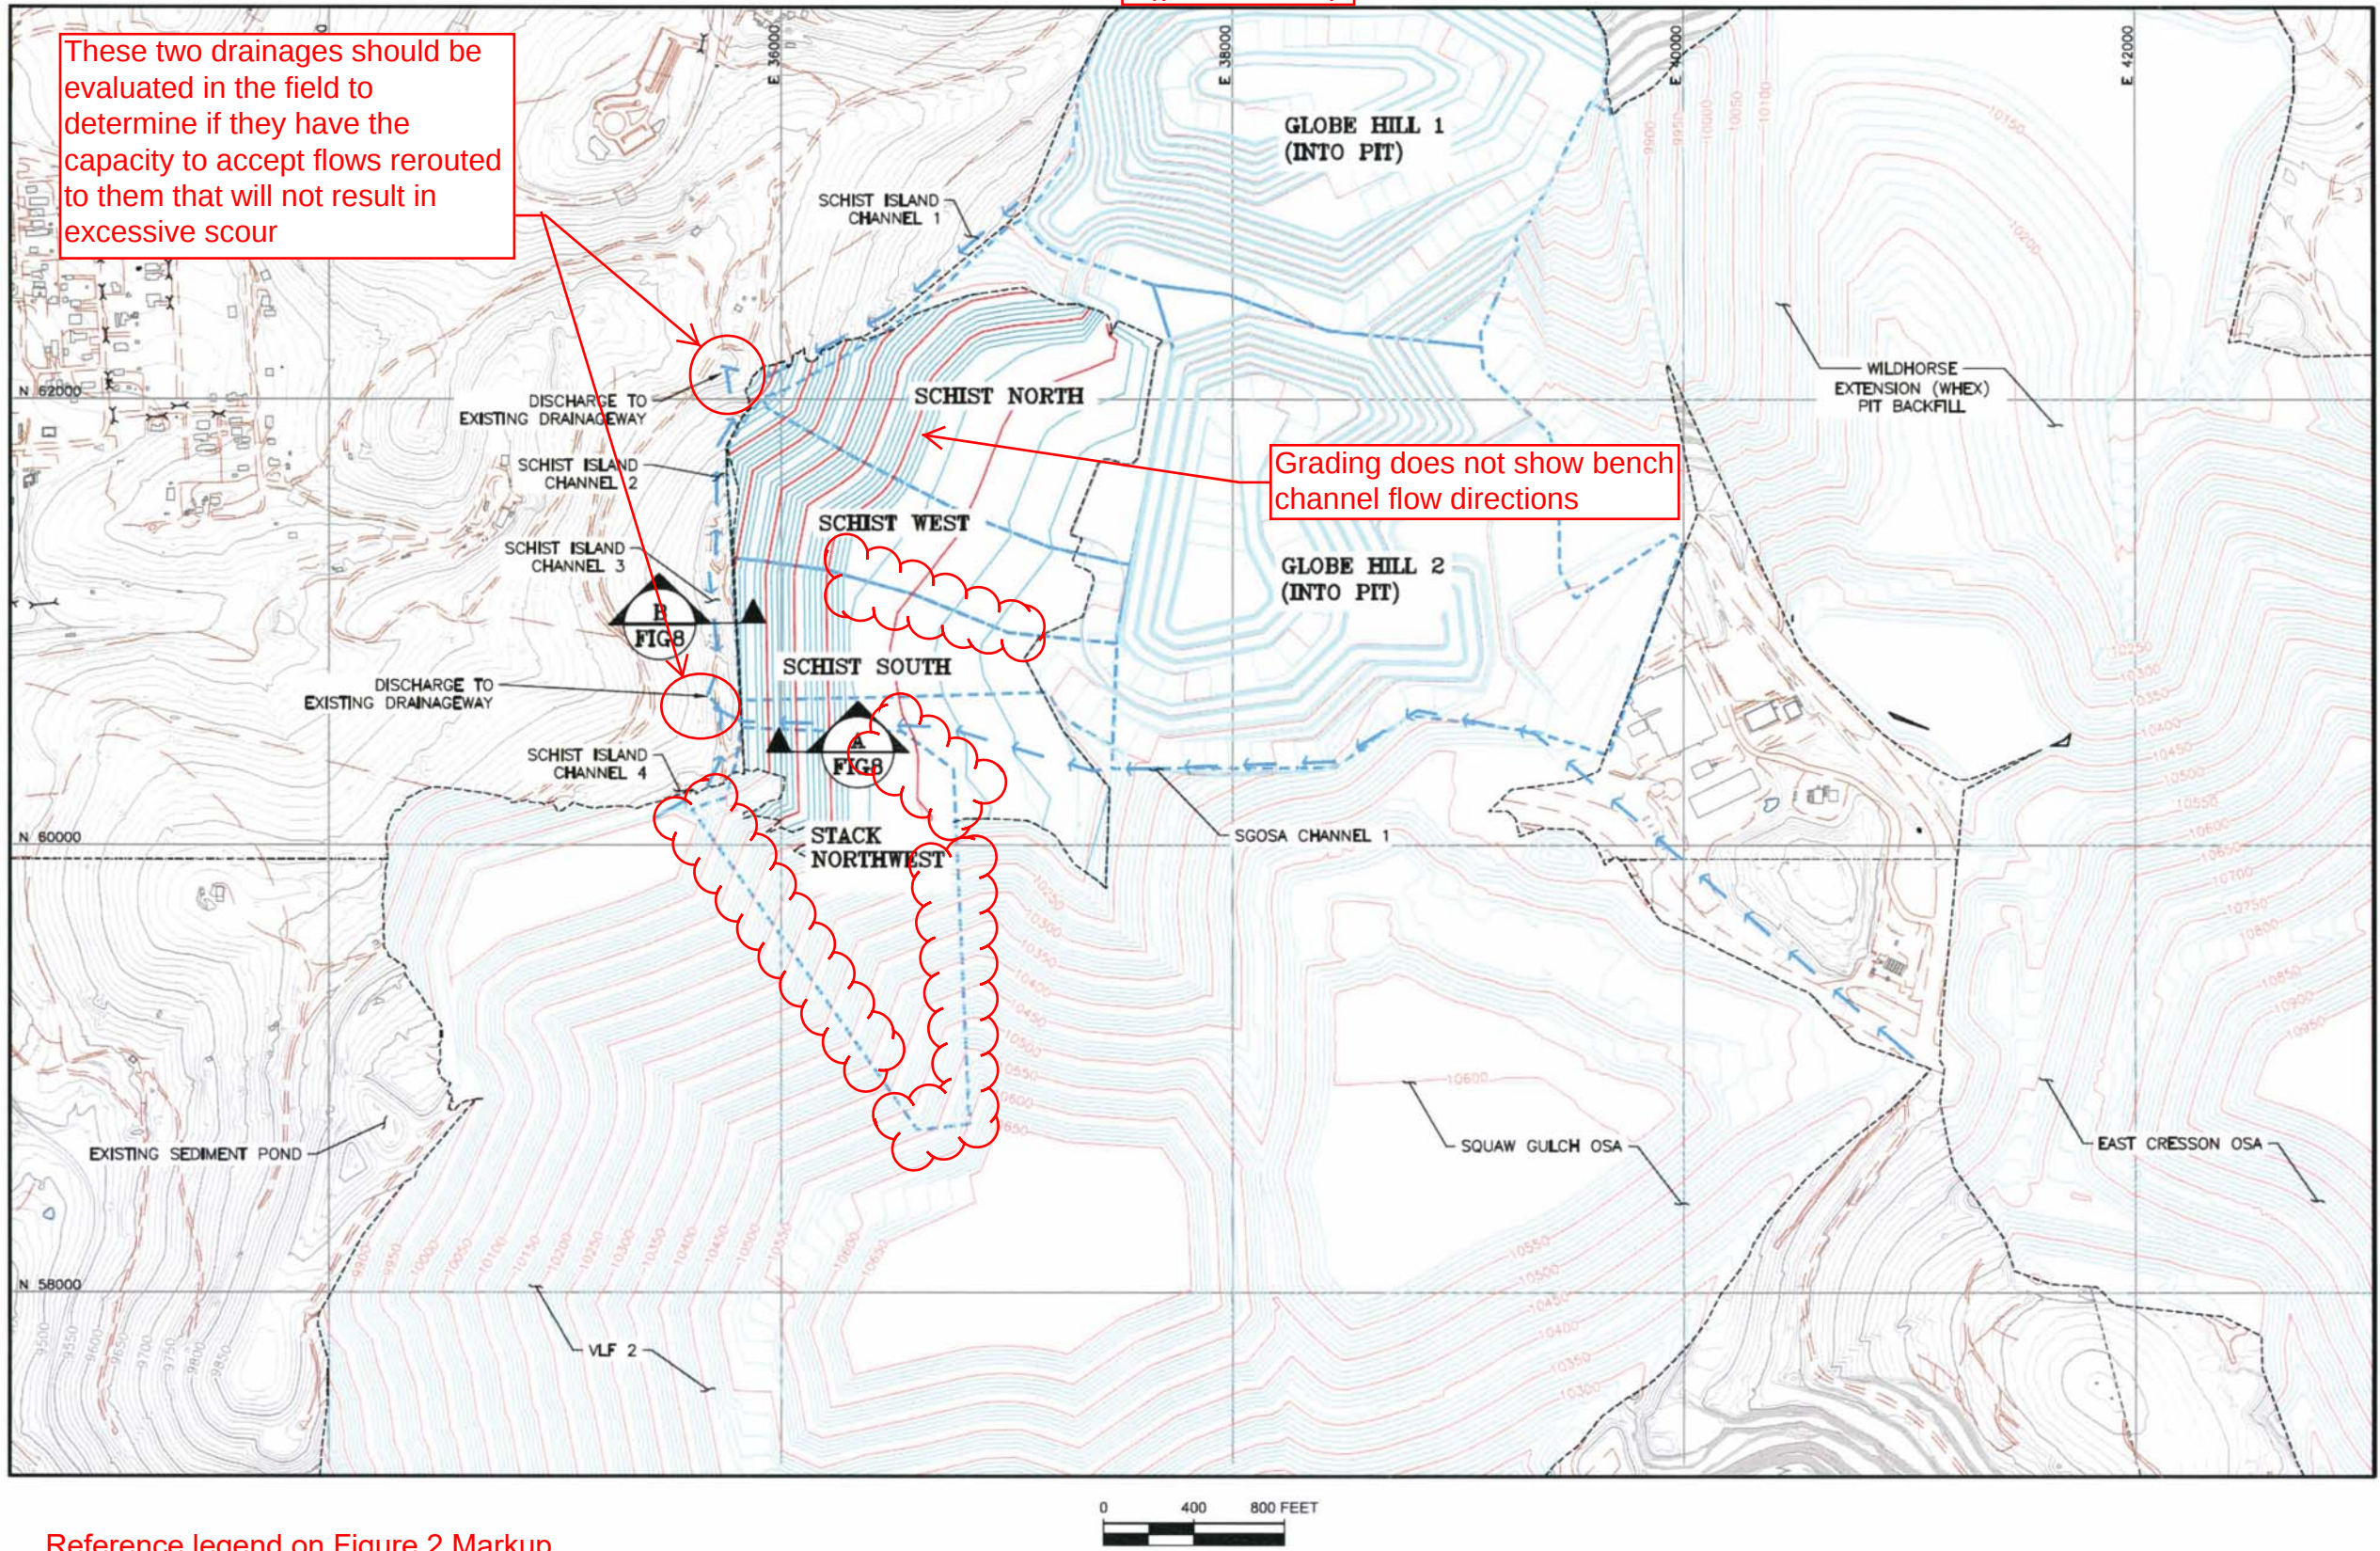
Figure 7 Markup

- a. Watershed delineation labels need to be added to the legend,
- b. There are two poorly defined drainages that may have considerable runoff directed to them. These should be evaluated in the field to determine if they have the capacity to accept flows rerouted to them that will not result in excessive scour.

These two drainages should be evaluated in the field to determine if they have the capacity to accept flows rerouted to them that will not result in excessive scour

Grading does not show bench channel flow directions

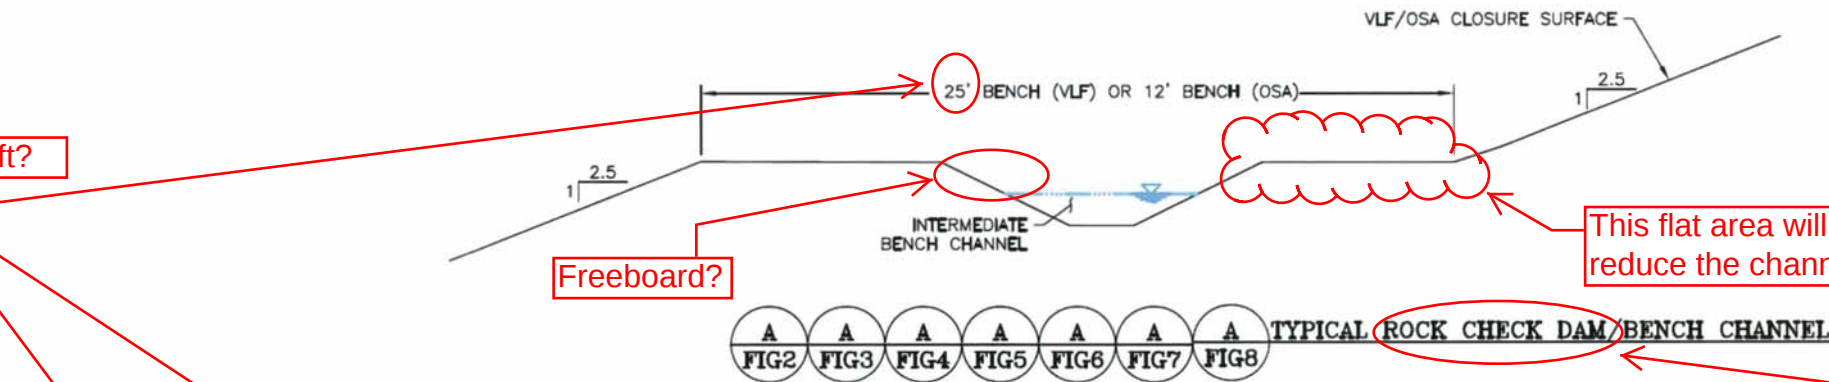
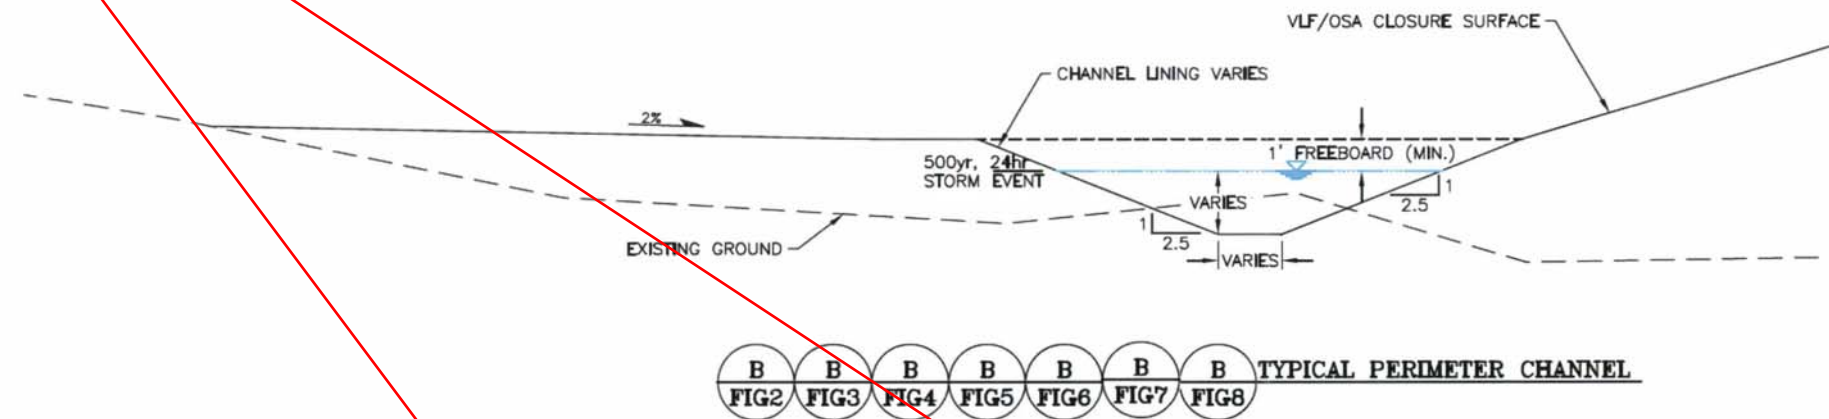
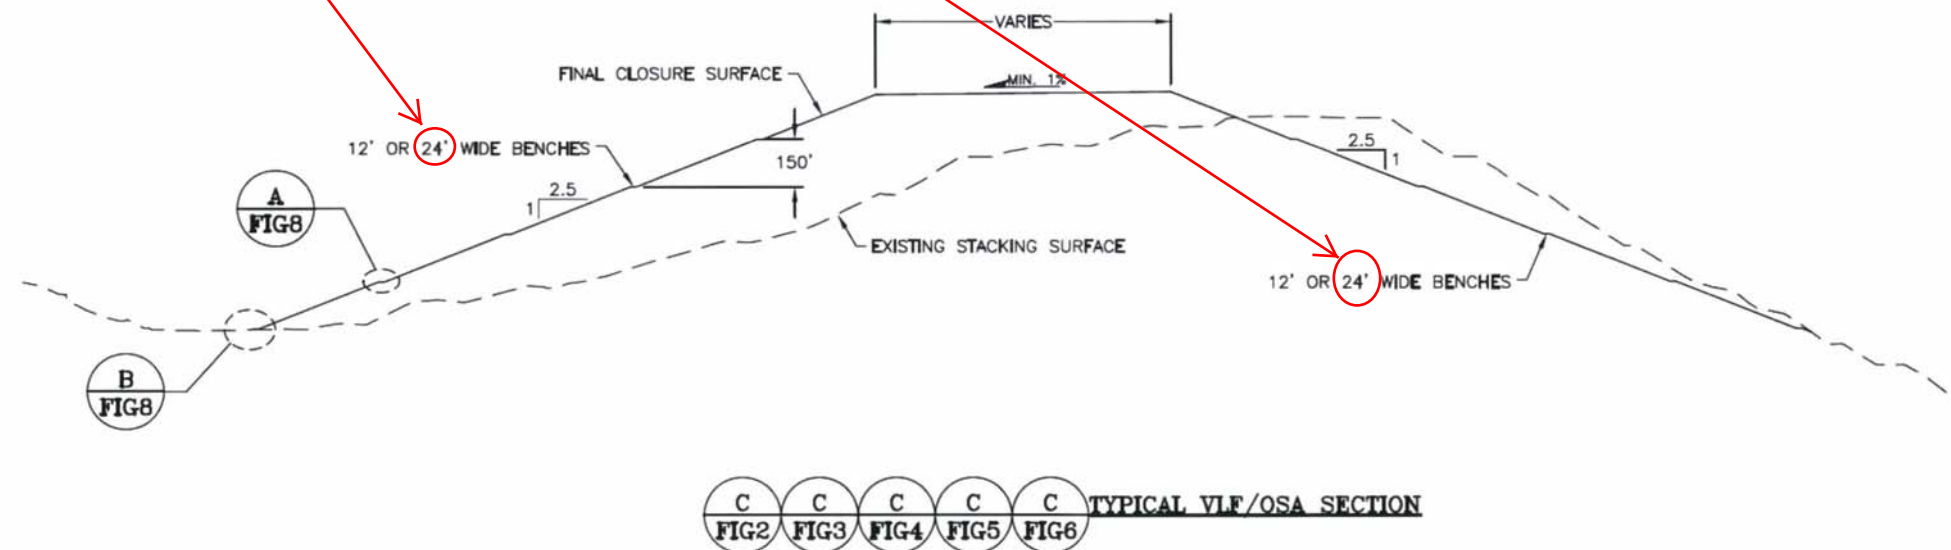
Figure 8 Markup

- a. There is a discrepancy between sections A and C as to whether the wider benches are 24 or 25 feet. Please correct as appropriate,
- b. This flat area between the upslope toe and the more centered bench channel will erode due to the runoff energy and generate sediment to reduce the channel capacity. Move the channel adjacent to the uphill slope to avoid this,

- c. Section A cites a “Rock Check Dam”. There are no details as to how a rock check dam would be integrated into the bench channel. This type of BMP would be expected to cause backwater conditions and likely lead to water levels exceeding the freeboard (also not specified) and resulting to overtopping, breakout erosion and channel failure. Please provide clarification and appropriate details.

Is it 24 ft or 25 ft?

Freeboard?

This flat area will erode due to the runoff energy and generate sediment to reduce the channel capacity. Move the channel adjacent to the uphill slope

How does a rock check dam fit in here?
