May 6, 2020

## Division Review No. 2; Notification of Water Quality Analysis Parameter Exceedance Re: February 27, 2020, Cresson Project, Permit No. M-1980-244

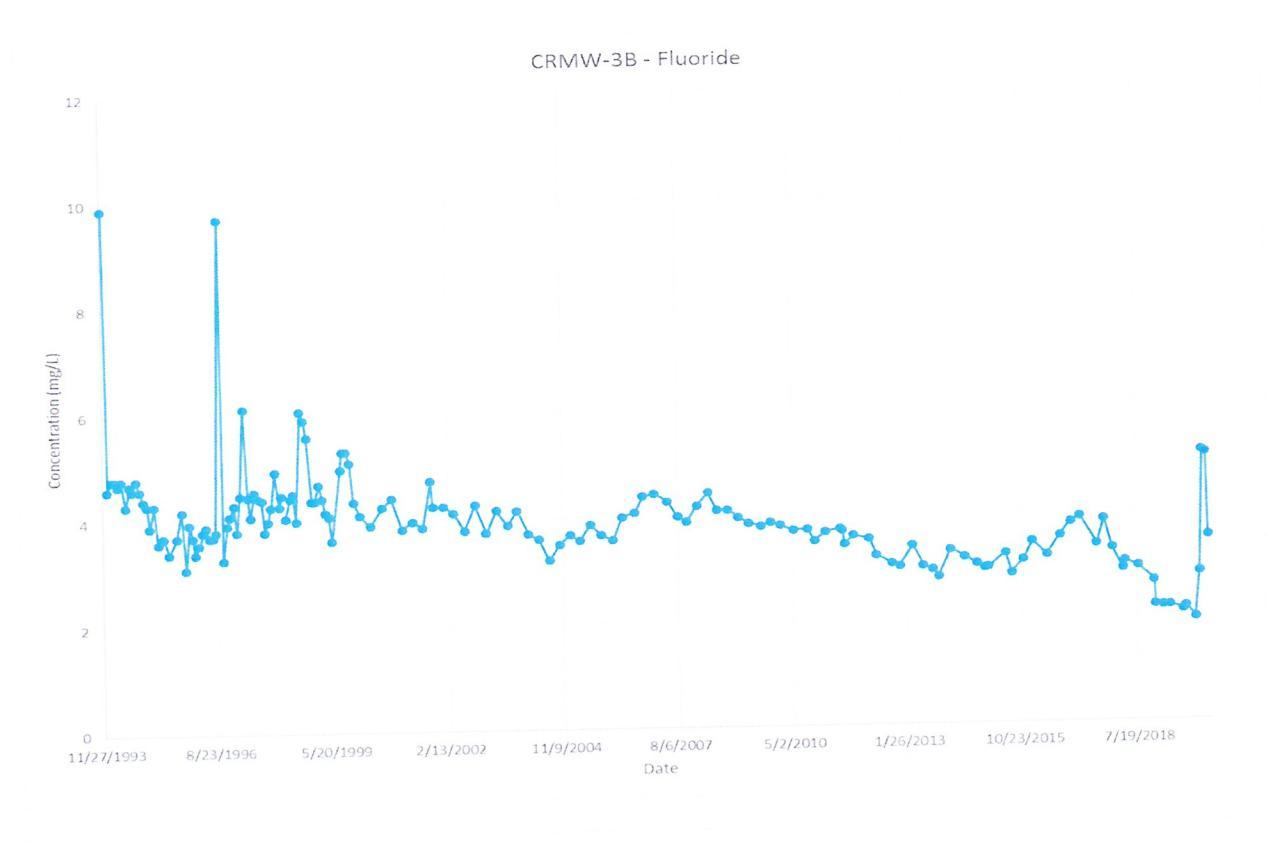
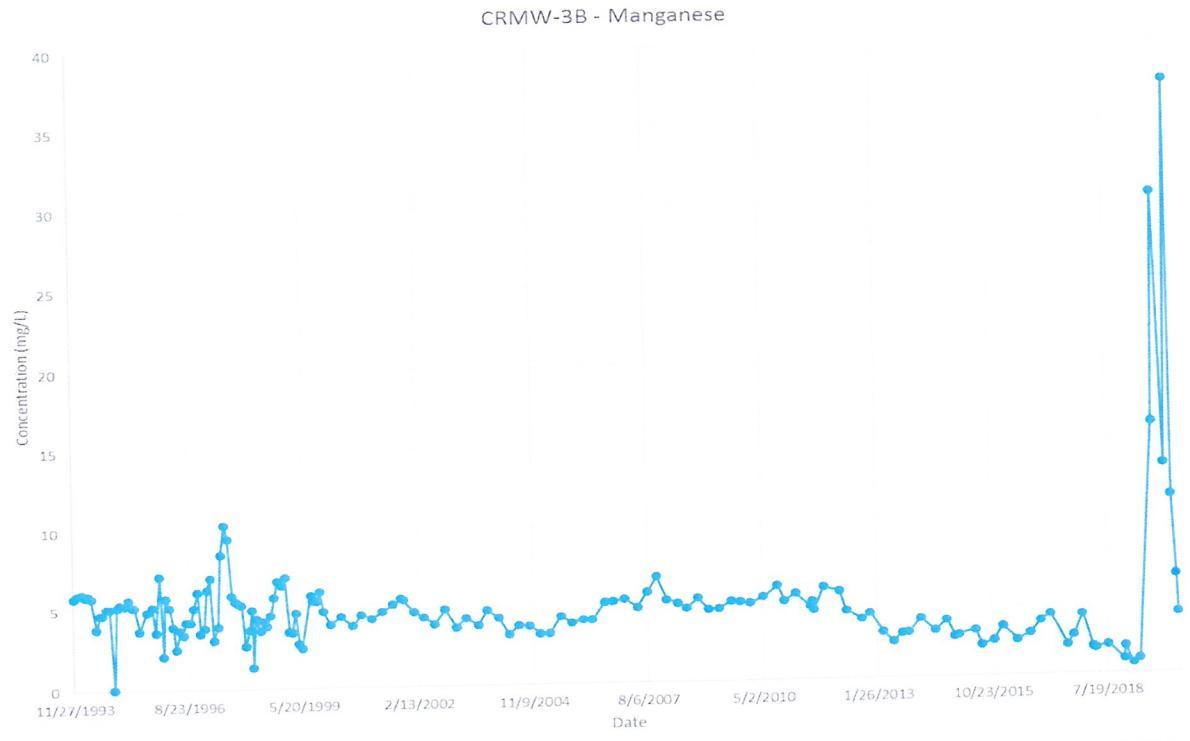
Continued sample collection demonstrates that the most recent observed fluoride and manganese concentrations at monitoring well CRMW-3B are consistent with historical concentrations (see attached CRMW-3B fluoride & manganese graphs). The data presented demonstrates that the water quality observed from Q3 2019 through Q1 2020 is the result of equipment failure and subsequent bio-fouling. The water quality observed in CRMW-3B from Q3 2019 through Q1 2020 was isolated to CRMW-3B and should not be interpreted as representative of groundwater quality in the area and should not be considered an impact to groundwater quality from CC&V's operations.

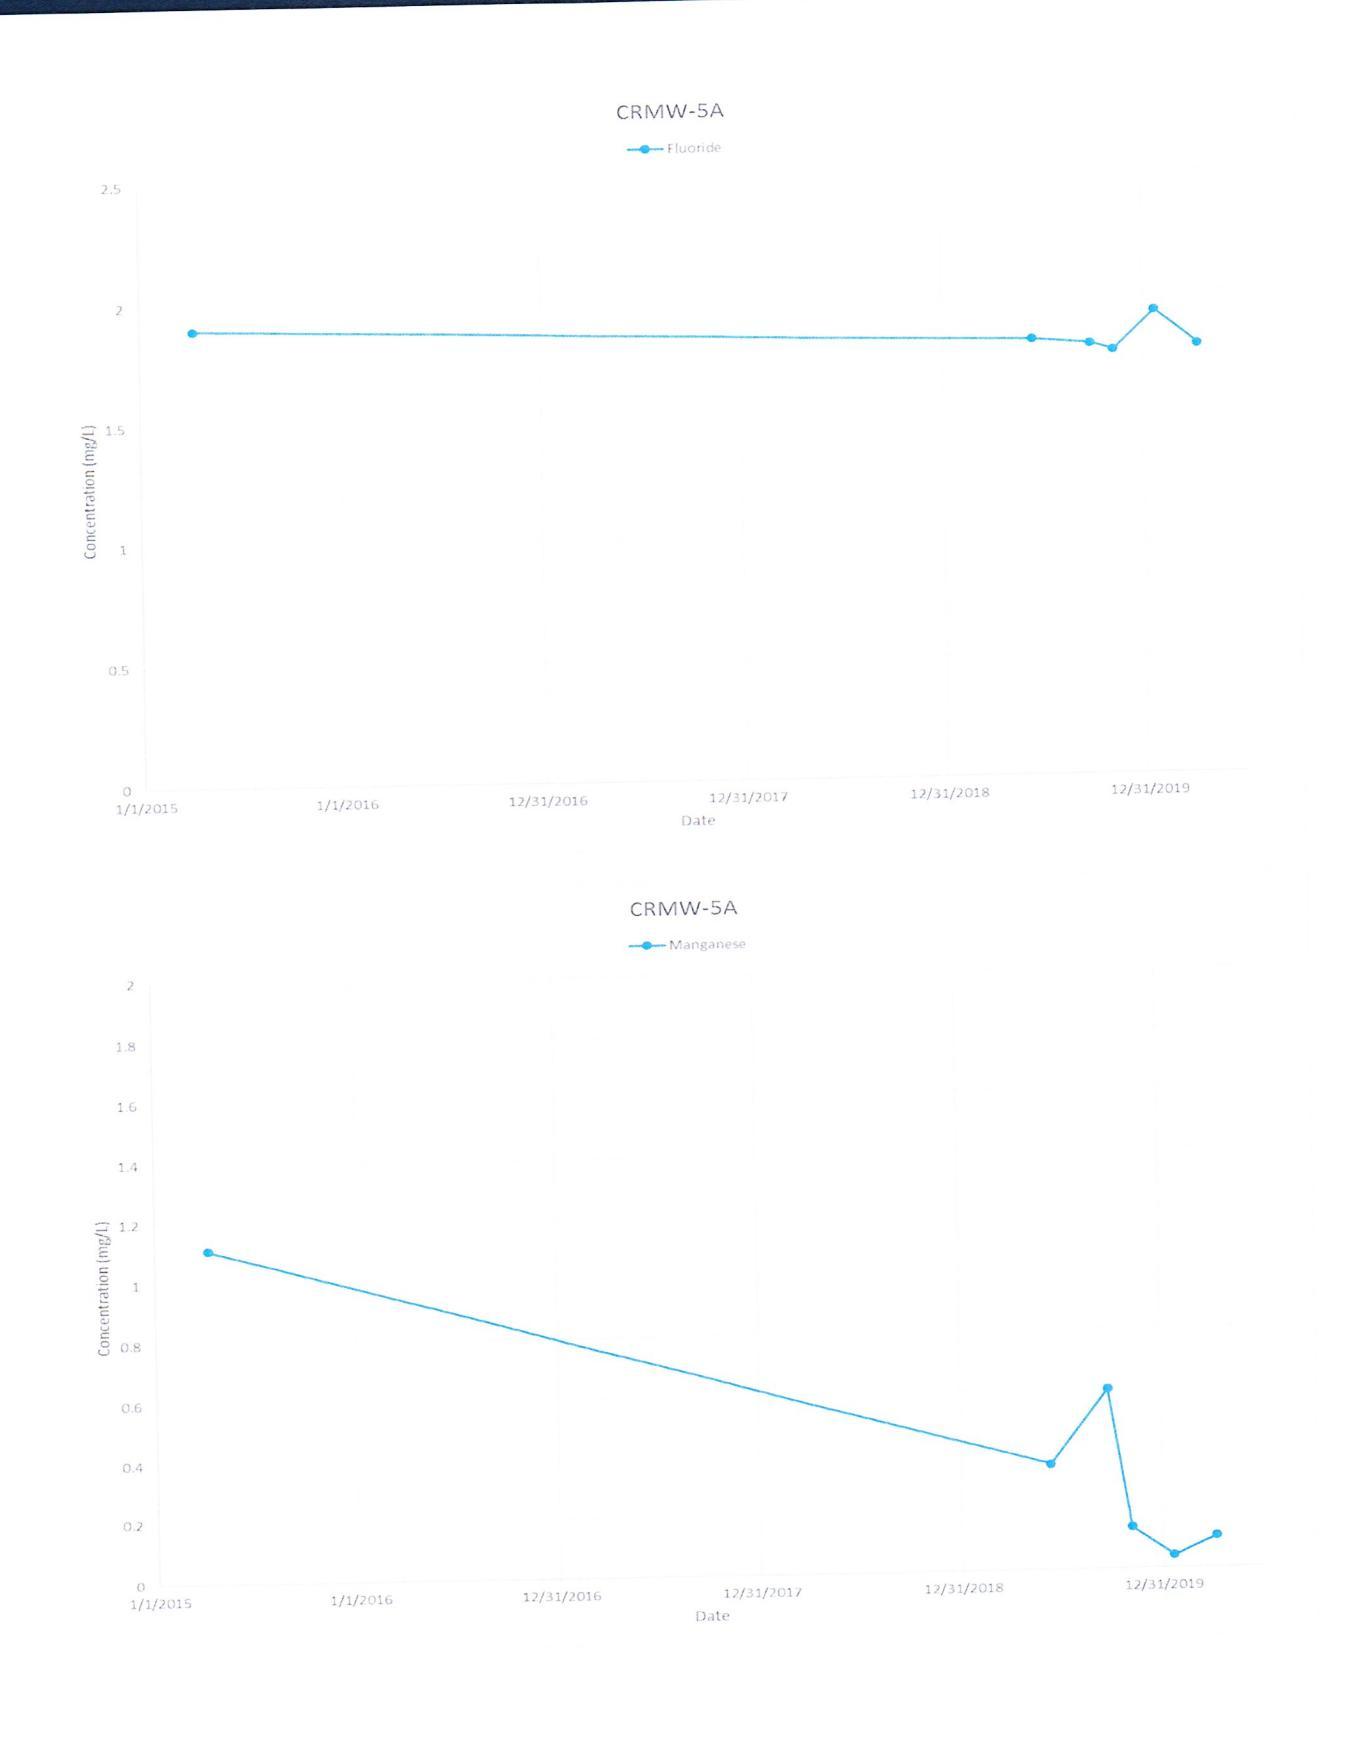
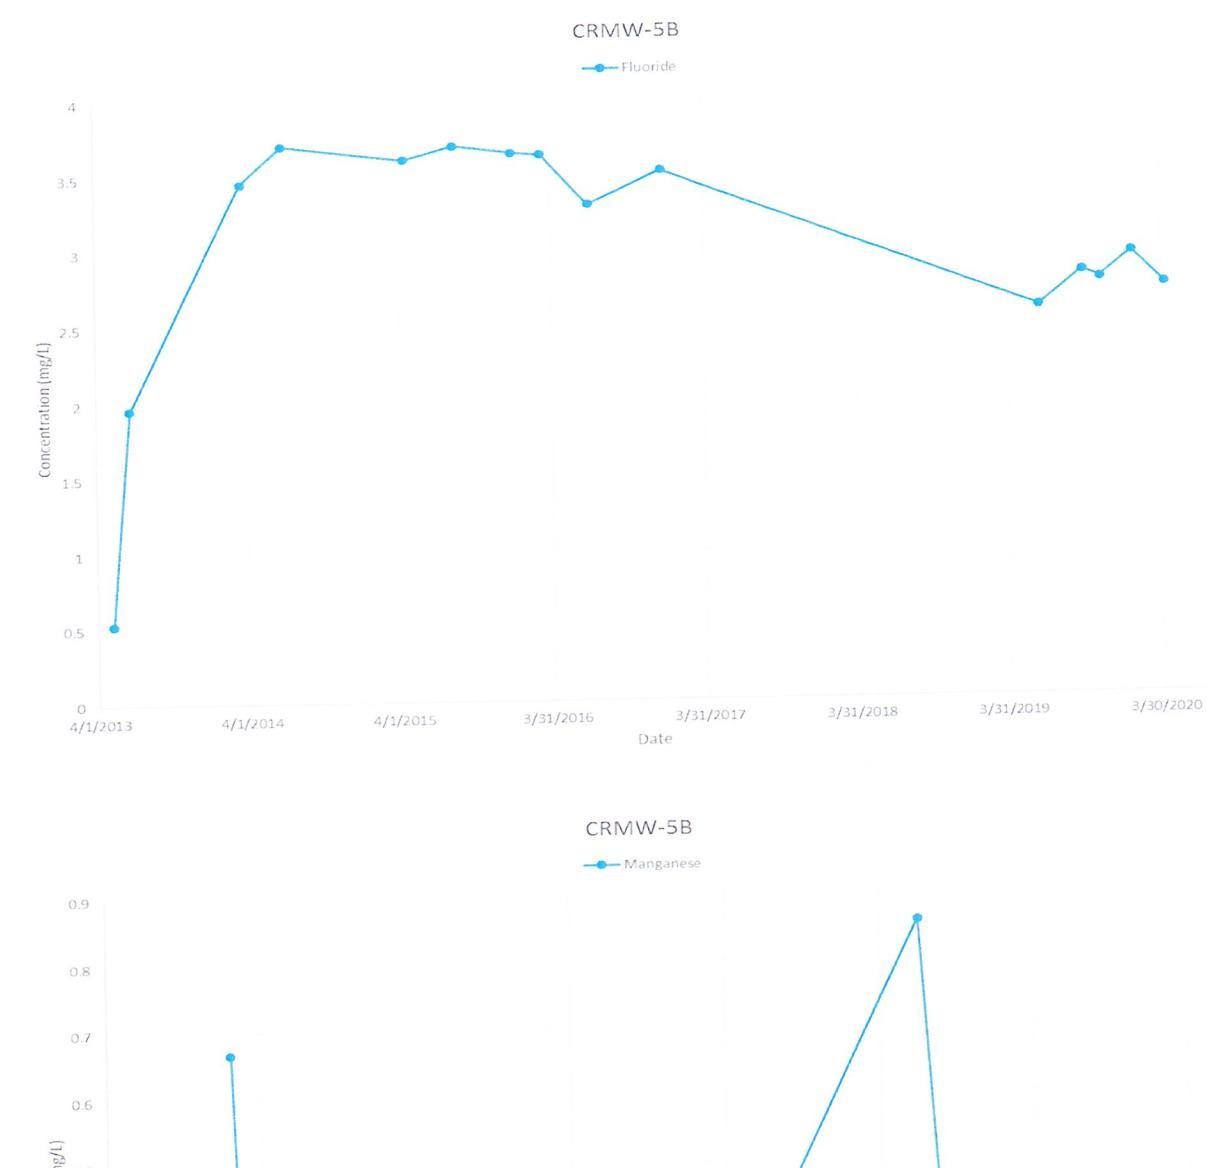
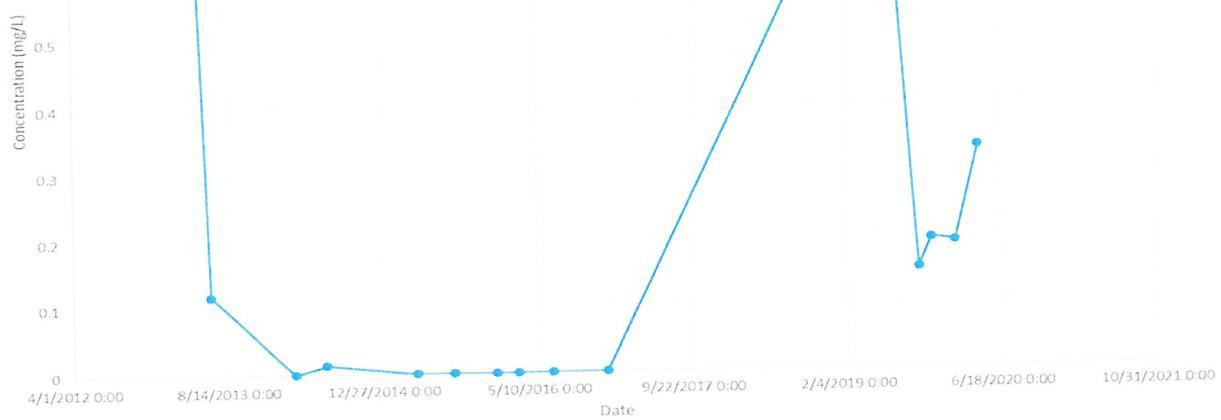
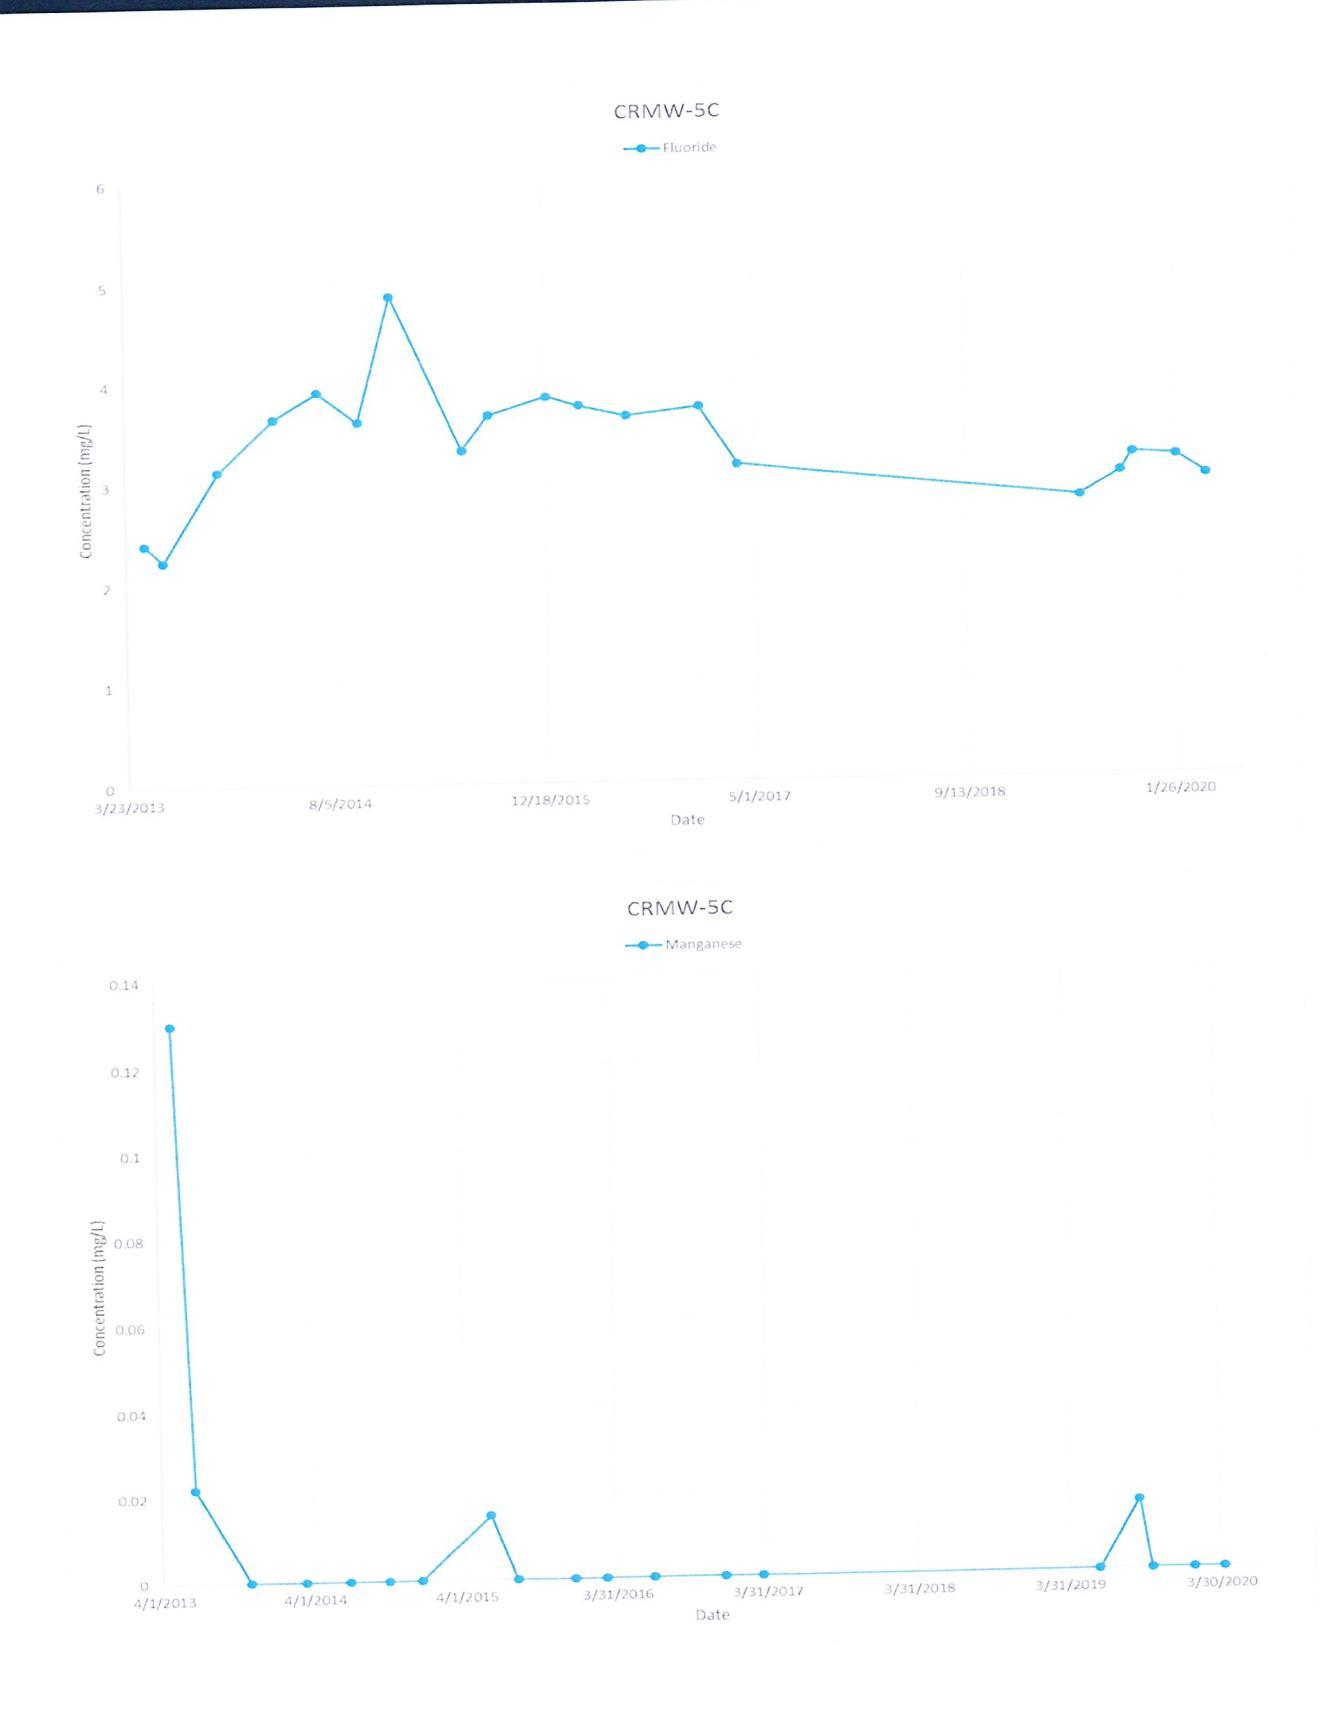
Please see the attached graphs for fluoride and manganese concentrations of the CRMW-5 (A-D) wells.
