# CC&V Permit M-1980-244 Written Release Notification, May 26, 2020

## Re: <u>Permit No. M-1980-244; Cripple Creek & Victor Gold Mining Company ("CC&V"); Cresson Project</u> - Written Release Notification - Refinery Sump Release - May 26, 2020

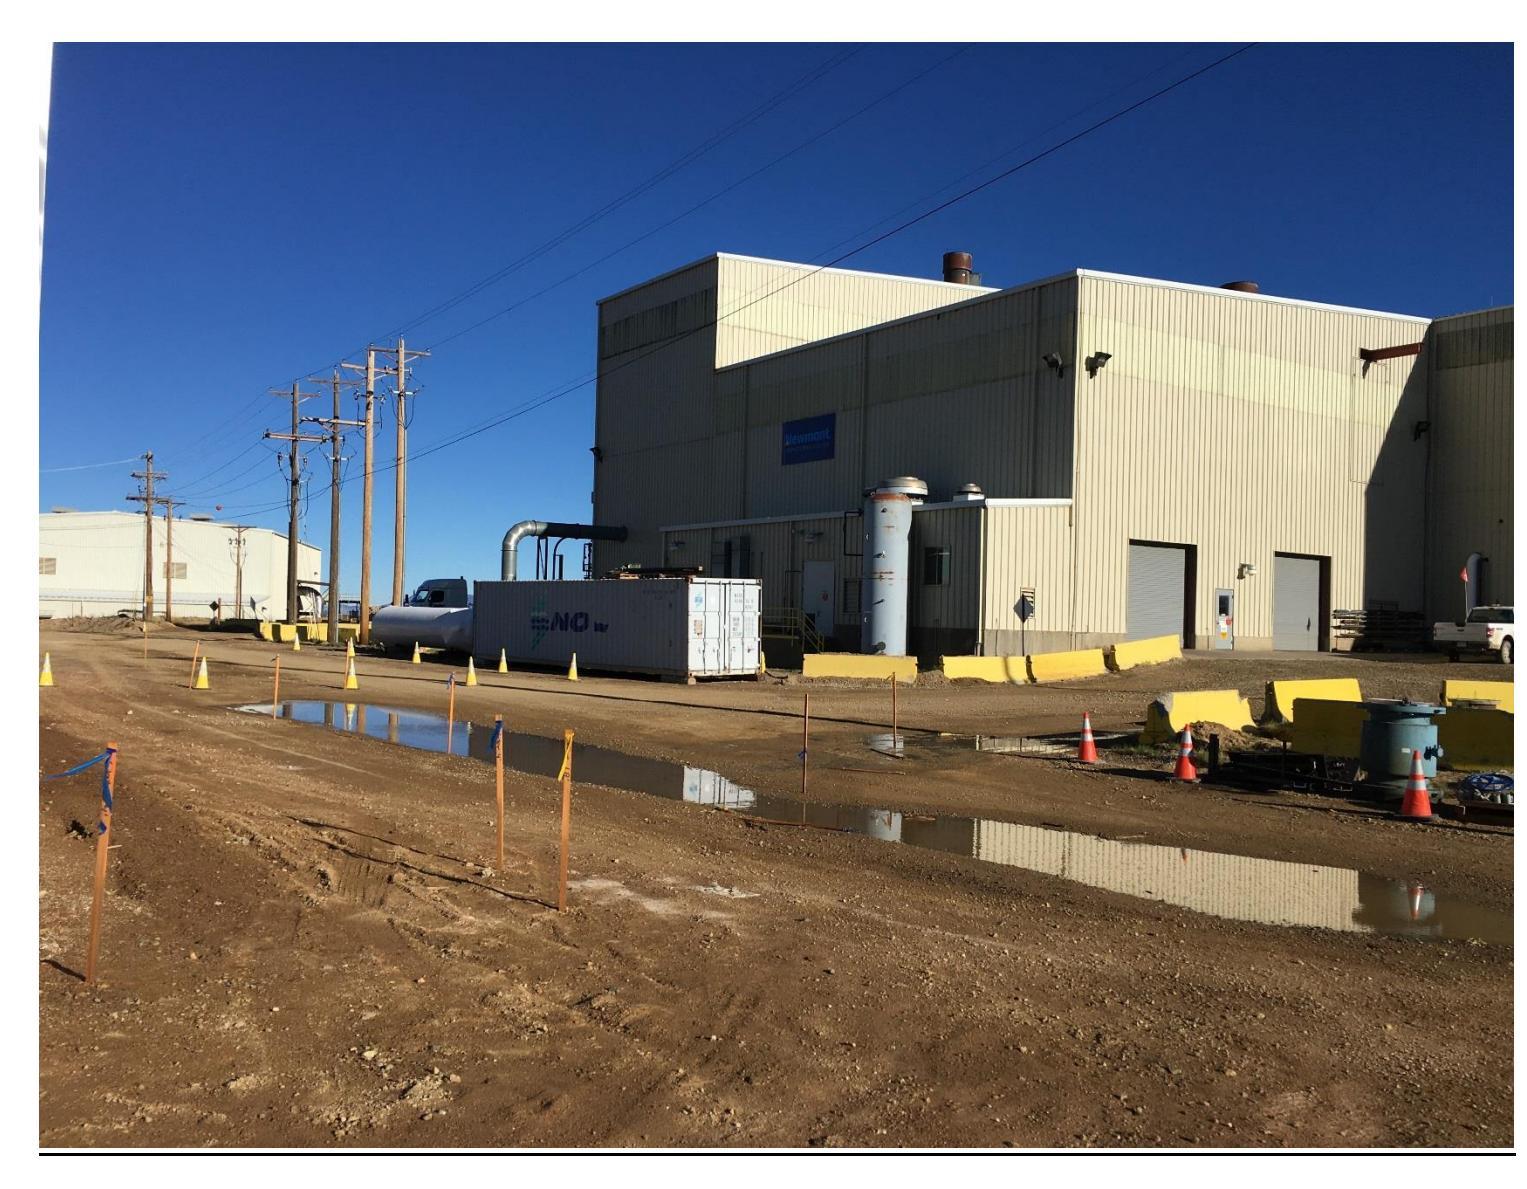
- At approximately 3:00 am personnel noticed the release and immediately restored power to the sump pumps, stopping the release.
- All of the water released from the refinery collected in a parking ditch and a low spot in the parking lot located in front of AGADR (see photos 1 and 2). Rainwater was already present in the same area from recent rainfall, which mixed with released water.

Photo 1: Photo of mixed rainwater and released water collected in the parking area in front of AGADR. [5-26-20]

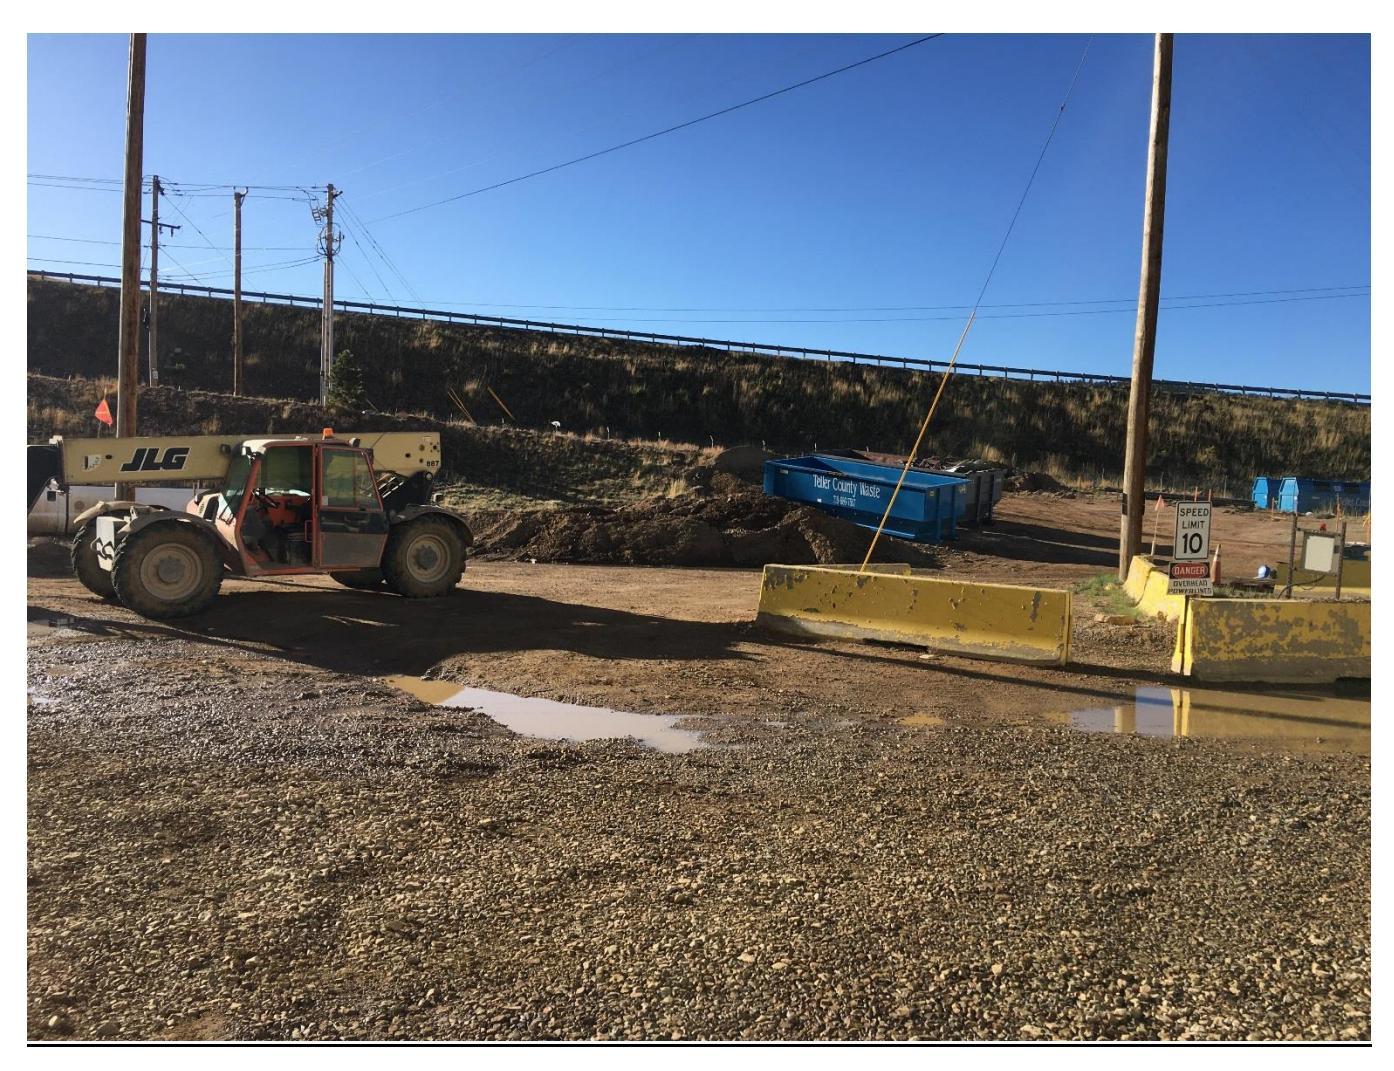
Photo 2: Photo of mixed rainwater and released water collected in the parking area in front of AGADR. [5-26-20]

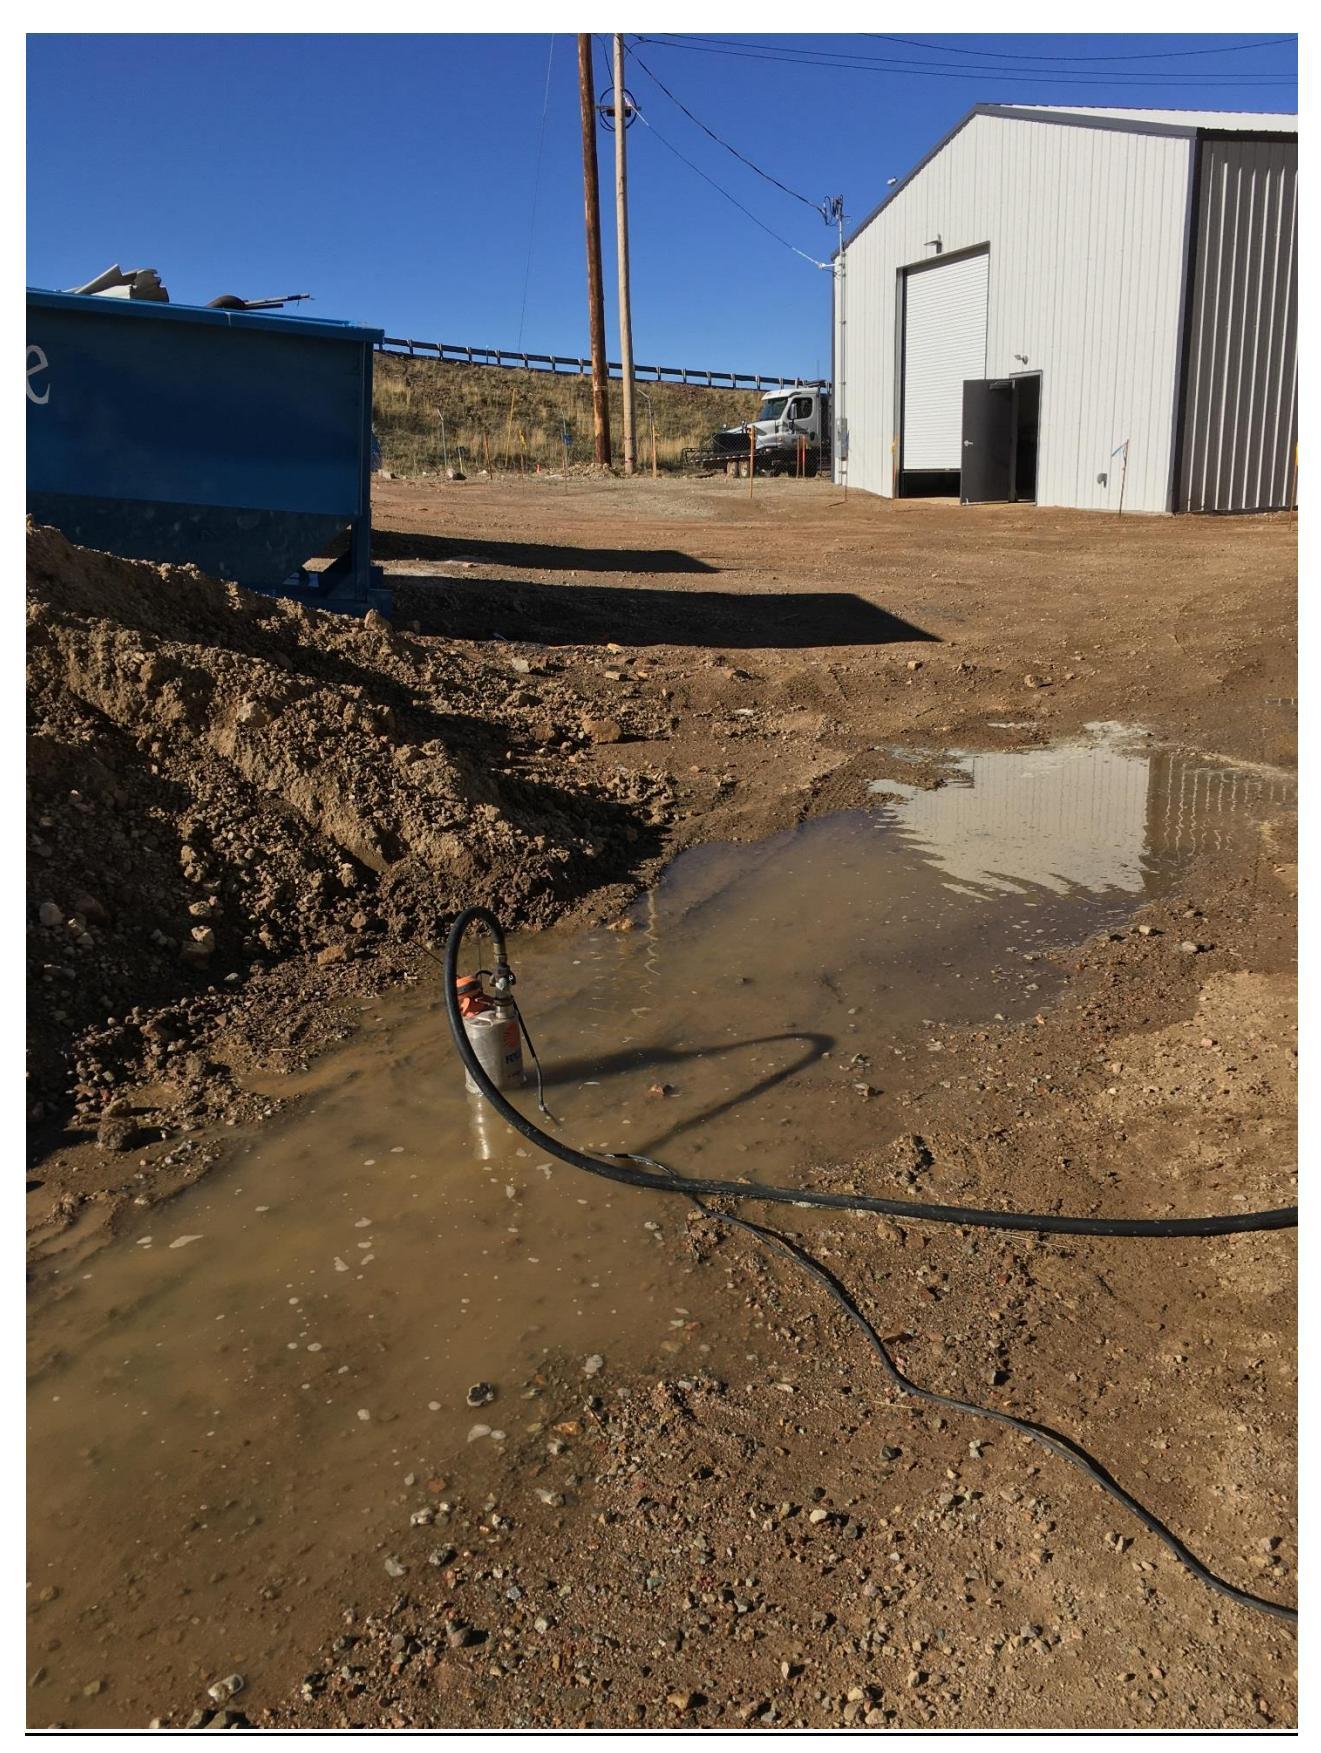
Photo 3: Submersible pump, removing the ponded water from the parking area. [5-26-20]

- A submersible pump was used to pump the pooled water from the collection areas back into AGADR (see photo 3). After ponded water was pumped back into AGADR, a skid steer was used to collect the impacted soil (see photo 4). The soil was removed using an 'over-excavation' approach. Depth of recovery was approximately six to twelve inches.

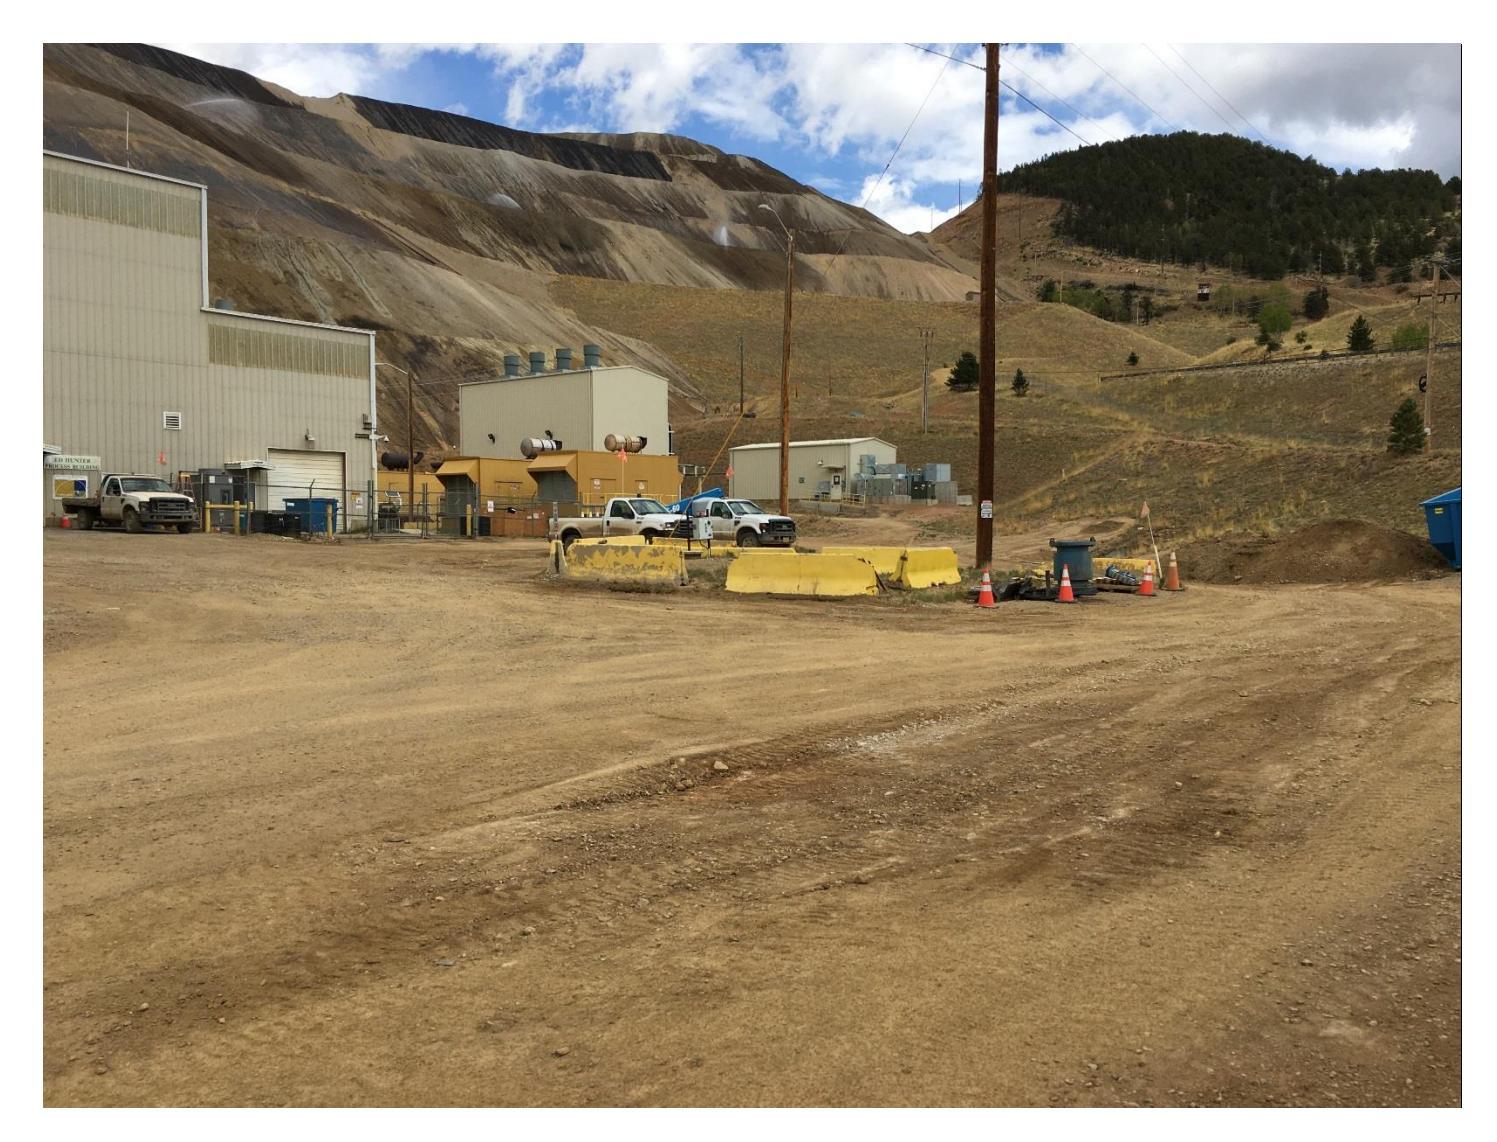
Photo 4: Over-excavated area in front of the refinery [5-27-20].

- Approximately 10 cubic yards of soil was excavated and transported to lined portions of the Arequa Gulch Valley Leach Facility.
- The over-excavated areas were filled in with clean fill and gravel.
