MINERALS PROGRAM INSPECTION REPORT PHONE: (303) 866-3567

MINE NAME:	MINE/PROSPECTING ID#:	MINERAL:	COUNTY:	
Dowe Flats Mine	M-1993-041	Limestone (general) and shale	Boulder	
INSPECTION TYPE:	INSPECTOR(S):	INSP. DATE:	INSP. TIME:	
Monitoring	Amy Eschberger	June 3, 2020	14:15	
OPERATOR:	OPERATOR REPRESENTATIVE:	TYPE OF OPERATION:		
CEMEX, Inc.	Cita Cisse, Robin Bay	112c - Construction Regular Operation		
REASON FOR INSPECTION:	BOND CALCULATION TYPE:	BOND AMOUNT:		
Normal I&E Program	Complete Bond	\$3,389,460.00		
DATE OF COMPLAINT:	POST INSP. CONTACTS:	JOINT INSP. AGENCY:		
NA	None	None		
WEATHER:	INSPECTOR'S SIGNATURE:	SIGNATURE DATE	SIGNATURE DATE:	
Clear	any Erchenger	June 5, 2020

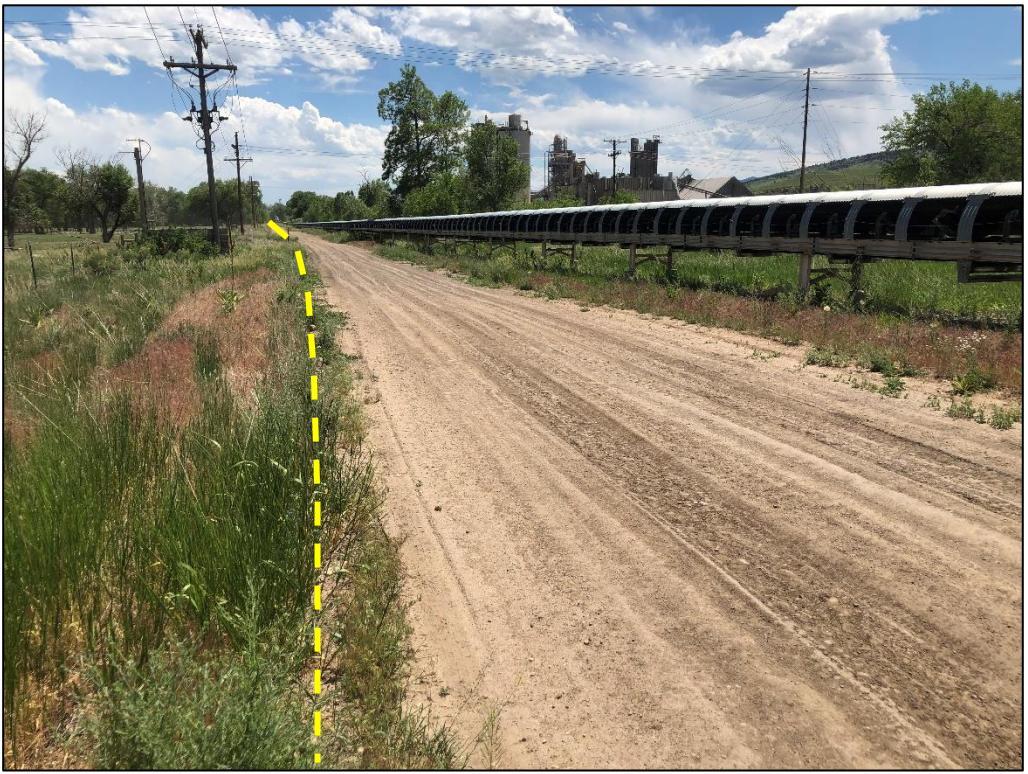
Photo 1. View looking south along eastern permit boundary (south of Hwy 66/Ute Hwy; approximate location indicated with yellow dashed line), which follows eastern edge of maintenance road that runs north-south along conveyor system.

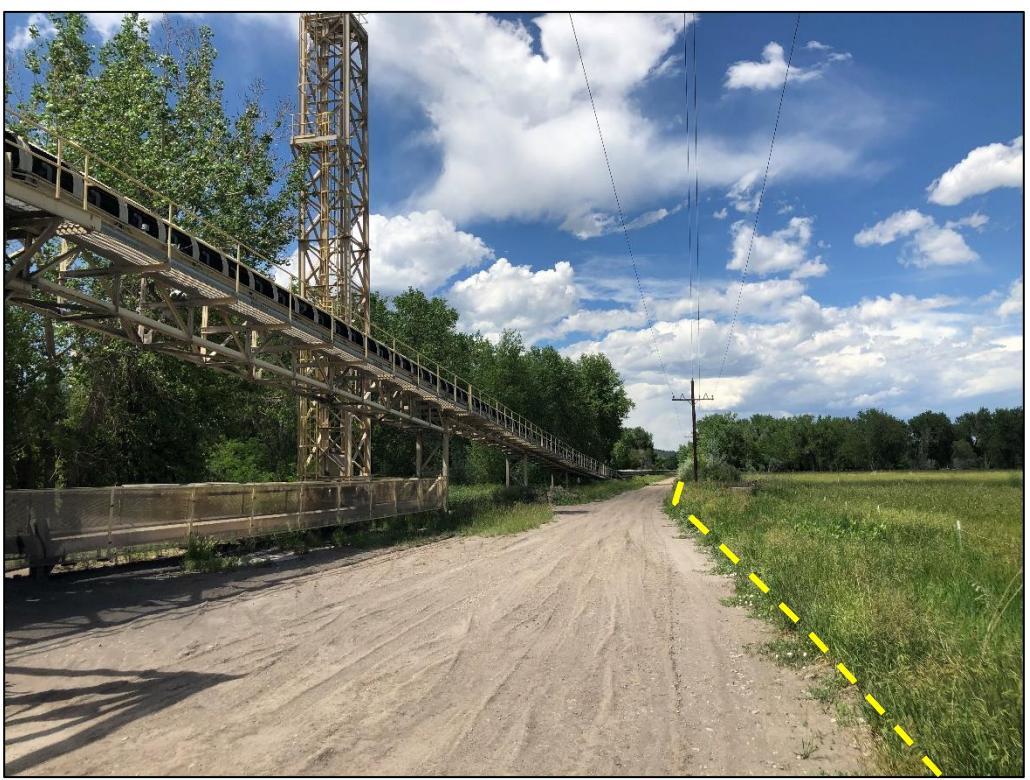
Photo 2. View looking north along eastern permit boundary (south of Hwy 66/Ute Hwy; approximate location indicated with yellow dashed line), which follows eastern edge of maintenance road that runs north-south along above-ground conveyor system.

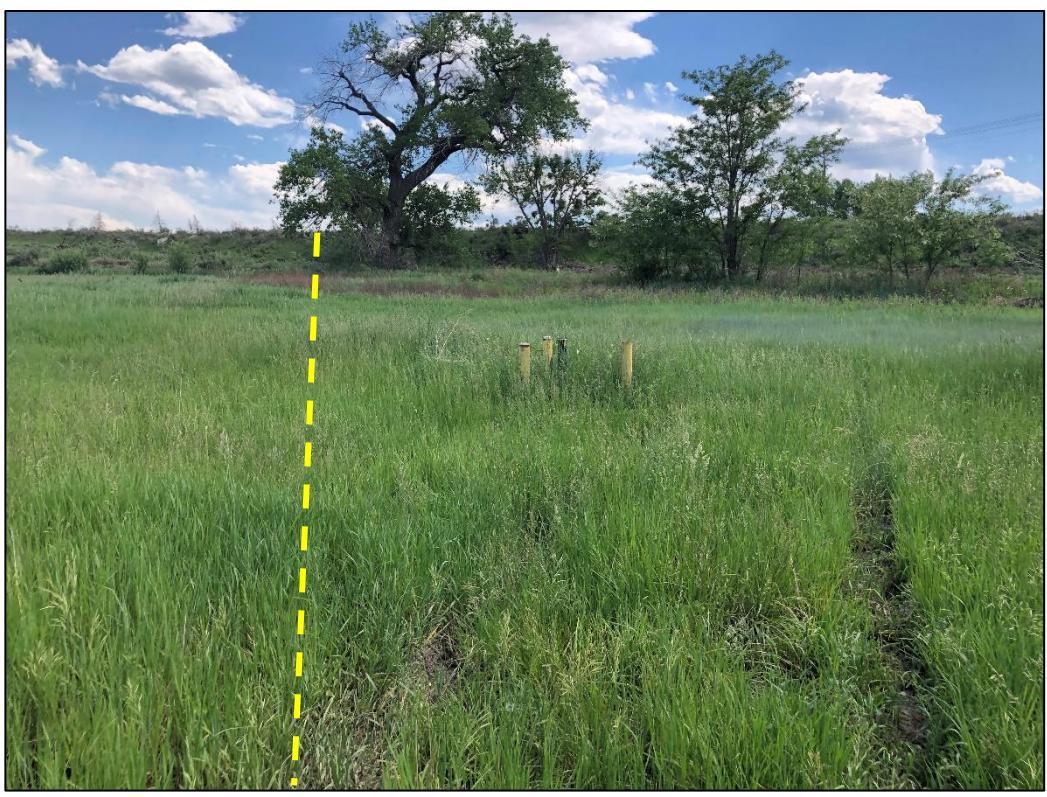
After conducting the last inspection, the Division was unable to find updated mining and reclamation plan maps in the permit file which depict the entire approved permit boundary and affected land boundary, particularly the portion located south of Hwy 66/Ute Hwy. Since then, the operator has provided updated maps (in TR-04) showing the entire approved permit boundary (see enclosed maps). During the inspection, the Division observed the portion of the permit area located south of Hwy 66/Ute Hwy in correlation with the permit boundary shown on the updated maps. Portions of the southern permit boundary are delineated by features such as roads, making them easier to trace in the field. For example, the eastern boundary follows the eastern edge of the maintenance road that runs along the eastern edge of the above-ground conveyor system. Other portions of the southern boundary, particularly the portion closer to Hwy 66/Ute Hwy, were more difficult to trace due to their lack of delineation in the field. The Division understands a portion of the southern permit boundary overlaps the permit area for the operator's other permit boundary to be marked by monuments or other markers that are clearly visible and adequate to delineate such boundaries. Therefore, the operator will need to place posts or other markers at least at the corners of the approved permit boundary so it can be easily traced in the field. The Division will follow up on this matter during its next inspection.

Photo 3. View looking south along eastern permit boundary (south of Hwy 66/Ute Hwy; approximate location indicated with yellow dashed line), which terminates in the vicinity of the large tree in the background. The corners of the permit boundary need to be marked with posts or other markers.

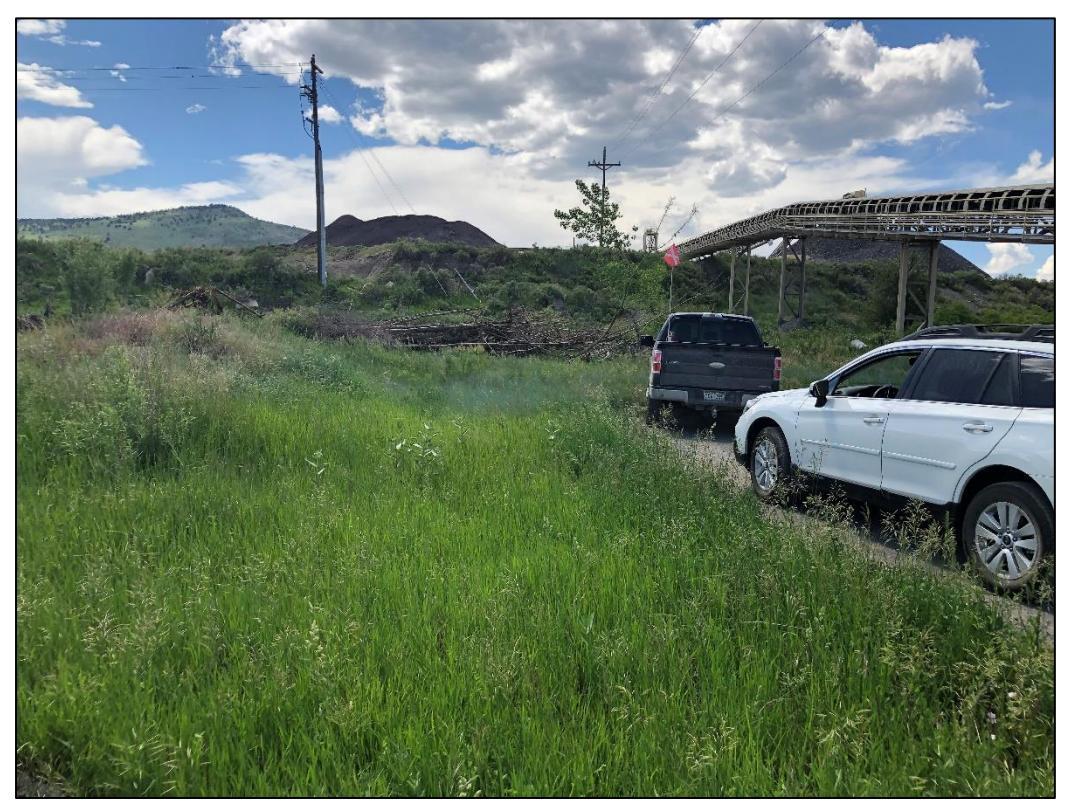
Photo 4. View looking west toward stockpiling area (on other side of berm) where conveyor deposits material mined and crushed in northern portion of permit area, north of Hwy 66/Ute Hwy. The area shown in this photo is included in the southern portion of the permit area for Dowe Flats Mine.

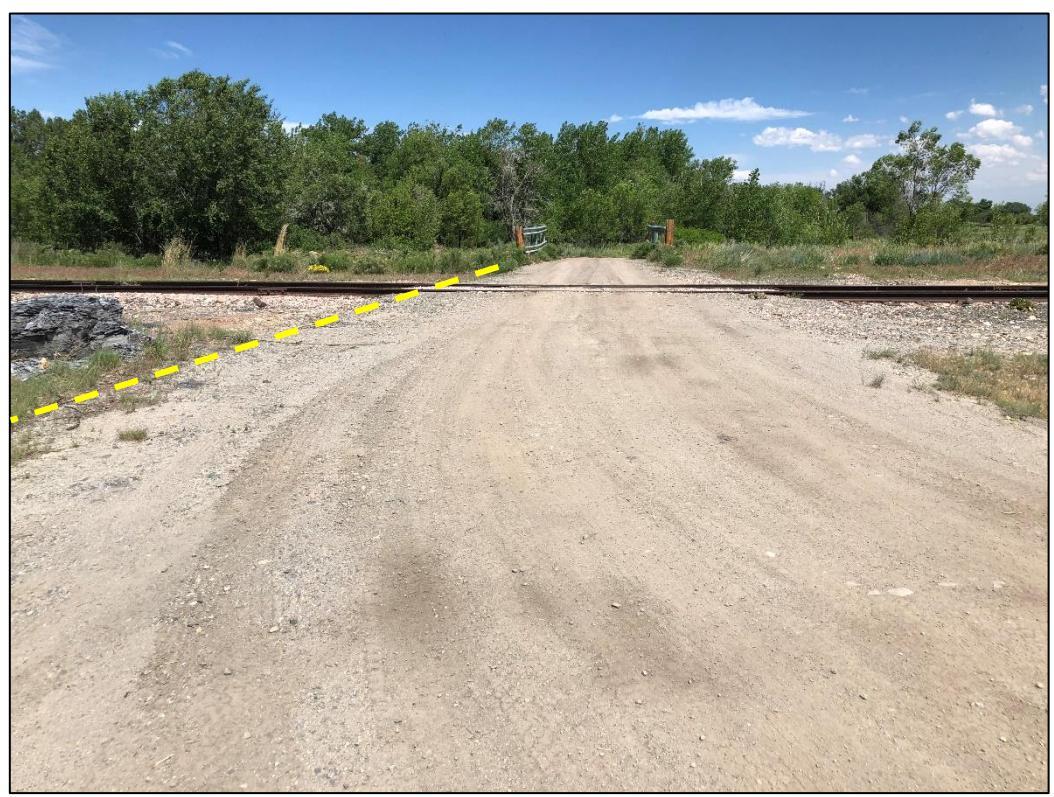
Photo 5. View looking east across maintenance road which crosses railroad tracks then runs south adjacent to conveyor system. A portion of the permit boundary (south of Hwy 66/Ute Hwy) runs along the northern edge of this road (approximate location indicated with yellow dashed line).

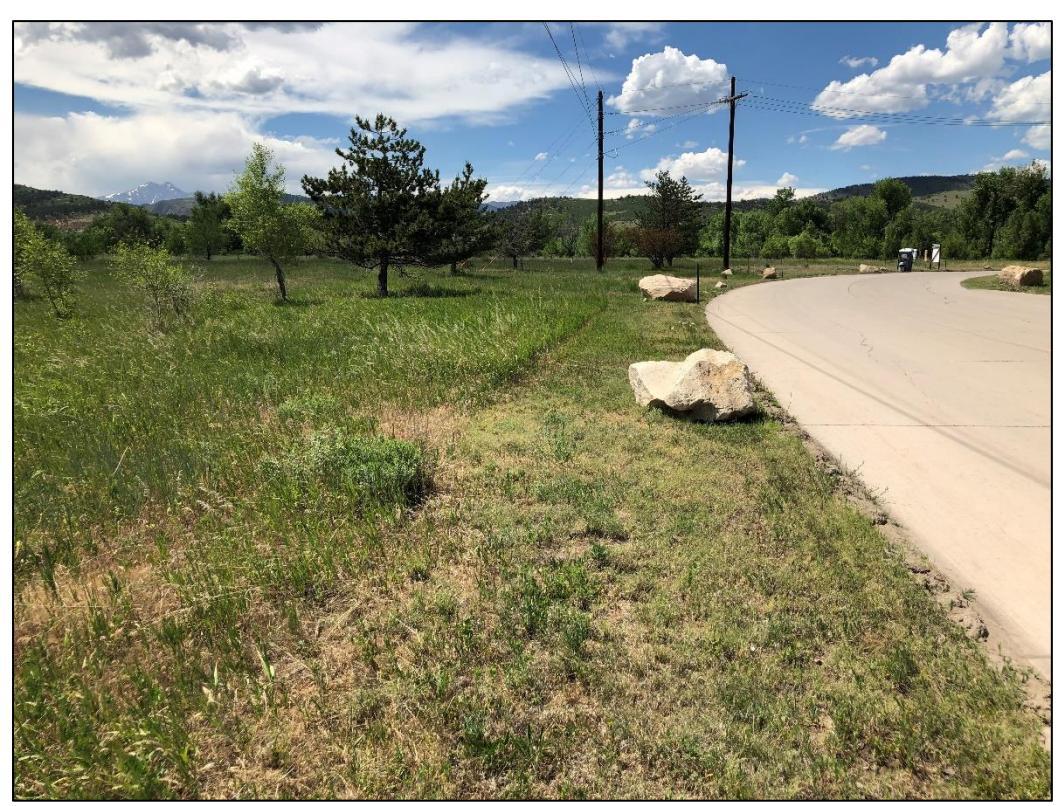
Photo 6. View looking north from main access road. The permit area includes this portion of the access road and extends to the east and west of the road. The corners of the permit boundary in this area need to be marked with posts or other markers.
