January 28, 2020

Asphalt Paving Co., Ralston Quarry M-1974-086
Technical Revision – Modifications to Slide Repair Designs and Plans

**Limited Geotechnical Evaluation
Slope Stability and Remediation Approach
Ralston Quarry
Jefferson County, Colorado
Revised6**

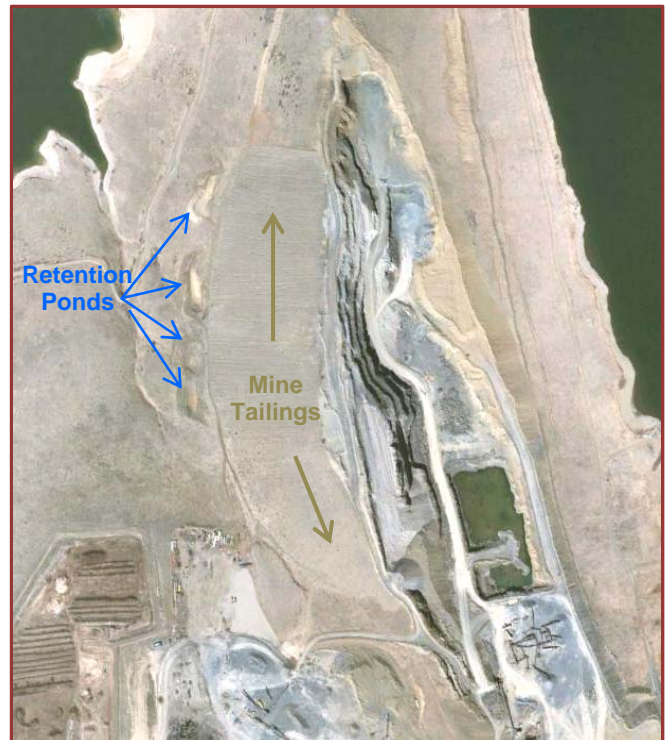
Area of Tailings Placed on West-facing Slope

Actual mining has been from the eastern side of the ridge. We understand that until approximately 20 years ago, tailings from the mining on the east side of the ridge were placed as fill on the west-facing side. The filled slope was graded at an approximately 2½ : 1 (horizontal : vertical) angle. In the early 2000's, several retention ponds also were constructed along the toe of the fill slope. These features are indicated in the historical Google Earth® image (above right).

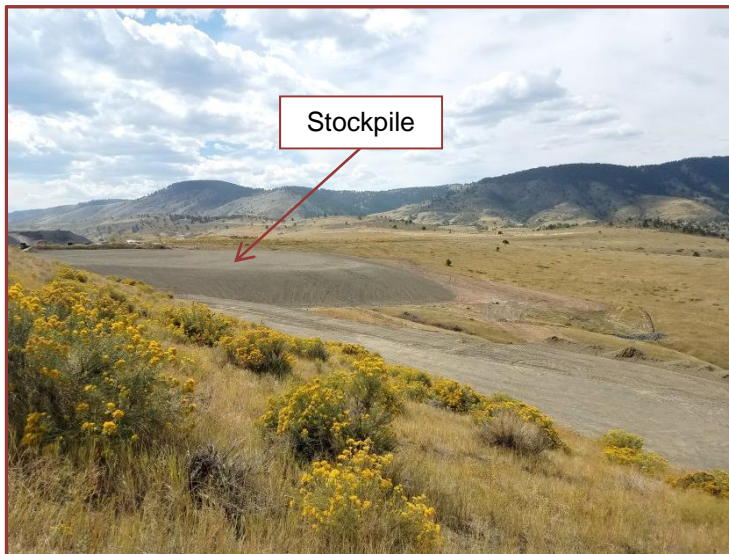
The stockpile extends over an area about 360 feet by 420 feet and is up to approximately 25 feet in thickness. The stockpile margin slopes descending to the north and to the west were graded at an angle of about 3 : 1 (horizontal : vertical) or slightly flatter as shown in the photographs below.

Stockpile of Relocated Tailings, seen from the northeast

The final configuration of the stockpile should be designed to direct surface water away from the taller northern and western slope faces and into appropriate drainage pathways. Periodic maintenance of the stockpile should be performed to correct ponded areas and re-establish effective surface drainage as well as repair sloughed or eroded areas on the slopes.

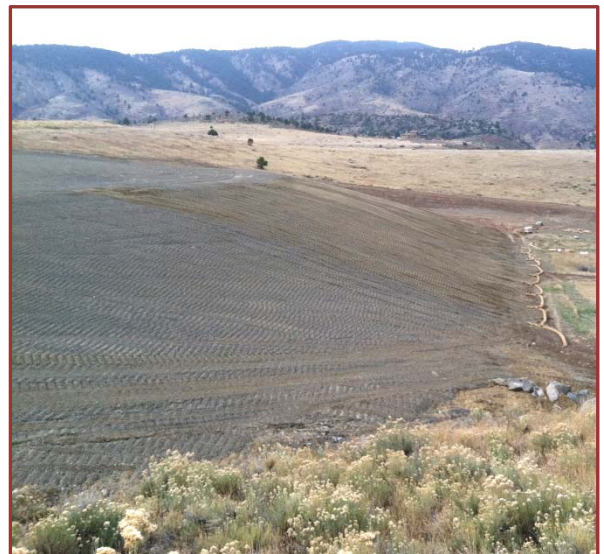
Northern Slope of Stockpile of Relocated Tailings

Scrapers were used to construct the stockpile, bringing material from the slope. An average penetration resistance value (sampler blow count, **N**) of 14 was obtained from the test holes advanced into the stockpile (Test Holes 10 and 11) indicating that the fill materials comprising the stockpile were reasonably well compacted.

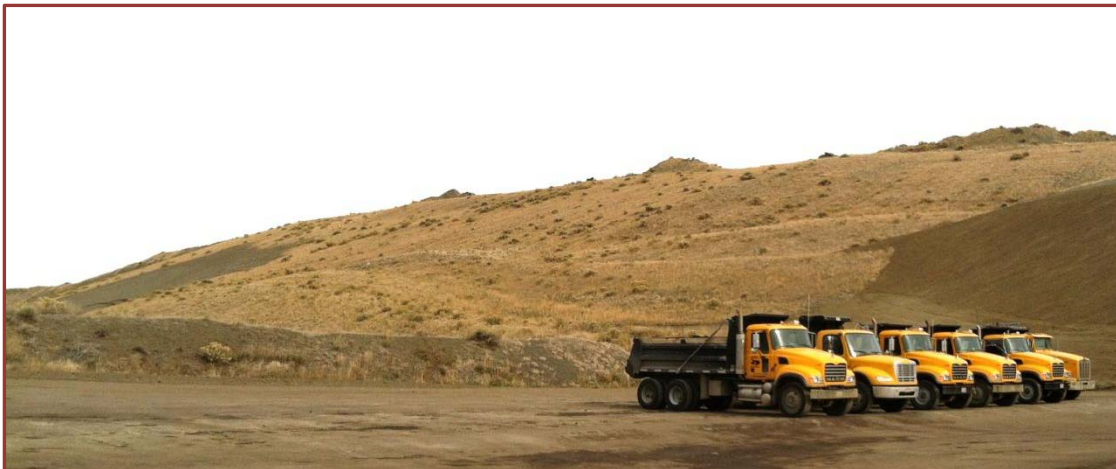
Zone 2 Slope seen from the southwest

No retention pond was constructed below this reach, however, and additional tailings and other excavated materials have been placed against the lower portion of the slope as shown in the photograph above.

The additional fill appears to act as a buttress to increase the factor of safety of this reach of slope. No slope failures have been reported in this zone, or noted on historic aerial photographs reviewed for this study. This area also is south of the reservoir with the Zone 1 fill to the west of it. A failure here, should it develop, appears unable to affect off-site areas or the reservoir adversely.

Remedial Measures Because of the apparent stability, historically, of this zone of the slope and the factor of safety obtained for Zone 2 by slope stability modeling, no further remedial measures appear necessary at this time. The slope should be observed periodically for indications of instability or excessive erosion, particularly after heavy precipitation events.

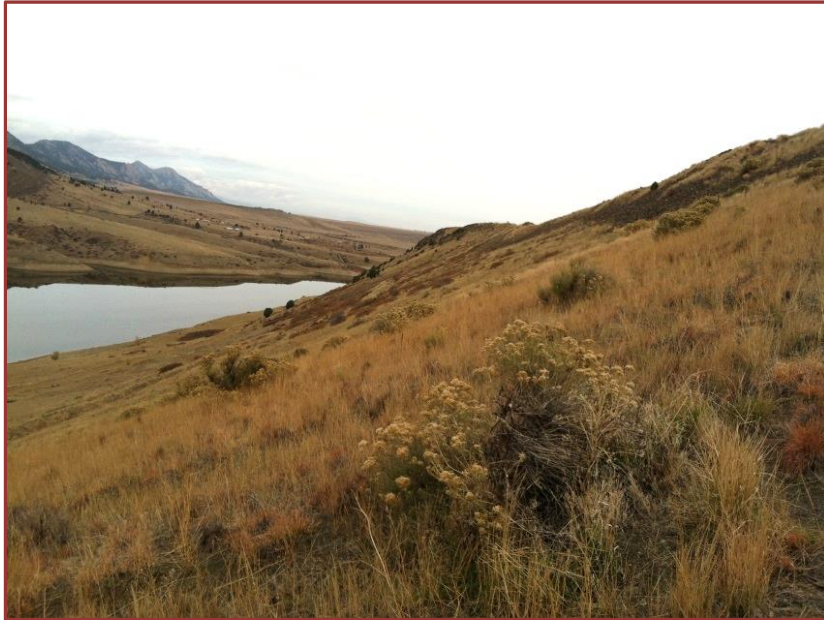
Zone 5 Native Slope seen from the south

No retention pond was constructed at the toe of slope in this zone and no slope failures have developed on this reach, based on reports from Asphalt Paving Company personnel and review of historic aerial photographs as old as 1999.

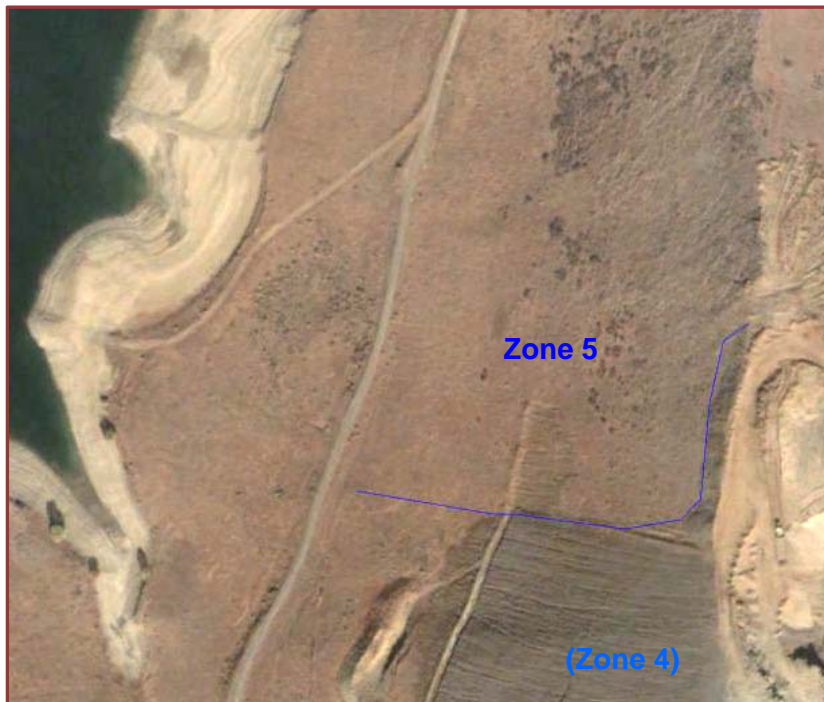
Tailings were not placed on this portion of the west-facing slope except on the uppermost approximately 25 vertical feet, as can be seen also in the November 22, 2003 Google Earth® image below. Native soils were encountered downslope of the tailings.

Zone 5 without Tailings

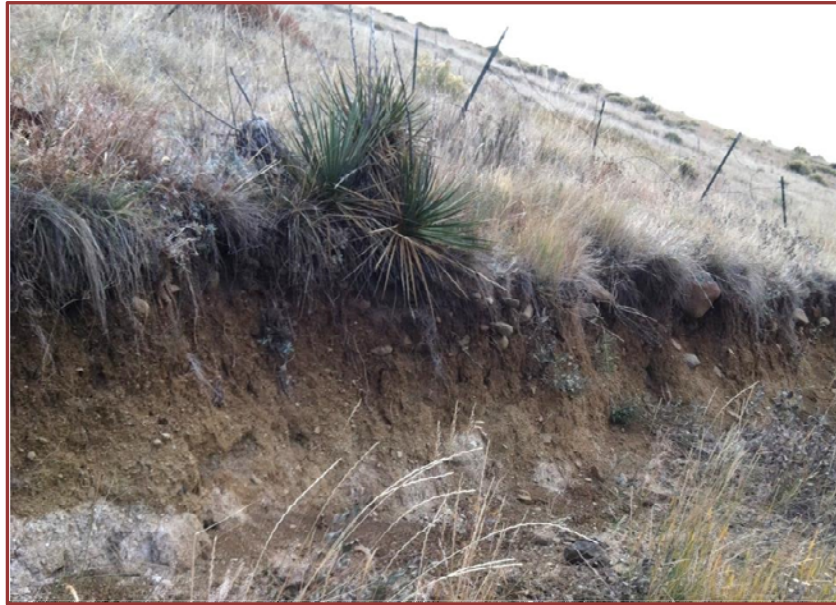
Colluvial Soils Exposed in Trail Cut in Zone 5

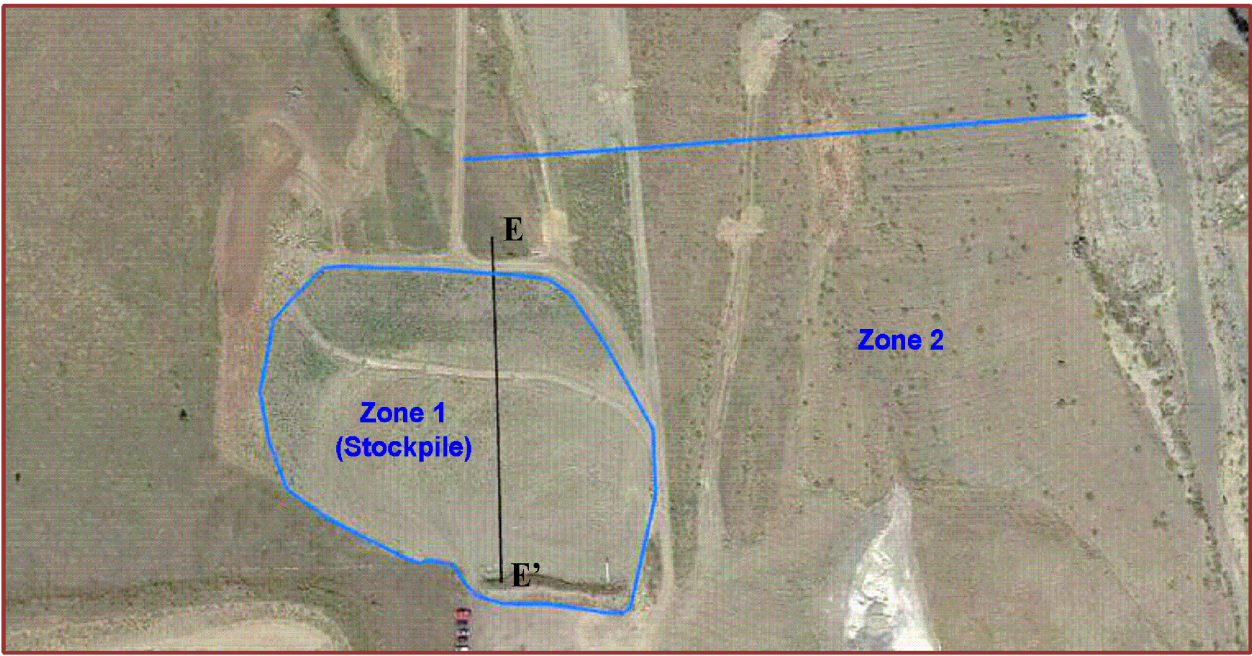
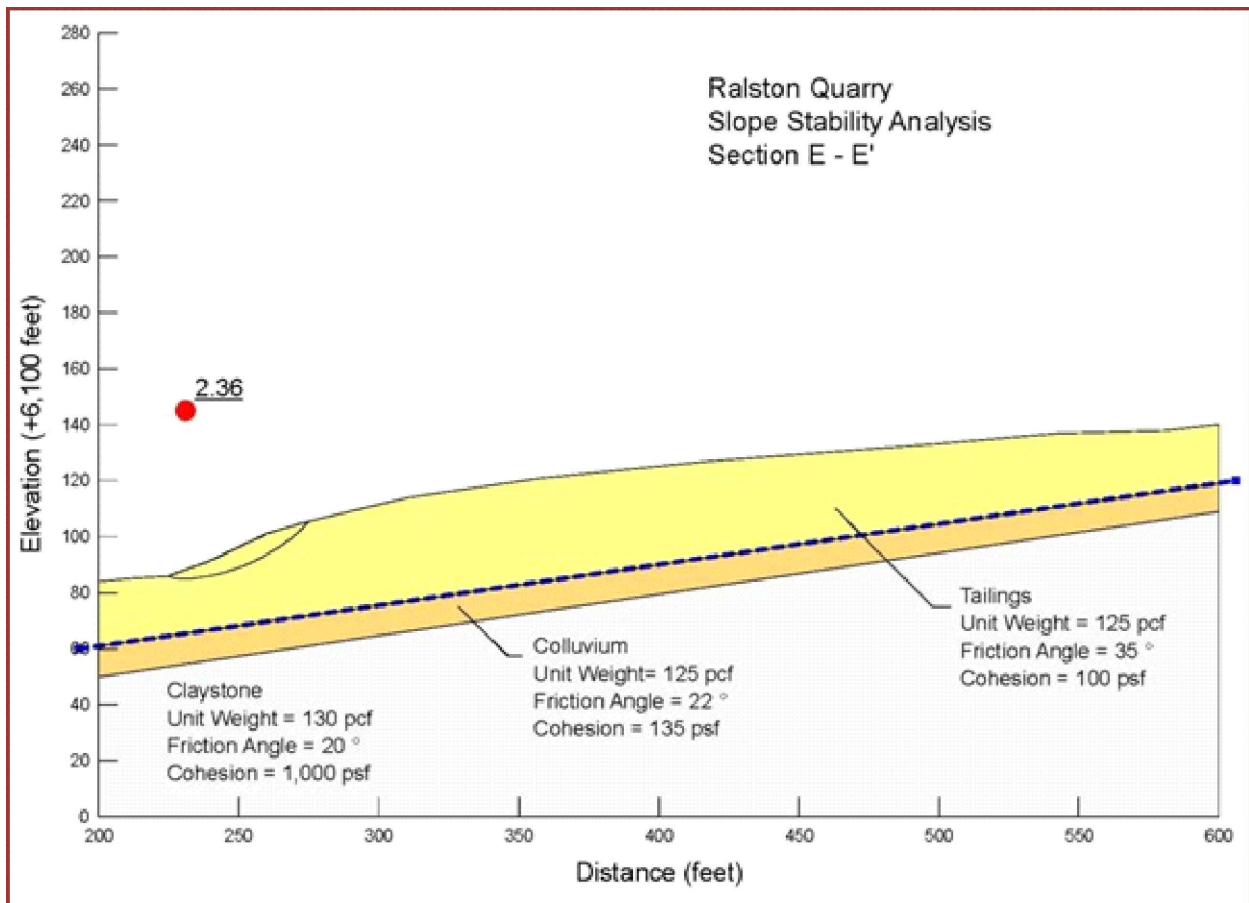
FIGURE: 21

Stability analyses of the stockpile slope (Section E – E') on the Google Earth® image on Figure 21 indicated a minimum, Morgenstern-Price factor of safety against failure of about **2.4**, as shown on the SlopeW® output below, even with the groundwater at the base of the tailings stockpile which we consider unlikely.

Zone 1 and Section E – E'

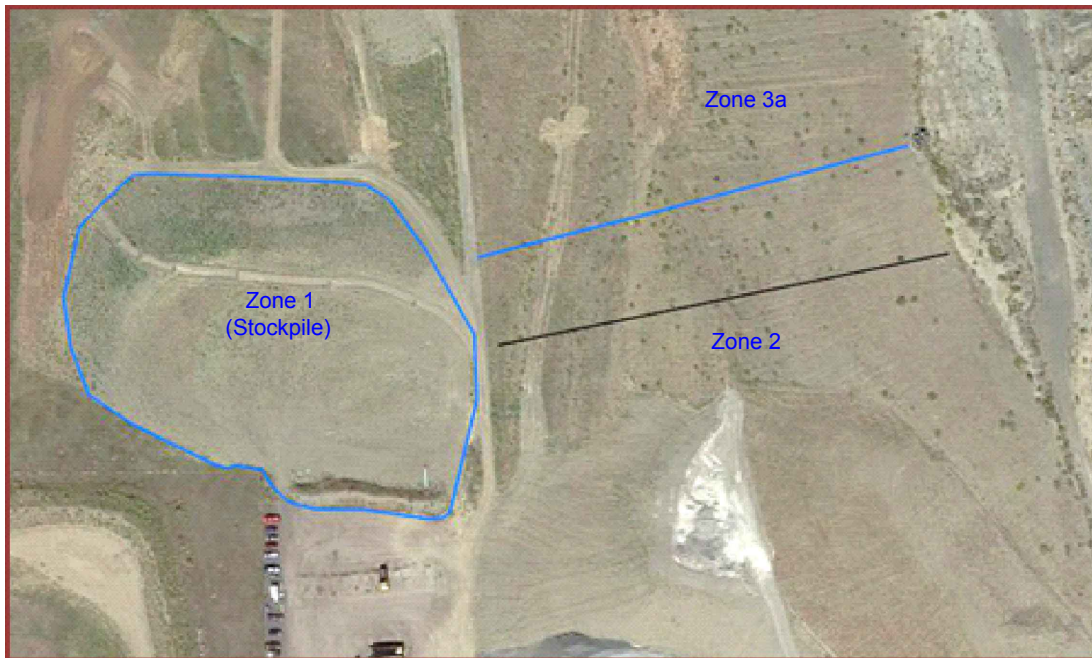
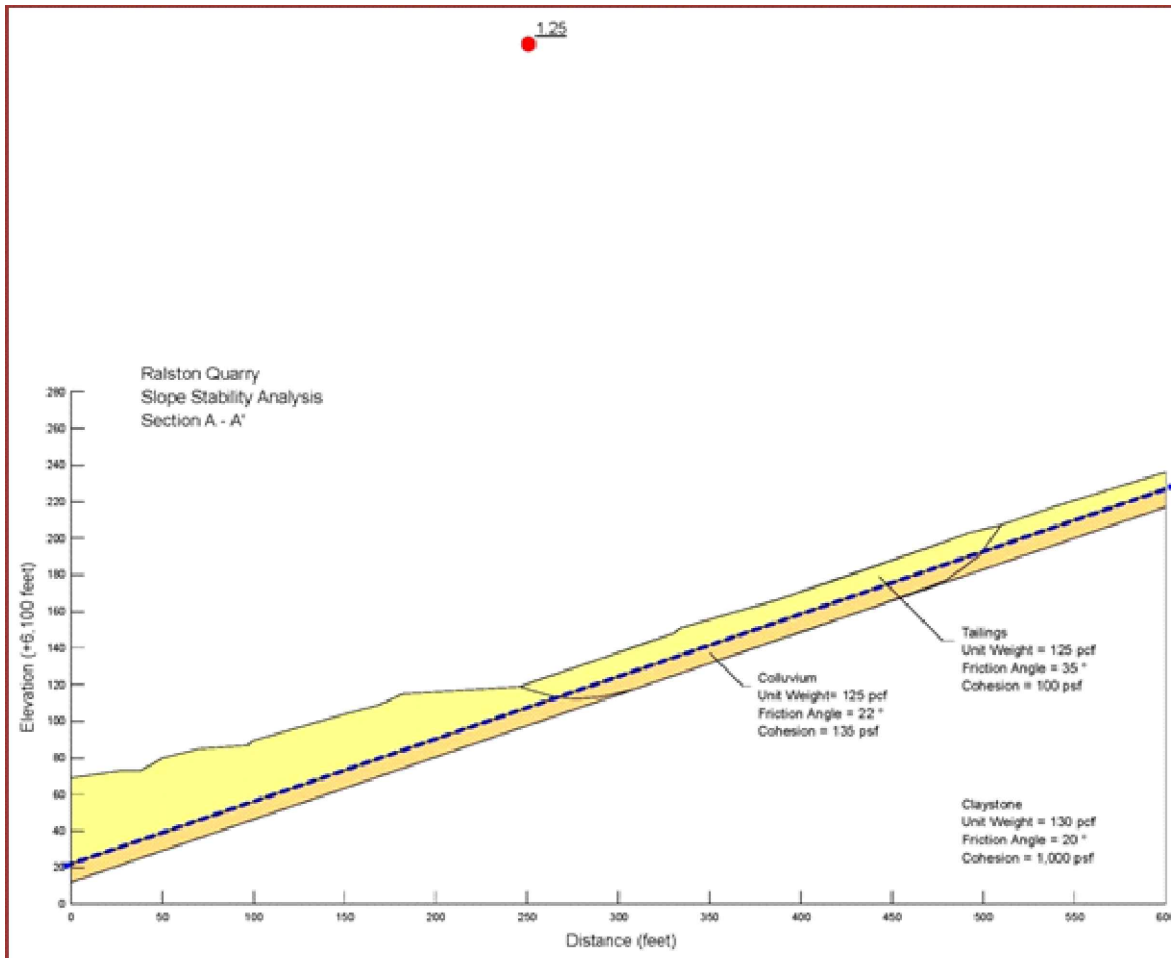
FIGURE: 22

Slope stability analyses of this zone of the slope in the proposed (re-graded) condition (Section A – A') indicated a Morgenstern-Price factor of safety against failure of about **1.25**, as shown on the SlopeW[®] output on Figure 22, even with the water at the contact between the tailings and the underlying, native soils.

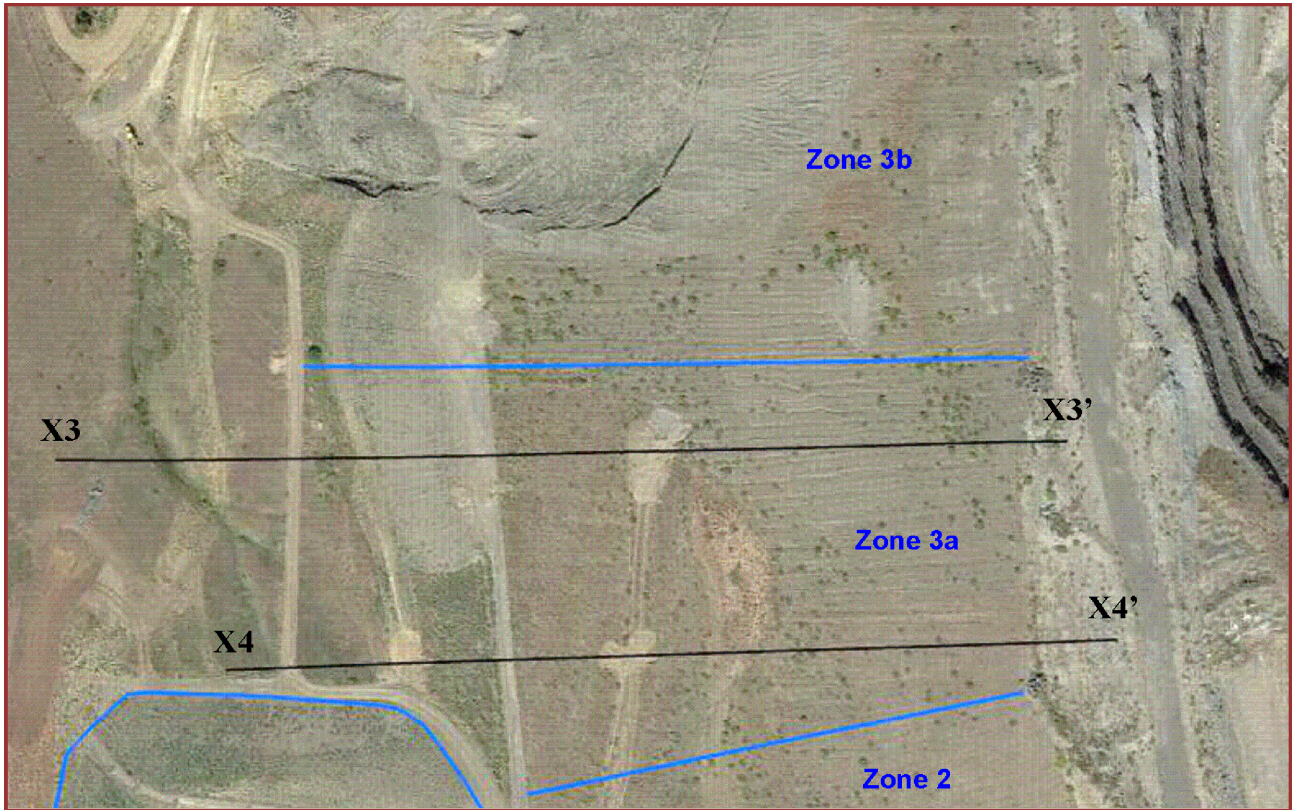
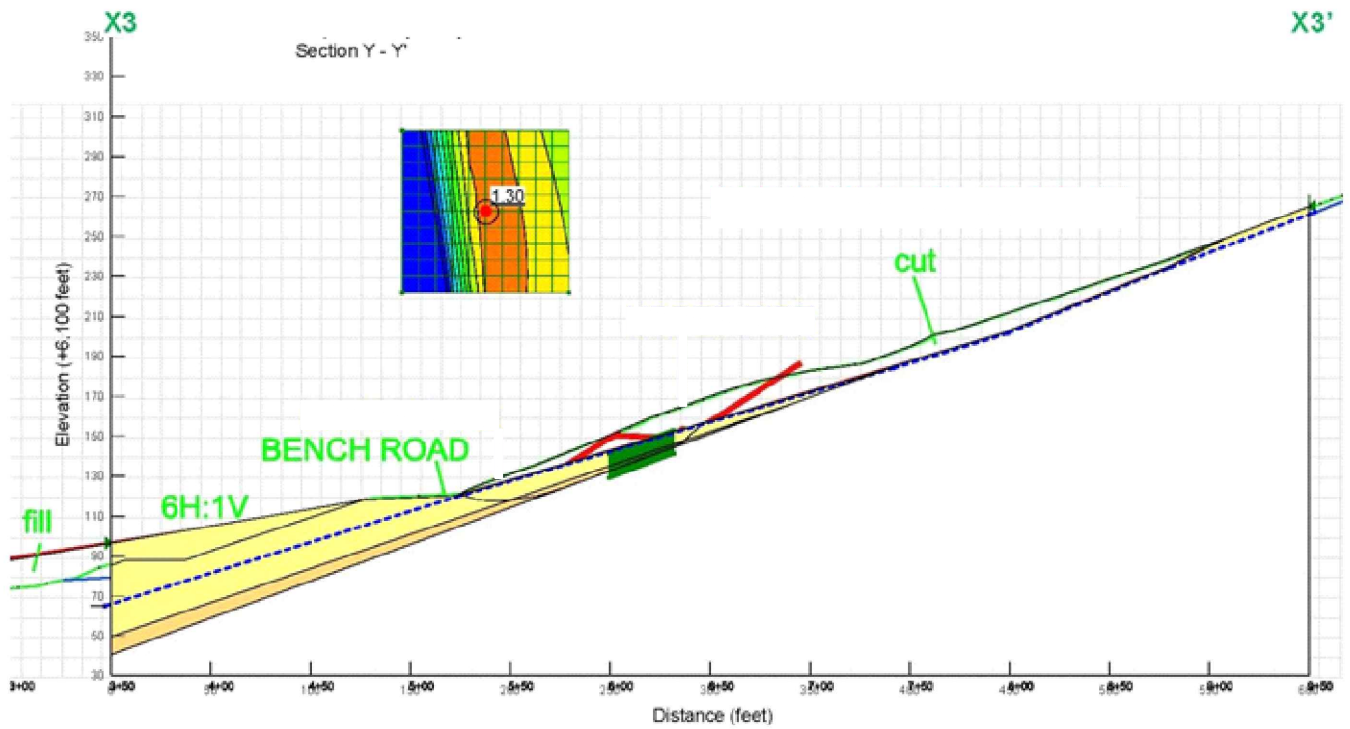
FIGURE: 23A

Slope stability analyses of this zone of the slope in the proposed (re-graded) condition (Sections X3 – X3' and X4 – X4') indicated a Morgenstern-Price factor of safety against failure of about **1.3** for both sections, as shown on the SlopeW[®] output on Figure 23, even with the water at the contact between the tailings and the underlying, native soils.

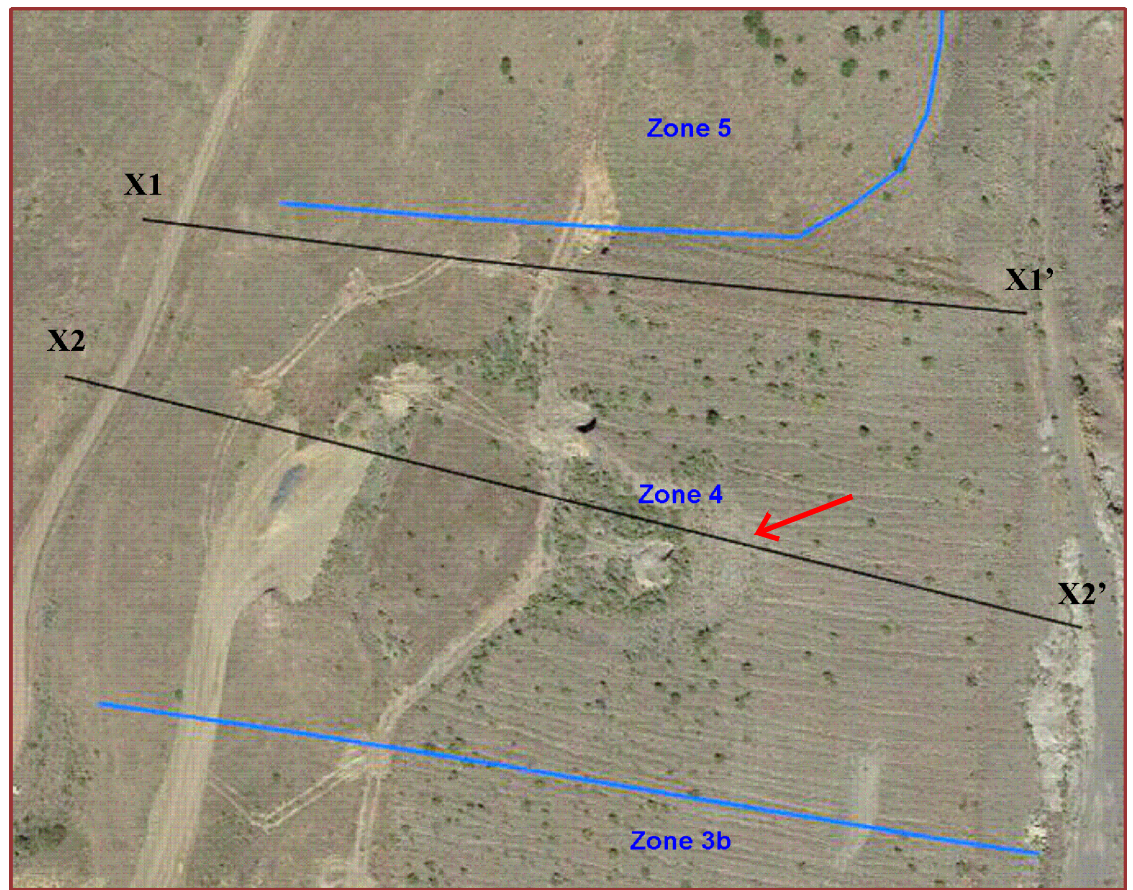
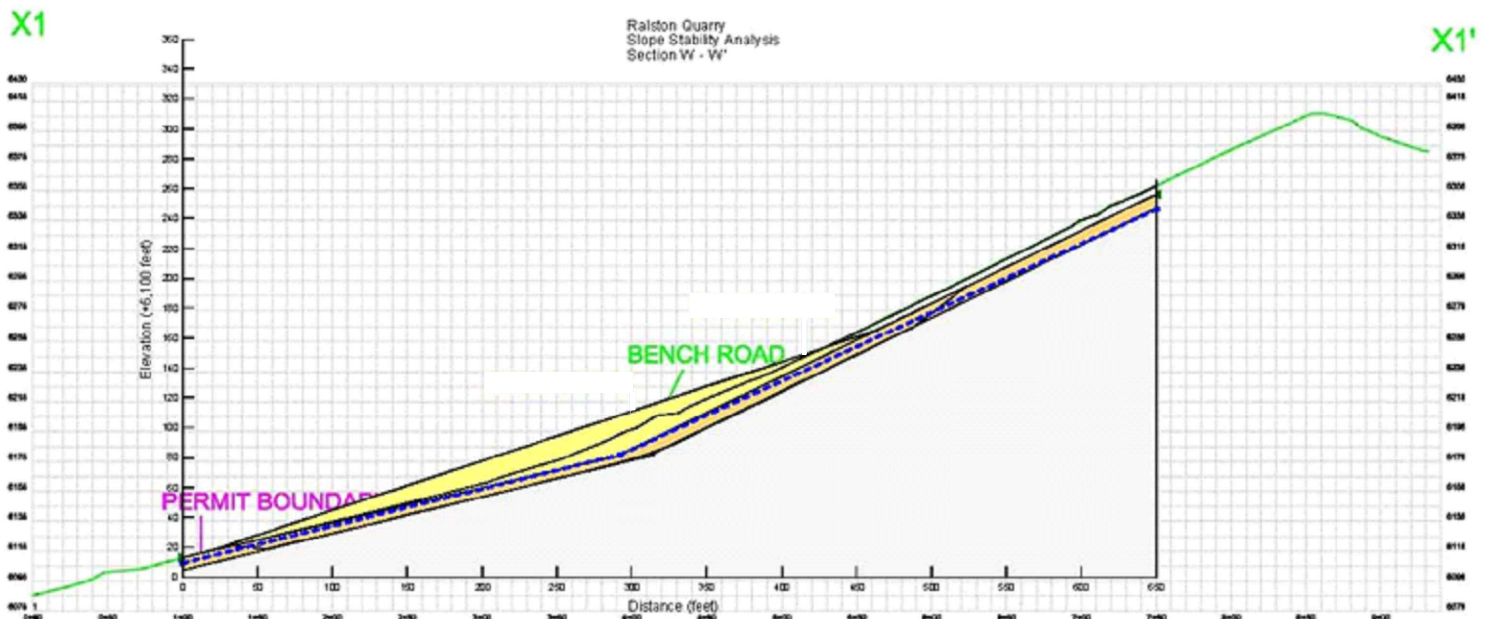
FIGURE: 27A

Zone 4 and Sections X1 – X1' and X2 – X2'
(Red arrow indicates (top of) older slope failure.)

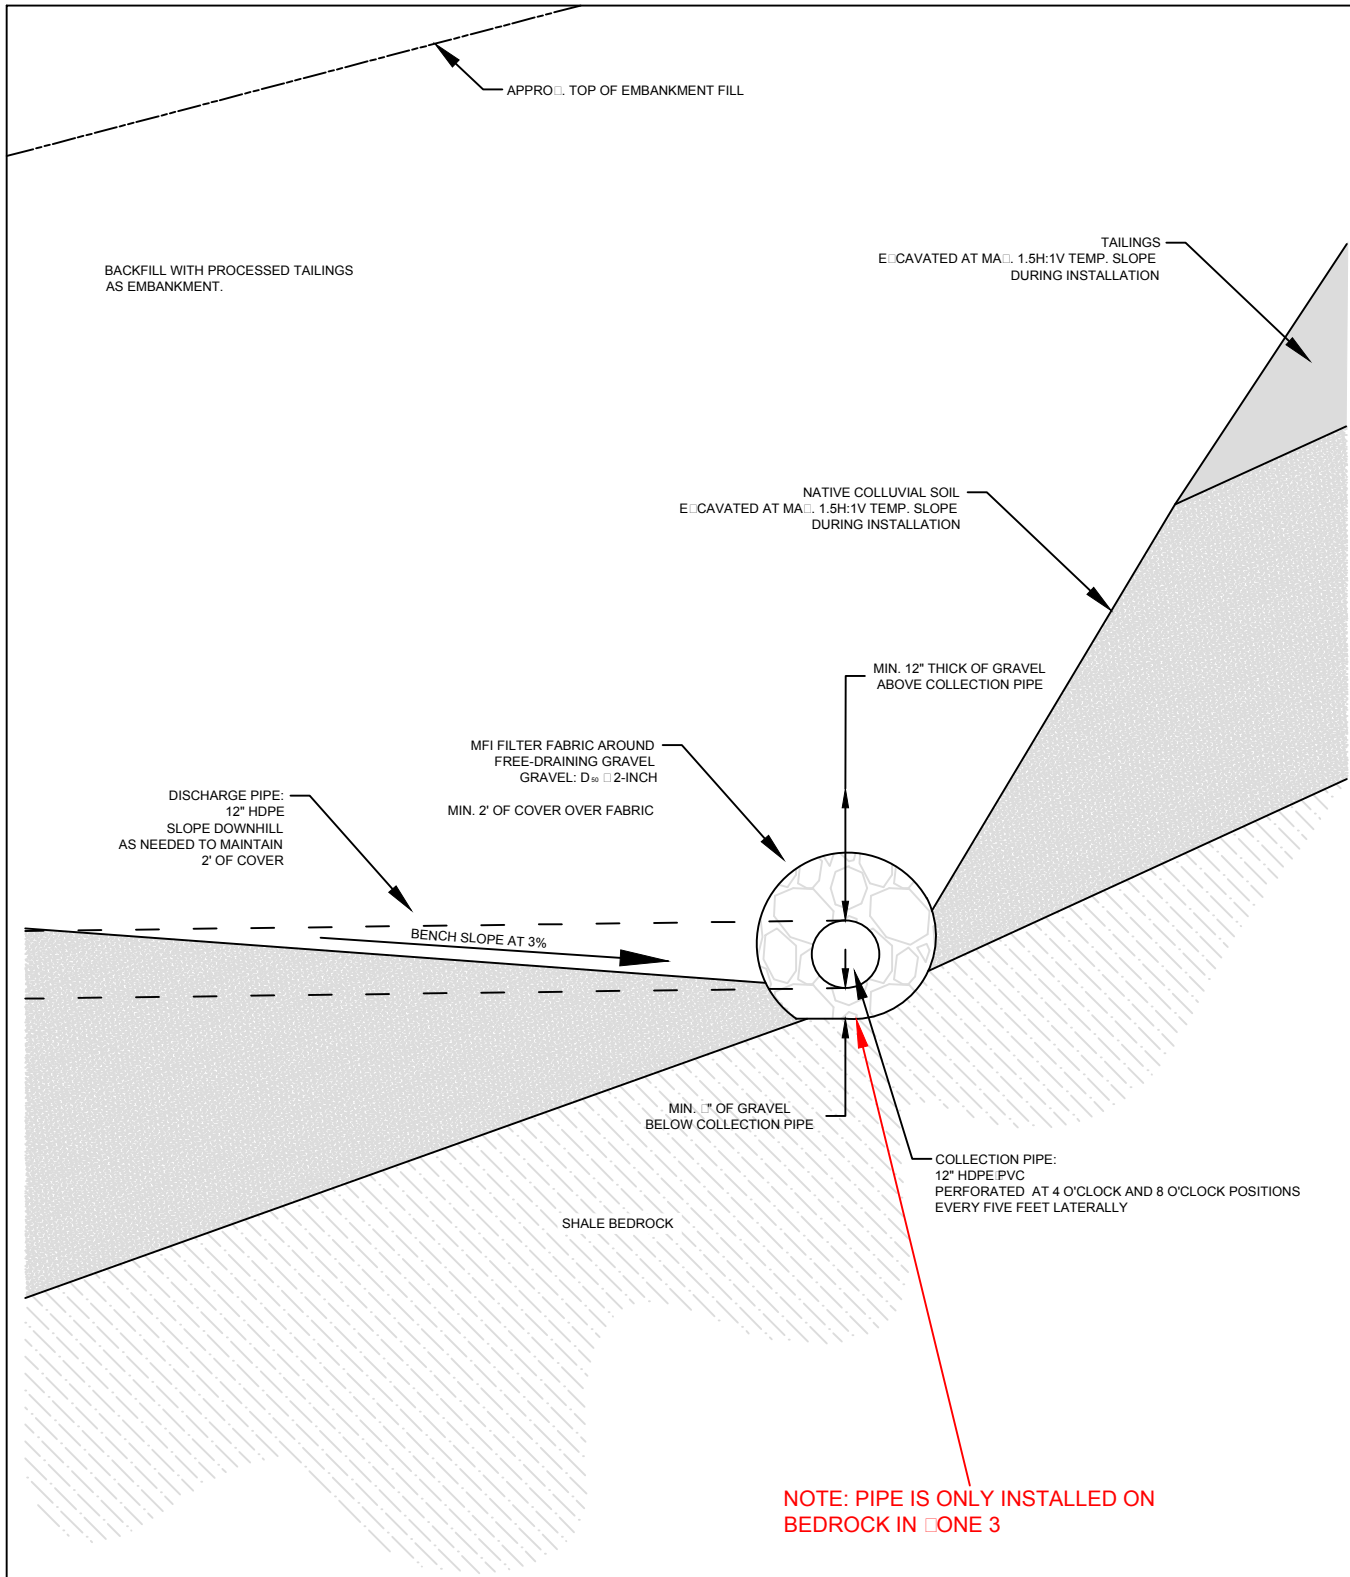
NOTE: PIPE IS ONLY INSTALLED ON BEDROCK IN ZONE 3

All subsurface drainage systems will consist of a minimum of 12-inch diameter pipe installed as shown on Map C-5. This pipe size was determined using the design standards from the Natural Resource Conservation Service Part NJ650.14¹ applied to a smooth HDPE pipe. The drainage area is ~17 acres. Inflow pipes (transverse to surface grade) will be perforated while transport pipes (longitudinal to surface grade) will be solid to convey drainage water to the slope toe. Additionally, this pipe size is in excess of Ground Engineering's recommendations for pipe size and flow capacity.
