# MINERALS PROGRAM INSPECTION REPORT PHONE: (303) 866-3567

MINE NAME:		MINE/PROSPECTING ID#:	MINERAL:	COUNTY:
Rocky Ford East Pit		M-1977-560	Sand and gravel	Otero
INSPECTION TYPE:		INSPECTOR(S):	INSP. DATE:	INSP. TIME:
Surety-Related Inspection		Daniel Cunningham	July 2, 2020	11:00
OPERATOR:		<b>OPERATOR REPRESENTATIVE:</b>	TYPE OF OPERATION:	
VALCO, Inc.		Tom Brubaker	112c - Construction Regular Operation	
			-	
<b>REASON FOR INSPECTION:</b>		BOND CALCULATION TYPE:	BOND AMOUNT:	
Surety Related		Complete Bond	\$193,678.00	
DATE OF COMPLAINT:		POST INSP. CONTACTS:	JOINT INSP. AGENCY:	
NA		None	None	
WEATHER:	INSPECTOR'S SIGNATURE:		SIGNATURE DAT	E:
Clear	A	with Culmber	July 20, 2020

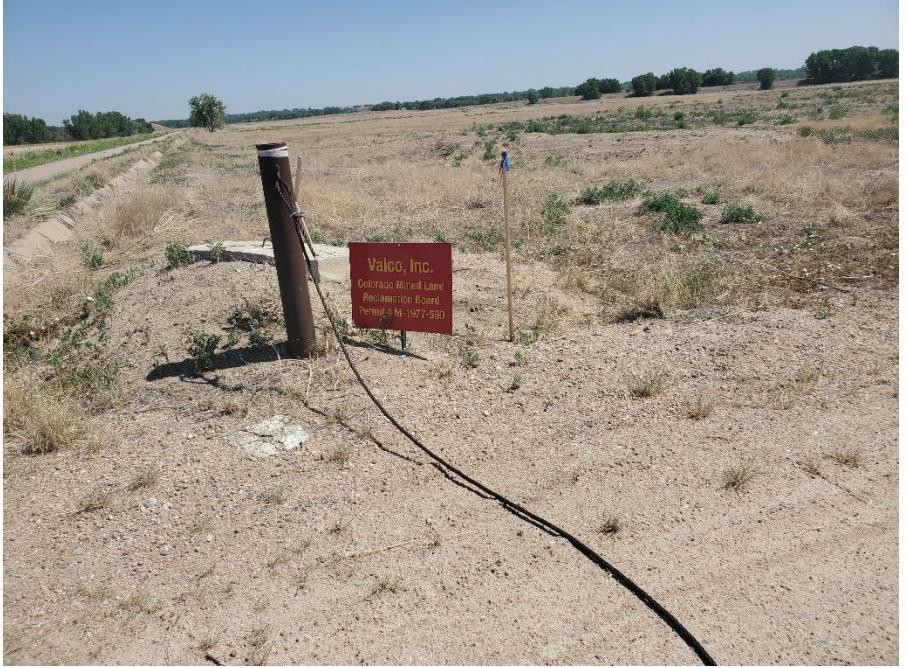
Mine Entrance Sign

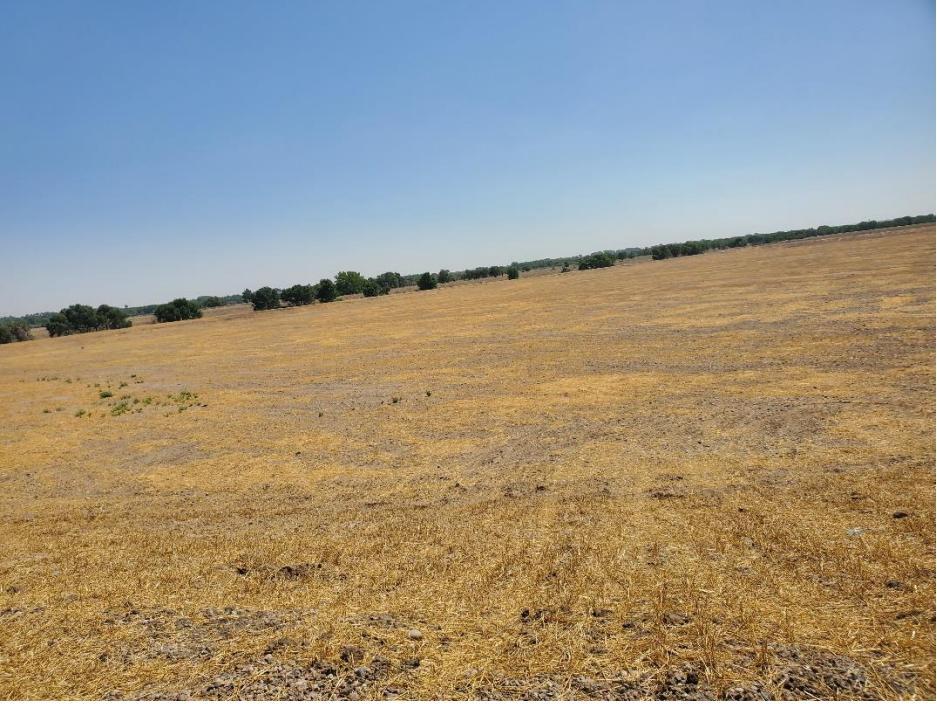
Mine Site Facing Southwest

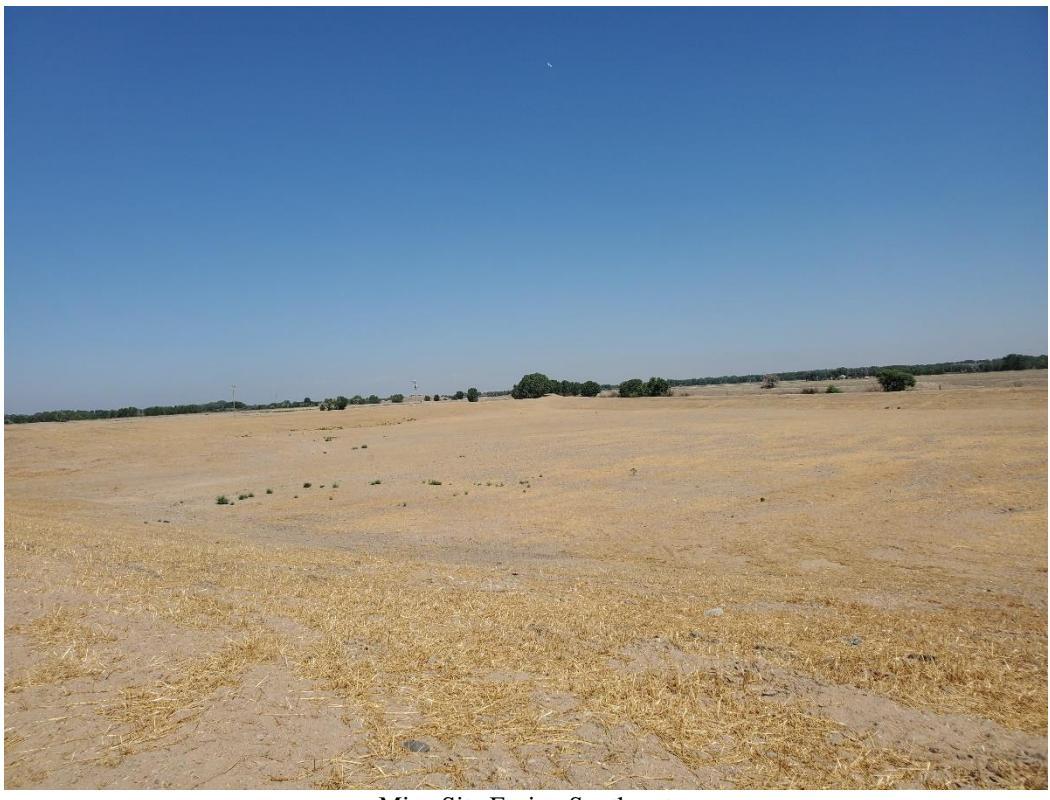
Mine Site Facing Southeast

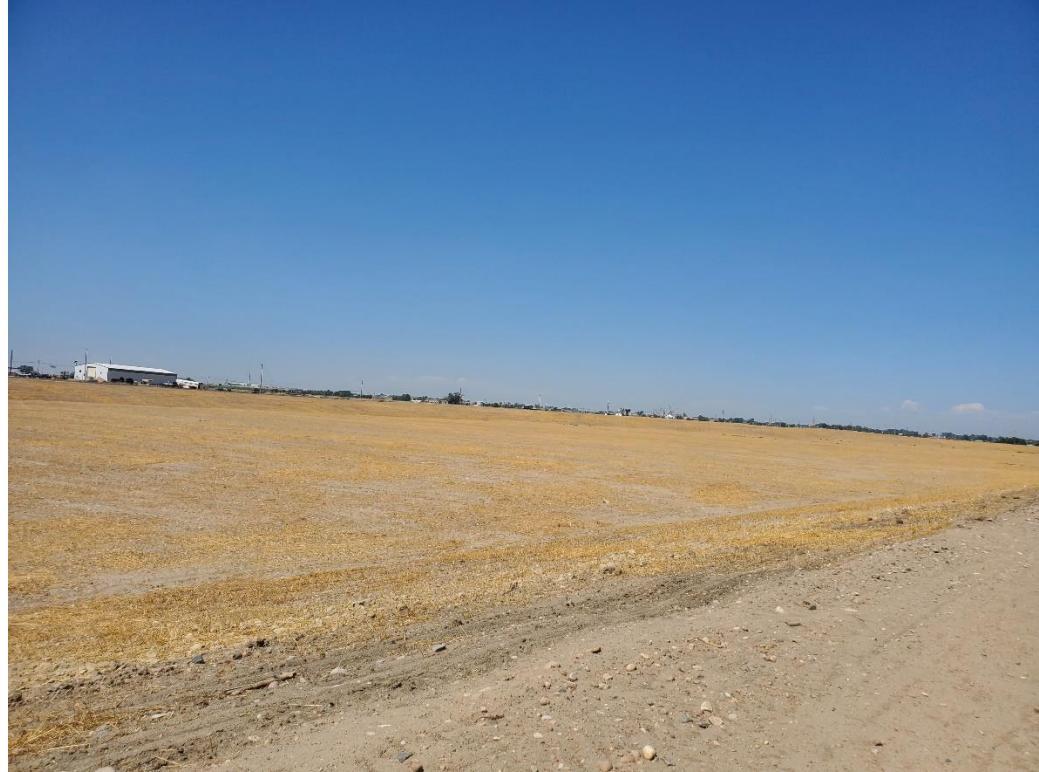
Mine Site Facing Northeast.
