# MINERALS PROGRAM INSPECTION REPORT PHONE: (303) 866-3567

MINE NAME:		MINE/PROSPECTING ID#:	MINERAL:	COUNTY:
Caldwell Brothers 3		M-1986-016	Sand and gravel	Otero
INSPECTION TYPE:		INSPECTOR(S):	INSP. DATE:	INSP. TIME:
Monitoring		Daniel Cunningham	July 2, 2020	10:00
OPERATOR:		<b>OPERATOR REPRESENTATIVE:</b>	TYPE OF OPERATION:	
Caldwell Brothers		Dennis Caldwell	112c - Construction Regular Operation	
		·		
REASON FOR INSPECTION:		BOND CALCULATION TYPE:	BOND AMOUNT:	
Normal I&E Program		Complete Bond	\$25,000.00	
DATE OF COMPLAINT:		POST INSP. CONTACTS:	JOINT INSP. AGENCY:	
NA		None	None	
WEATHER:	INSPECTOR'S SIGNATURE:		SIGNATURE DATE:	
Clear	Danih Culpult

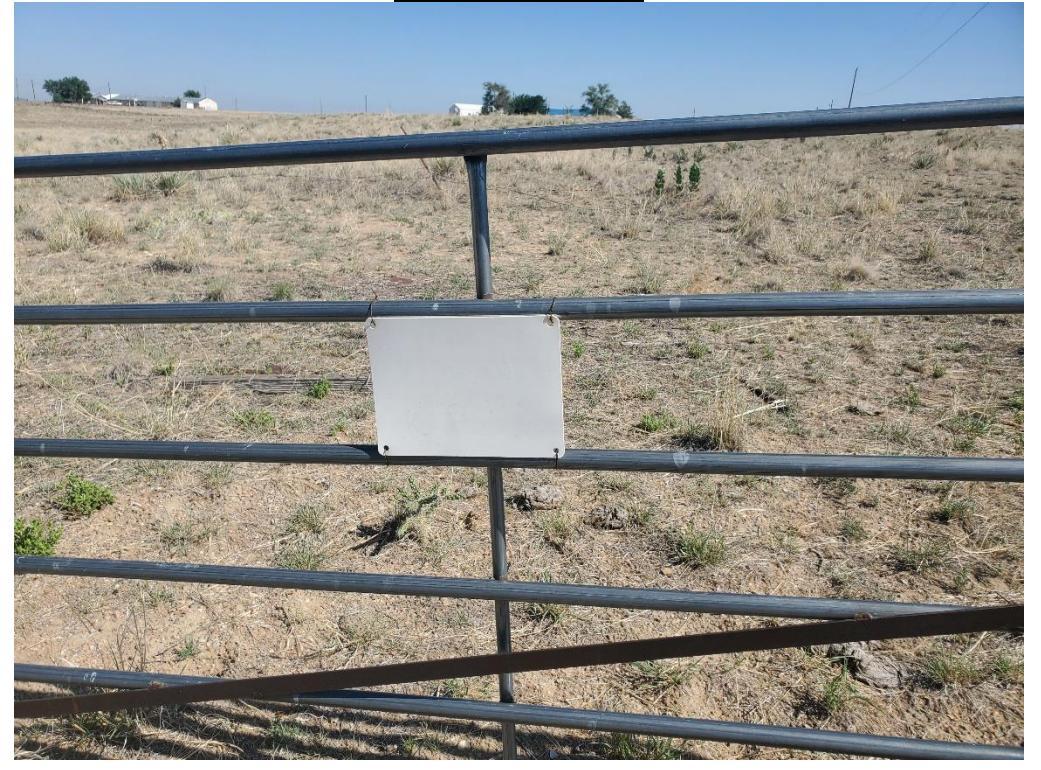
**PROBLEM:** The entrance sign was unreadable. This is a problem for failure to maintain the required mine entrance sign in accordance with Rule 3.1.12.

The site identification sign was posted at the mine entrance, however it has been completely worn down and needs to be replaced. At this time this is being cited as a problem and Operator needs to submit proof that the sign has been replaced.

Photo 1: Mine entrance sign.

**CORRECTIVE ACTIONS:** Submit evidence that the mine entrance sign has been replaced and that the new sign follows all of the requirements of Rule 3.1.12.

**CORRECTIVE ACTION DUE DATE:** 8/10/20

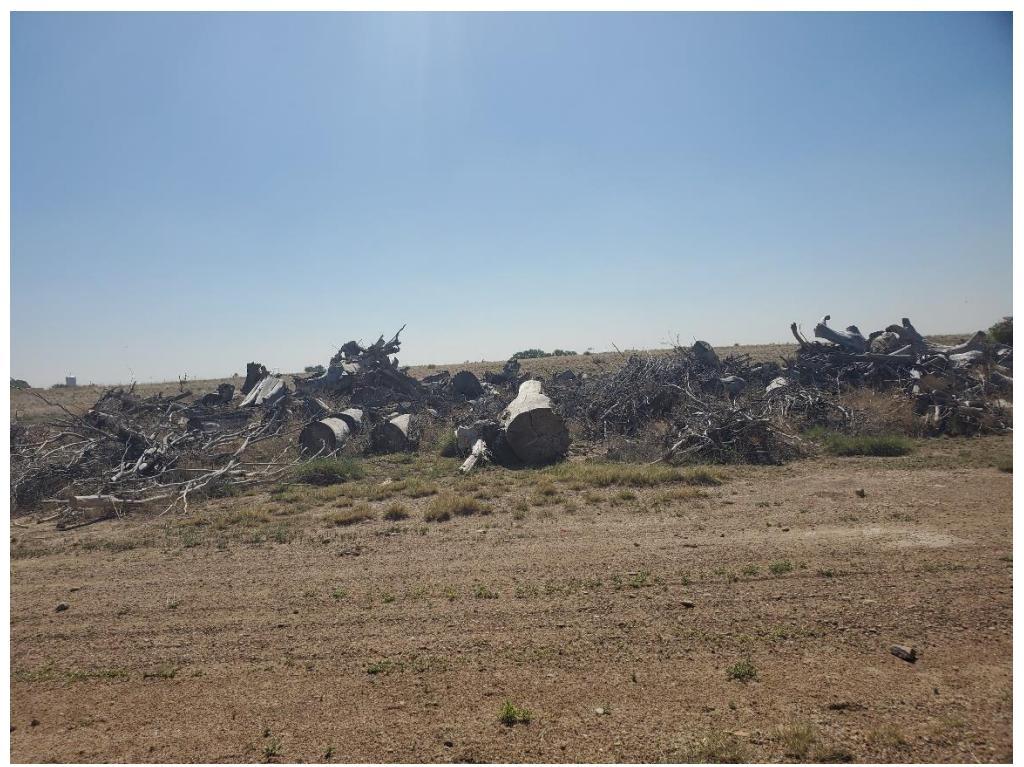
One small stockpiles of material was seen on the permitted area. A 15 foot highwall that ran for 450 feet was seen on site. Several small trash piles of tires and tarps were seen near the highwall and a large area of dead trees were seen on site. The Operator was informed that if the site was to be released, these areas would need to be cleaned and all debris would need to be removed, the material may not be backfilled into the pit.

Photo 2: Dead trees on permitted area

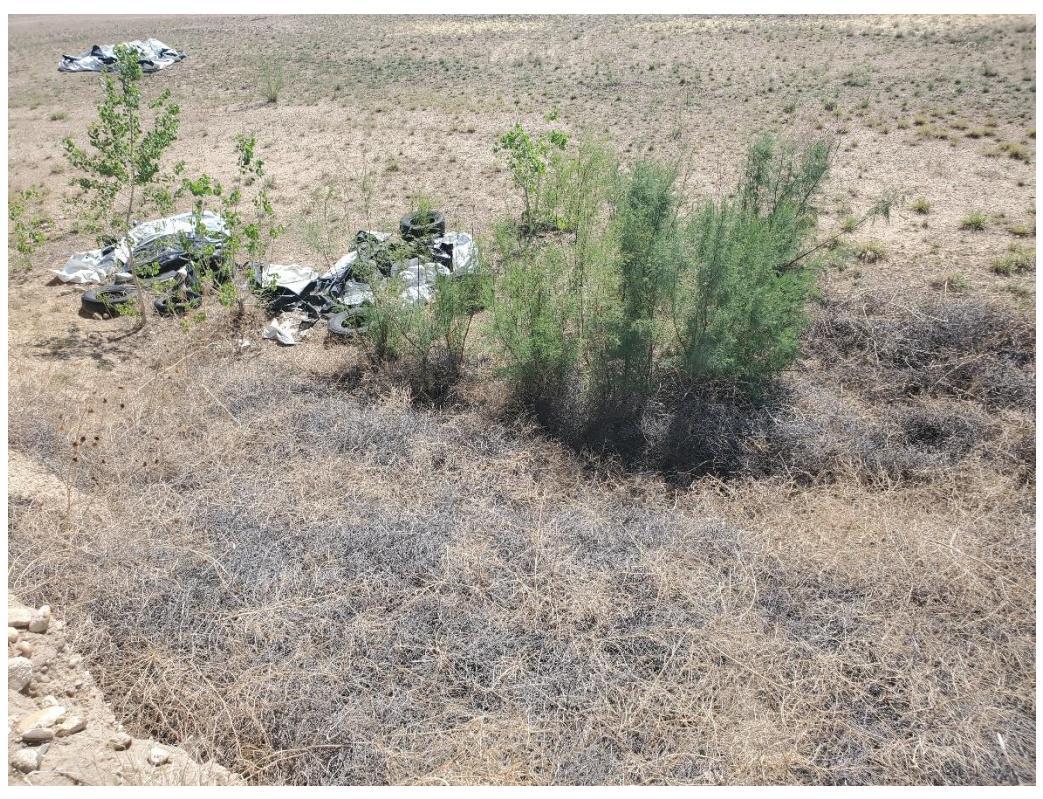
Photo 3: Tires on site

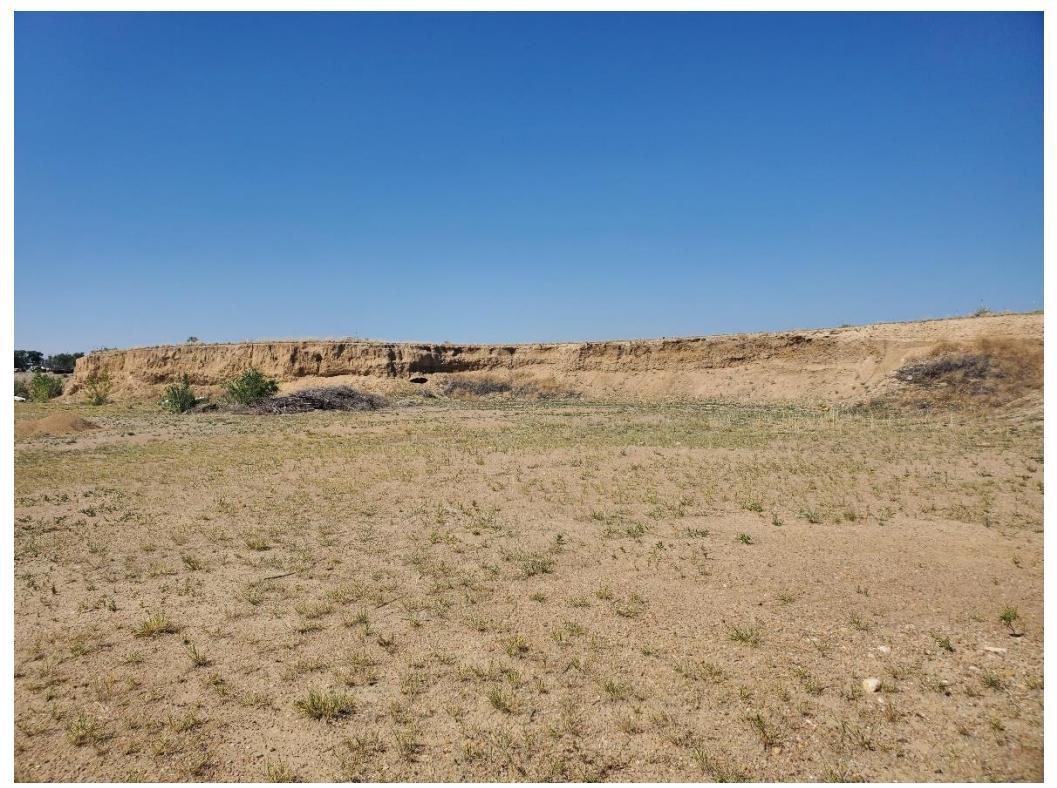
Photo 4: Highwall
