# FIELD WEEKLY PROGRESS REPORT

PROJECT: VALLEY LEACH FACILITY (VLF2) PHASE 2 CQA

SITE: CRIPPLE CREEK & VICTOR GOLD MINE (COLORADO)

WEEK ENDING: SATURDAY, MAY 30, 2020

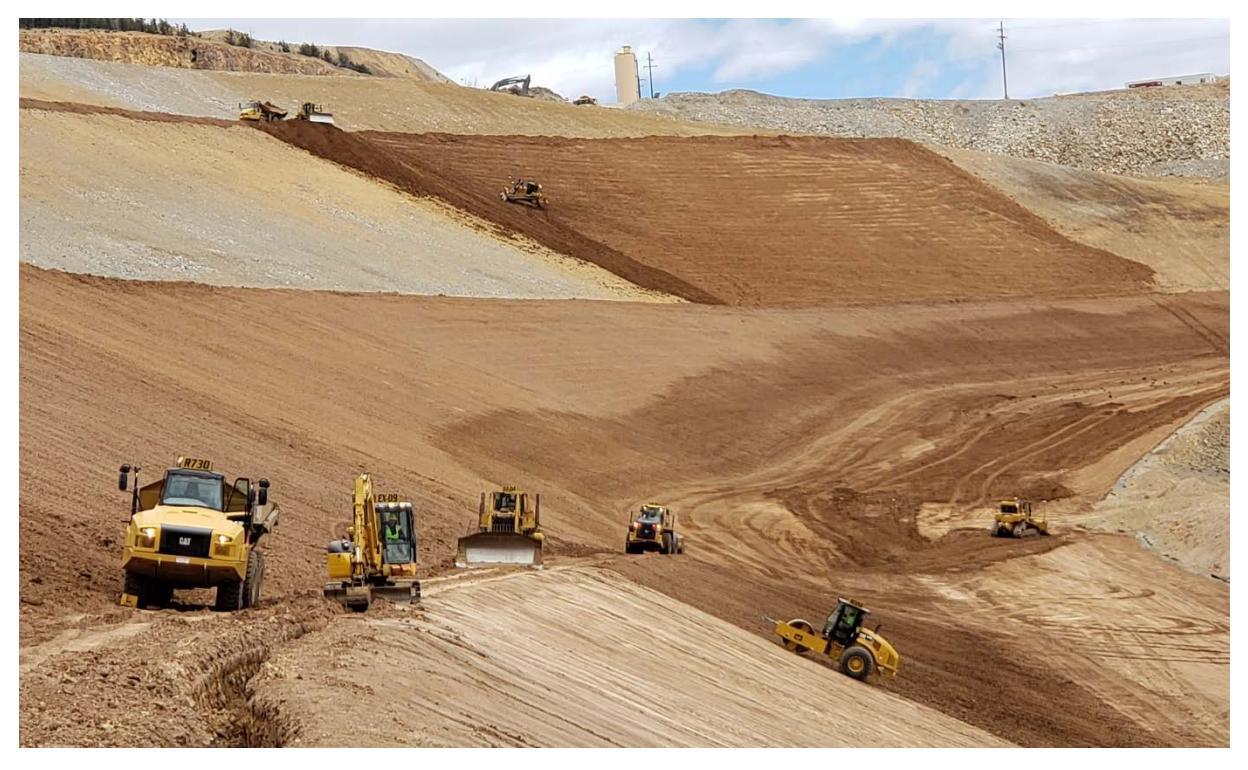
May 26, 2020 – SLF placement, compaction and anchor trench excavation (BM)

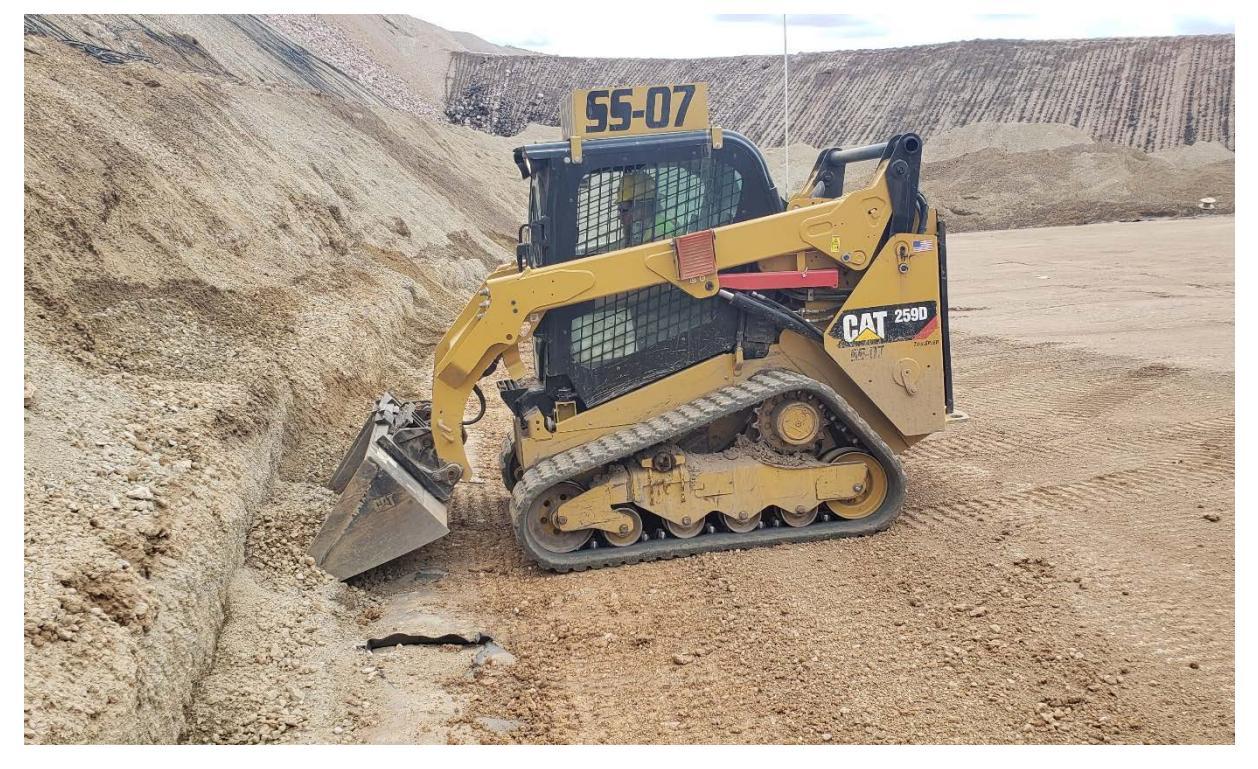
May 26, 2020 - Cleaning off the Phase 1 liner tie-in (BM)

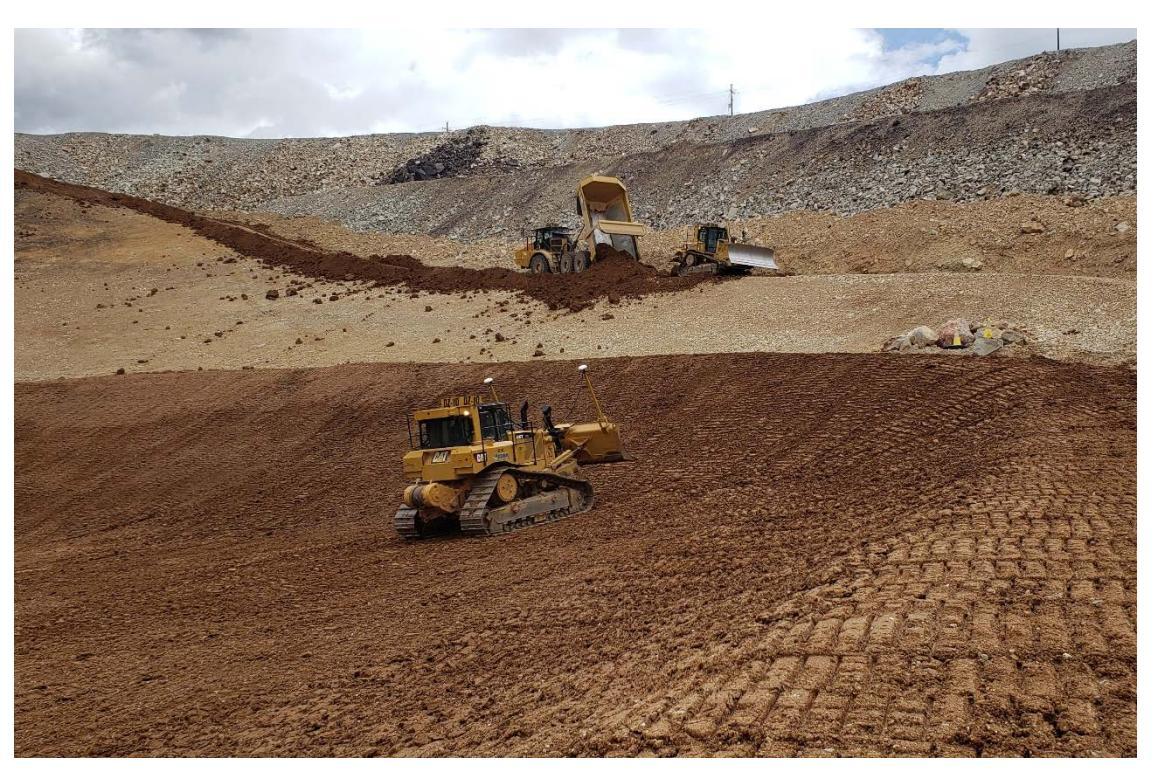
May 27, 2020 – SLF placement along the edge of Phase 2B (BM)

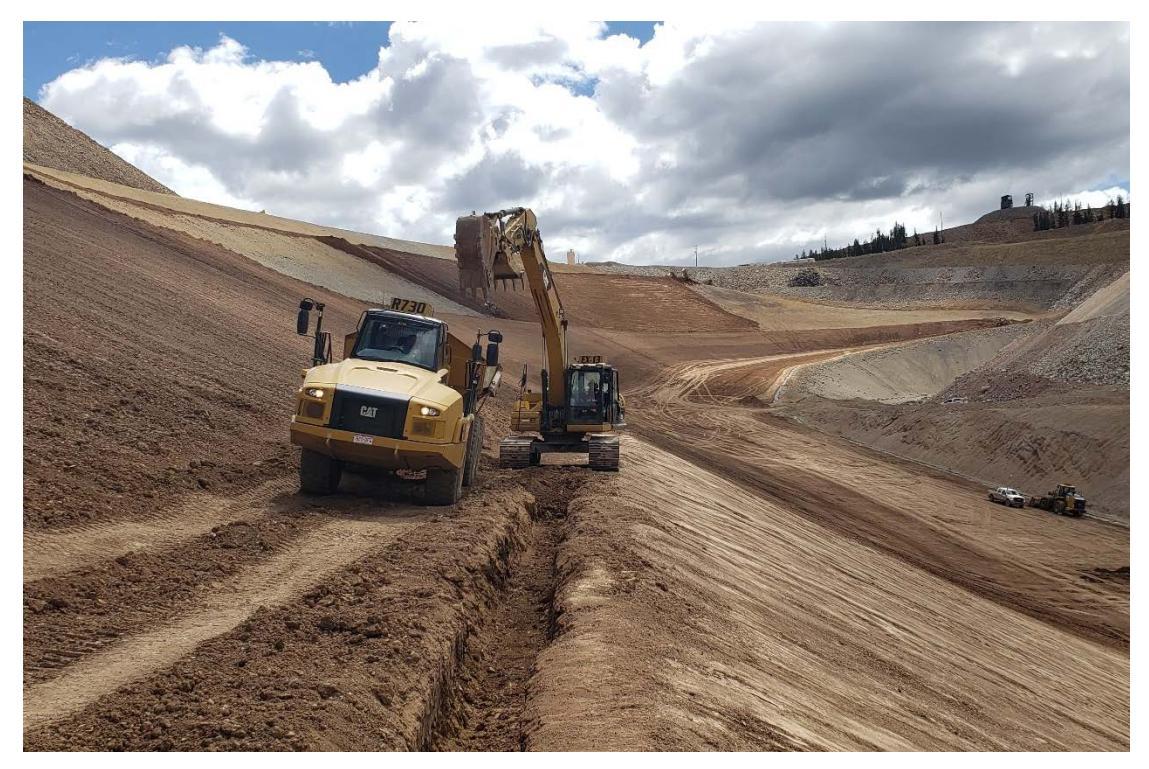
May 27, 2020 – Anchor trench excavation on the 9,950' bench (BM)

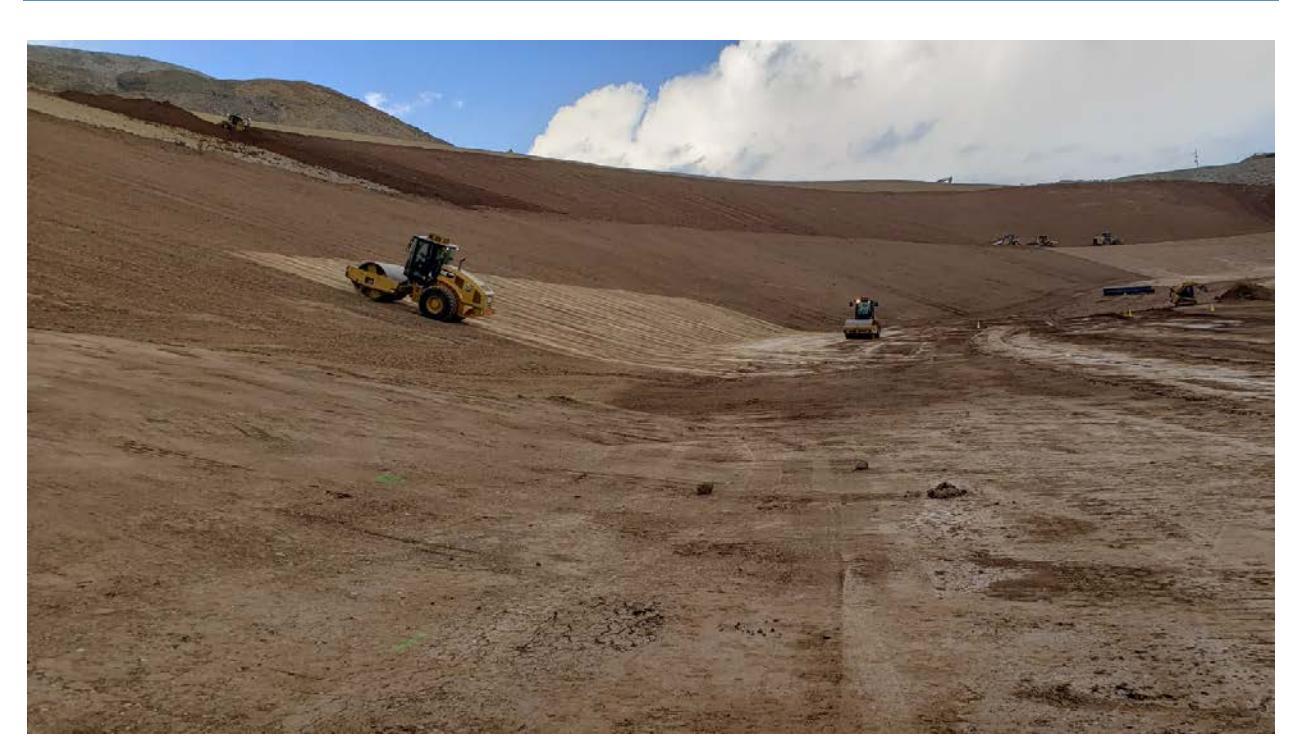
May 28, 2020 - SLF compaction in Phase 2A-5 (BM)

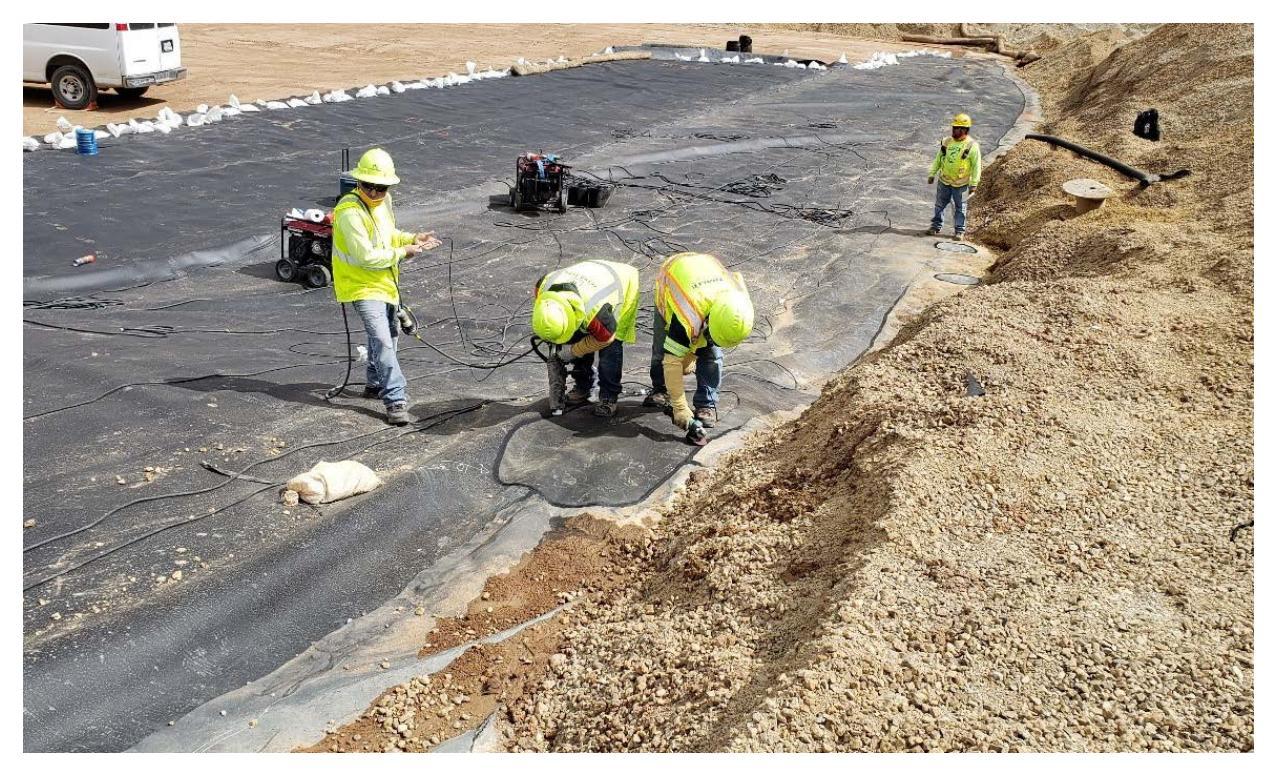
May 29, 2020 – Extrusion welding along the Phase 2A tie-in (BM)

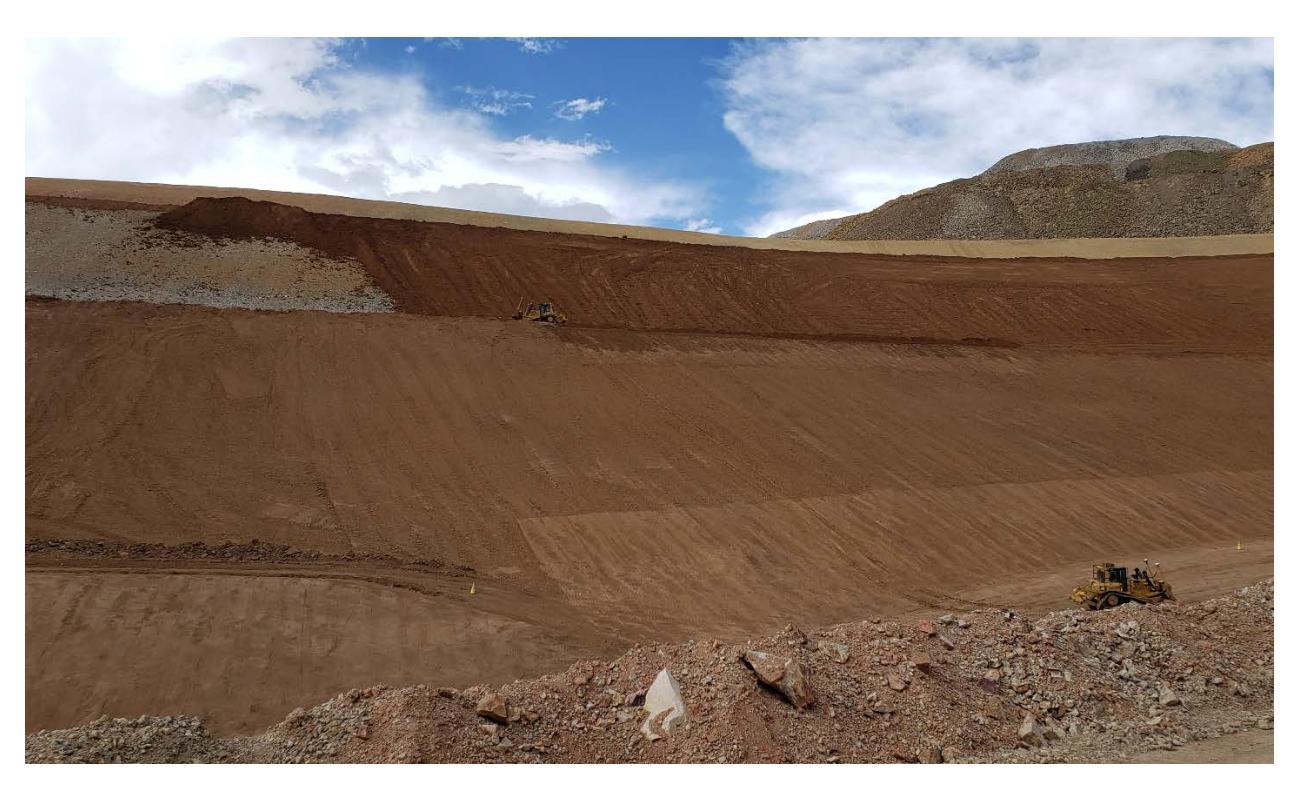
May 29, 2020 – SLF placement progress (BM)

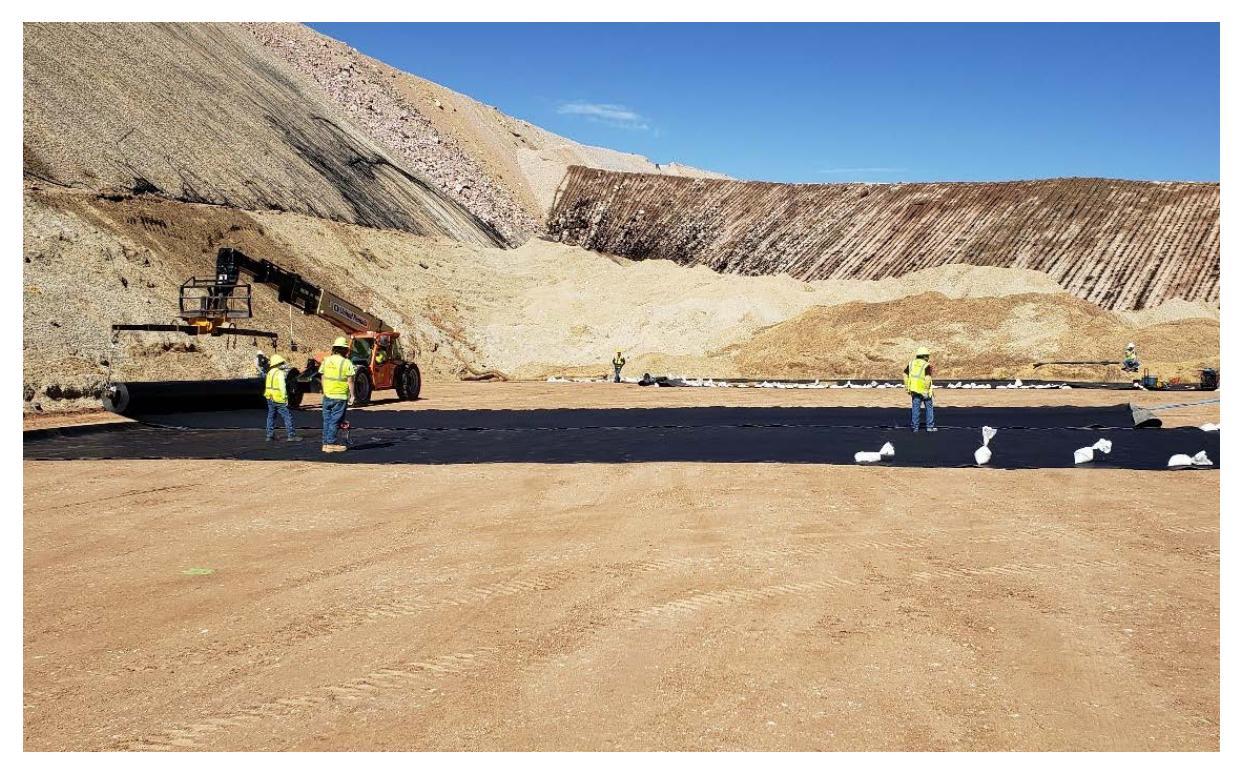
May 30, 2020 – Geomembrane deployment (BM)

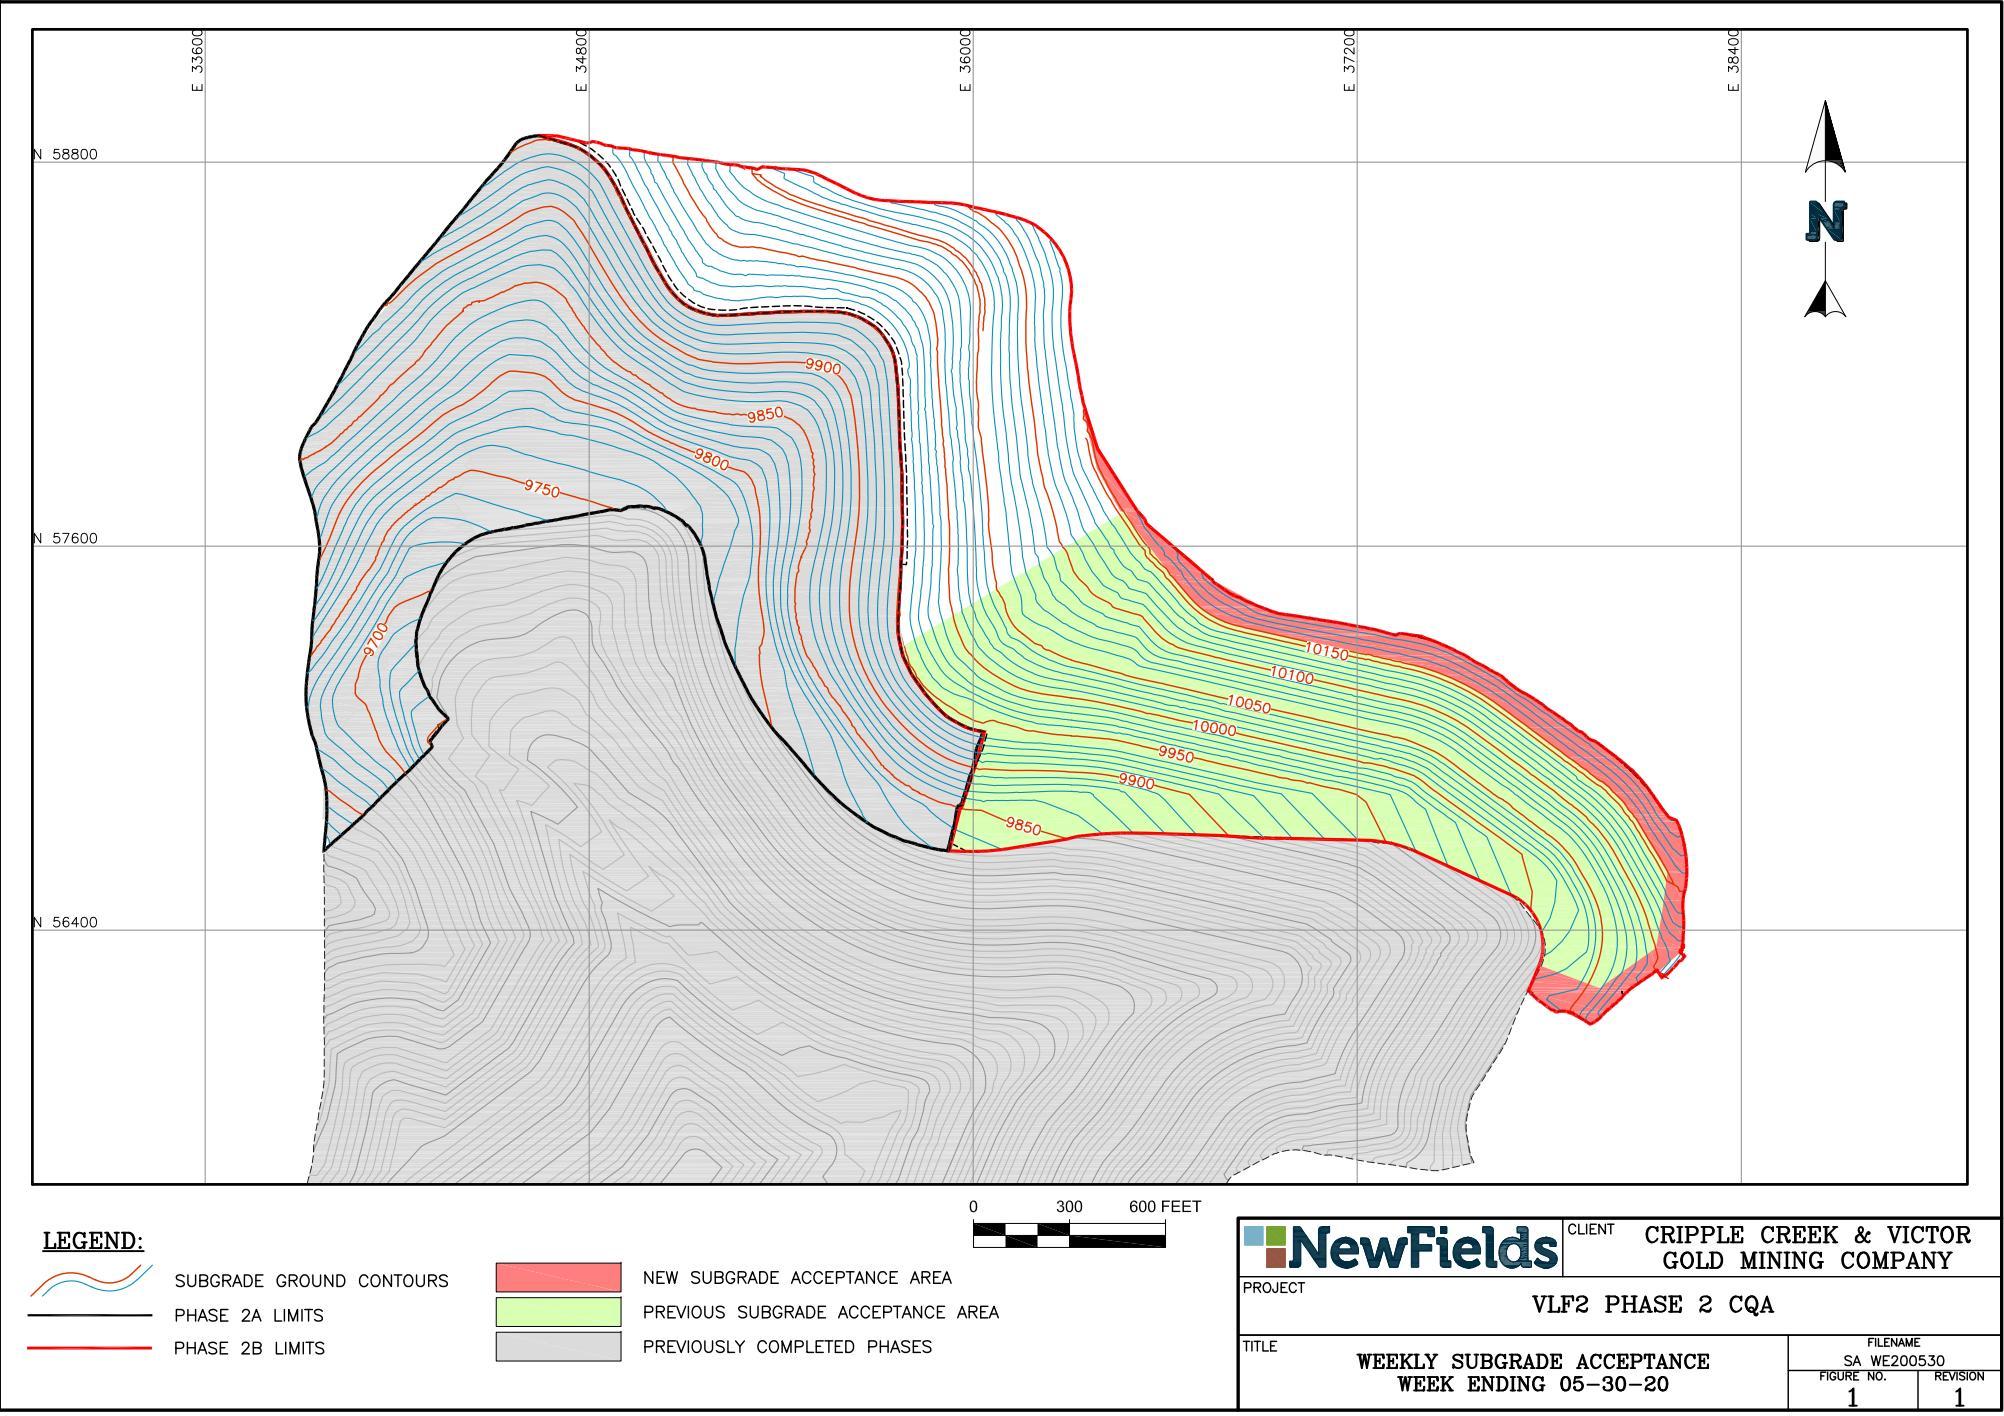
One area of subgrade was accepted during this reporting period. Figure 1 shows the current area of subgrade acceptance.

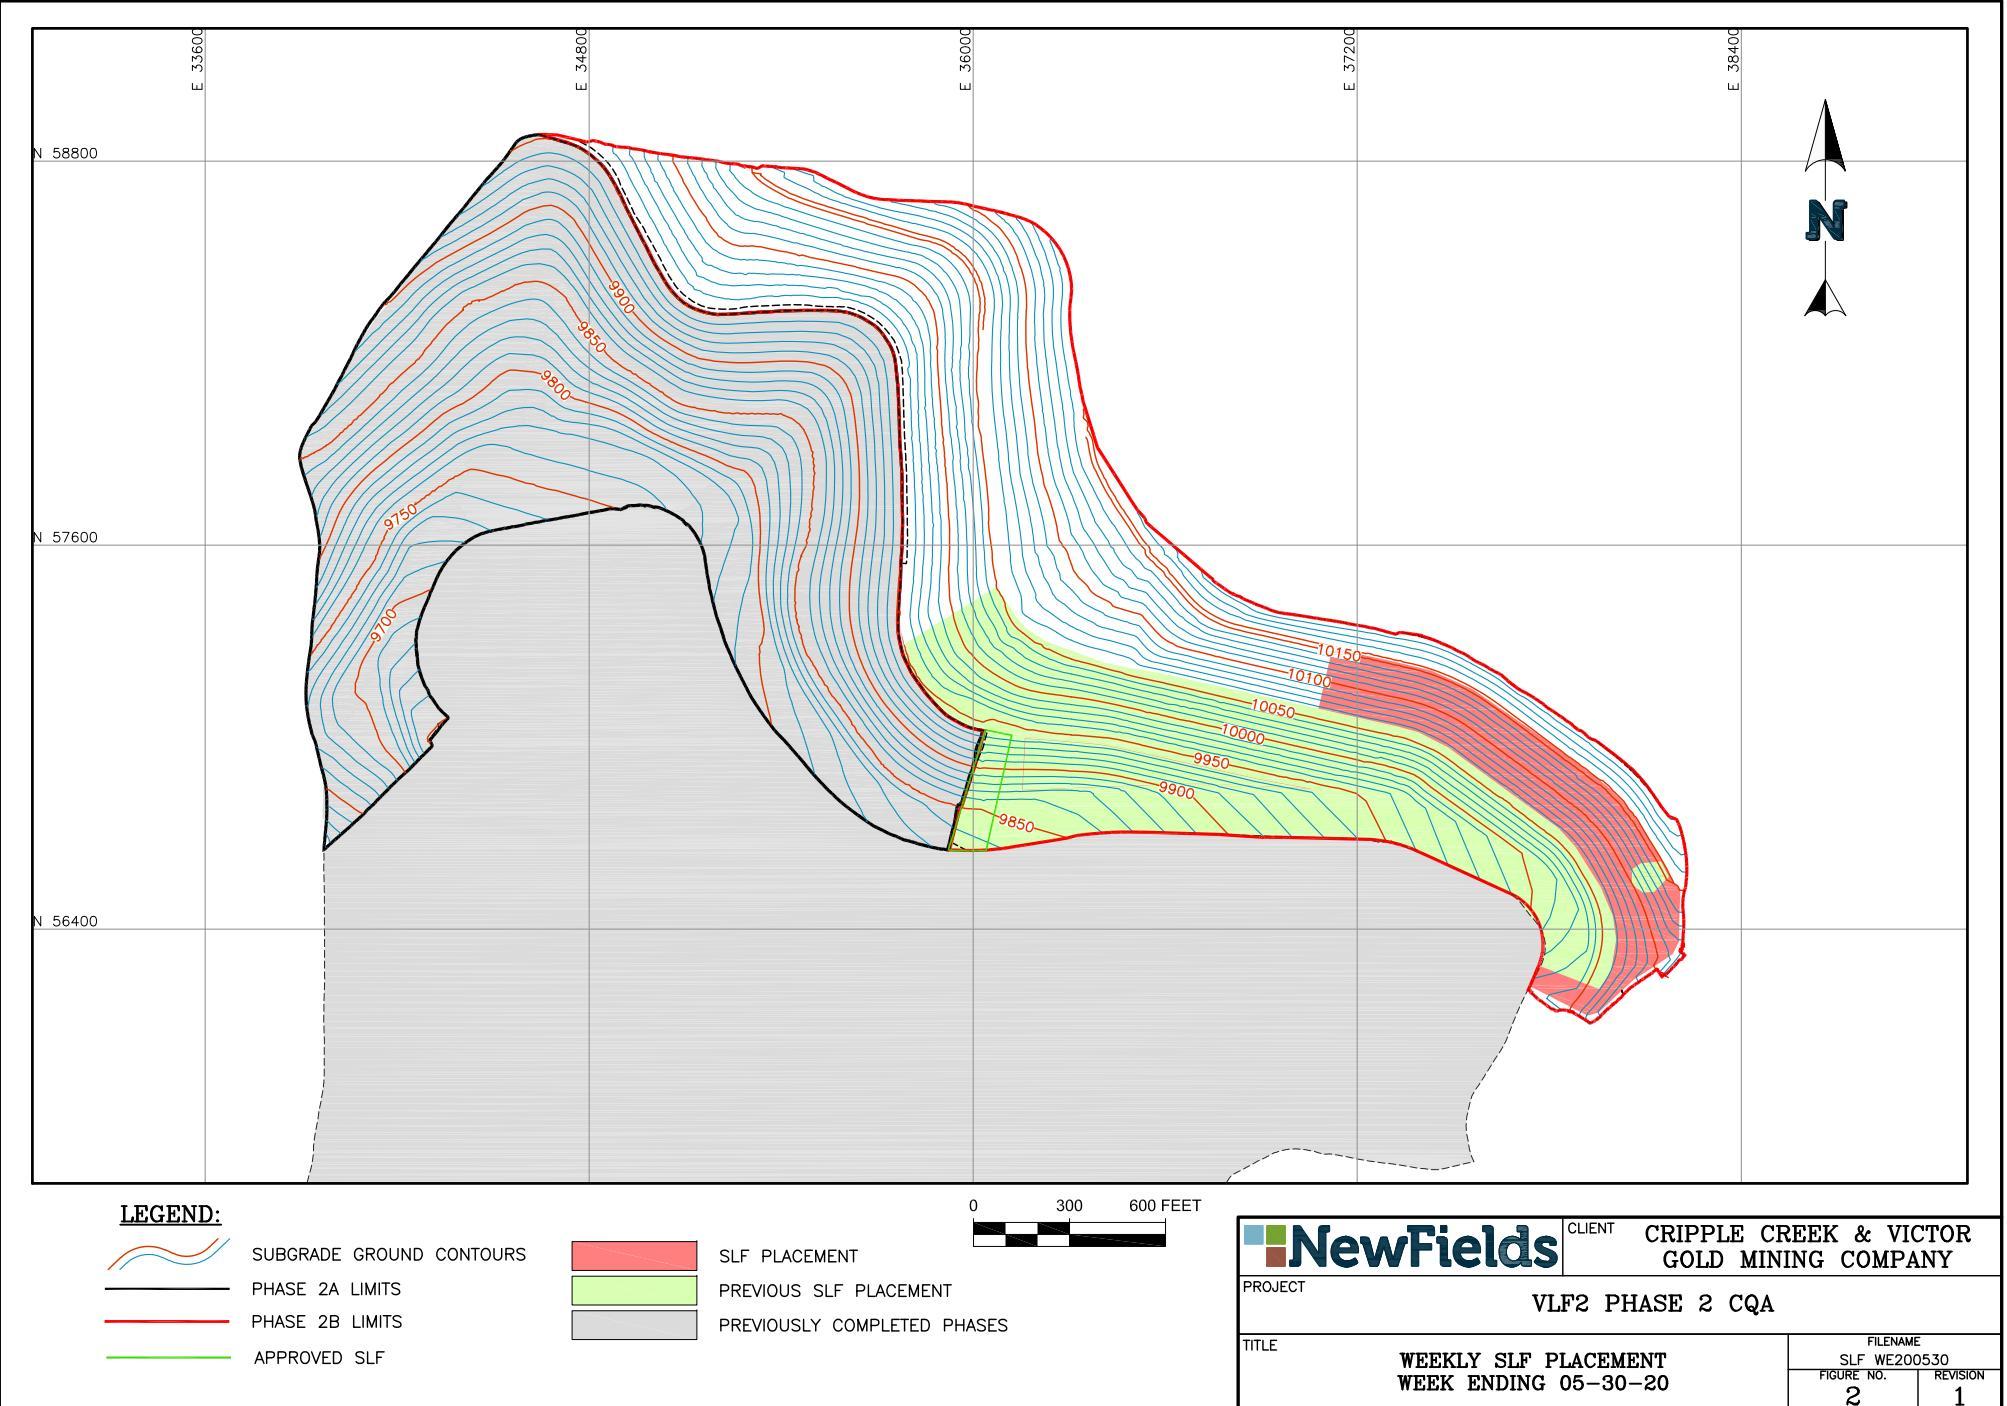
Soil Liner Fill (SLF) placement continued in the southwest portion of Phase 2B between the 10,050' and 10,150' benches. There was also placement on a small area below the 10,050' bench. SLF material was hauled from the Dump 1 stockpile using articulating haul trucks. The material was then spread with low ground pressure CAT dozers equipped with GPS. Moisture conditioning of SLF material was performed in place using a water truck, and compaction was done using a vibratory smooth drum compactor. Figure 2 shows the area of SLF placement during this reporting period.

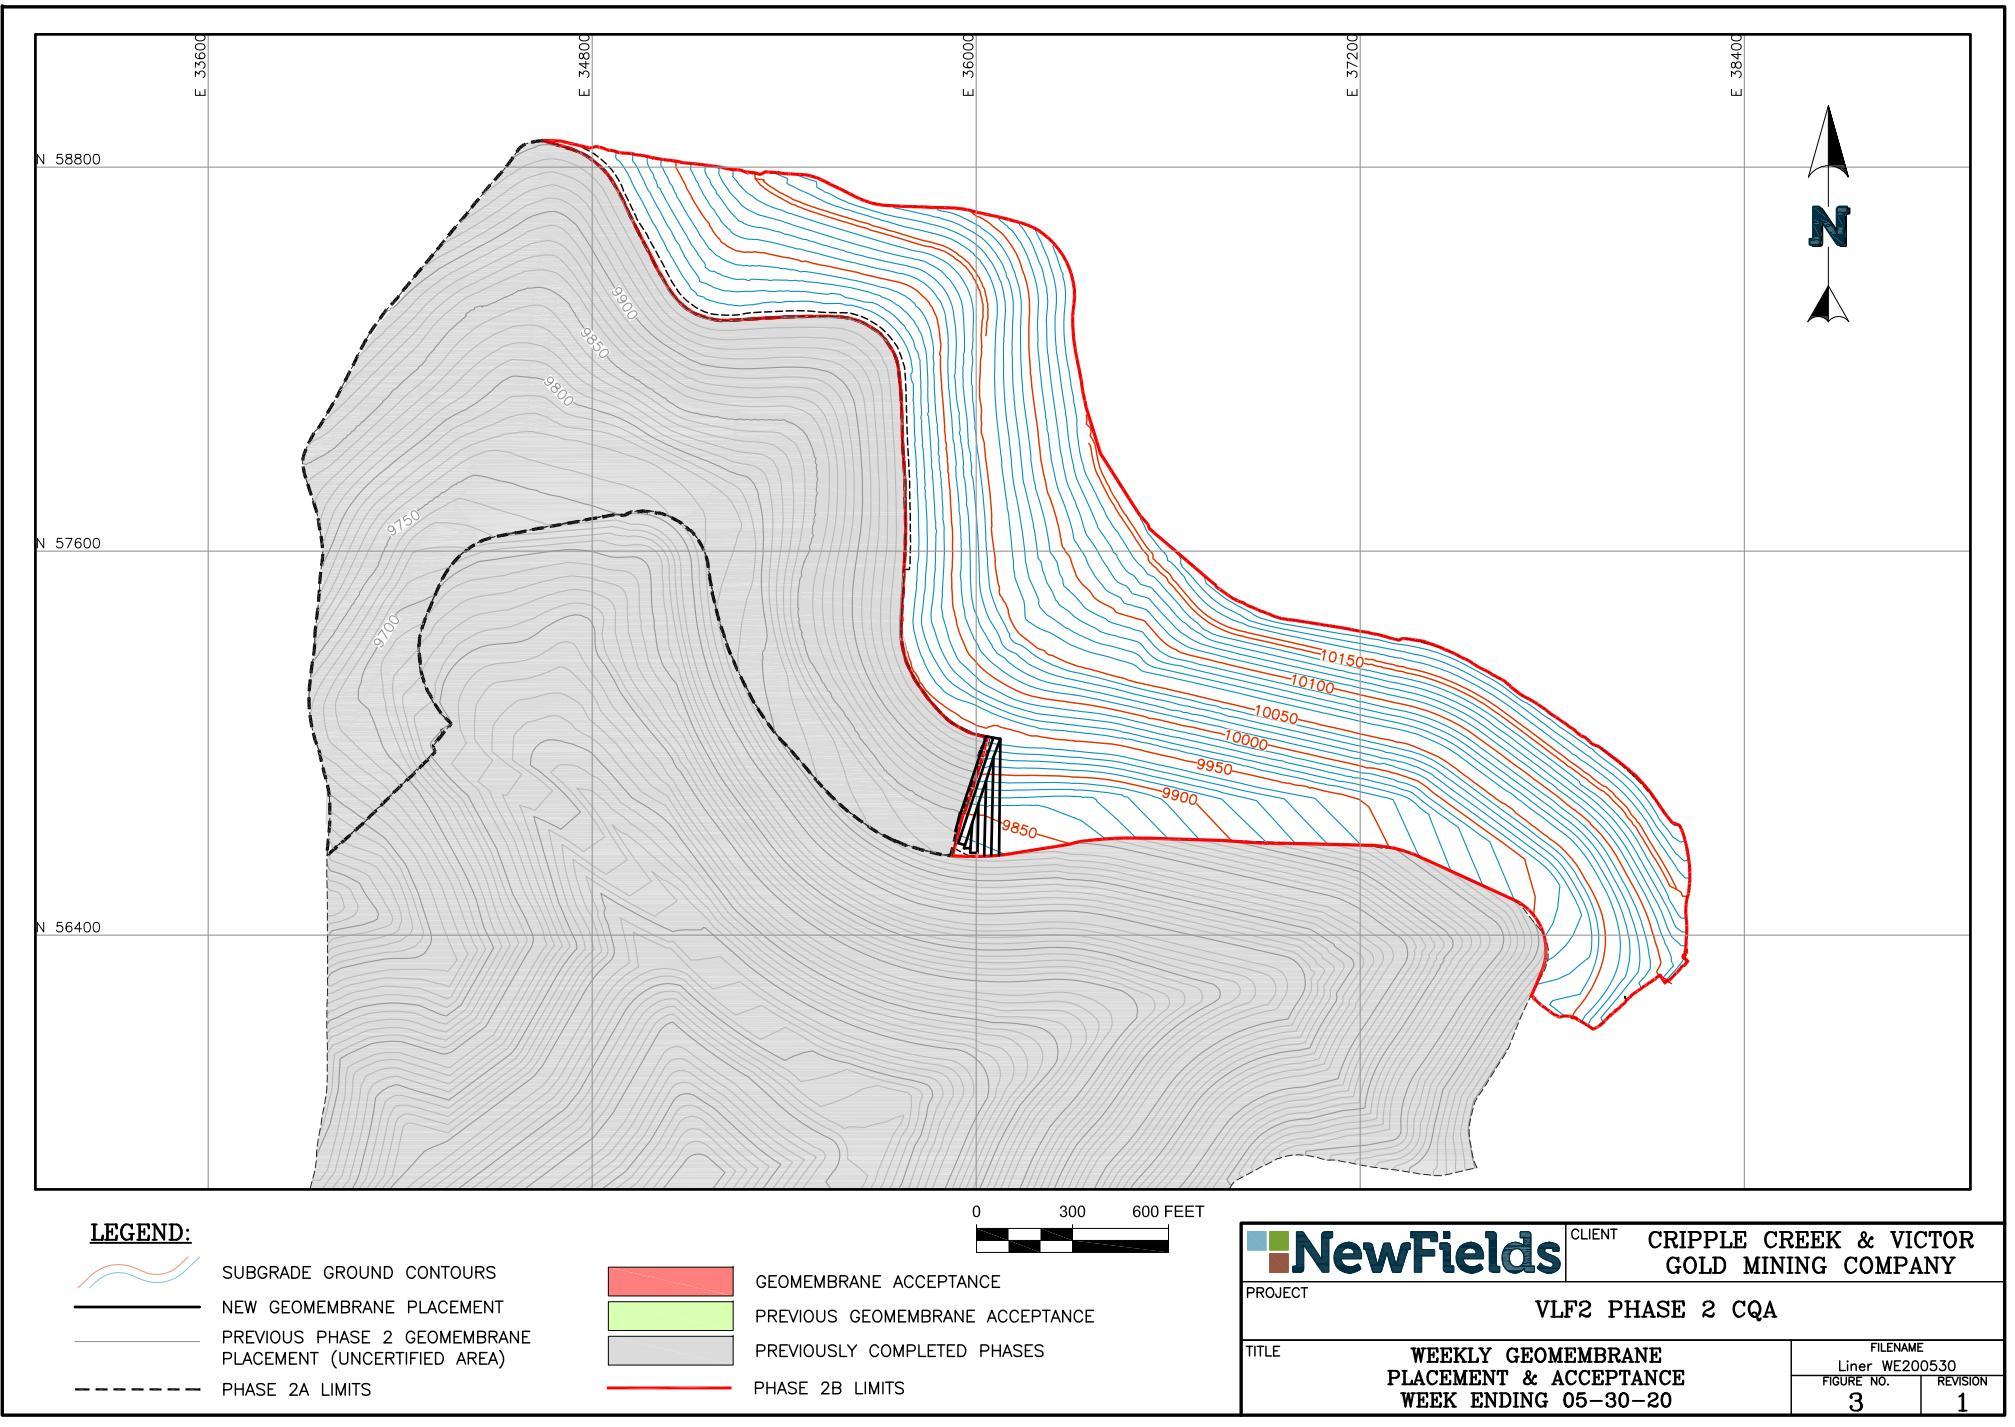
Geomembrane installation began within the Phase 2A-5 limits as shown on Figure 3. Approximately **40,175** square feet (P-3193 to P-3199) of 80-mil LLDPE (double sided textured) was deployed. Subgrade was inspected and approved by NewFields, Tezak, Newmont and AEG representatives prior to geomembrane deployment. Approximately **1,819** linear feet of seam was fusion welded using two fusion welding machine/operator combinations. **Three** destructive testing samples were marked during fusion seaming. Approximately **136** linear feet of seam was extrusion welded using one extrusion welding machine/operator combination. **One** destructive testing sample was marked during extrusion seaming. Non-destructive testing was performed for

fusion welded seams. Repairs were performed using the extrusion welding method for all marked defects.
