MINERALS PROGRAM INSPECTION REPORT PHONE: (303) 866-3567

MINE NAME:	MINE/PROSPECTING ID#:	MINERAL:	COUNTY:
Phoenix Mine	M-1982-075	Gold and silver	Clear Creek
INSPECTION TYPE:	INSPECTOR(S):	INSP. DATE:	INSP. TIME:
Monitoring	Peter Hays	September 11, 2020	10:00
OPERATOR:	OPERATOR REPRESENTATIVE:	TYPE OF OPERATION:	
Alvin Mosch - Patricia Mosch	David Mosch	110(2) - Hard Rock Limited Impact

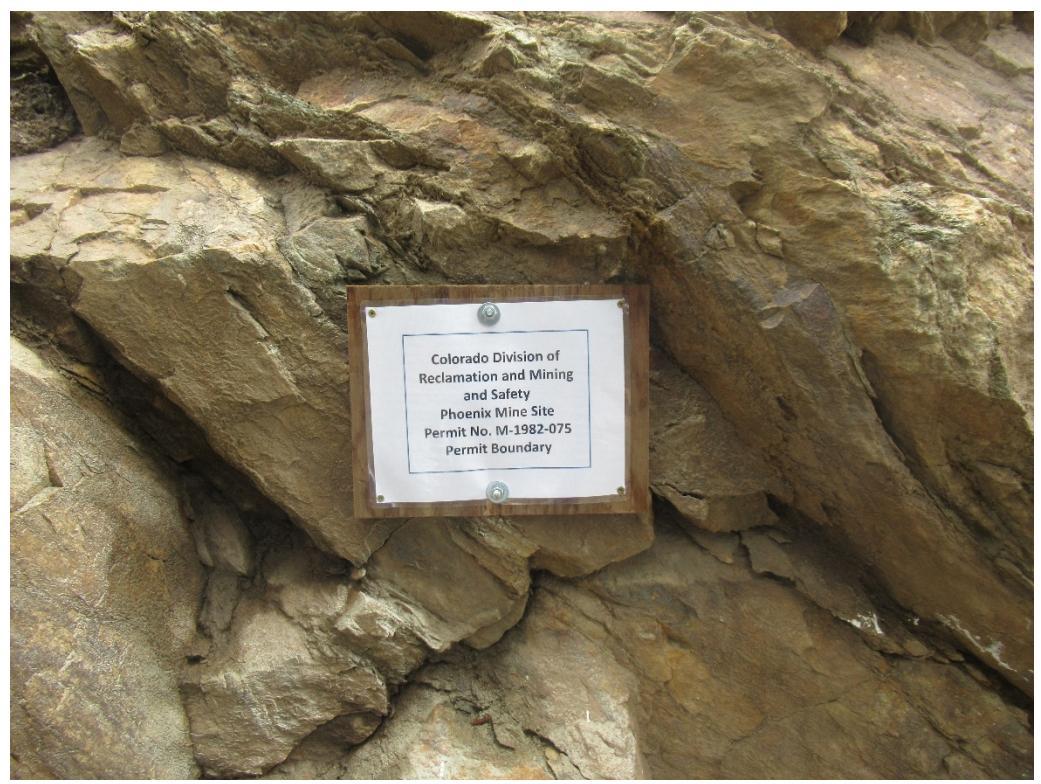
The mine sign and boundary markers were observed as required by Rule 3.1.12. Based on the Division's file, the permit boundary is composed of two (2) polygons for a total permit area of 0.44 acres. The Operator though the southern triangle shaped polygon had been removed from the permit boundary. The Division's file indicates the triangle polygon in the amendment application (AM-01) submitted on June 30, 1994 and in the technical revision (TR-03) submitted on March 23, 2016. Copies of the maps are attached for reference.

Mine sign and permit boundary marker

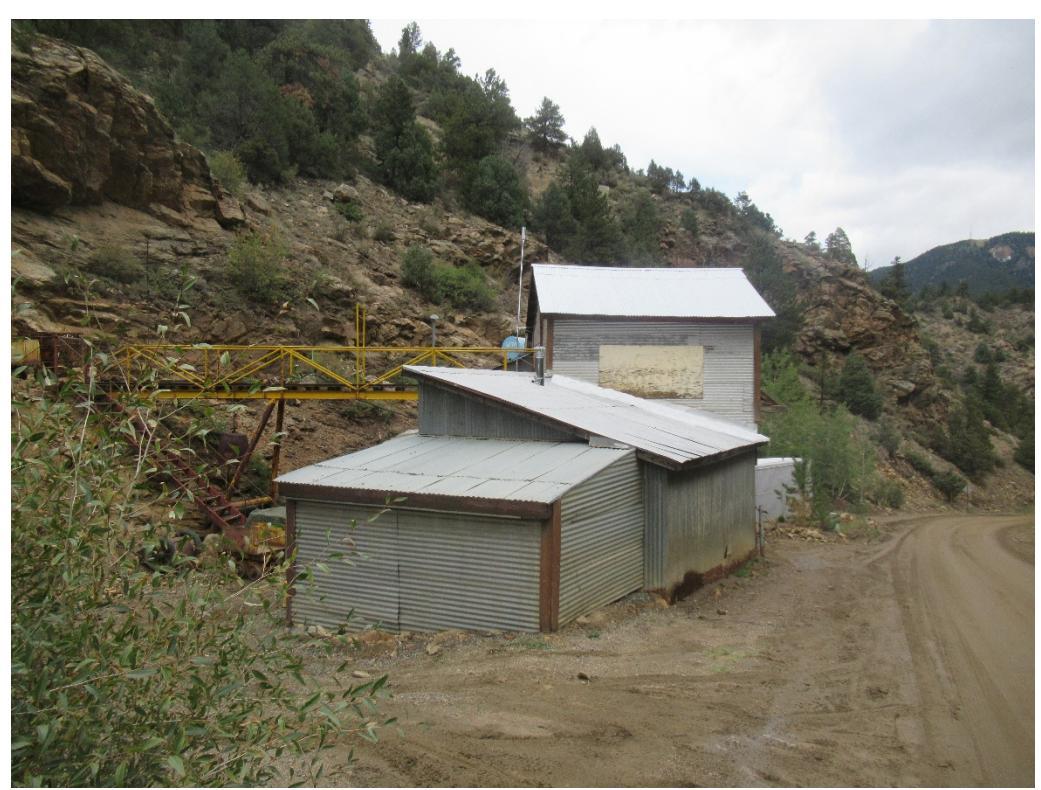
The inspection focused on the surface facilities at the site. The underground portions of the mine were not inspected by the Division. All mine entrances are secured with steel doors with locks. The mill building houses a jaw crusher, a ball mill, a bank of float cells and a shaker table. According to the Operator, the mill building has not been operational for decades. The bank of float cells were not hooked up to the milling circuit. The mill would require some additional work to be fully functional, which the Operator intends to perform to operate the mill. The milling process currently does not use chemicals in metal recovery and relies on gravity concentration. The Division found no evidence of chemicals being stored or used in the mill. A variety of spare parts and tools are stored in the mill building. The Operator stated they intend to clean up the mill building as time allows. The upper level of the mill is accessed by way of a cat-walk which connects to the hillside above the mill building. The upper level of the mill building contains an office area and the jaw crusher. The current Mining Plan does not contain any details about how the mill will be operated. The pending conversion to a DMO operation must include a complete explanation of all processing facilities, including the mill, as part of an updated Mining Plan.

View of the mill building looking northwest

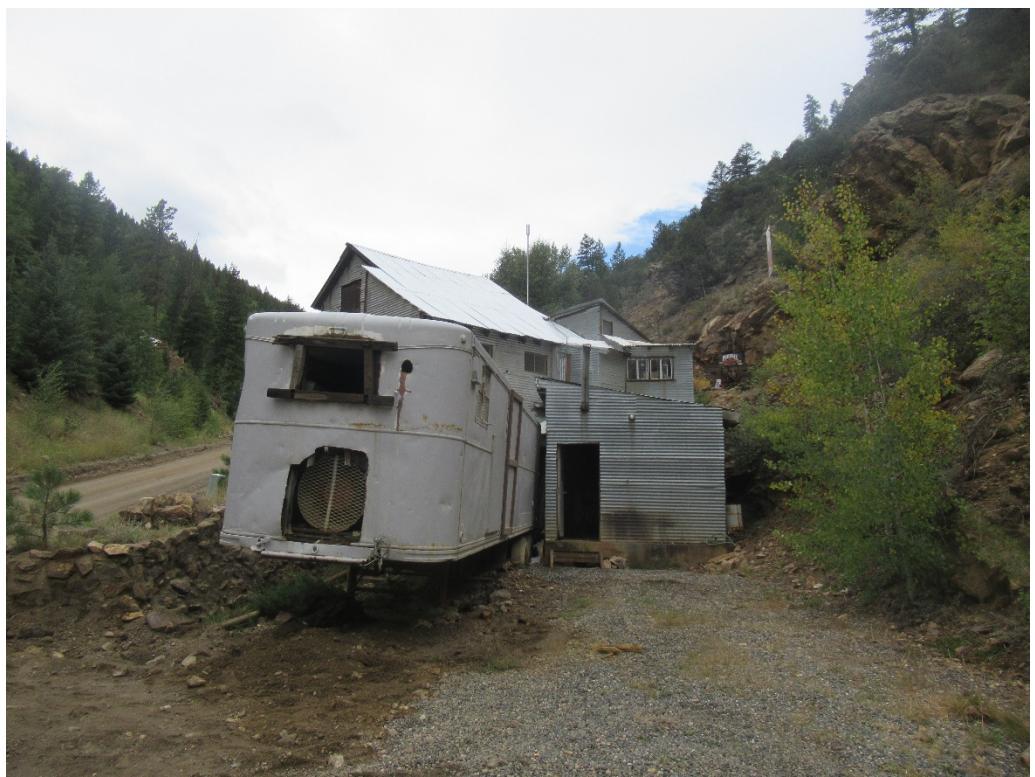
Generator trailer, to be removed this year

The Operator stated the empty fuel tank located in the southern portion of the permit boundary on the bench above Trail Ridge Road and the generator trailer located north of the mill building would be removed from the site this year.

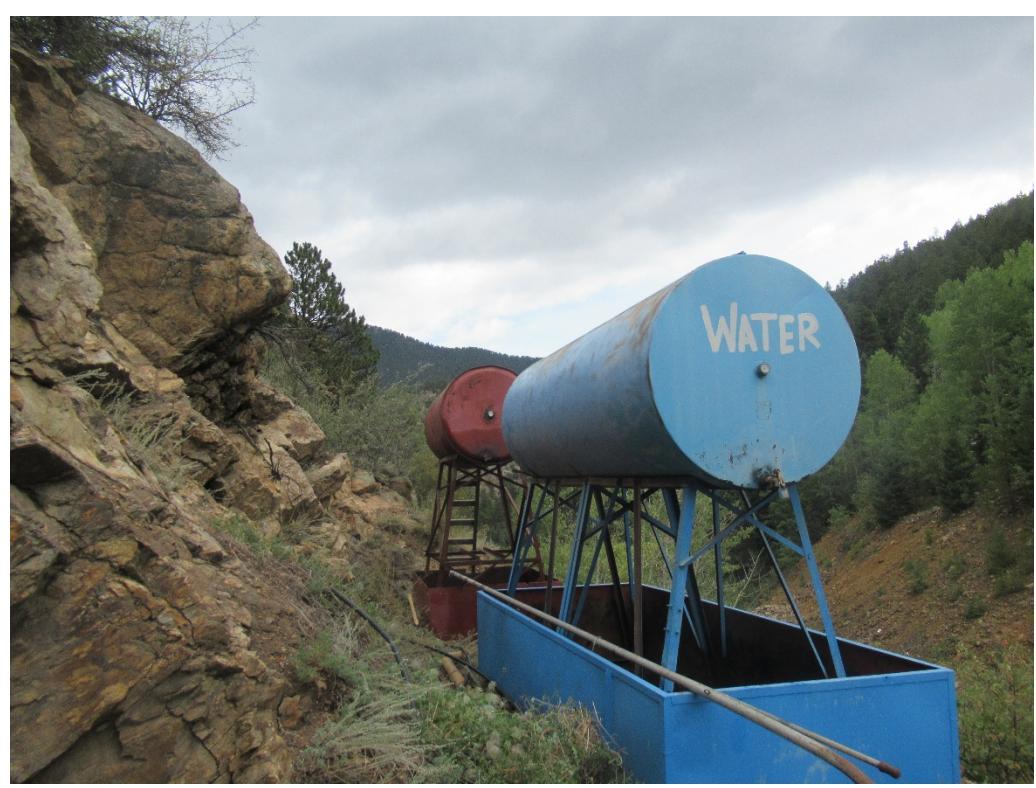
Tanks, to be removed this year

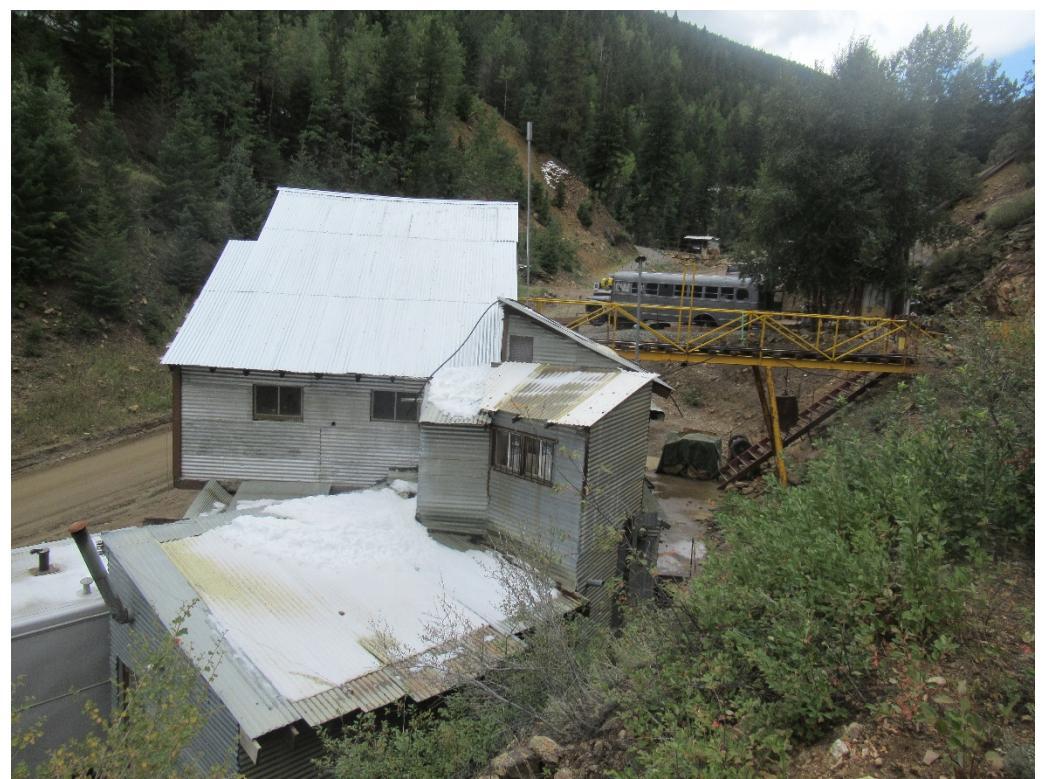
View of the mill building looking southeast

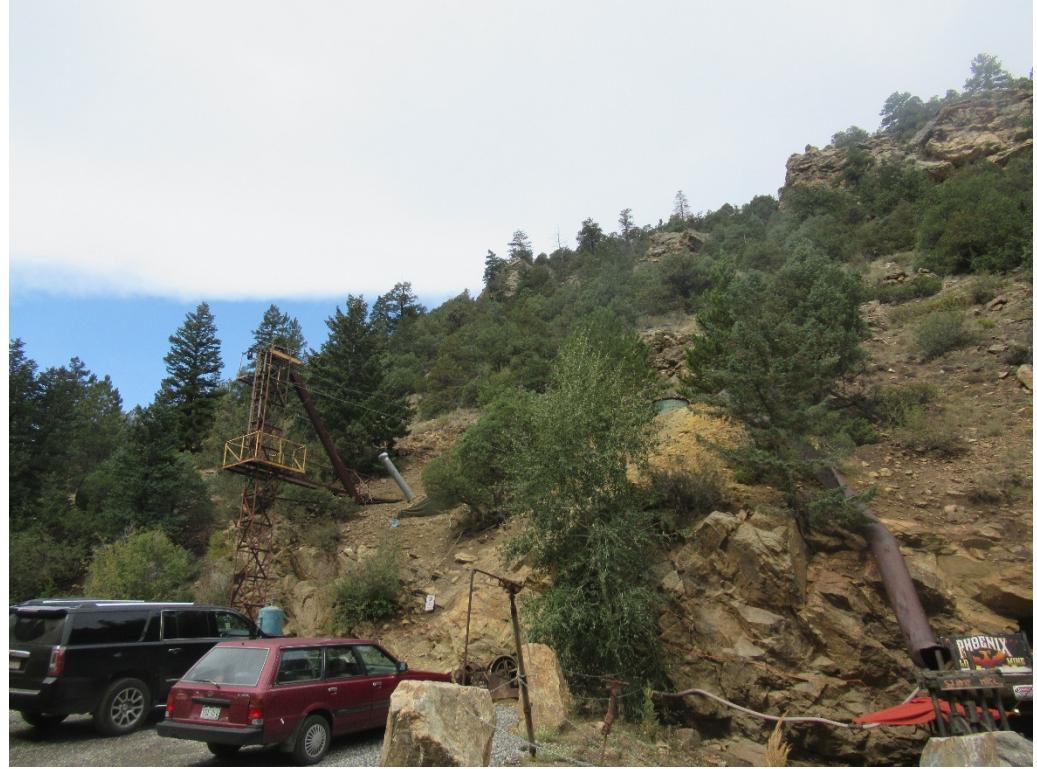
View of the triangle shaped polygon from the northeast corner looking southwest

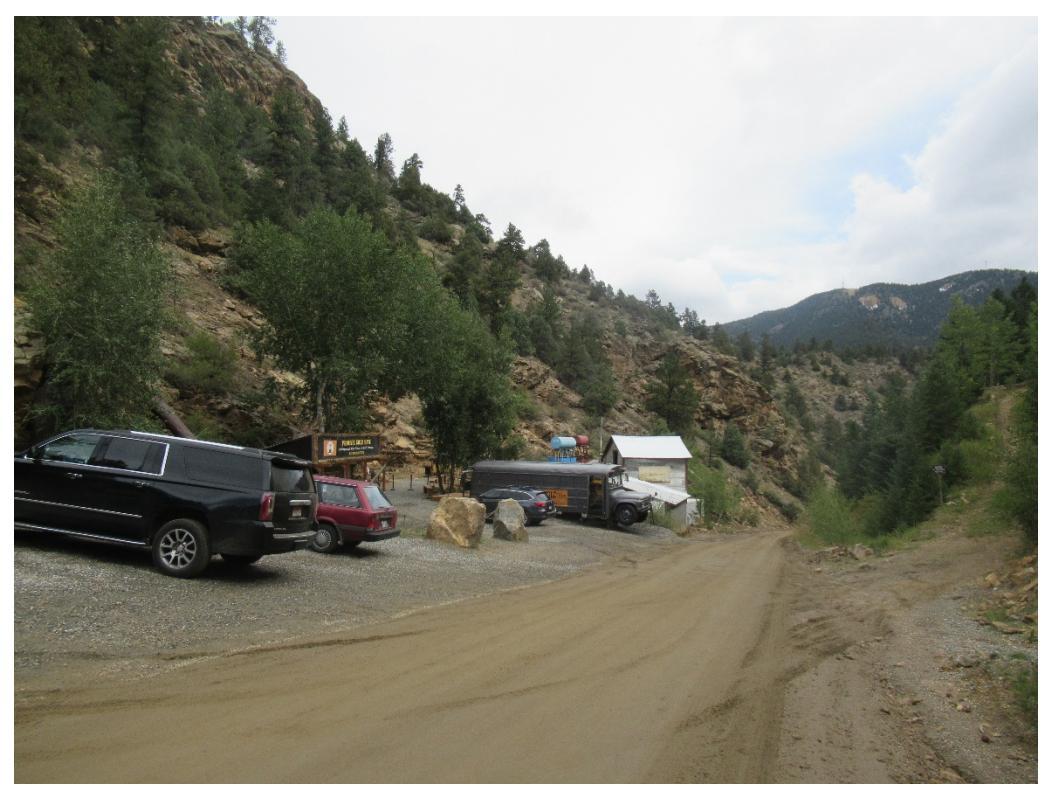
View of the rectangle shaped polygon from the southeast corner looking northwest

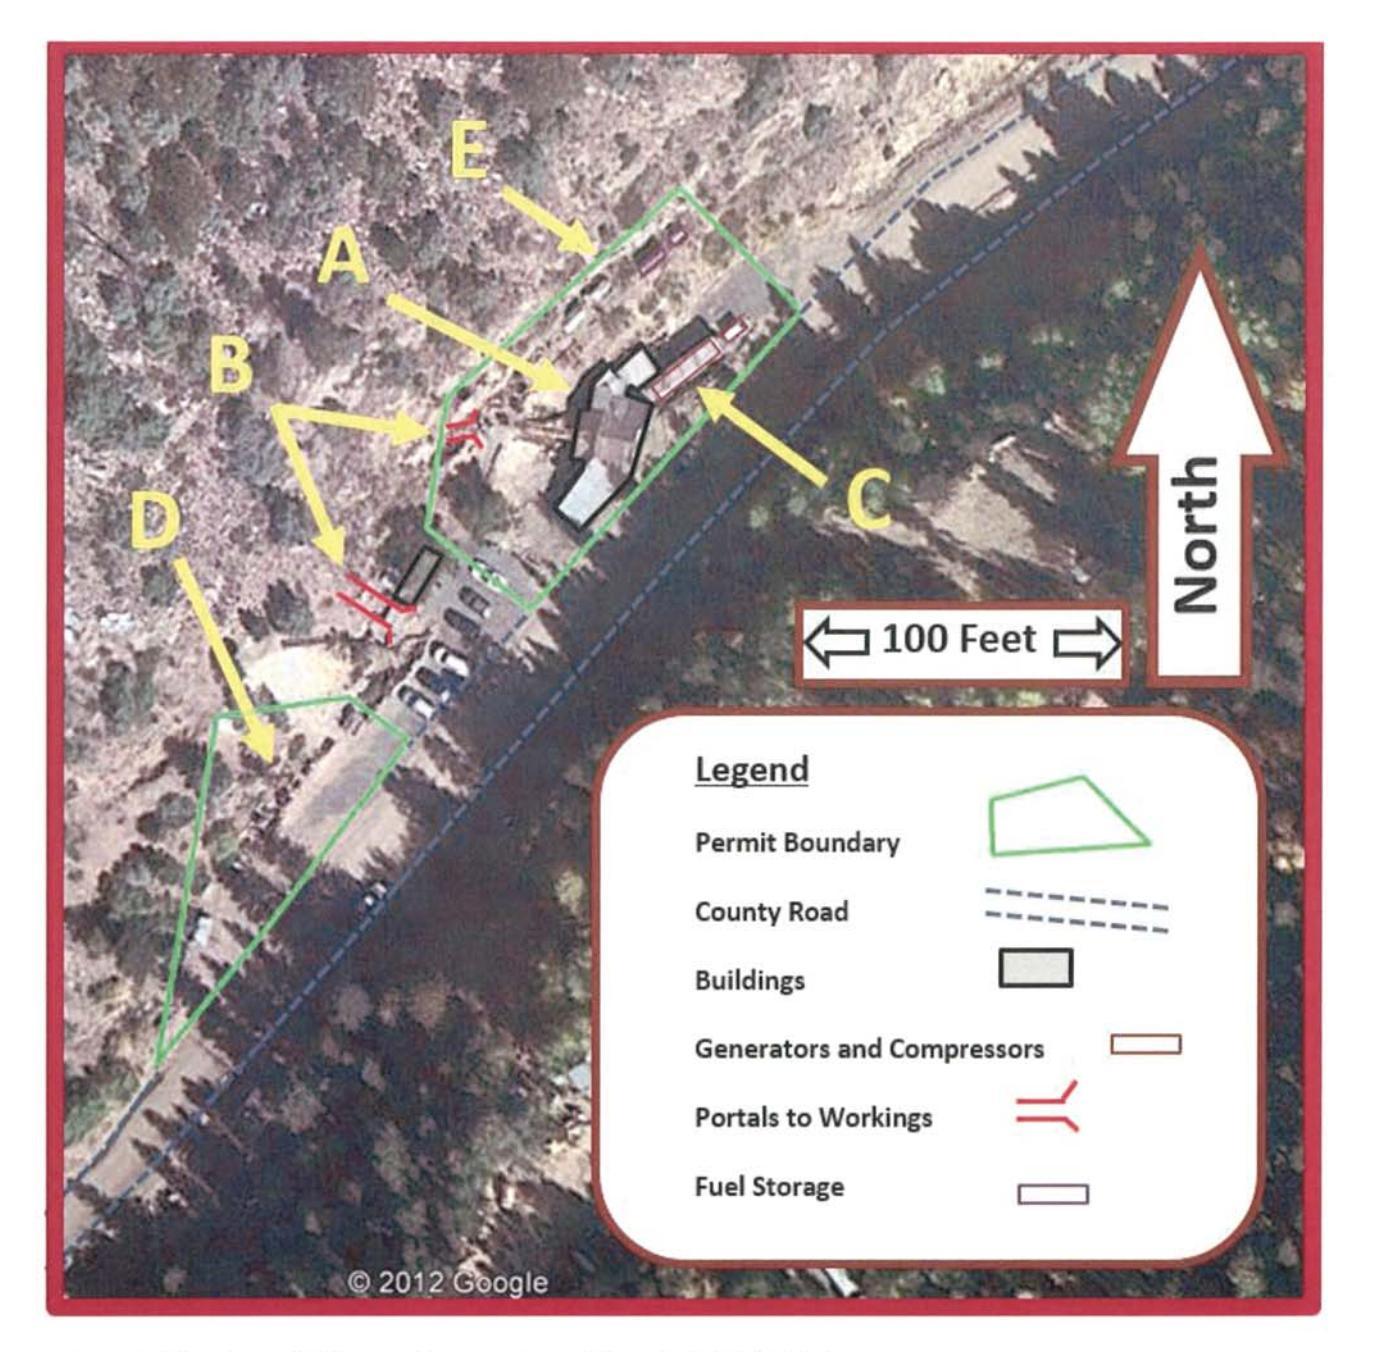
Figure 1; The Over All Permit Boundaries of Permit M-1982-075

Letter "D" of Figure 1 shows the location that is part of the permitted area to store equipment that at one time may have be needed for the mining operation. The equipment in this are includes mining, processing and exploration equipment. All of it is at least 50 years old and are considered to be antiques. In this site is also a 20-foot metal tower that was constructed at one time to contain a vertical belt conveyor.

The letter "E" shows the location of the old air compressor and fuel storage equipment that powered the mine in the 1970's and 1980's.

The area within the permit boundary (shown in green in Figure 1) is 0.45 acres. The permit area is on the patented mining claims named the Phoenix, US Mineral Survey No. 526A and the Phoenix MS, US Survey No. 586B. These claims are located in Clear Creek County and are located in the North-East 1/4th of the North-West 1/4th of section 33, Township 3 South, Range 73 West of the 6th Principle Meridian.
