MINERALS PROGRAM INSPECTION REPORT PHONE: (303) 866-3567

MINE NAME:	MINE/PROSPECTING ID#:	MINERAL:	COUNTY:
Parker-Dersham Resource	M-2006-003	Sand and gravel	Weld
INSPECTION TYPE:	INSPECTOR(S):	INSP. DATE:	INSP. TIME:
Monitoring	Eric Scott	November 16, 2020	10:00
OPERATOR:	OPERATOR REPRESENTATIVE:	TYPE OF OPERATION:	
Hall-Irwin Aggregates, LLC	Ed Lafferty	112c - Construction Regular Operation

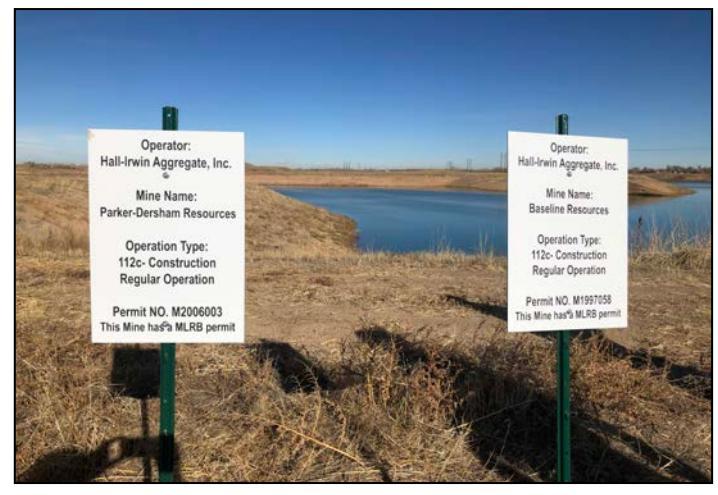
Photo 1 – Site identification sign near entrance from WCR 2

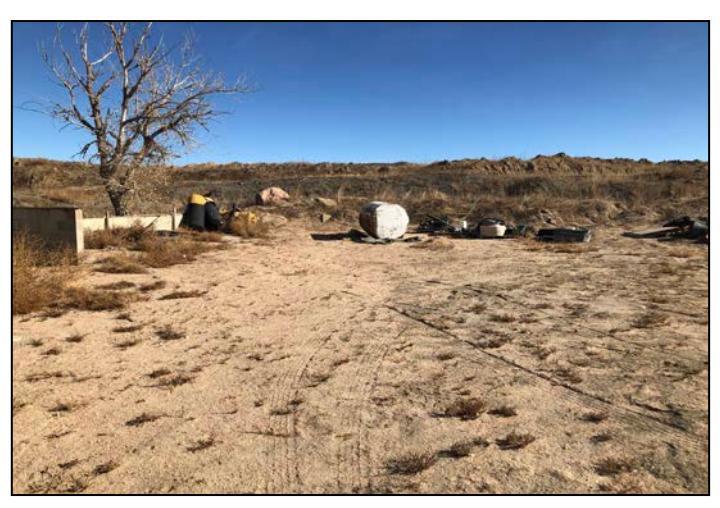
PROBLEM/POSSIBLE VIOLATION: Problem: Trash and refuse was noticed on the site (photo 2). This is a problem at this time for failure to dispose of refuse in a manner that controls unsightliness or deleterious effects of such refuse pursuant to C.R.S. 34-32.5-116(4)(e).

- 1) Trash was noted on site that will need to be removed and disposed of properly (photo 2)
- 2) Vegetation at the site at this time, although recently mowed, appears to be in generally poor condition and consists mainly of weeds and noxious species such as cheat-grass and Russian thistle. The permittee will need to take aggressive action to eliminate noxious species and establish the approved reclamation vegetation.
- 3) A significant amount of overburden will need to be removed to return the NW portion of the permit area to approximate original grade prior to replacing topsoil and establishing reclamation vegetation.
- 4) A technical revision to the reclamation plan may need to be submitted to DRMS to update the reclamation plan as needed to reflect any proposed changes to the approved reclamation plan.

Photo 2 – Trash in NW area of site that will need to be removed and disposed of properly.

CORRECTIVE ACTIONS: The operator shall submit a written notice to the Division with photo documentation, that the trash has been removed from the site by the corrective action date.

CORRECTIVE ACTION DUE DATE: 12/18/20

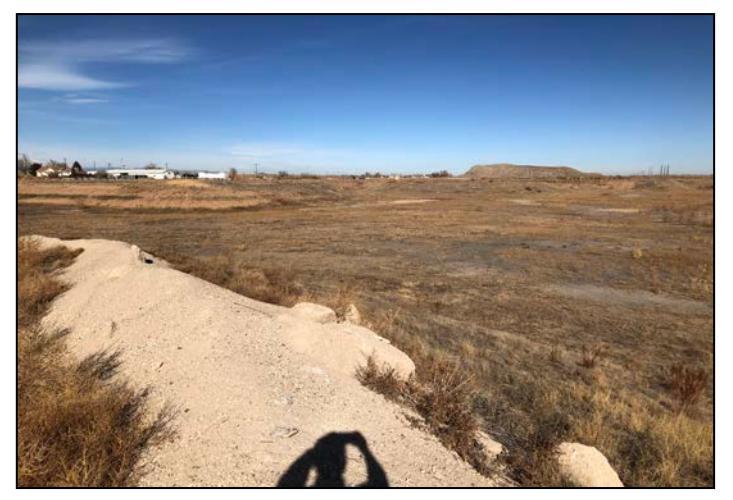
Photo 3 – Dry lined reservoir area in SW area of site.

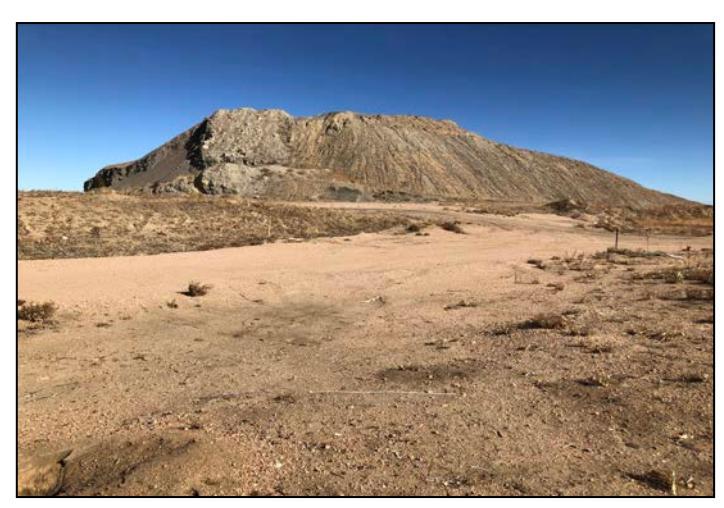
Photo 4 – Large stockpile of overburden (shale) in NW area of site that will need to be removed from the site prior to revegetation.

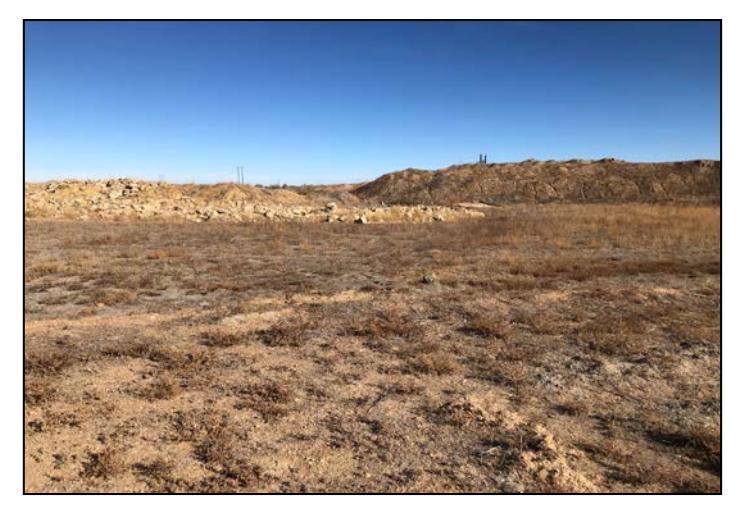
Photo 5 – Additional overburden and concrete that will need to be removed from NW area of permit.
