Minerals Plan of Operations Inspection U.S. Department of the Interior Bureau of Land Management Royal Gorge Field Office

Date: Nov 6, 2020	Operation Name: Field of Dreams Mine			
Time: 12:35 pm	Operator: Gold Tamers LLC			
Weather: Sunny	Case Number: COC73930			
	CDRMS Number: M-2009-056			
Attendees	General			
BLM: A. Sanderson & J. Elkington (Images taken by J. Elkington)	Operation(s) are in-compliance with documentation on file □ Yes ⊠ No □ N/A			
Operator (s): Contacted, but not present	Operation(s) and disturbance onsite coincide with the			
	operations and access on file			
Other(s): None	\boxtimes Yes \Box No \Box N/A

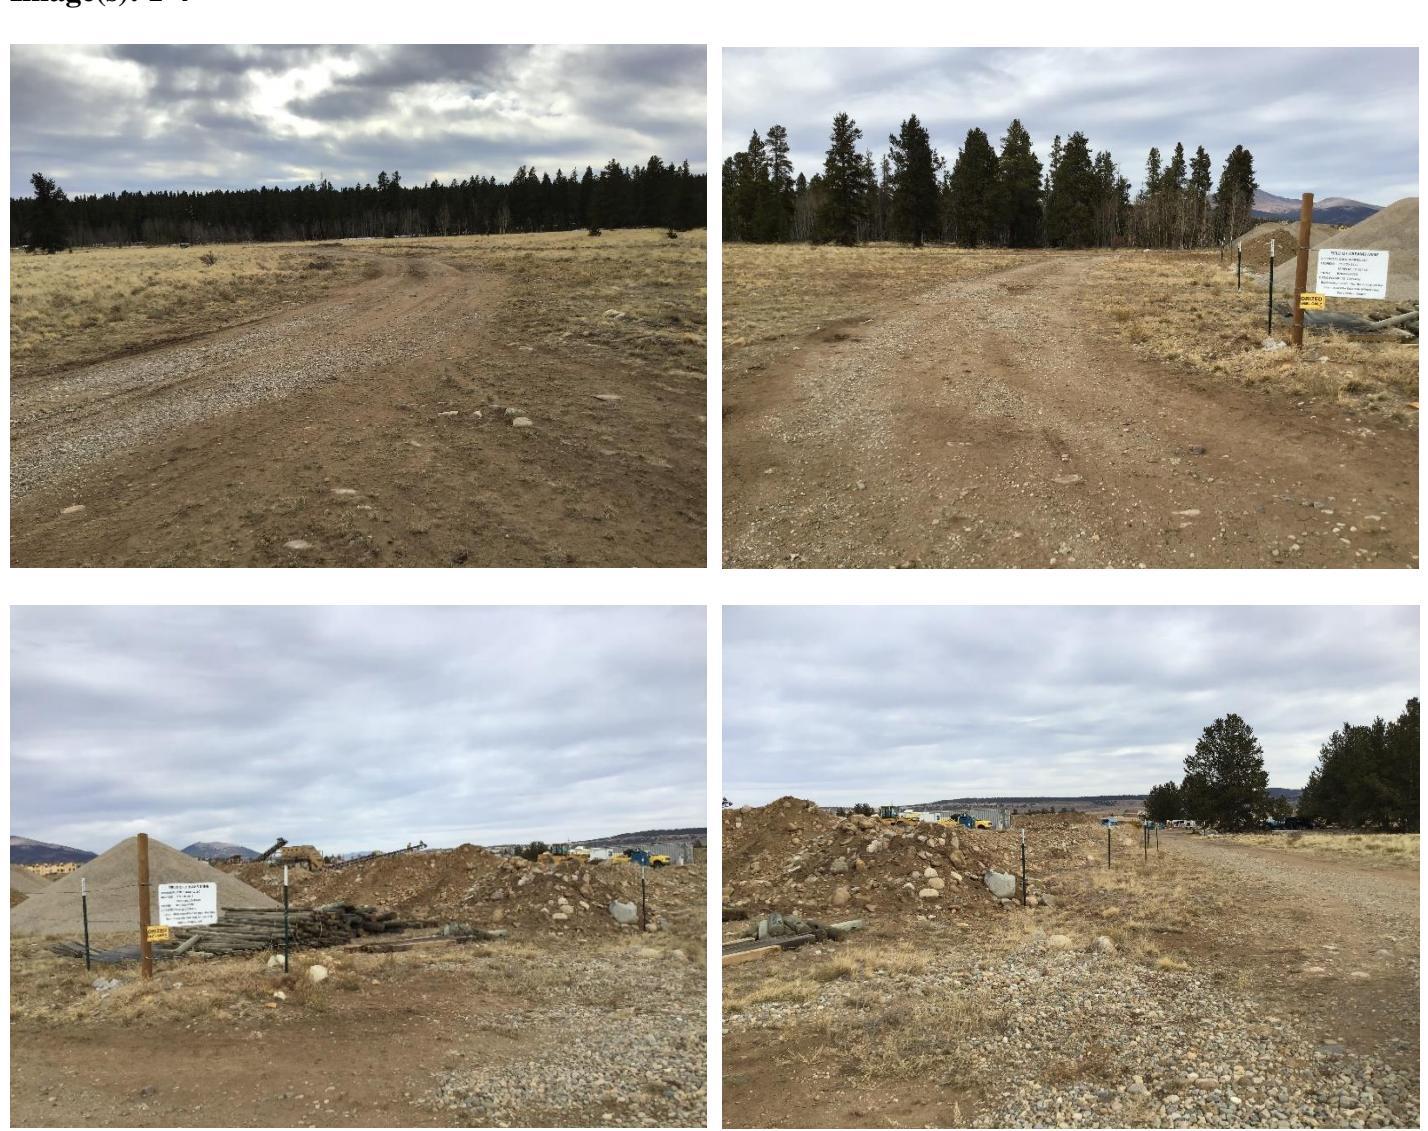
Image(s): 1-4

Comment: Adequate mine entrance, access road, signage, fencing and parking area.

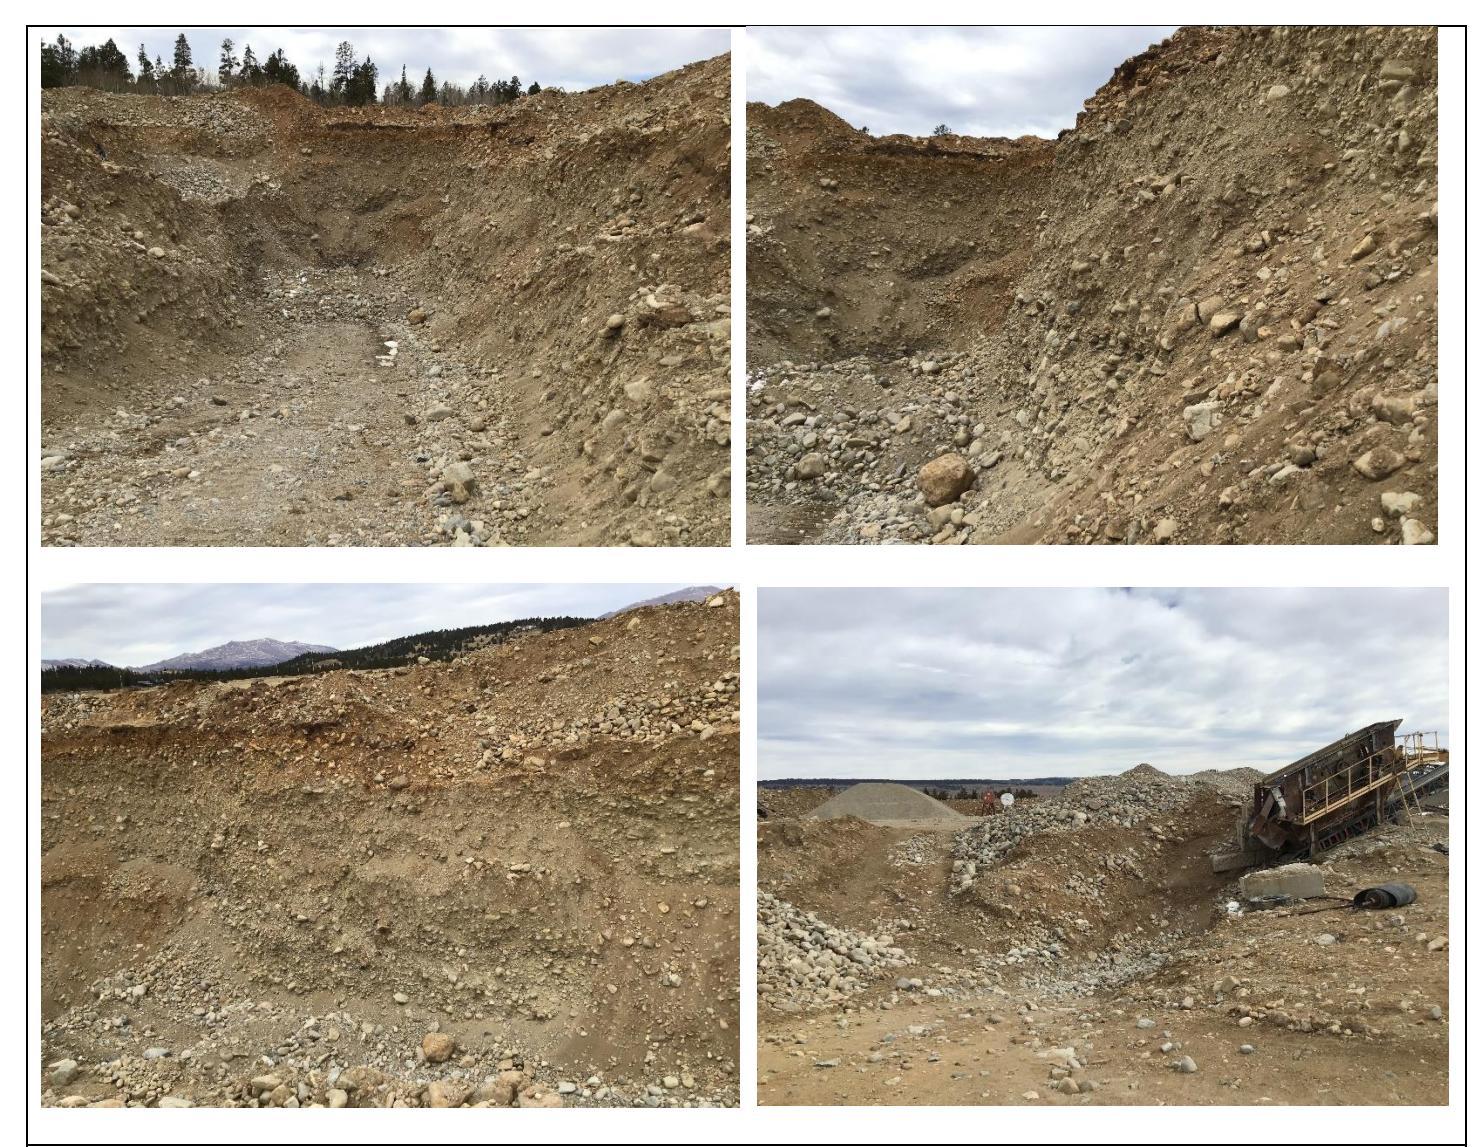
Image(s): 5-8

• The active excavation pit contains a 1:1 slope along the northern and southern edges (ref. images 5-8). To decrease potential safety issues, these slopes will need to be reduced to an active slope of 2:1 per the approved Plan of Operations. Per the Interim Management Plan, all steep slopes will be pulled down prior to seasonal shutdowns.

Comment: Current disturbance located along the northern storage area. The operator has processed the material which was mined last operational season and is now excavating material from a pit along the northern boundary.

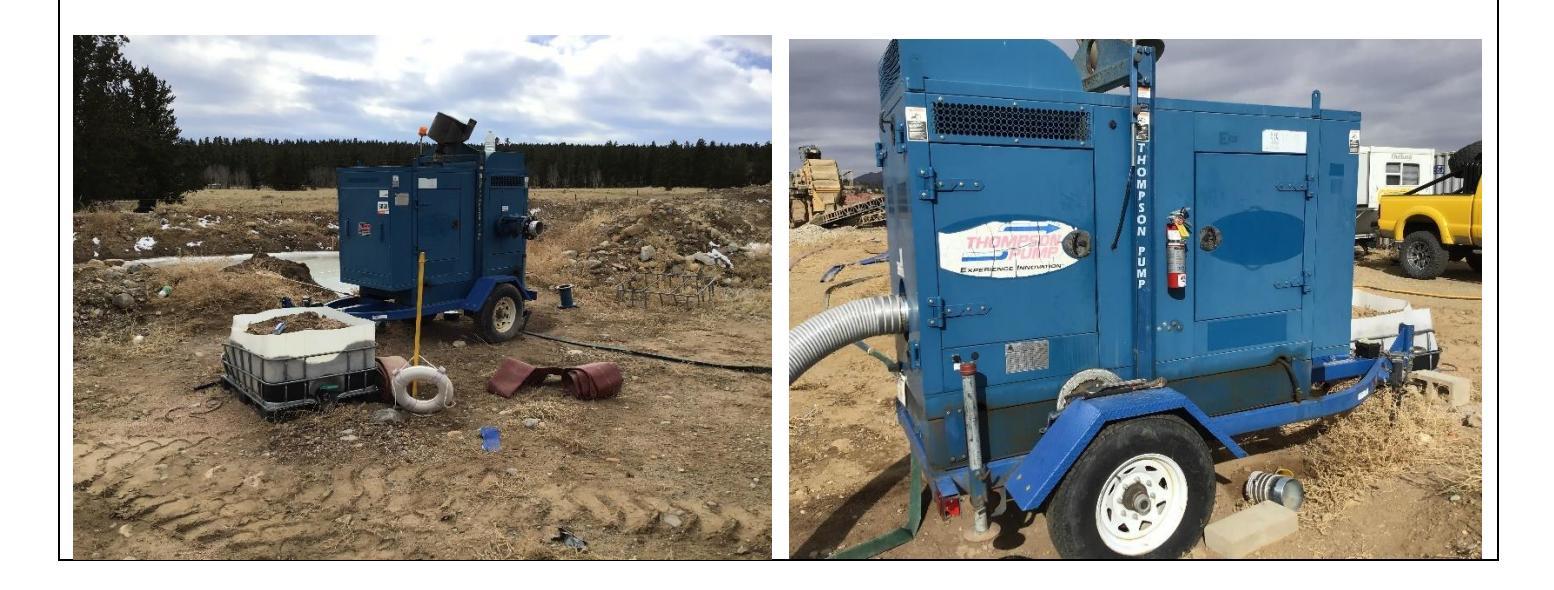
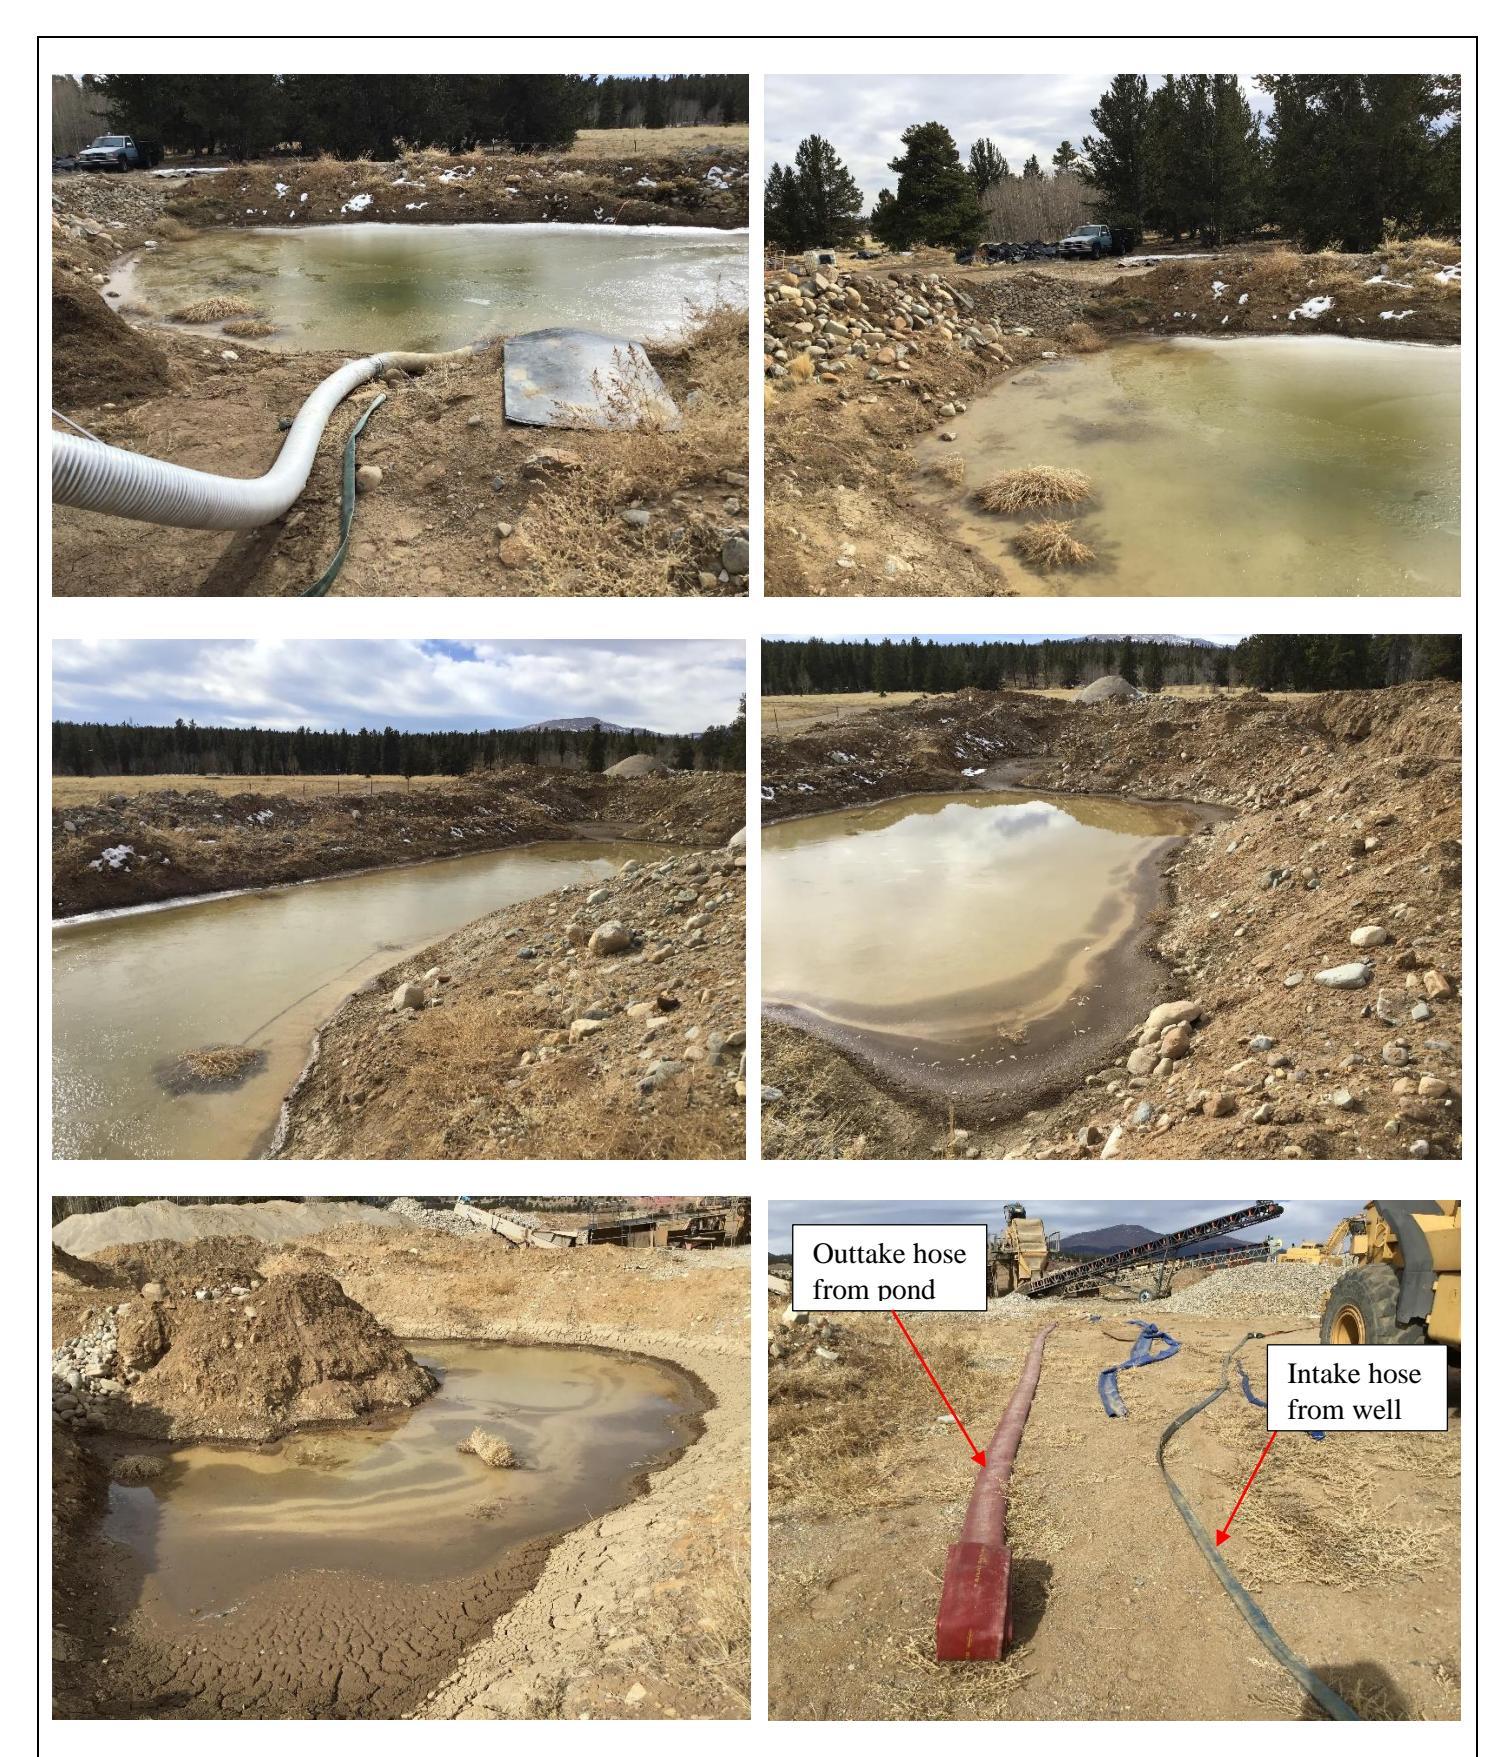
Image(s): 9-16

Comment: A water circulation pond with a diesel-powered water pump is used to process the ore and sand and gravel materials. The water is sourced from an authorized onsite well (sourced from S. Platte River; SPRAP authorization/use balance) and is pumped from the circulation pond lined with an impermeable clay layer. A noise control system is utilized to mitigate the total accumulated machinery noise. No oil sheen was visible on the water surfaces and a life preserver was available near the pump as a safety precaution.

Abundant Russian thistle vegetation located along the bermed edges of the pond. This is not considered a noxious weed in Colorado; however, it is not desirable and usually occurs in disturbed areas.

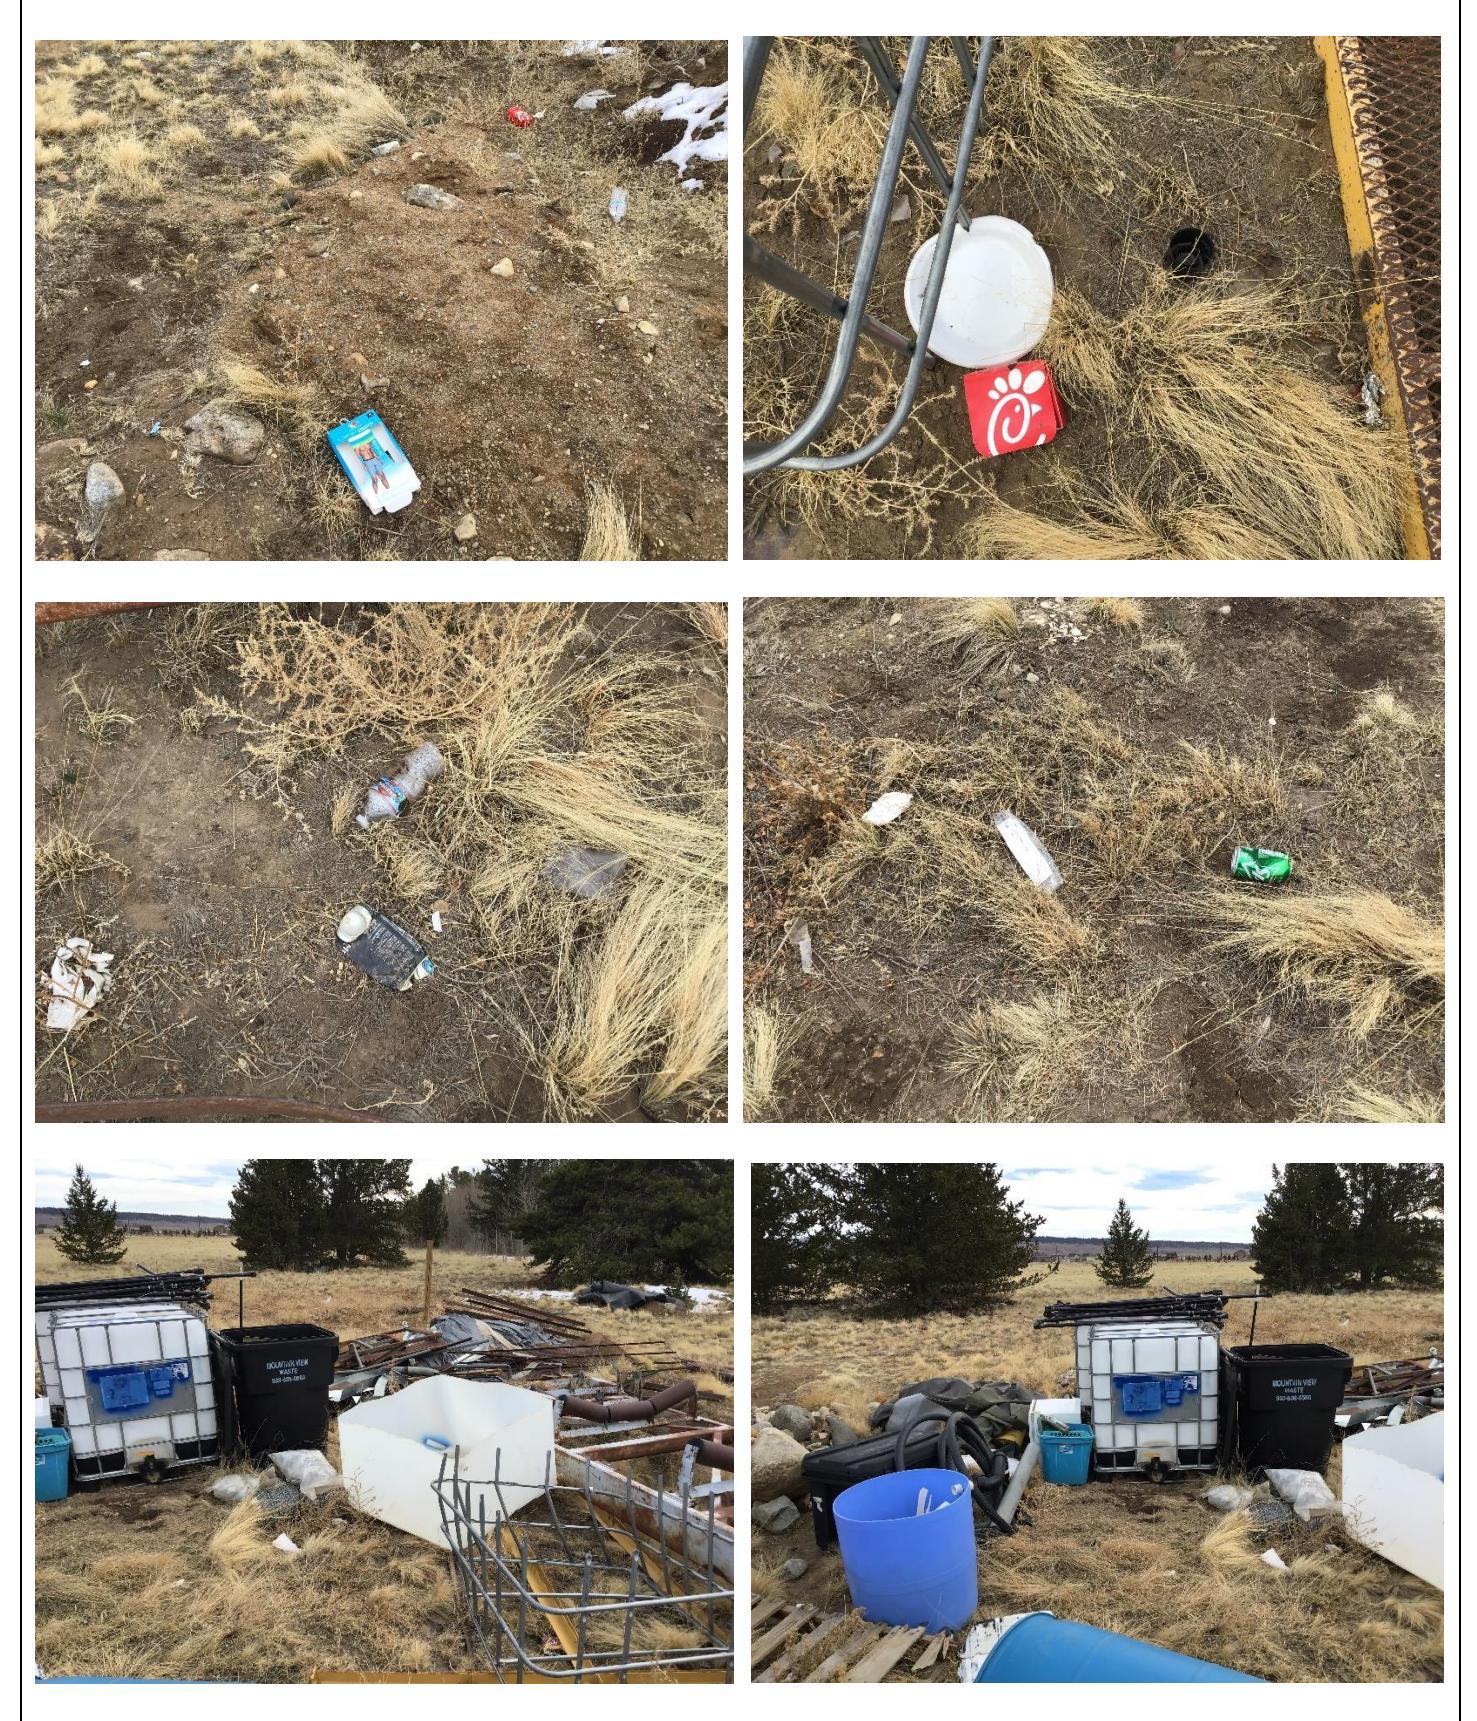
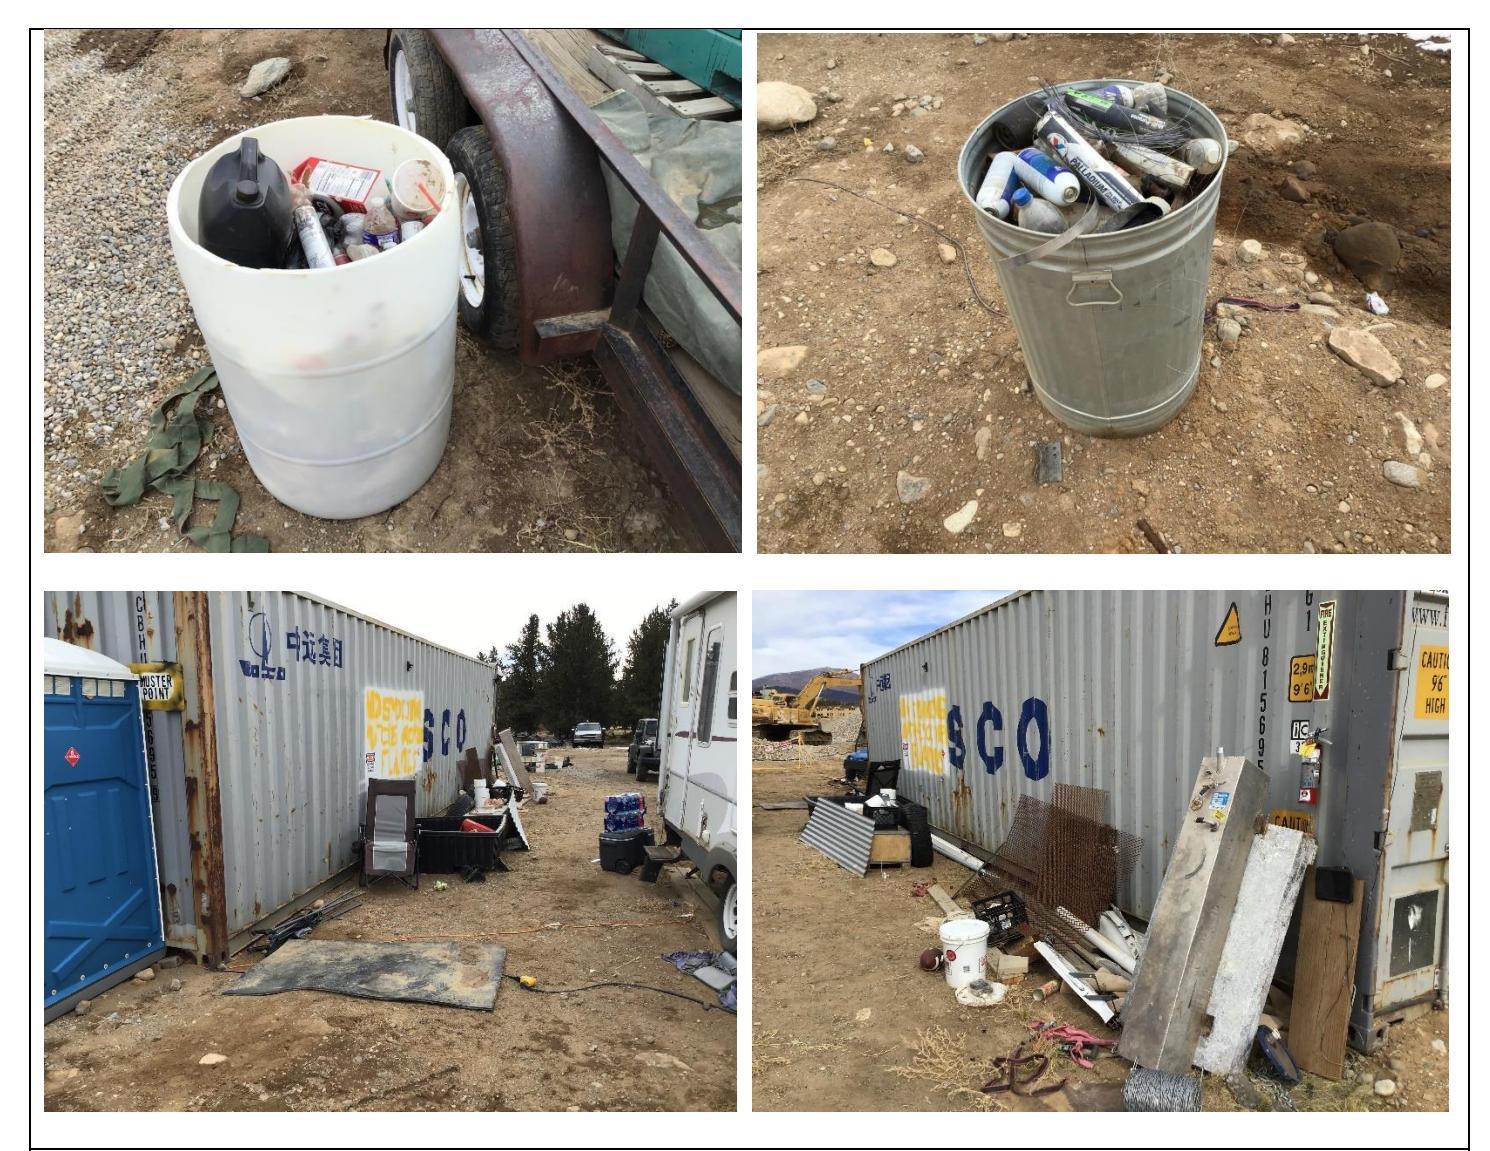
Image(s): 17-26

- Diesel and oil containers are not properly stored on-site. Multiple open spent oil and diesel containers were stored behind the maintenance truck located along the SE boundary and starter fluid cans located near the 3R dumpster. All POL substances need to be stored in appropriately labeled containers and within secondary containment vessels. Several large oil spills were also observed throughout the site. Best Management Practices suggest storing all POLs away from water resources and within secondary containment. Note: No sheen was observed on water surfaces. *All POLs will need to be emptied and stored in adequate secondary containment or in the storage container prior to the seasonal shut-down*

- Trash is littered throughout the site
- Multiple blue, white and metal 55-gallon bung-hole drums are stored in the SE storage area. These drums are not correctly labeled and contain an unknown red fluid. All containers must be stored and adequately labeled according to OHSA or MSHA regulations.

Comment: House Abundant amount of trash littering the site. The site is currently in noncompliance regarding housekeeping.

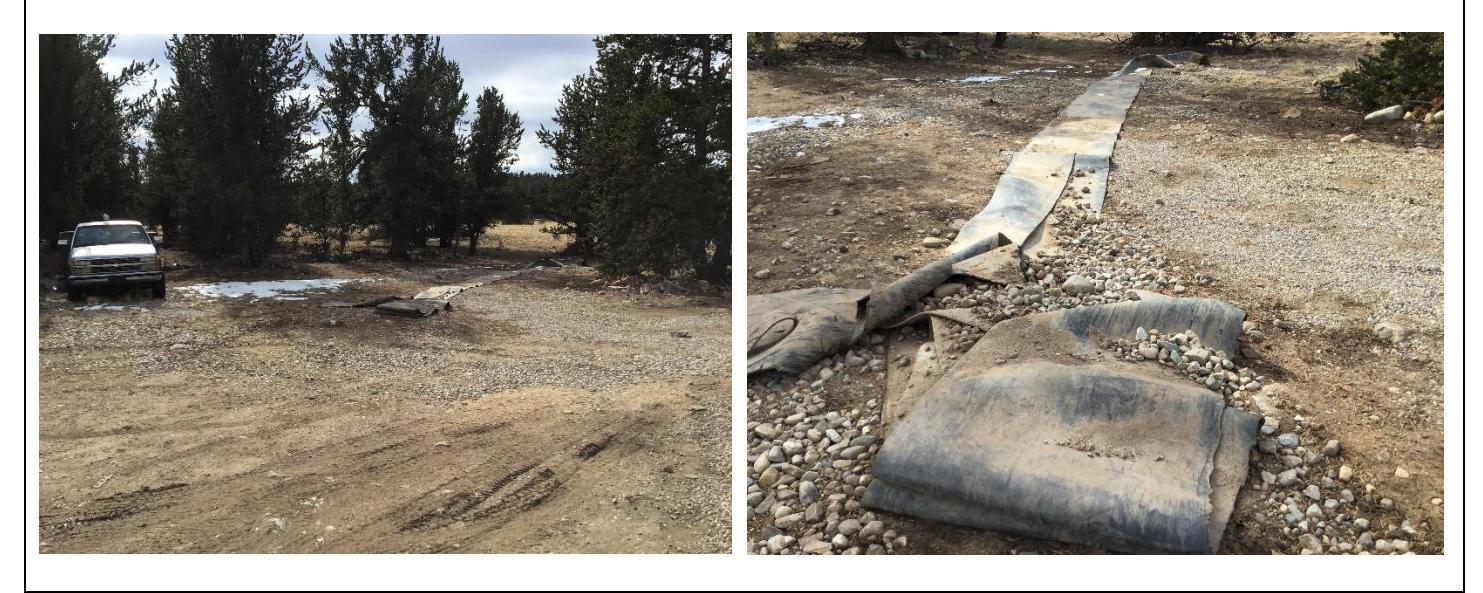
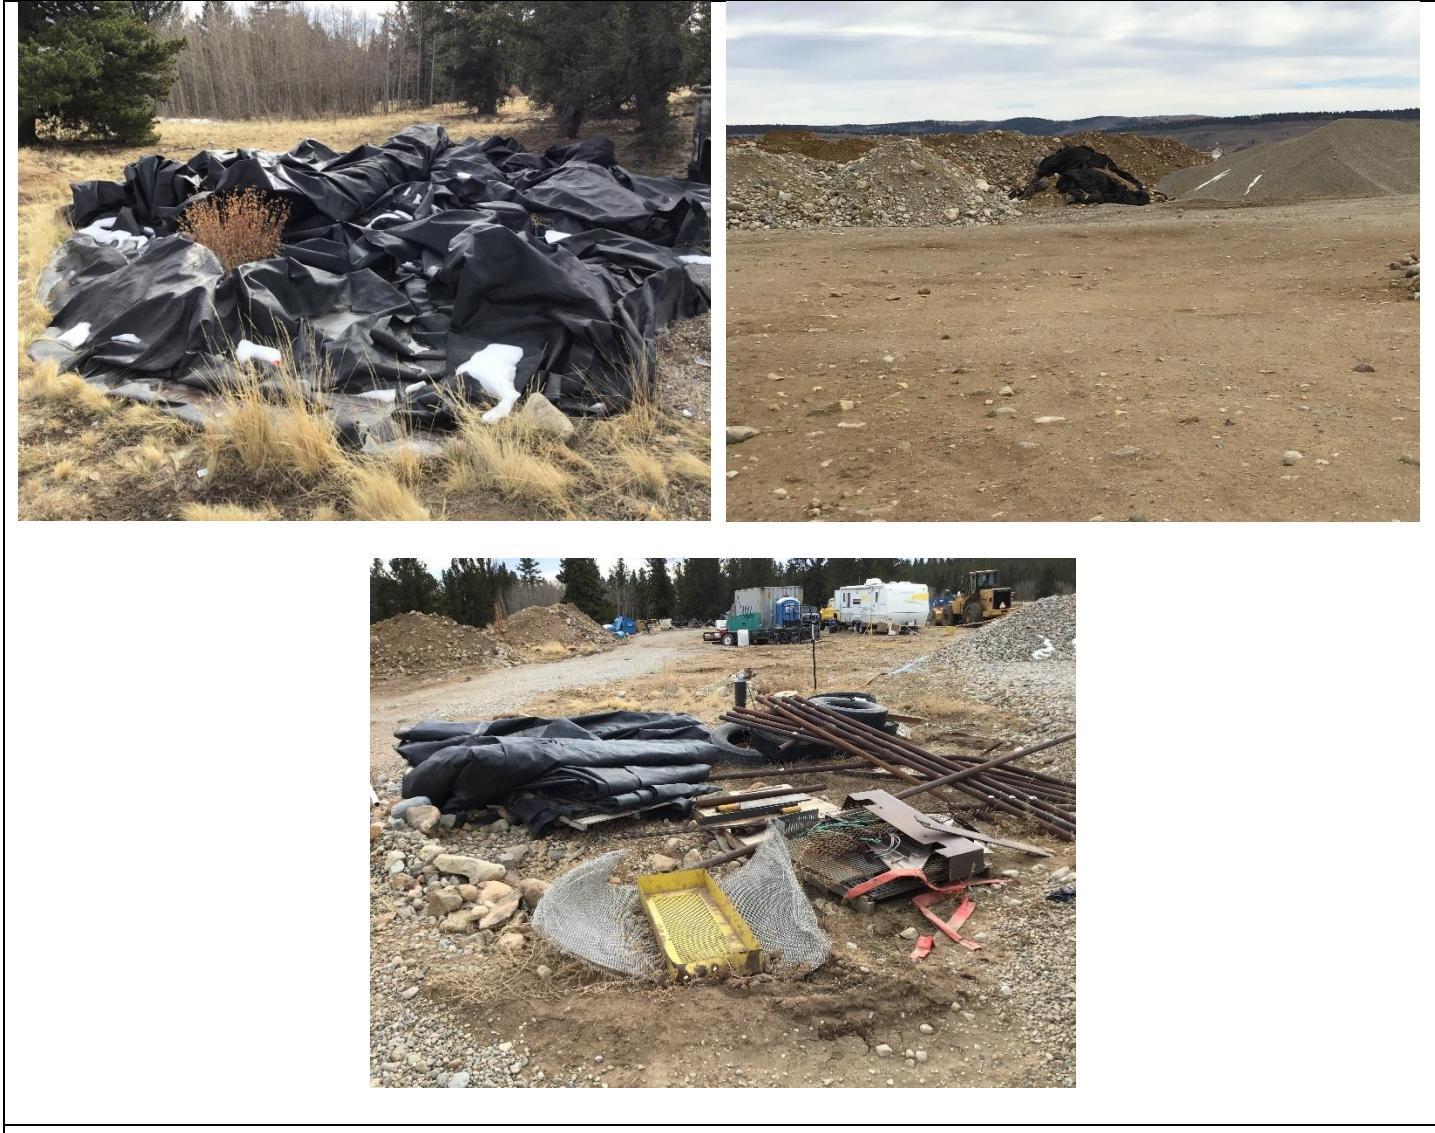
Image(s): 27-31

- Rubber sound proofing scattered across the SE boundary near the storage area

#7 Operator stated the pond liner would be either re-salvaged and stored in a general location or removed from the site NLT 11/29/18. As of 07/22/20 inspection, the pond liner remains onsite and stored in various locations: along the western and northern boundaries and the SE material storage area (ref. images 27-31). The operator is planning to sell the liner following the first spring thaw. The pond liner is no longer outside the authorized boundary.

Comment: Rubber noise cancelation for the processing plant and pond liner located along the S/SE storage area and surrounding the water well along the eastern boundary.

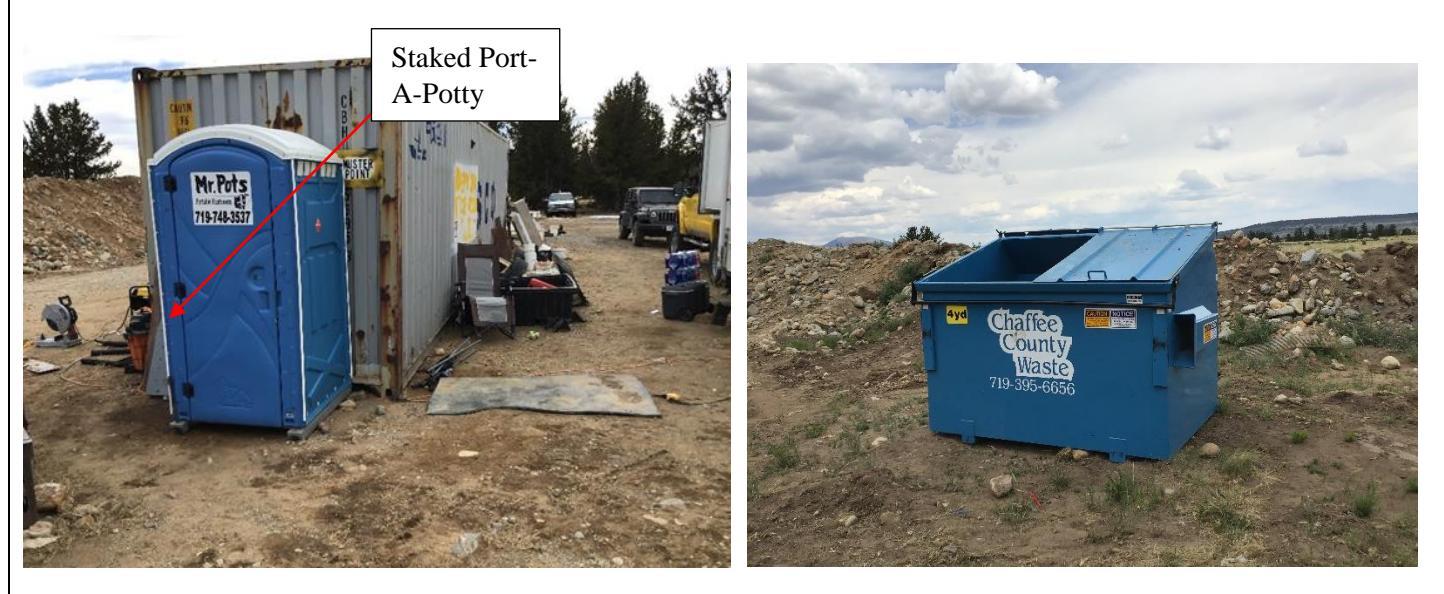
Image(s): 32-33

Comment: Waste disposal -1) Port-a-Potty located near the watchman's office/camper and was staked to secure the structure to the ground and 2) 3R Dumpster located near the conveyor belts and material storage.

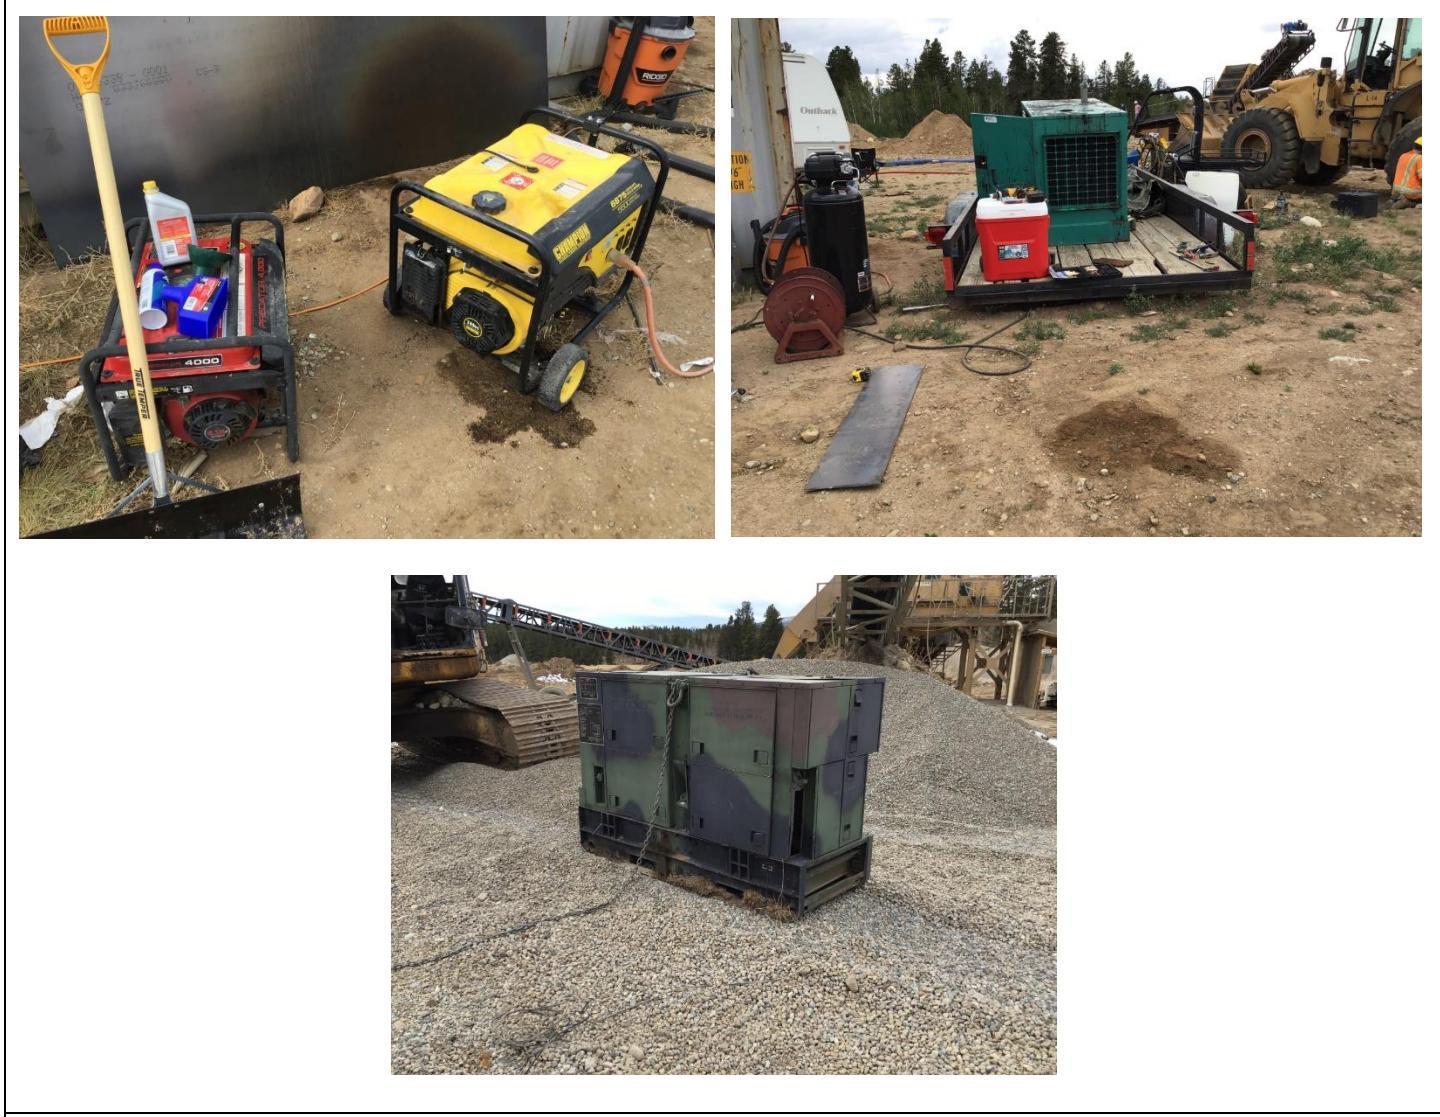
Image(s): 34-36

Comment: Variety of generators used as the main power source for the processing facility, air compressor and other powered equipment. Inactive generator, 2 small generators and 1 large generator as the main power source.

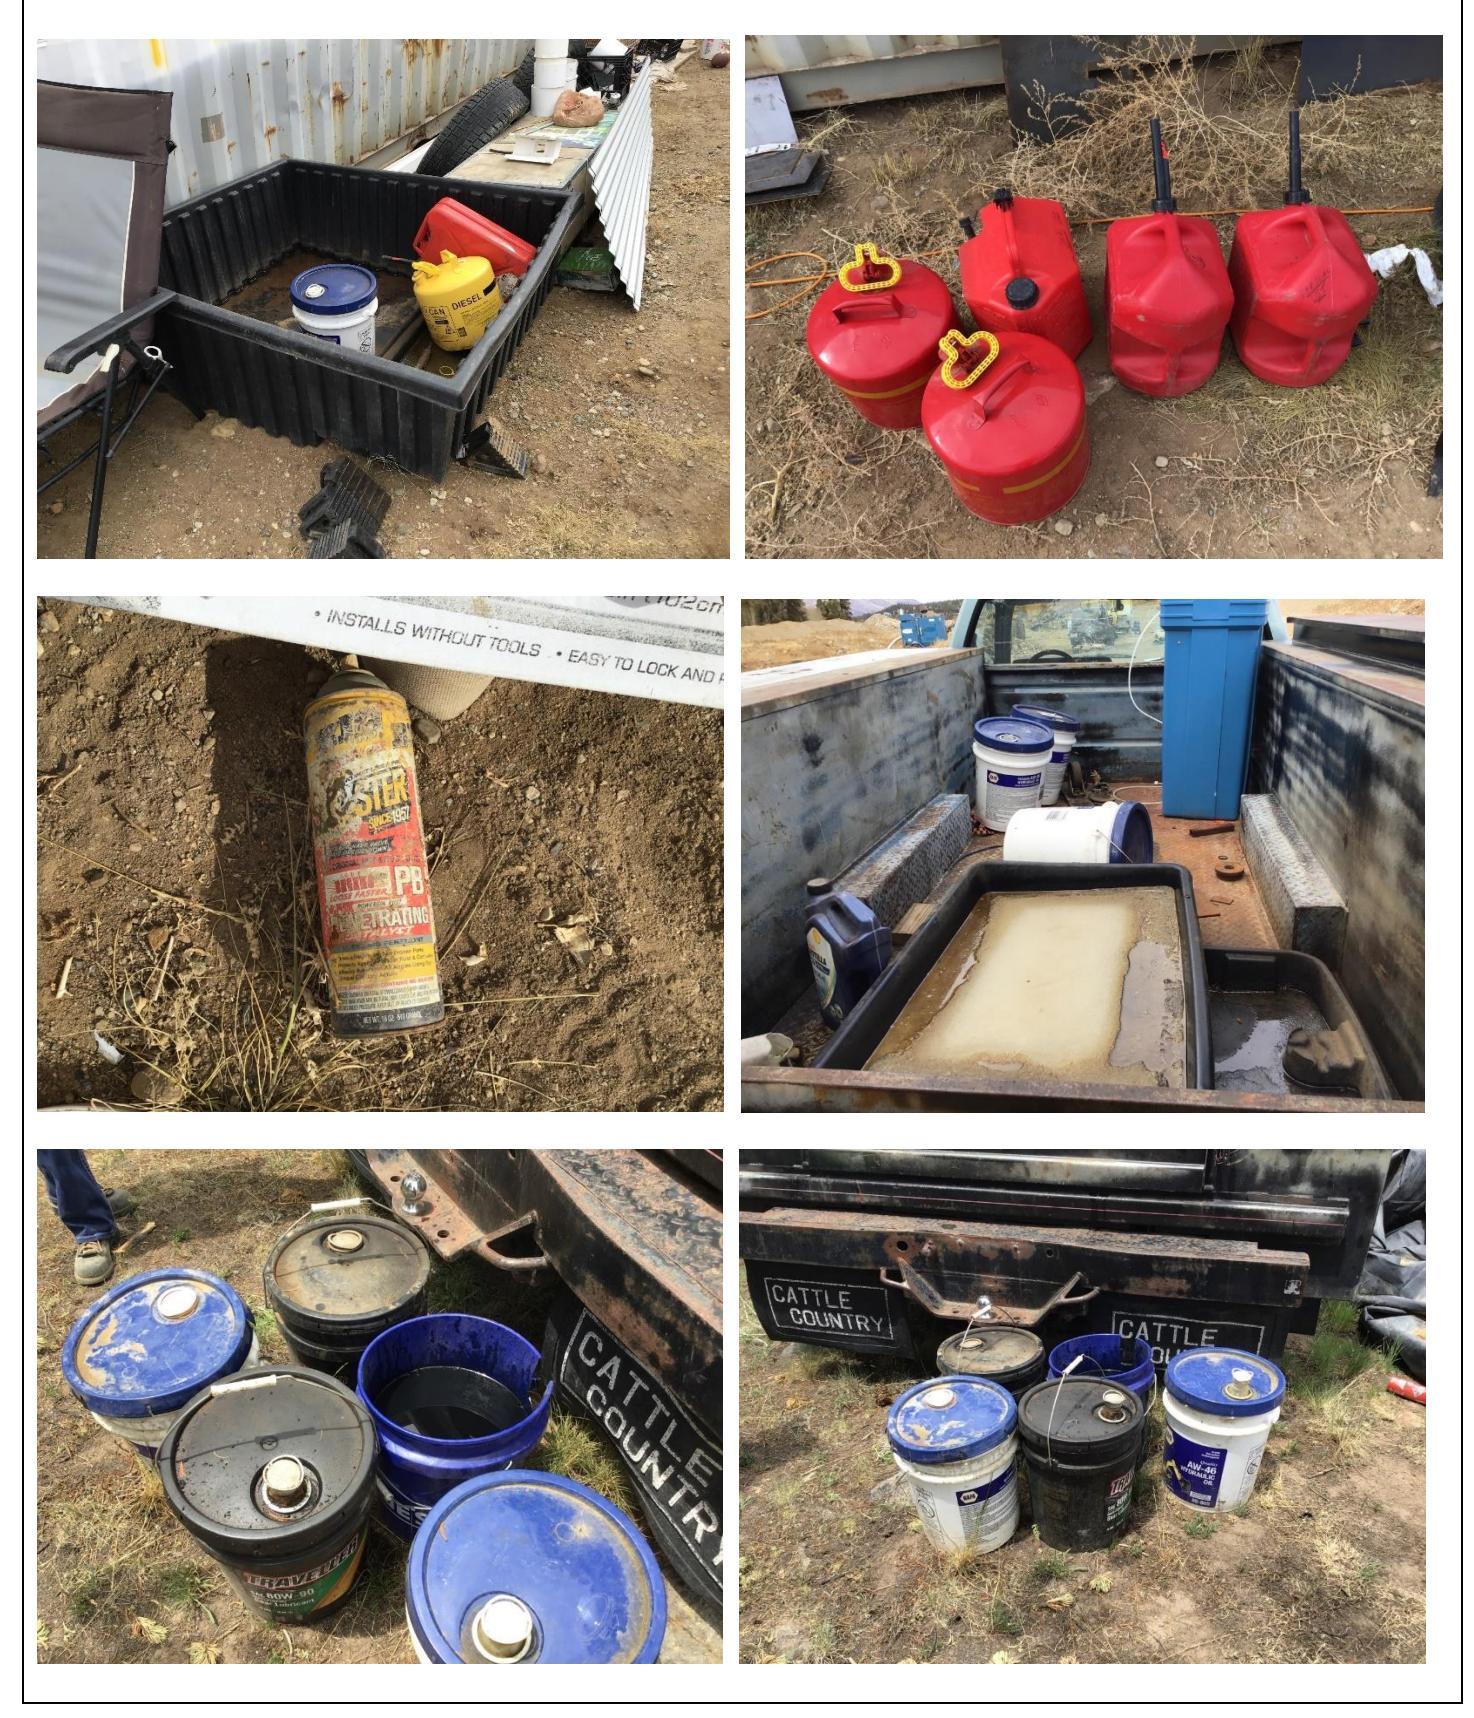
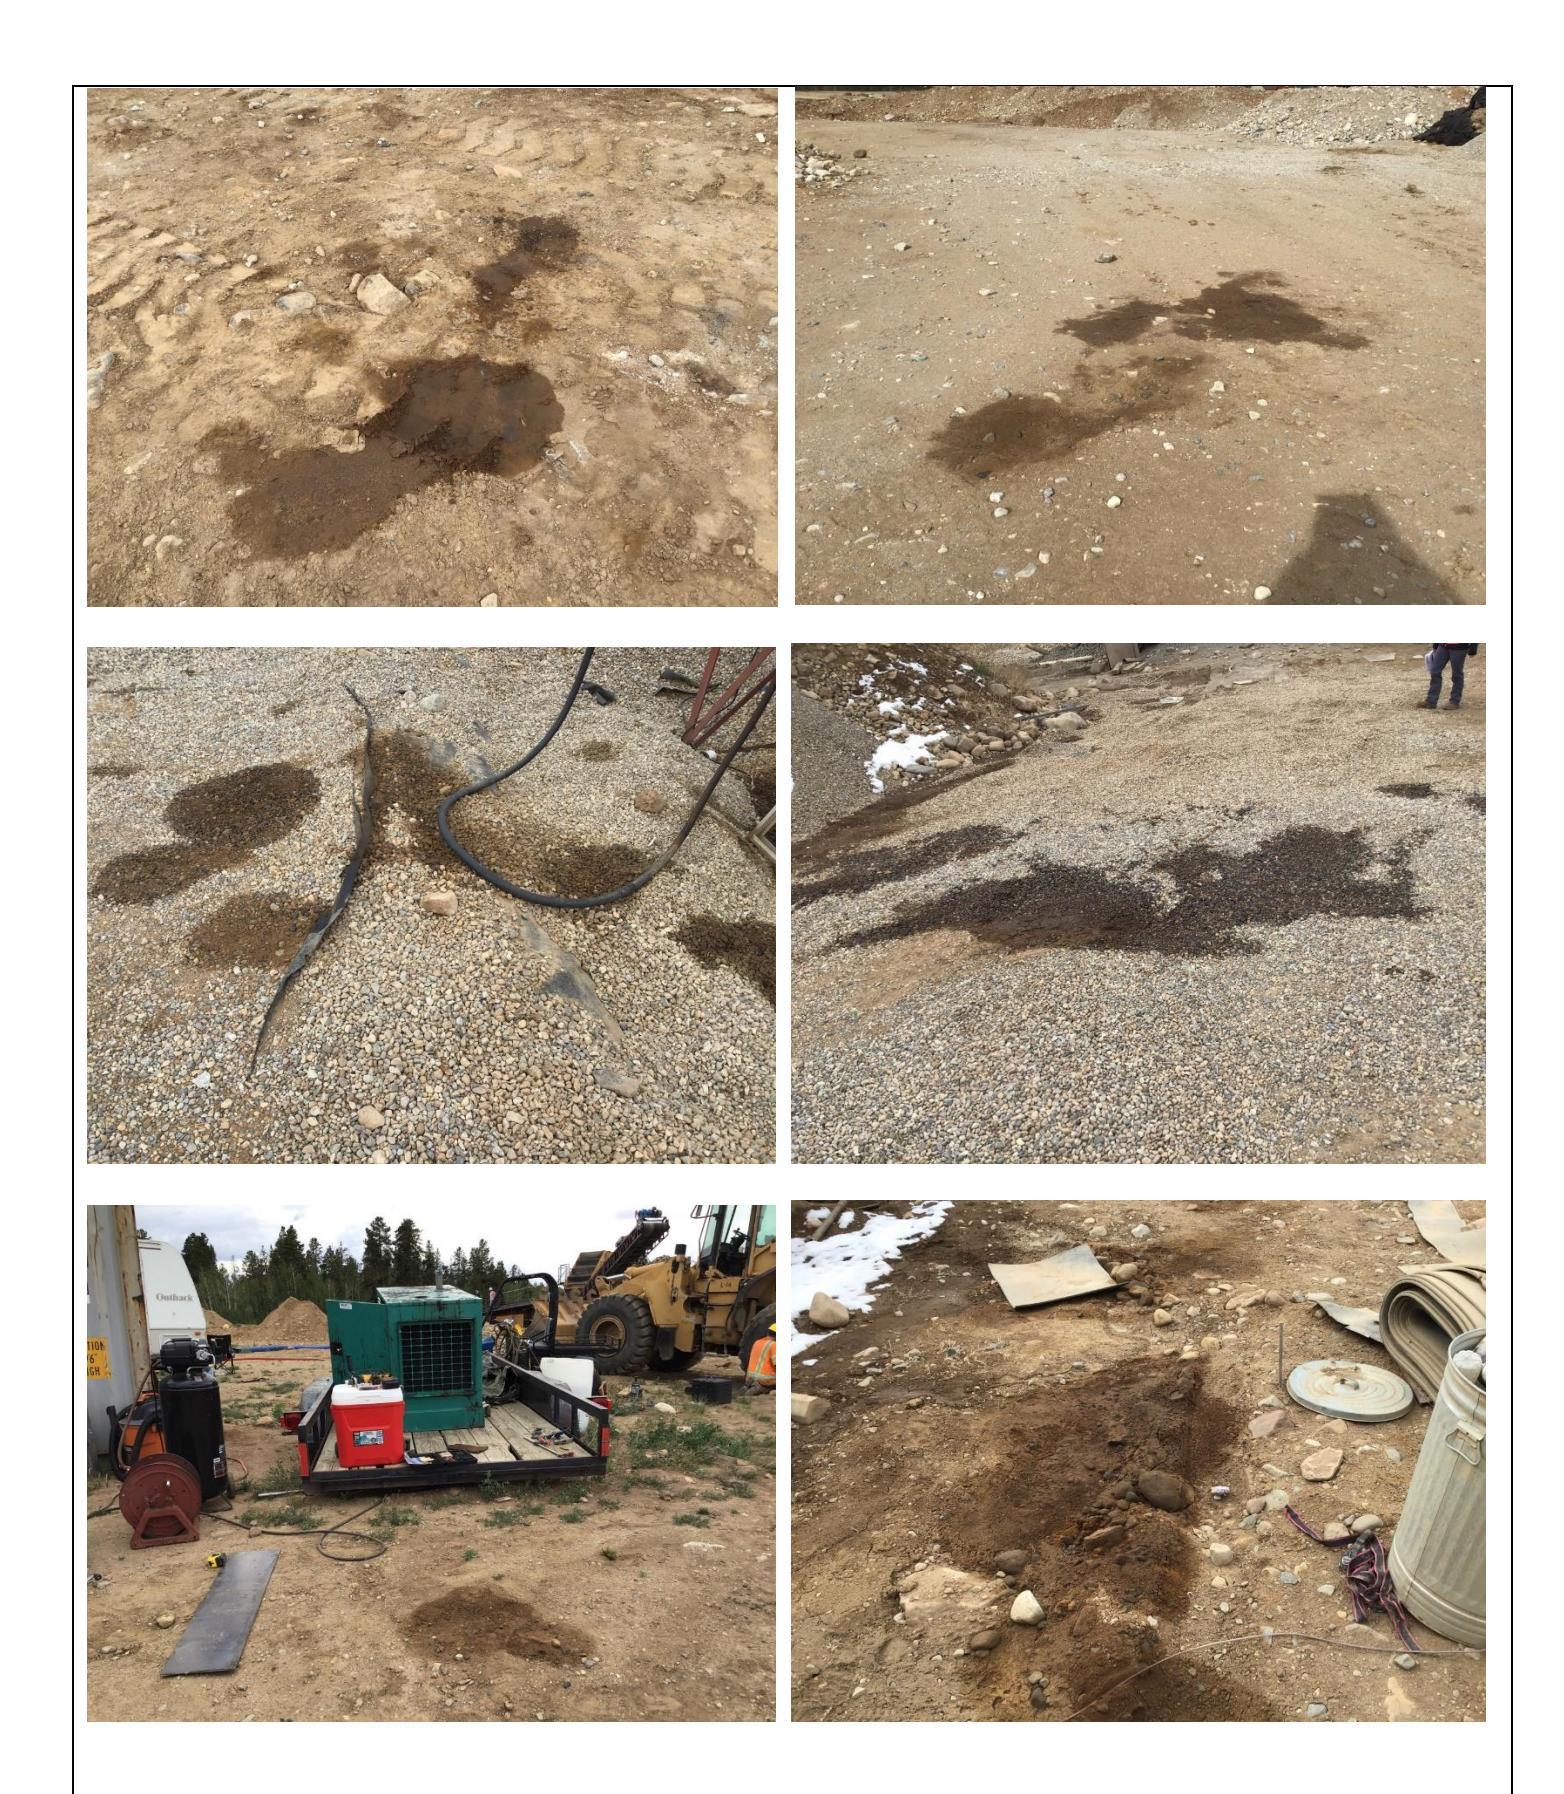
Image(s): 37-48

Comment: POL storage and secondary containment. The spent oil located behind the maintenance truck needs to be properly stored and disposed of once no longer in-use. Any POL spills need to be cleaned and disposed of according to the spill contingency plan (ref. map below for oil spill locations).
