Minerals Plan of Operations Inspection U.S. Department of the Interior Bureau of Land Management Royal Gorge Field Office

Date: Nov 6, 2020	Operation Name: Field of Dreams Mine			
Time: 12:35 pm	Operator: Gold Tamers LLC			
Weather: Sunny	Case Number: COC73930			
	CDRMS Number: M-2009-056			
Attendees	General			
BLM: A. Sanderson & J. Elkington (Images taken by J. Elkington)	Operation(s) are in-compliance with documentation on file □ Yes ⊠ No □ N/A			
Operator (s): Contacted, but not present	Operation(s) and disturbance onsite coincide with the			
	operations and access on file			
Other(s): None	\boxtimes Yes \Box No \Box N/A

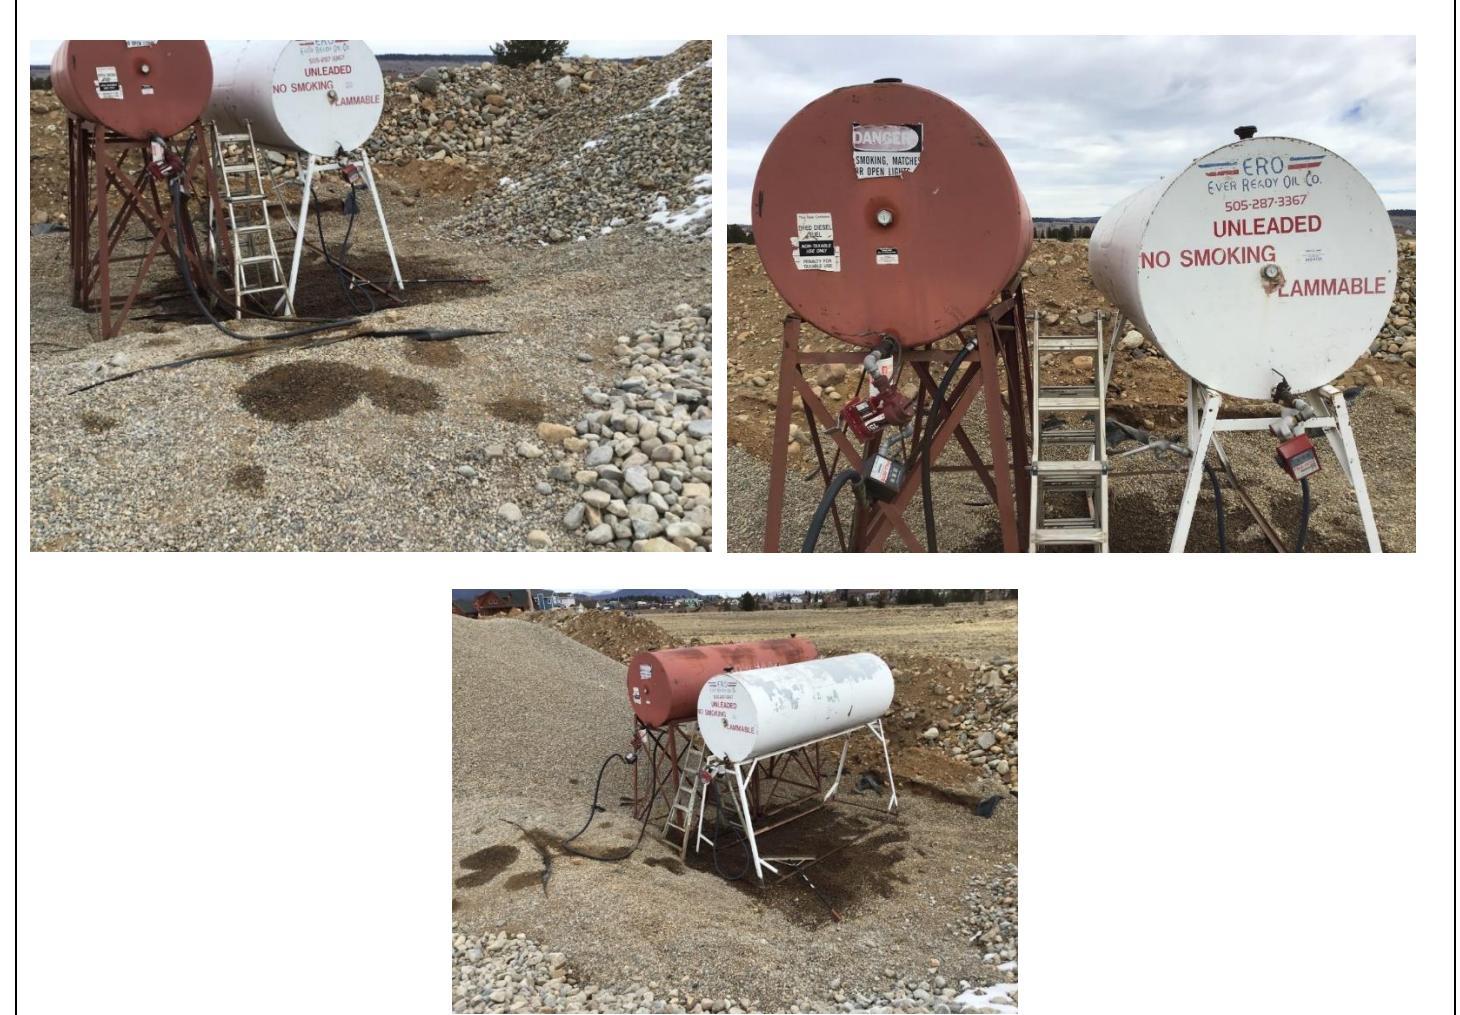
Image(s): 49-51

- A new POL storage area containing 2 Aboveground Storage Tanks (ASTs) with secondary containment (black pond liner with roadbase) have been installed along the central eastern boundary (ref images 49-51). These diesel storage tanks provide fuel for heavy equipment onsite. Does the operator still have plans to utilize small portable plastic cans and if so, these cans will need to be stored properly in secondary containment to prevent spills/leaks.

Comment: New POL storage area containing approximately two 500-gallon gravity flow fuel tank with secondary containment. Multiple oil spills observed outside the secondary containment area. The operator should take the appropriate measure according to the Spill Contingency Plan to clean-up all spills and leaks.

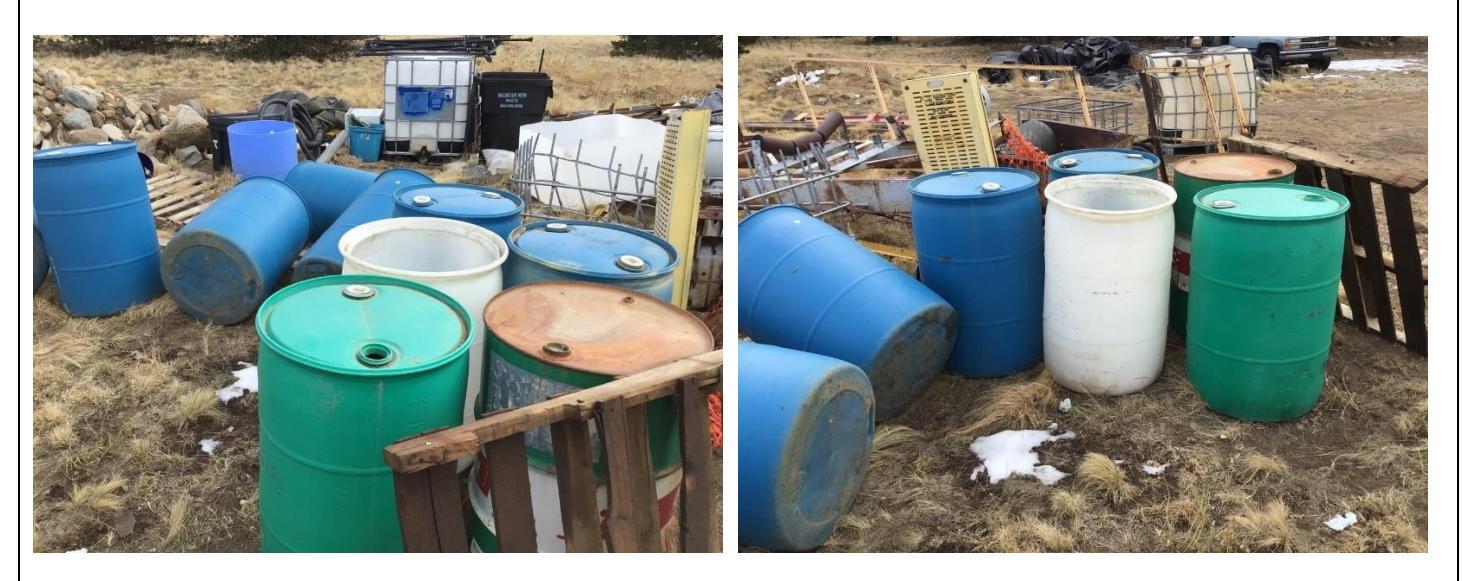
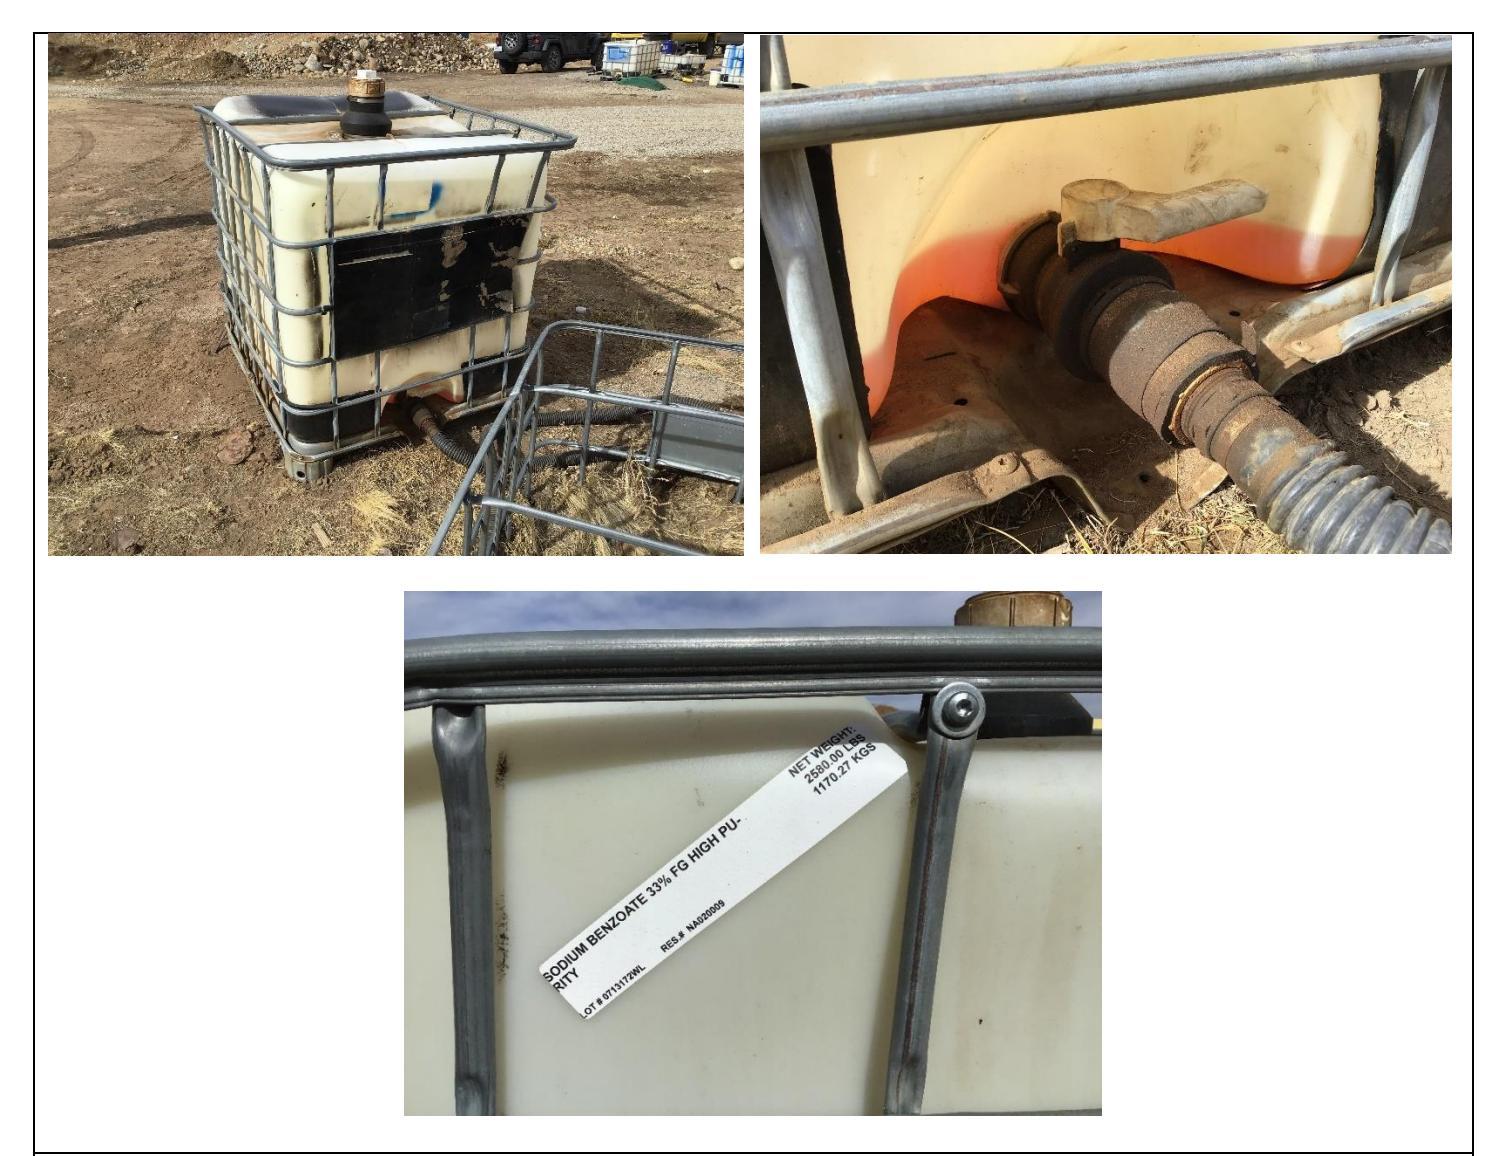
Image(s): 52-56

- Trash is littered throughout the site
- Multiple blue, white and metal 55-gallon bung-hole drums are stored in the SE storage area. These drums are not correctly labeled and contain an unknown red fluid. All containers must be stored and adequately labeled according to OHSA or MSHA regulations.

Comment: Blue, white and metal 55-gallon drums located in the primary storage area along the SE corner boundary. These drums need to be adequately labeled according to OSHA regulations. Other white square containers with a light pink fluid are labeled sodium benzoate and stored in the SE storage area. This chemical is not authorized under the current Plan of Operations. If the fluid is not sodium benzoate, remove the label and relabel the container the type of substance.

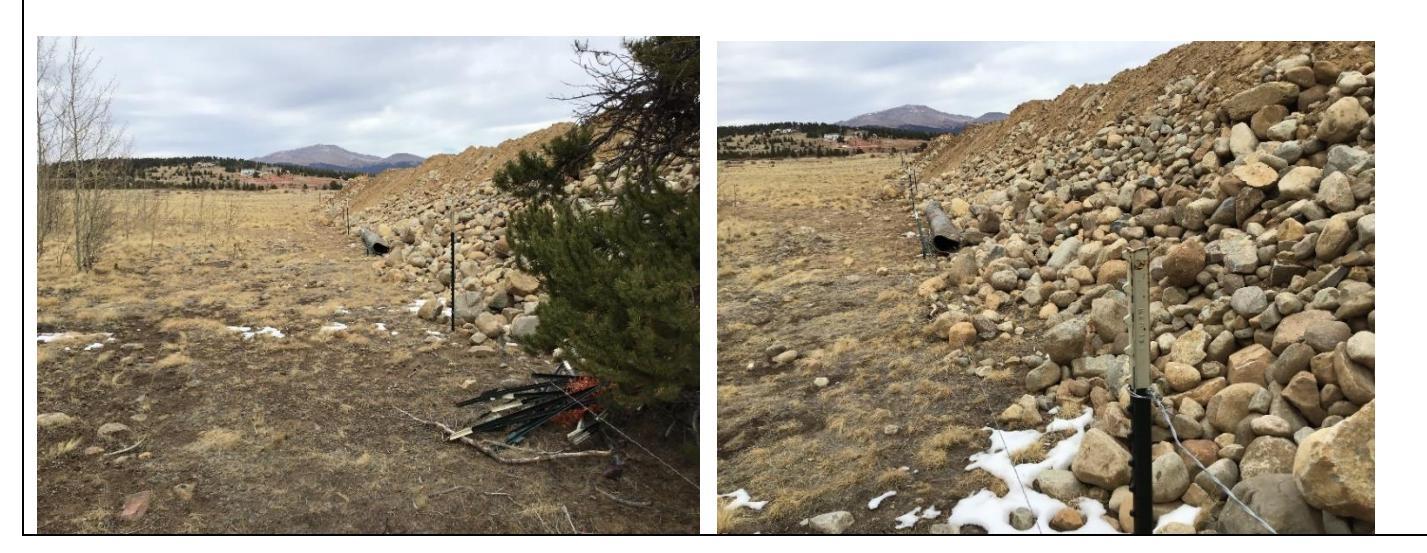
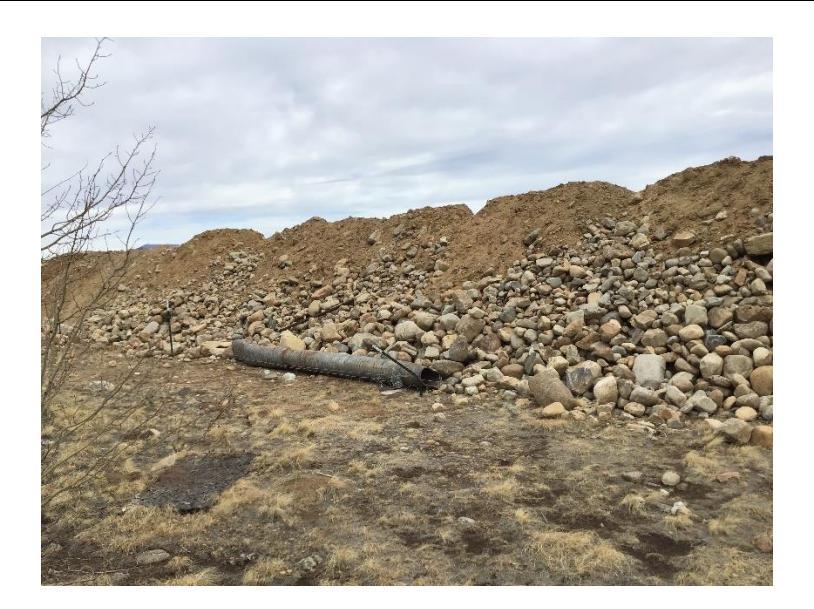
Images(s): 57-59

- 5. The mine boundary fence has been installed; however, in the previous inspection, BLM documented that the western boundary had been illegally cut by unknown trespassers (ref. 07/22/2020 inspection). The operator has constructed a 20-foot berm along the NW/W boundary with overburden material (ref. images 57-59).

Comment: The 3 rung straight wire perimeter fence is completely constructed; however, approximately 15 feet of the western fence was cut by an unknown trespasser or public land user and documented in the previous inspection (inspection 07/22/20; image). The operator has now constructed a berm consisting of overburden material to keep out trespassers and decrease safety issues.

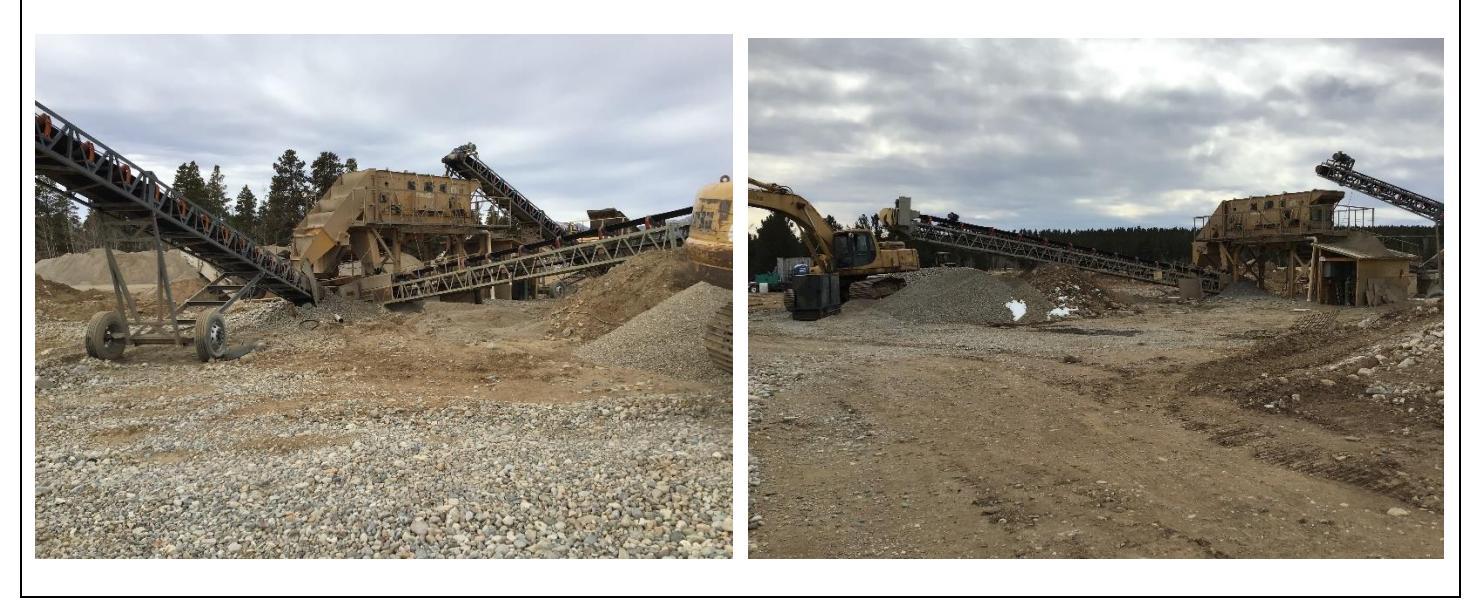
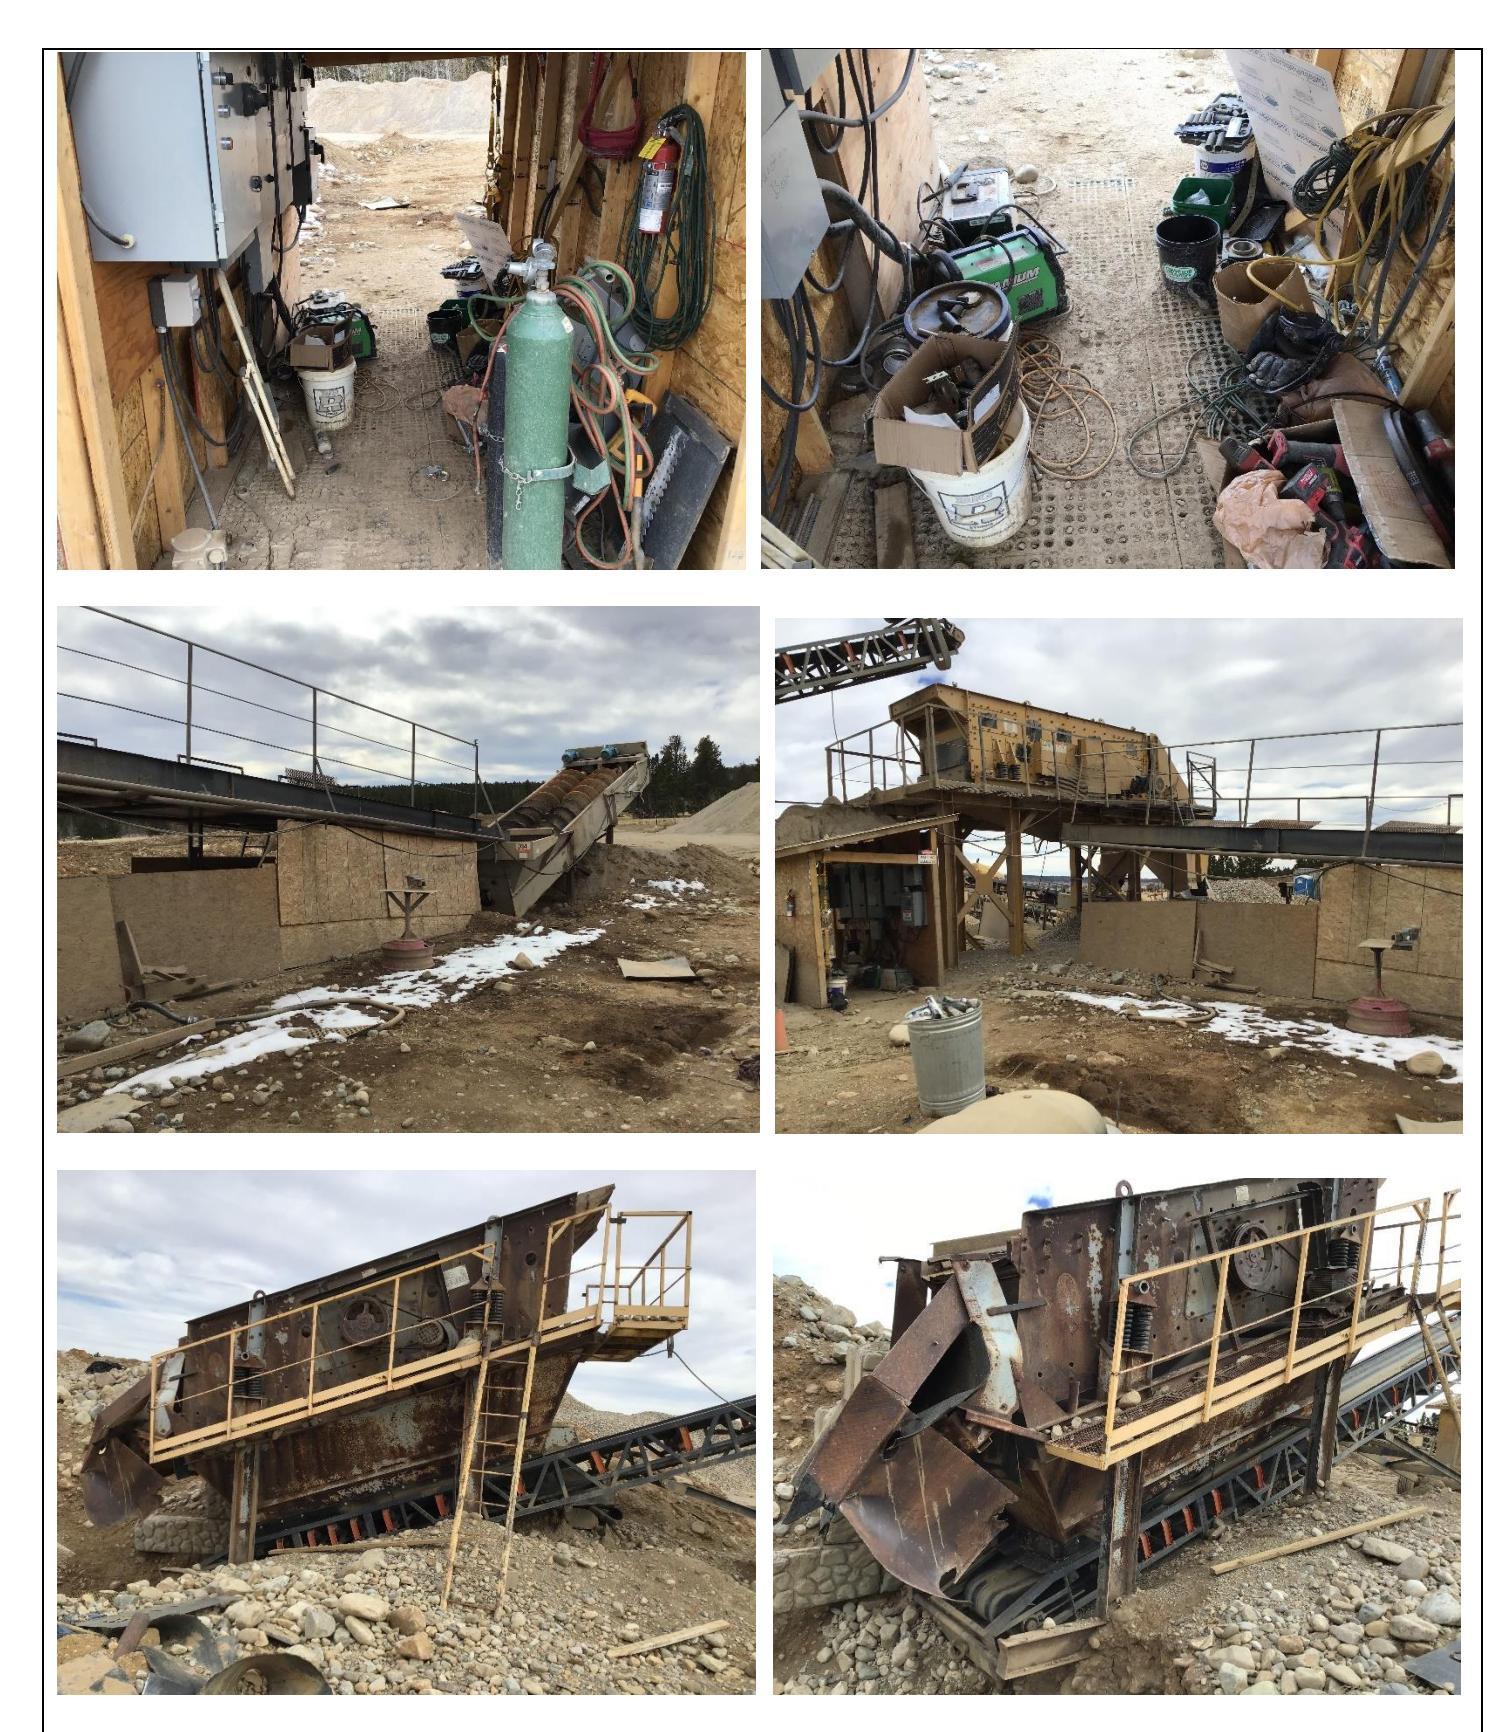
Image(s): 60-71

Comment: New wash/processing plant authorized in the Plan of Operations minor modification on 08/15/19. The plant was active during the operations, sorting ore from inert mineral materials. Material is sorted by 3 sizes: medium grained sand (0.25-0.55 mm), roadbase ³/₄-, pebbles (2-4 mm) and cobble and boulders (ref. images below for details regarding mineral material products).

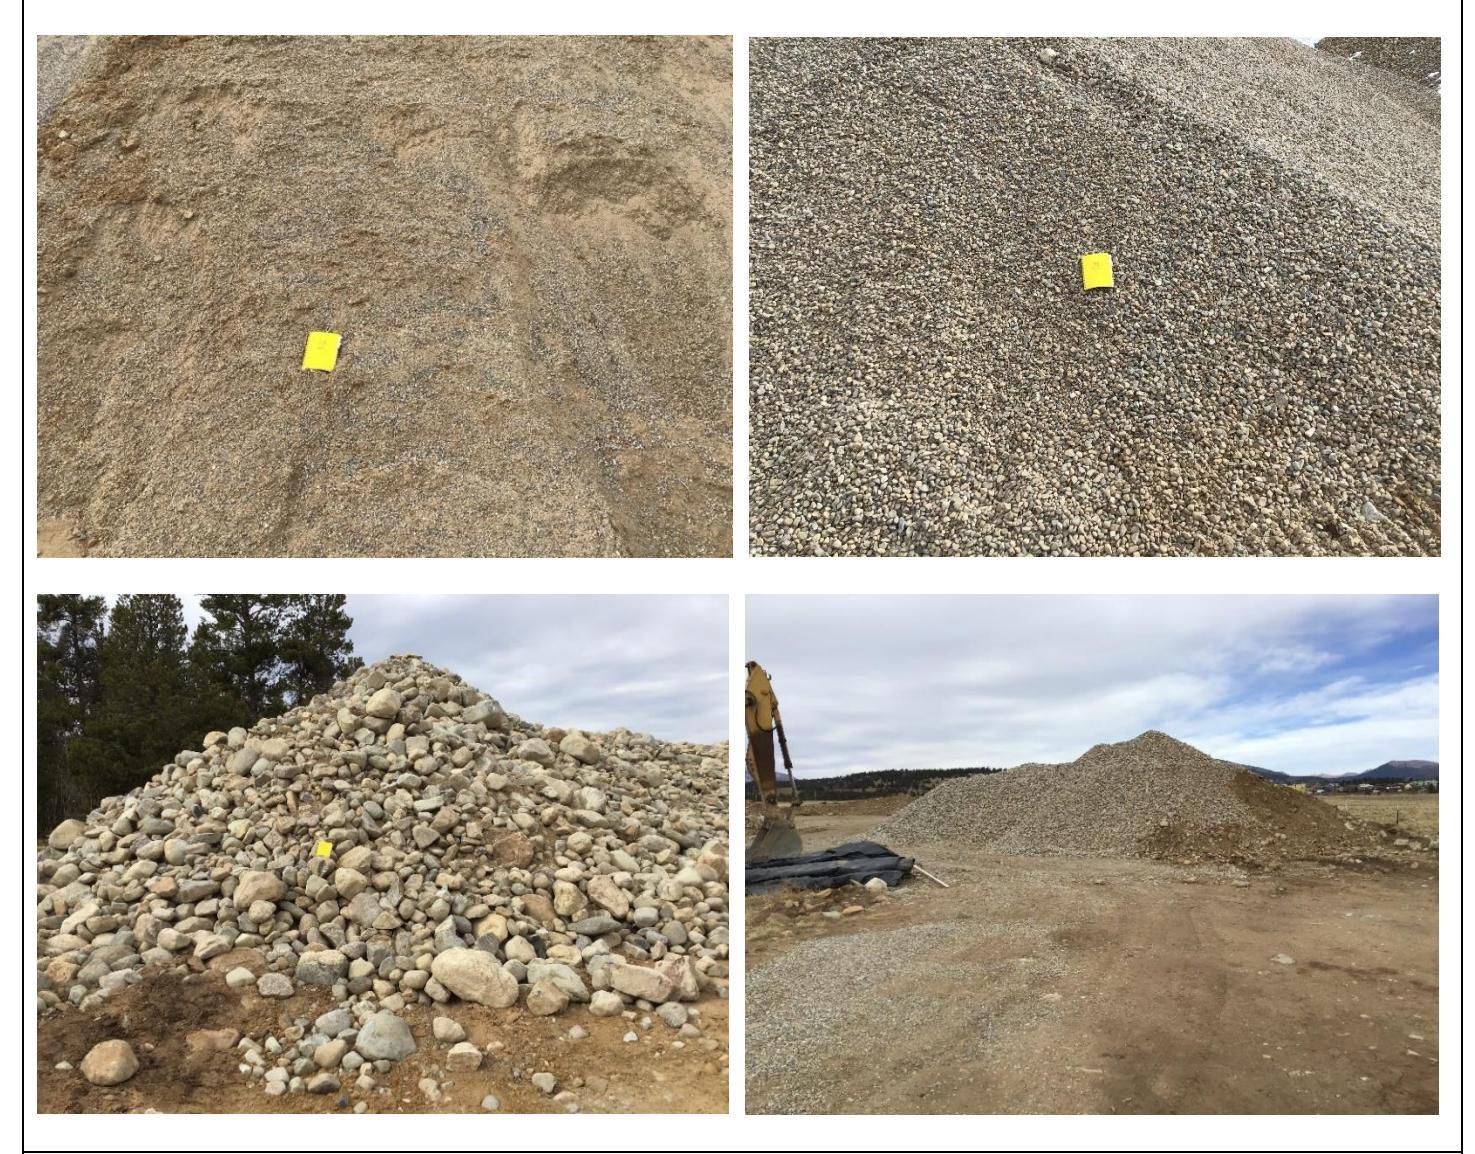
Image(s): 72-75

- 2. Aggregate materials are sorted (no crushing) on-site from the ore materials and sold under a BLM mineral material contract. Product commodities consist of medium sand sized material and roadbase while other larger overburden waste materials are stored along the western & eastern boundaries for later use as backfill during reclamation (ref. images 72-75).

Comment: Mineral materials sold under the current mineral material contract. Reference the map below for locations of the various product and waste stockpiles (e.g. fines, roadbase and overburden)

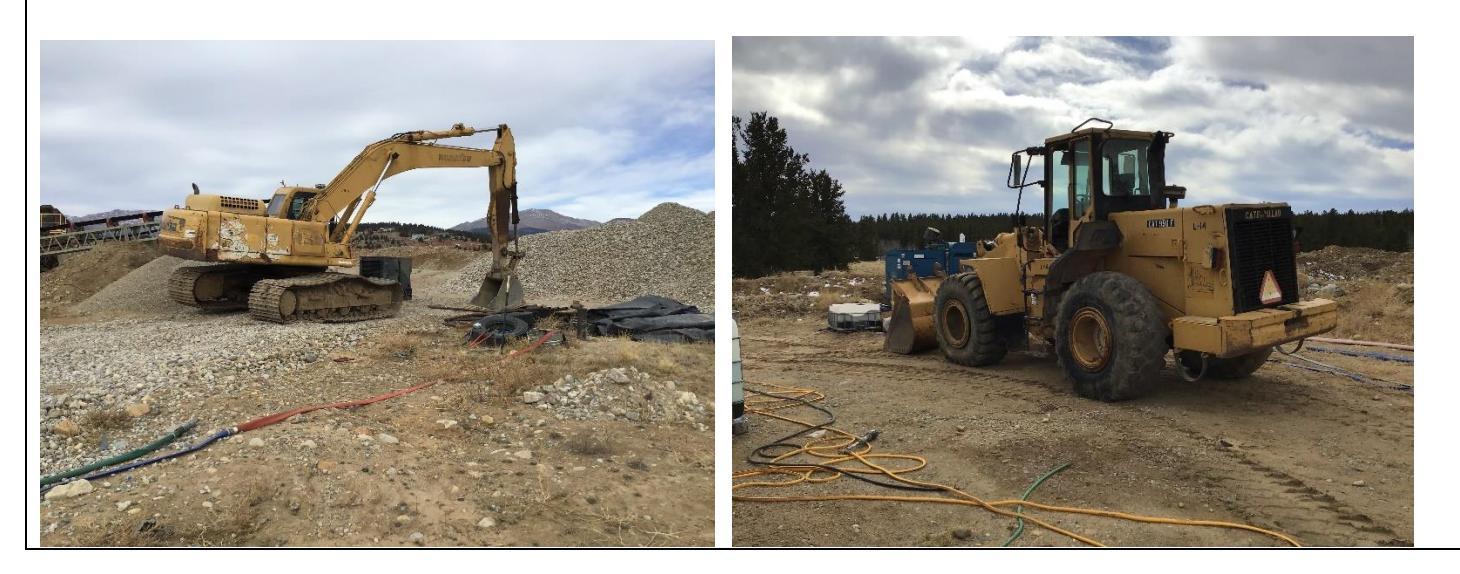
Image(s): 76-77

Comment: Mining equipment, transportation vehicles and other structures onsite. Reference the 03/25/2020 map for locations of all other structures onsite.

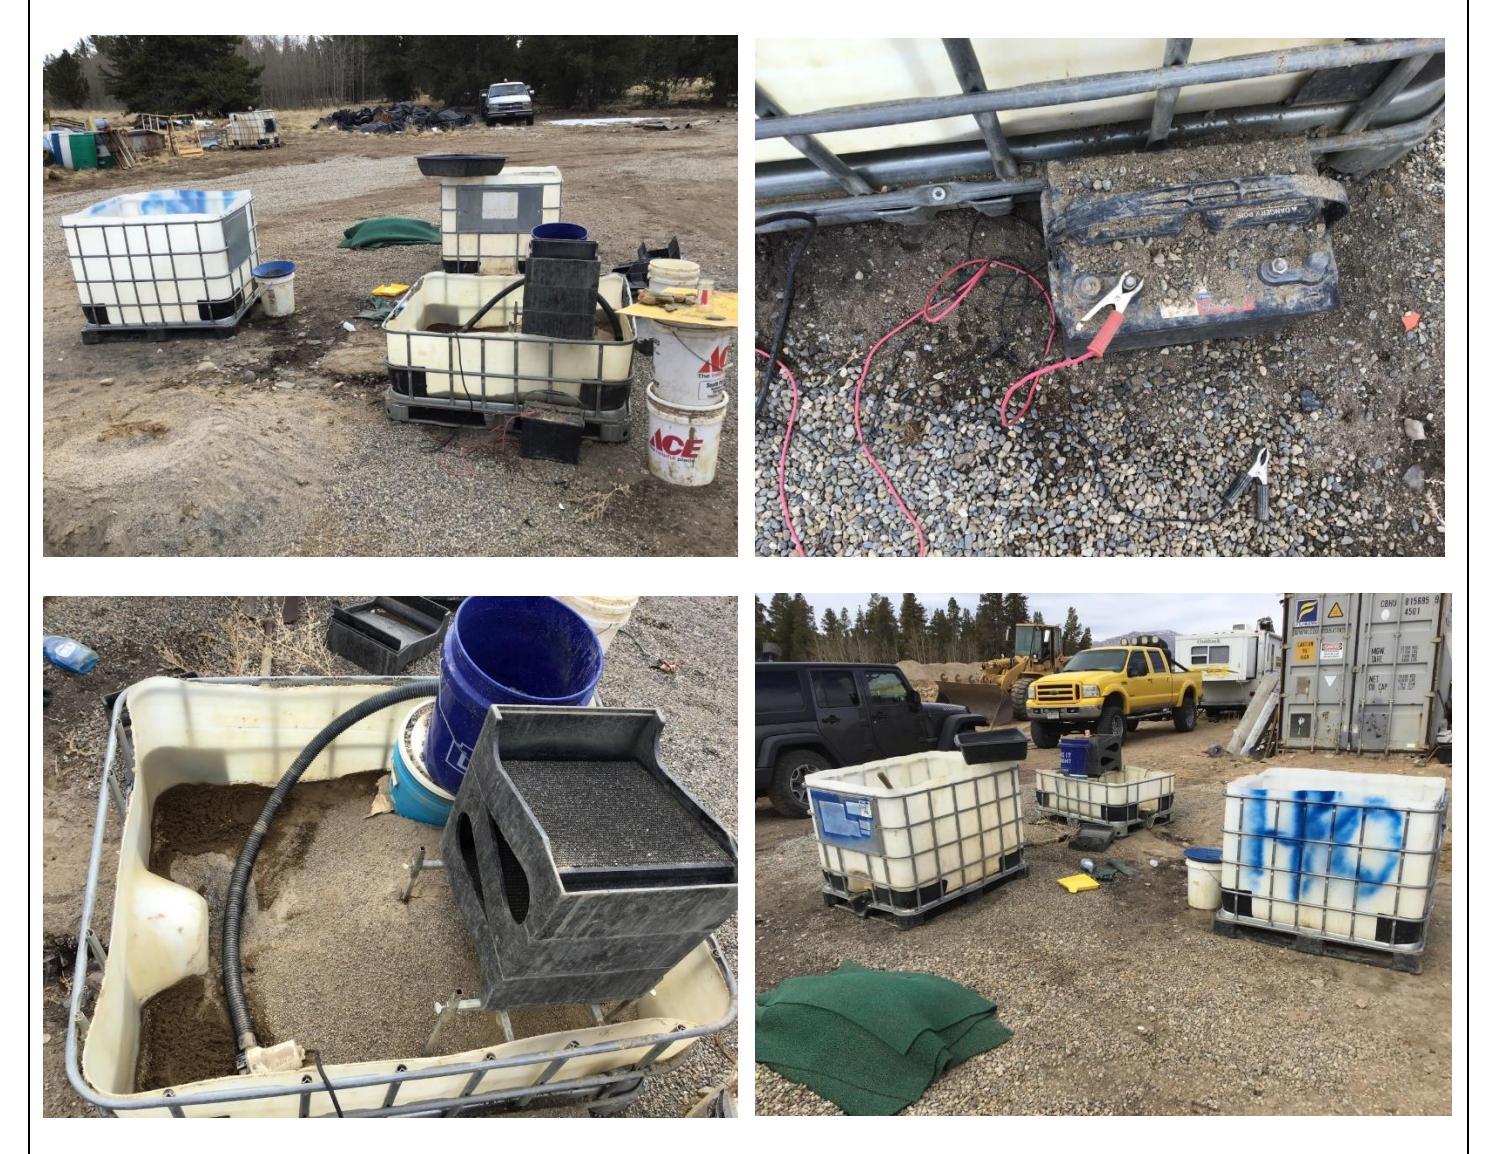
Image(s): 78-81

- 6. A gold processing area has been installed near the office/camper storage and parking areas. This area consisted of multiple types of equipment: gold pans, gold cube, sluice, battery, containment area and concentrates.

Comment: Newly installed gold processing area to separate gold concentrates using a gold pan, sluice and gold cube.

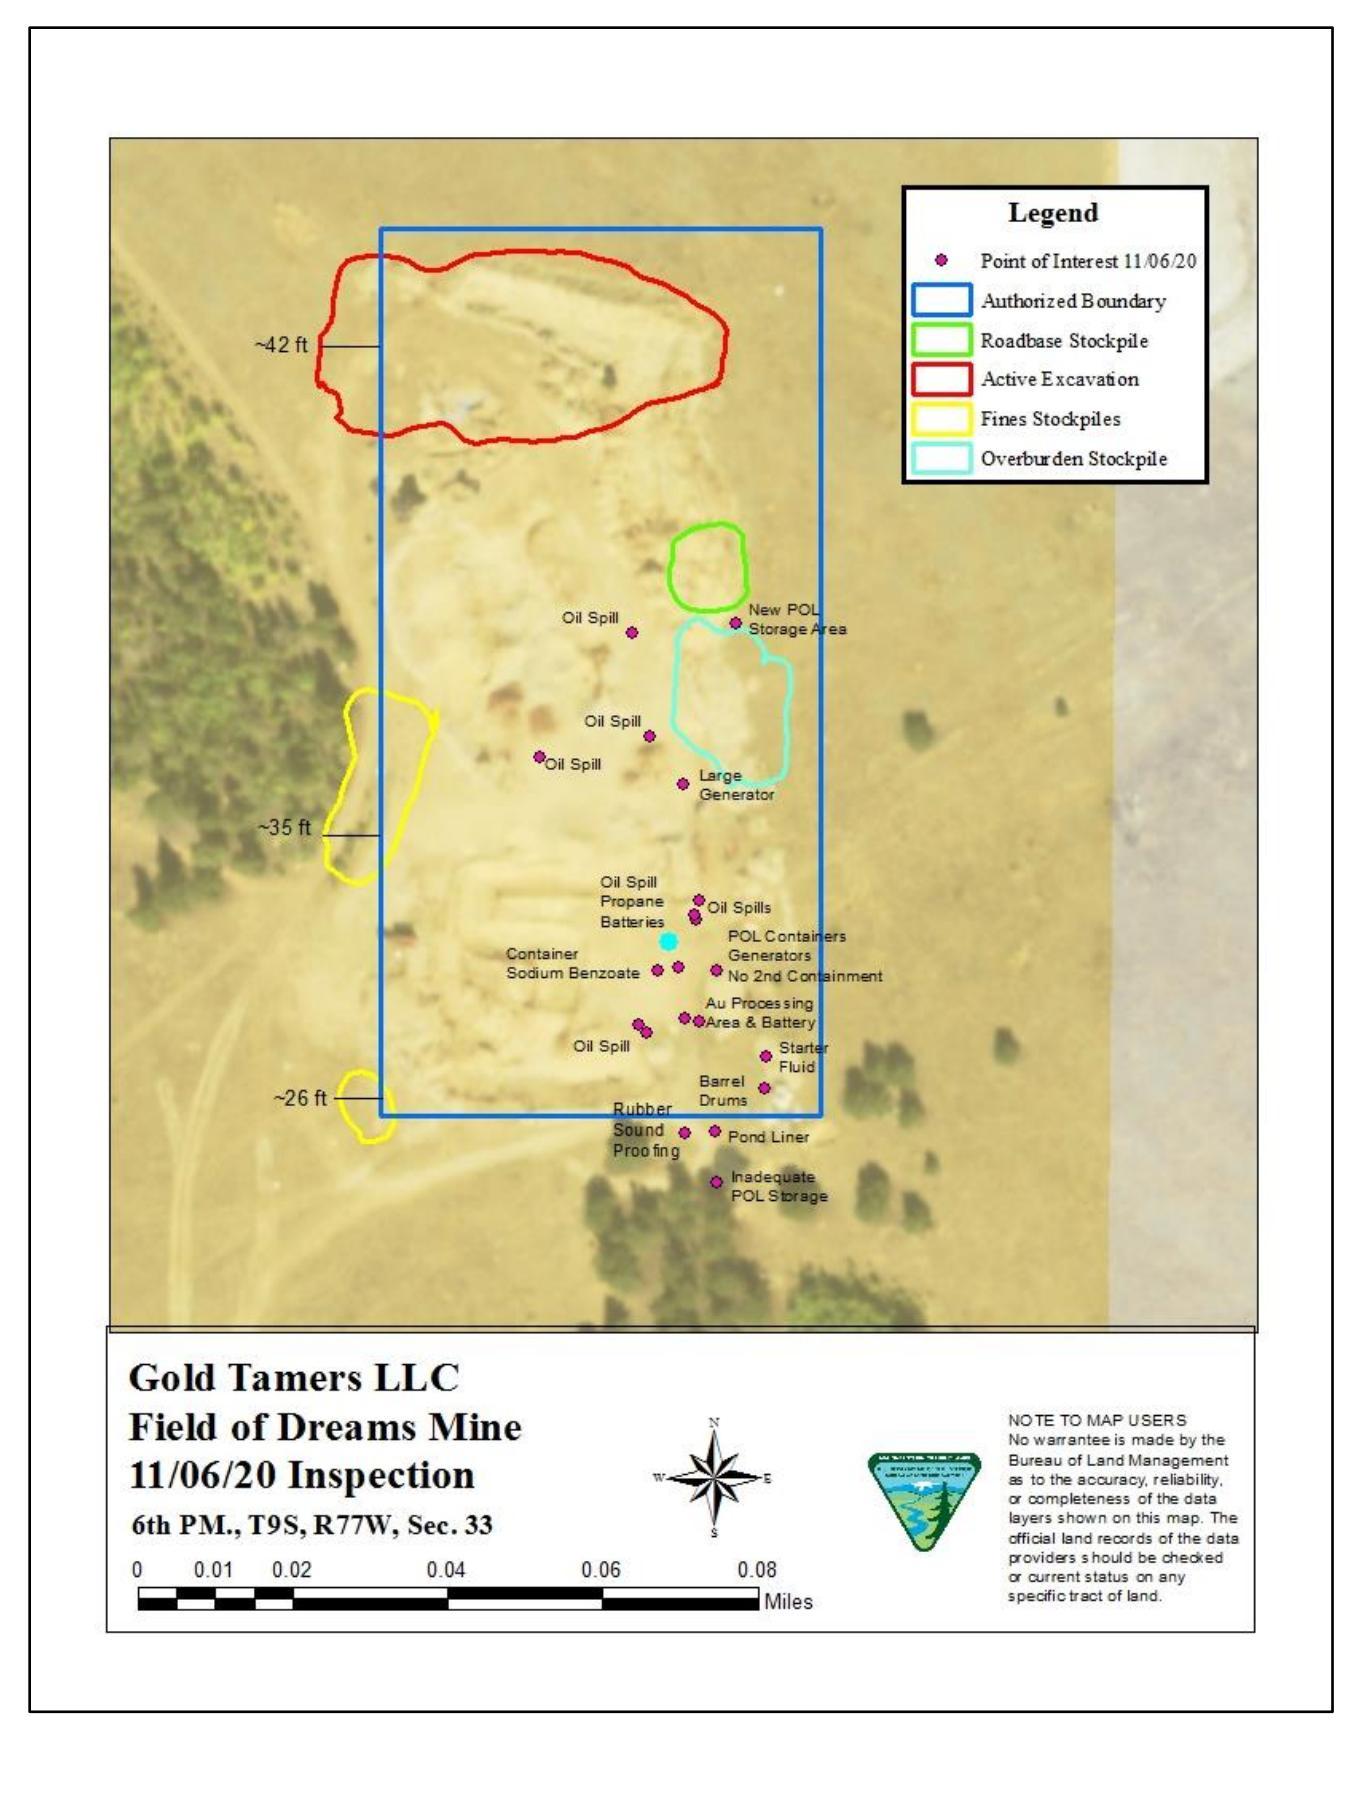
Figure 1: Map of the oil spills, trash and product material locations. The Collector app that was used to collect the GPS data has an error of approximately 56 feet; therefore, the product material and excavation trench, max 42 feet outside the western boundary, is most likely within the authorized NEPA boundary. (Map created by A. Sanderson, 11/24//20)
