## MEMORANDUM

**Re: Morrison Quarry – Permit No. M-1973-021, Amendment 7 (AM-07);  
Geotechnical Slope Stability Preliminary Adequacy Review**

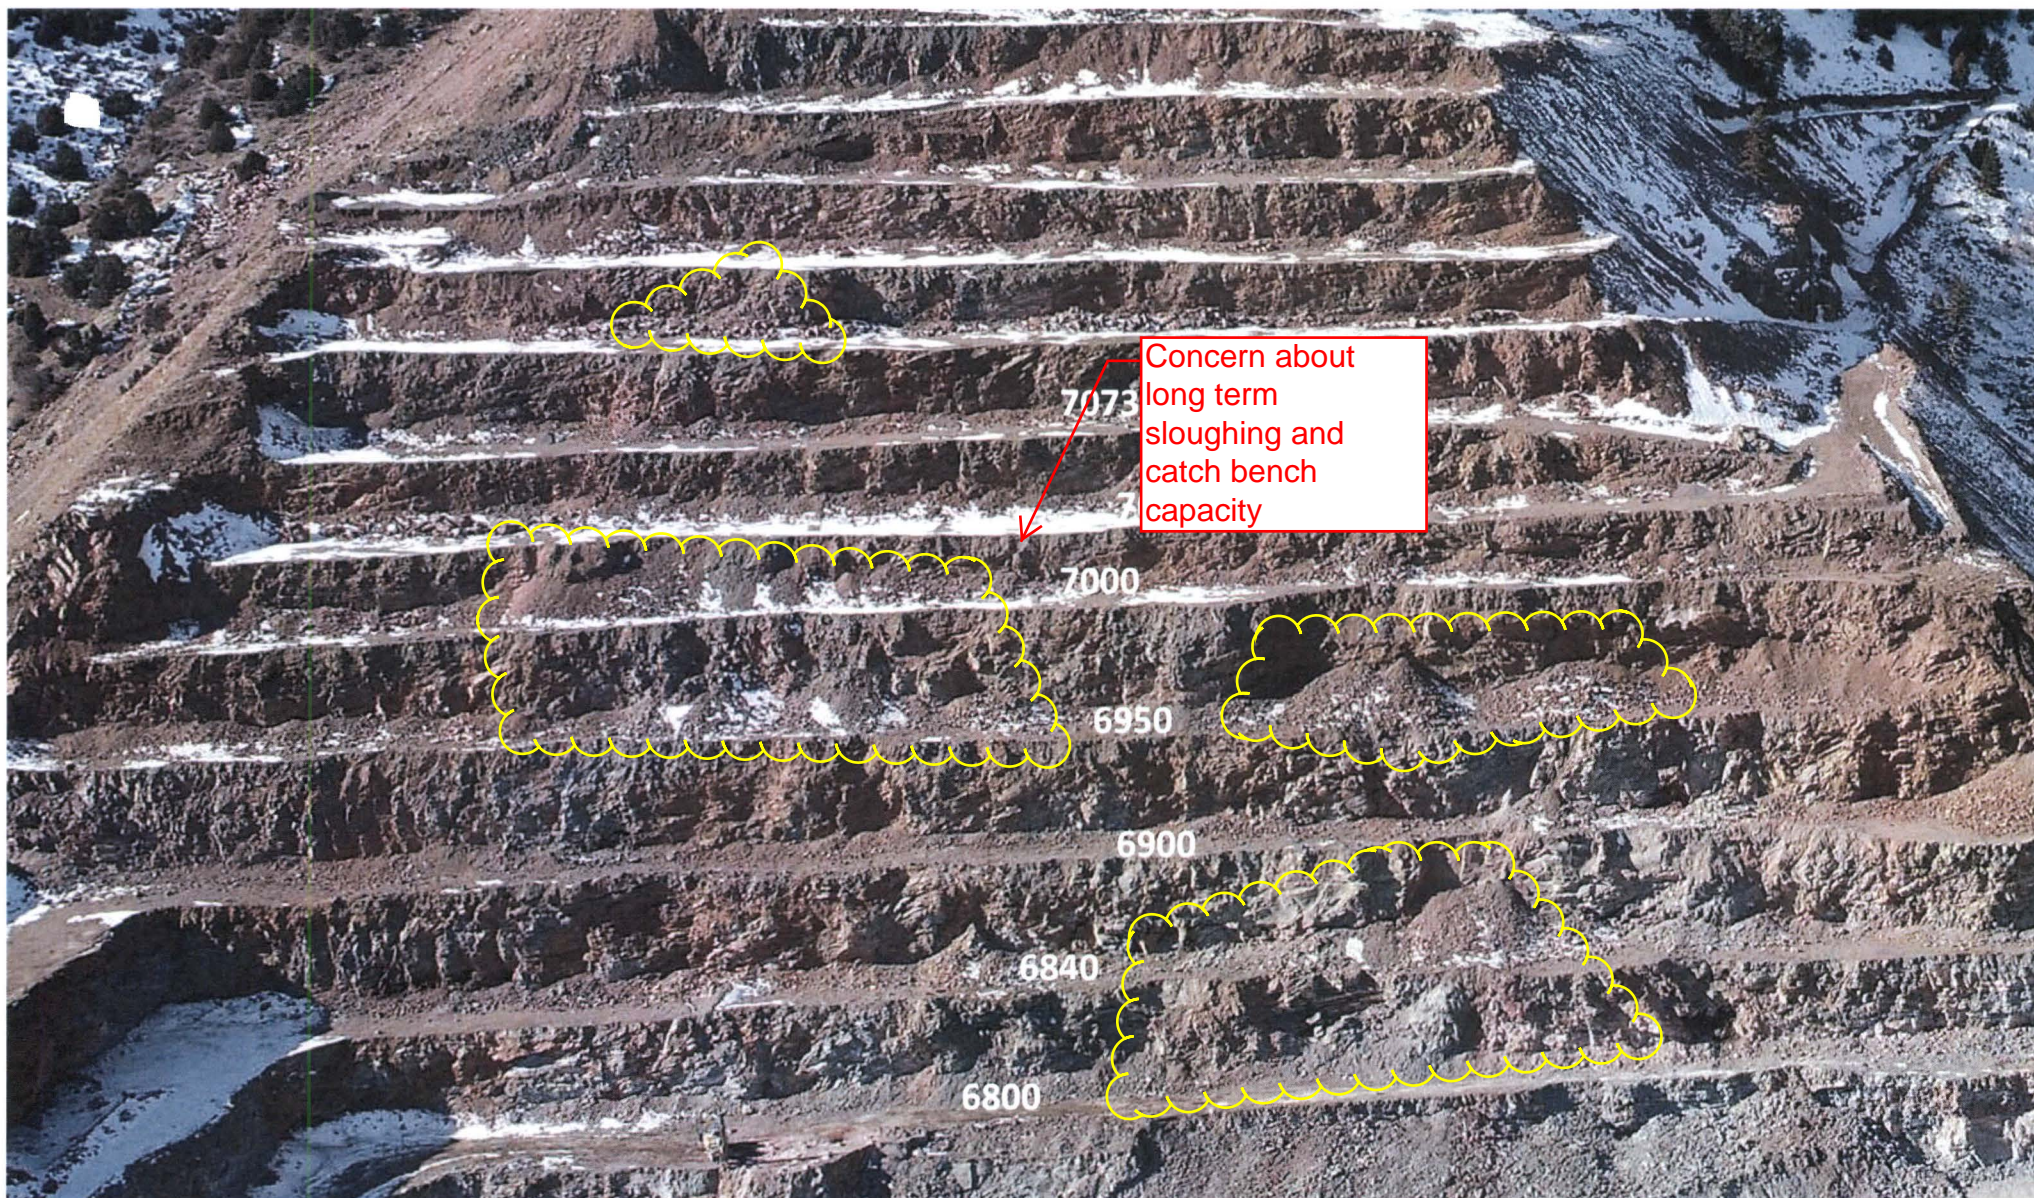
**ATTACHMENT B** - from p. 16 of Appendix B

As stated in the title of Table 1 of MLRB Policy 30, our factor of safety minimums apply not to just operations, but to reclamation as well. The observed kinematic failures to date, as shown in Photo 8-1 of the submittal and an image from Appendix B (see **Attachment B**) suggest the currently proposed highwall configuration may not meet the criteria outlined in Section 30.2, Declaration of Purpose in Policy 30 to: i) Protect and promote the safety and general welfare of the people of Colorado, ii) Ensure reclamation of lands affected by mining to beneficial use, and iii) Aid in the protection of aquatic resources and wildlife. The DRMS is also concerned about how these kinematic failures might interfere with the reclamation plan proposed for the benches: either in preventing access for backfill or topsoil placement; or a significant failure subsequent to reclamation affecting significant reclaimed areas and/or failing to provide adequate safety to people or protect wildlife in a post-reclamation scenario.

A review of the 2019 Annual Report Geotechnical Addendum suggests benches 6950 and 6740 in the South Quarry may have portions reaching or exceeding bench capacity for rock fall. Please describe and commit to how the high potential for kinematic failures (including GEI’s recommendation to perform a “detailed assessment and evaluation of discontinuity conditions”) can or will be mitigated to prevent multiple bench failures raised by the GEI recommendations section. [*Note: DRMS has accepted adequate catch-bench capacity analyses for other projects, which is alluded to in Section 8.3, second paragraph.*]
