MINERALS PROGRAM INSPECTION REPORT PHONE: (303) 866-3567

MINE NAME:	MINE/PROSPECTING ID#:	MINERAL:	COUNTY:
Pioneer Farm	M-2000-080	Sand	Arapahoe
INSPECTION TYPE:	INSPECTOR(S):	INSP. DATE:	INSP. TIME:
Monitoring	Patrick Lennberg	May 13, 2021	10:30
OPERATOR:	OPERATOR REPRESENTATIVE:	TYPE OF OPERATION:	
Pioneer Sand Company, Inc.	Russ Bartz	112c - Construction Regular Operation

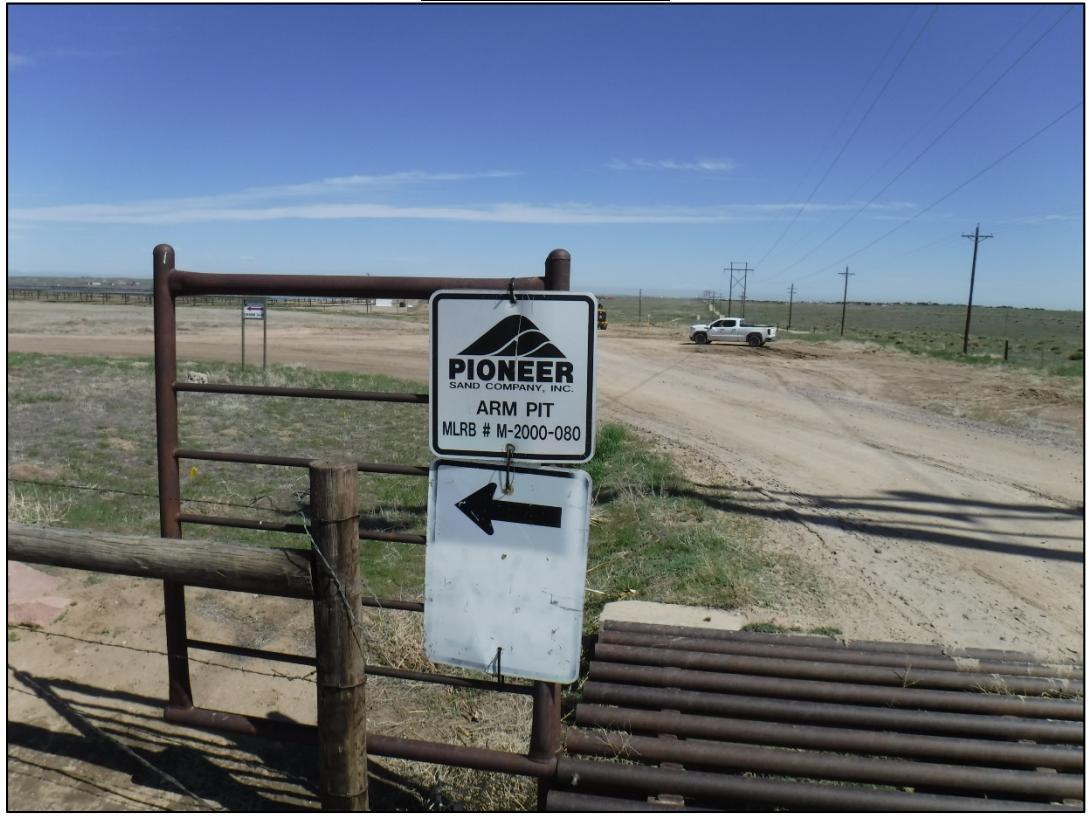
Pioneer Farm is a 310 acre 112c mining operation on privately owned land. The commodity mined at the site is topsoil and fill material. The site is surrounded by rural residential and agricultural land with the approved post mining land use of cropland. A mine sign was observed as required by Rule 3.1.12.

Photo 1: Mine Sign

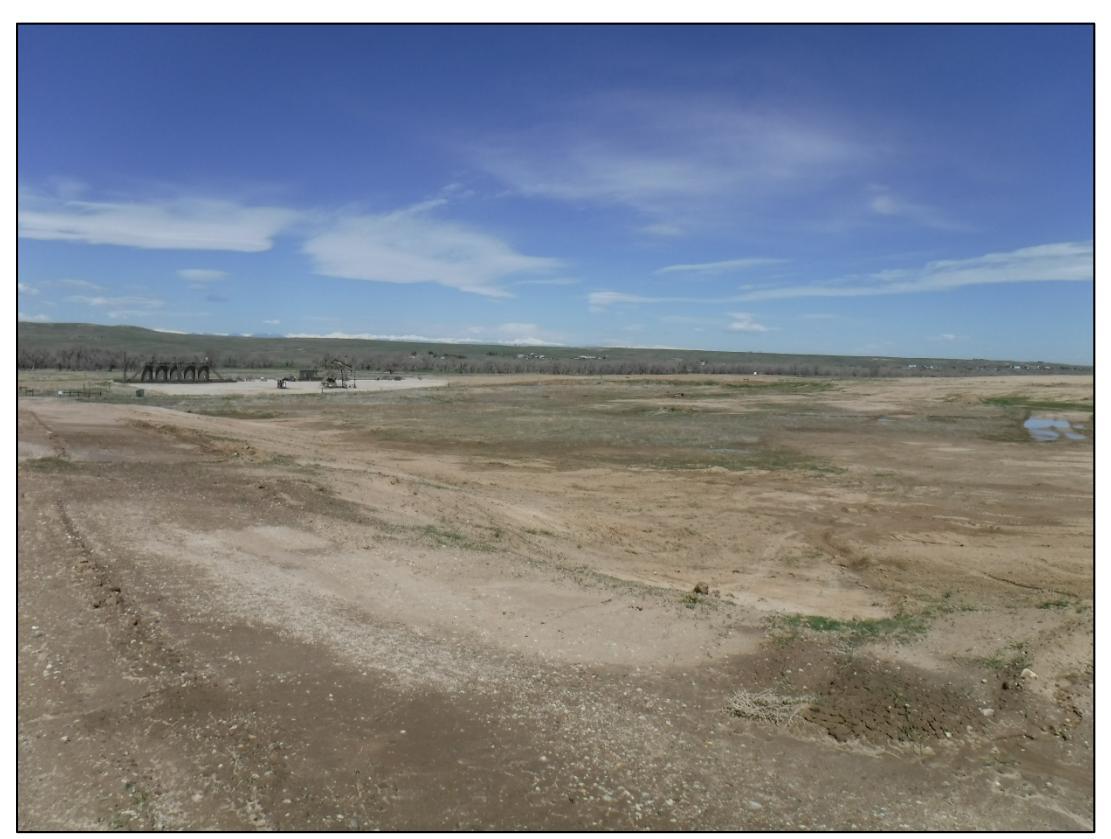
Photo 2: Conoco well released in AR-01 and updated in TR-01 in 2013, also former processing area was located in the center of the picture

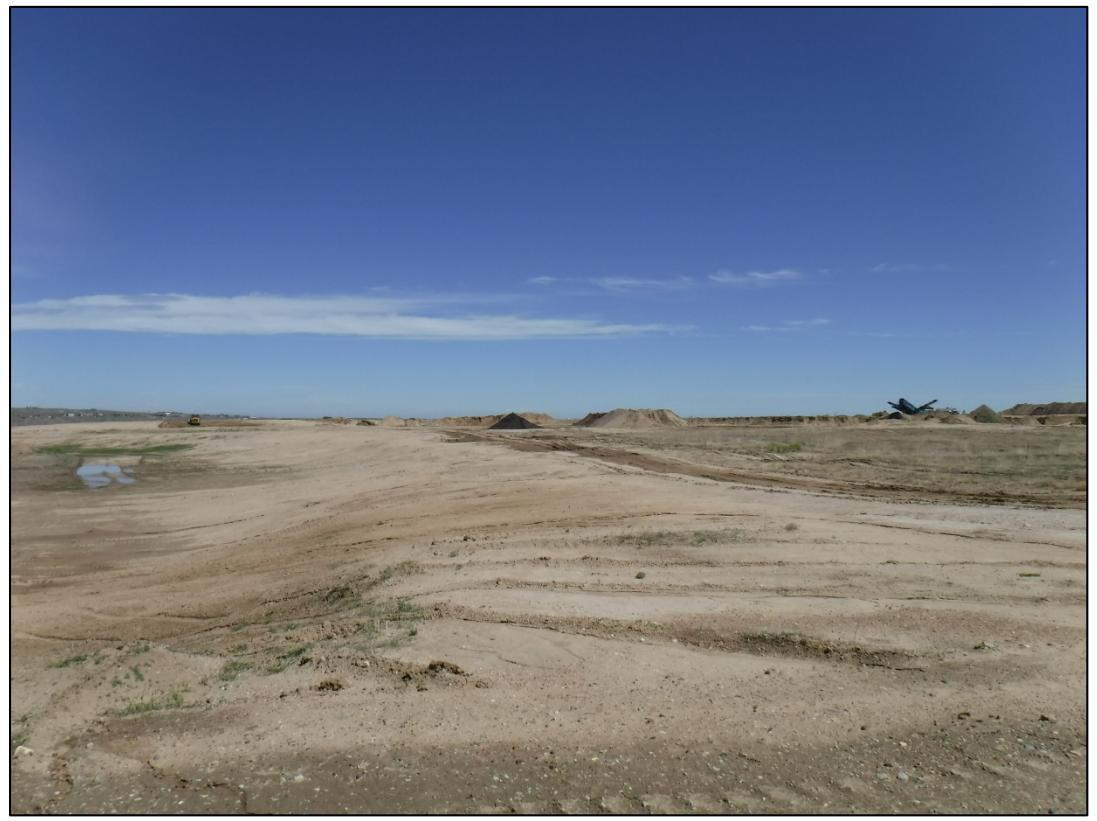
Photo 3: Current processing and stockpiling area

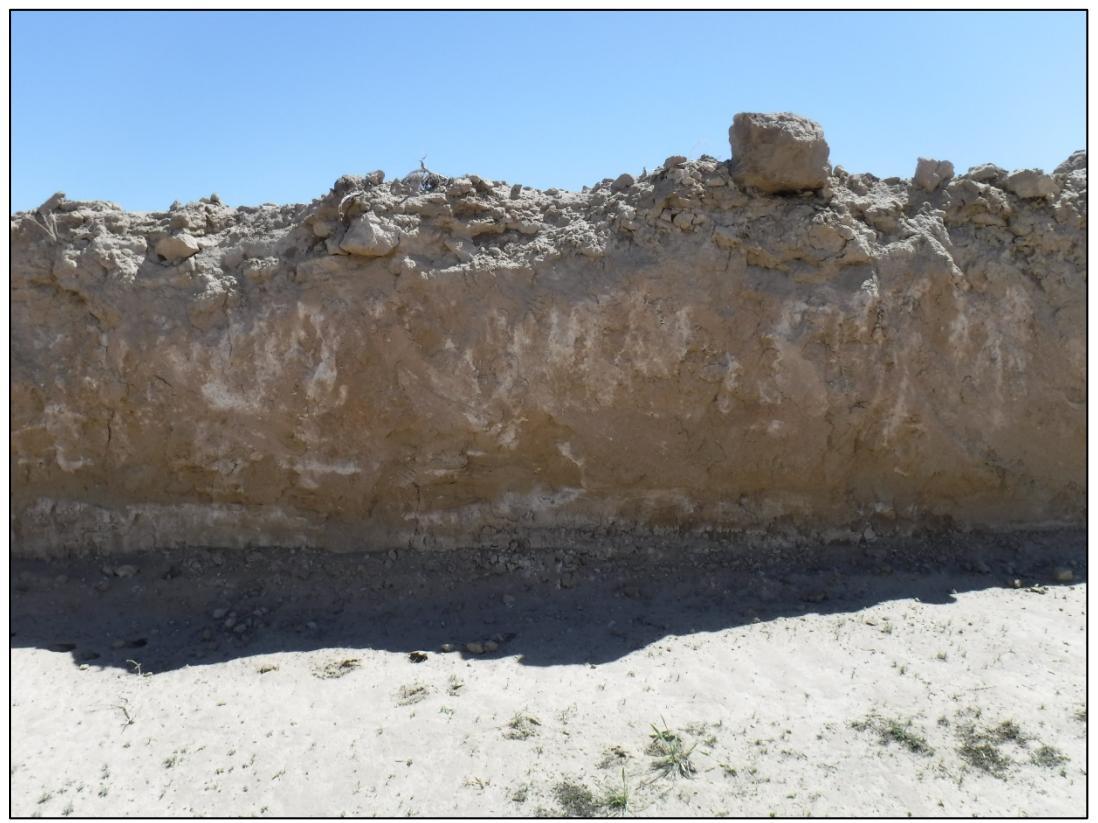
Photo 4: Cross-section of material being mined, sand at base of the section is not mined

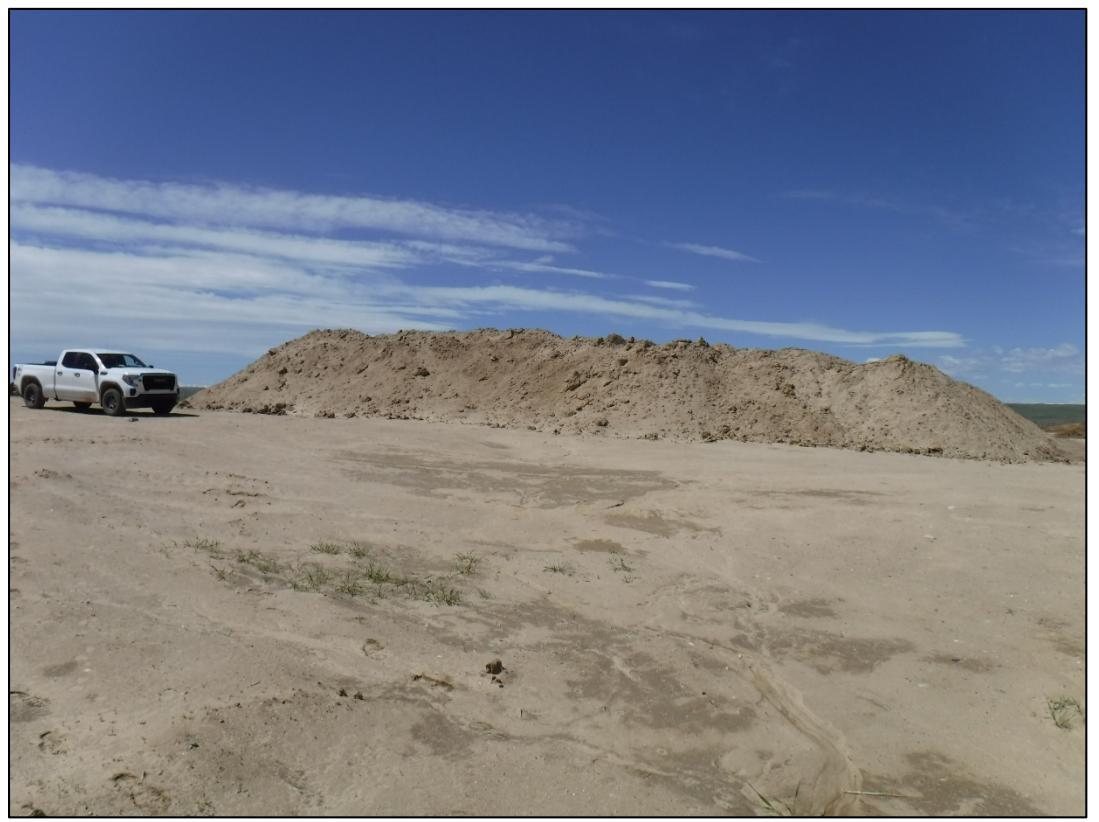
Photo 5: Stockpile of material being used for reclamation

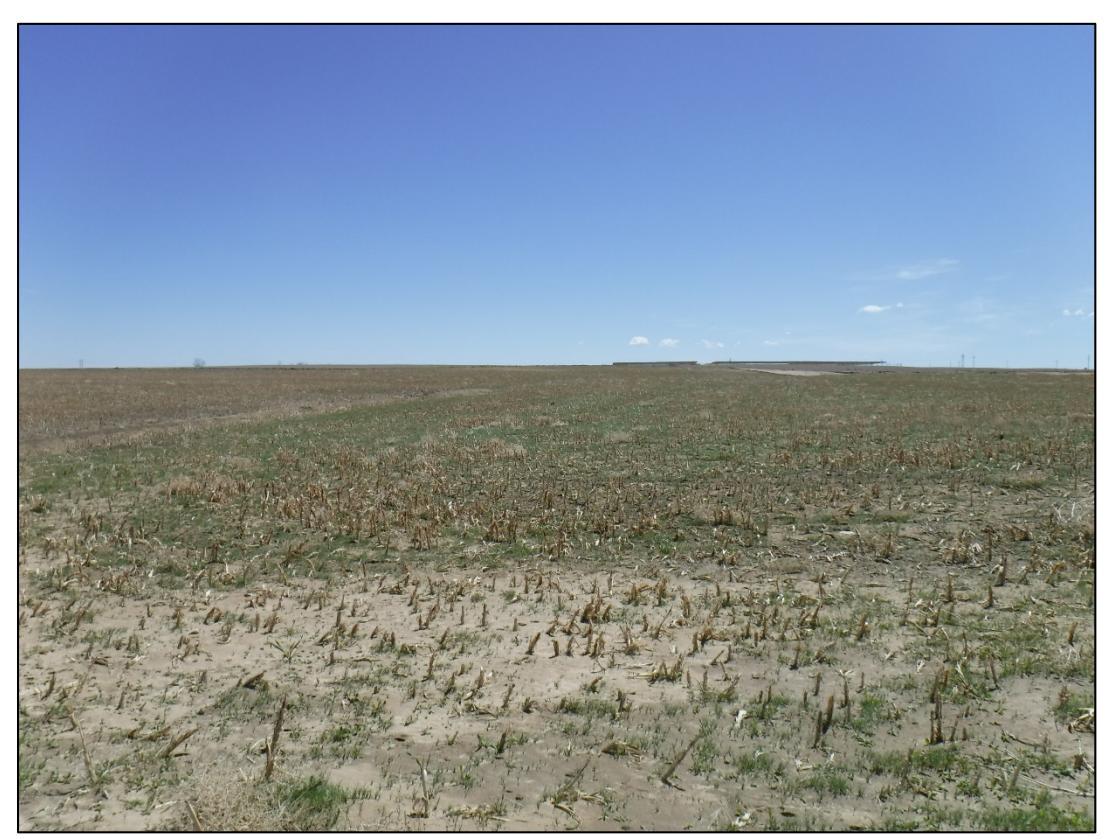
Photo 6: Cropland area immediately adjacent to processing area, not mined yet

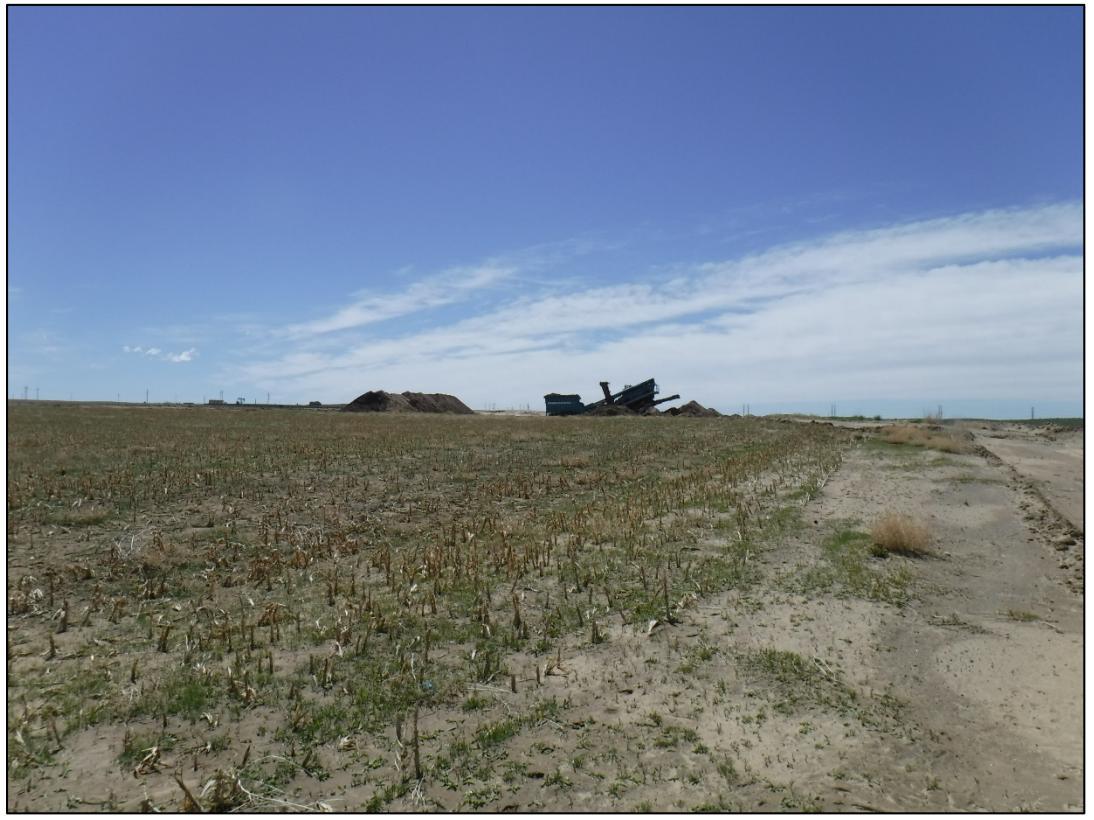
Photo 7: Dry processing area

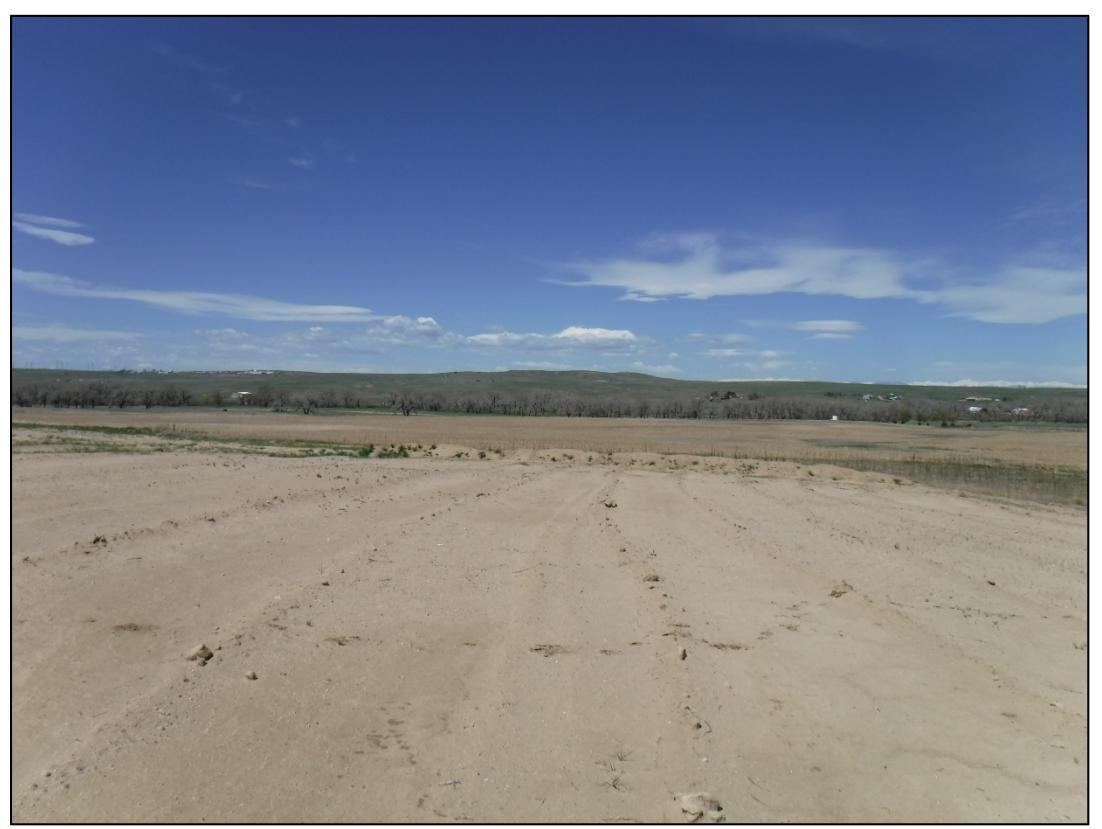
As mining is progressing the operator is conducting concurrent reclamation to facilitate the land owner to plant crops. In the areas where reclamation has been completed it appears those areas are sustaining cultivation well.

Photo 8: Reclaimed area ahead of crop planting

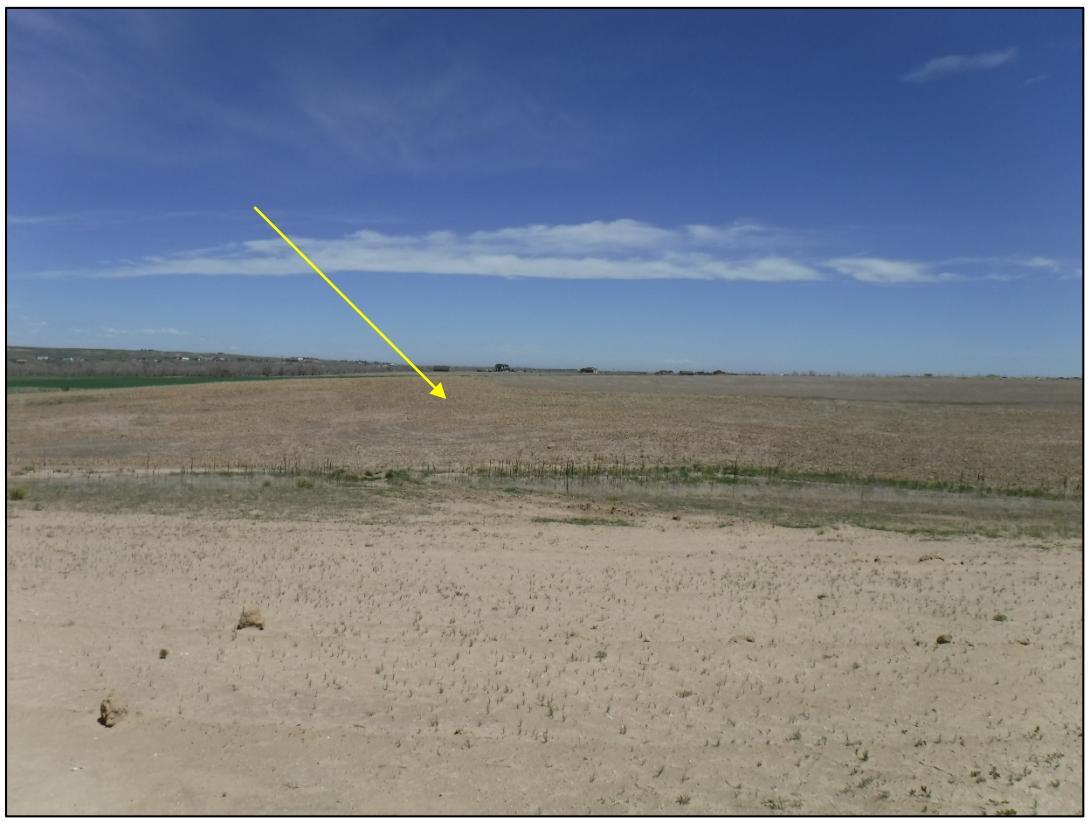
Photo 9: Reclaimed area that has been planted crops (arrow)

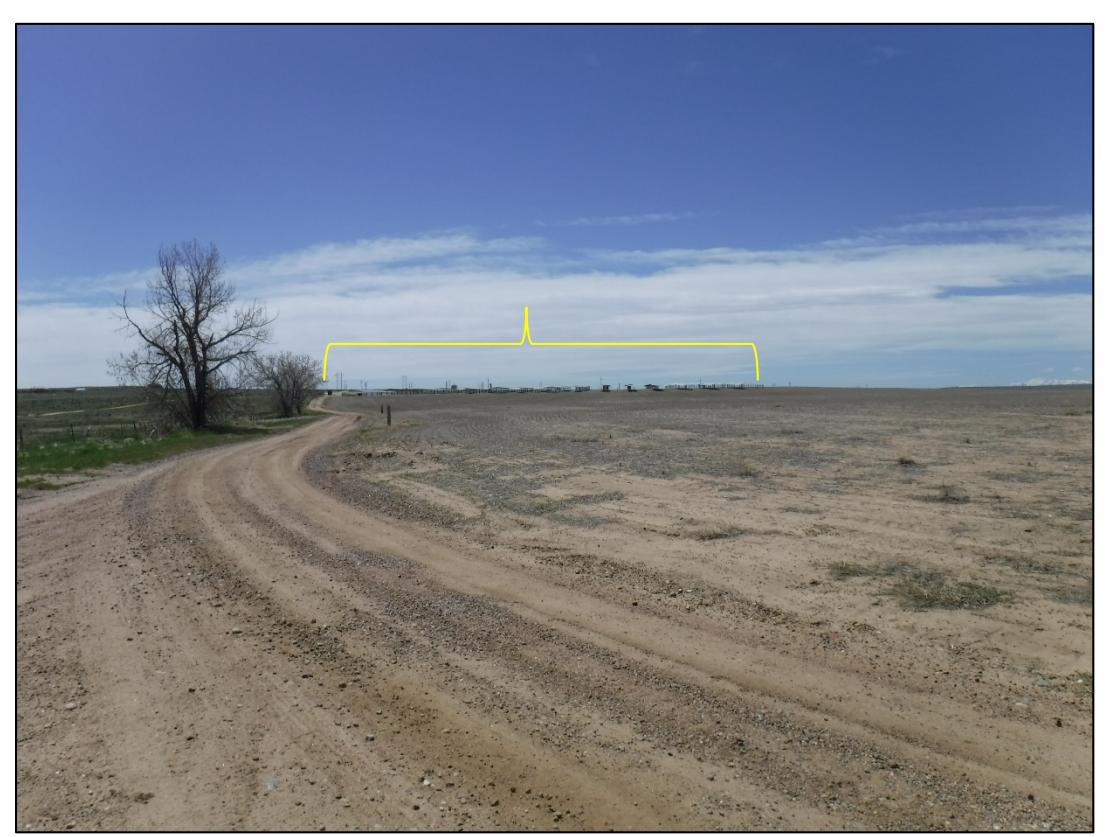
During the inspection it was observed that there is a solar farm, approximately 11 acres, located within both the permit and affected land boundaries. Russ stated that the solar farm was installed over the last couple of years and a 10 year lease agreement was signed by the land owner. The operator was involved with negotiations pertaining to the solar farm and does not anticipate mining that area for another 10 or more years. The Mining and Reclamation Plan Maps need to be updated to reflect the current location of the solar farm.

Photo 10: Solar farm area looking south (bracket)

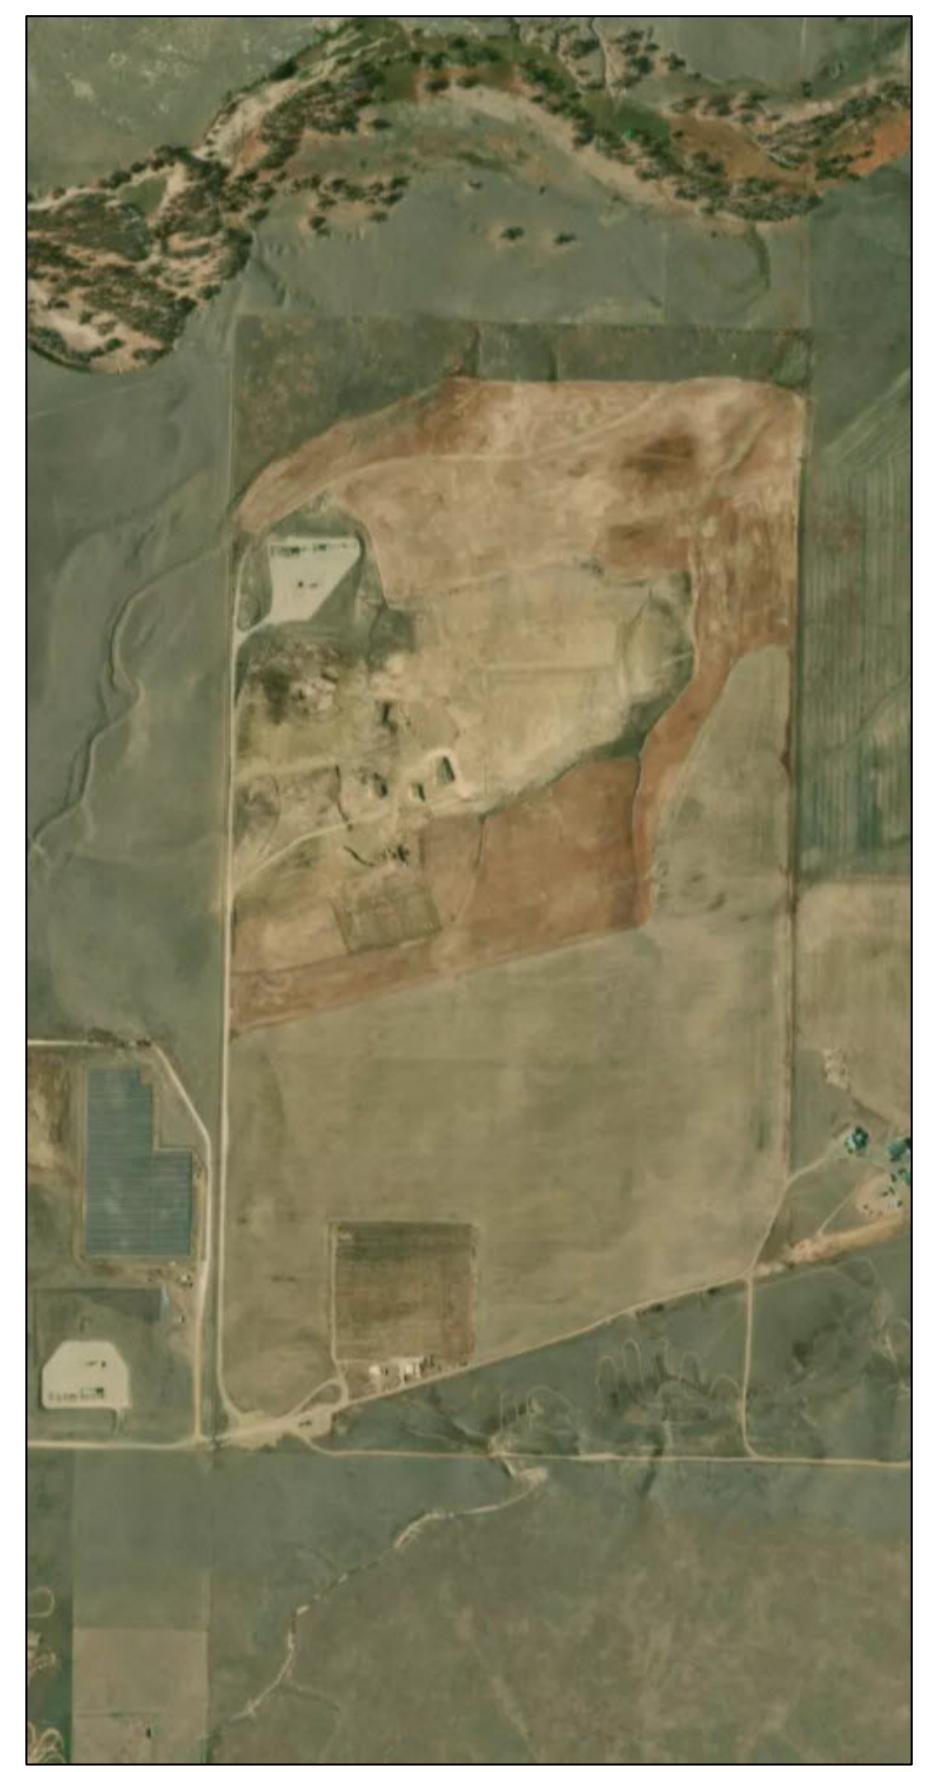
Photo 11: Recent aerial photo of site, actual date unknown
