# MINERALS PROGRAM INSPECTION REPORT PHONE: (303) 866-3567

MINE NAME:		MINE/PROSPECTING ID#:	MINERAL:	COUNTY:		
Green/Croissant Property Sand and Gravel Mi		M-2001-022	Sand and gravel	Weld		
INSPECTION TYPE:		INSPECTOR(S):	INSP. DATE:	INSP. TIME:		
Monitoring		Jared Ebert	May 20, 2021	09:30		
OPERATOR:		<b>OPERATOR REPRESENTATIVE:</b>	TYPE OF OPERATION:			
Loveland Ready-Mix Concrete, Inc.		Stephanie Fancher-English	112c - Construction Regular Operation			
<b>REASON FOR INSPECTION:</b>		BOND CALCULATION TYPE:	BOND AMOUNT:			
Citizen Complaint (CT01)		None	\$209,700.00			
DATE OF COMPLAINT:		POST INSP. CONTACTS:	JOINT INSP. AGENCY:			
NA		None	None			
WEATHER:	INSPECTOR'S SIGNATURE:		SIGNATURE DATE:			
Clear	Ja	NO EDOX	May 28, 2021

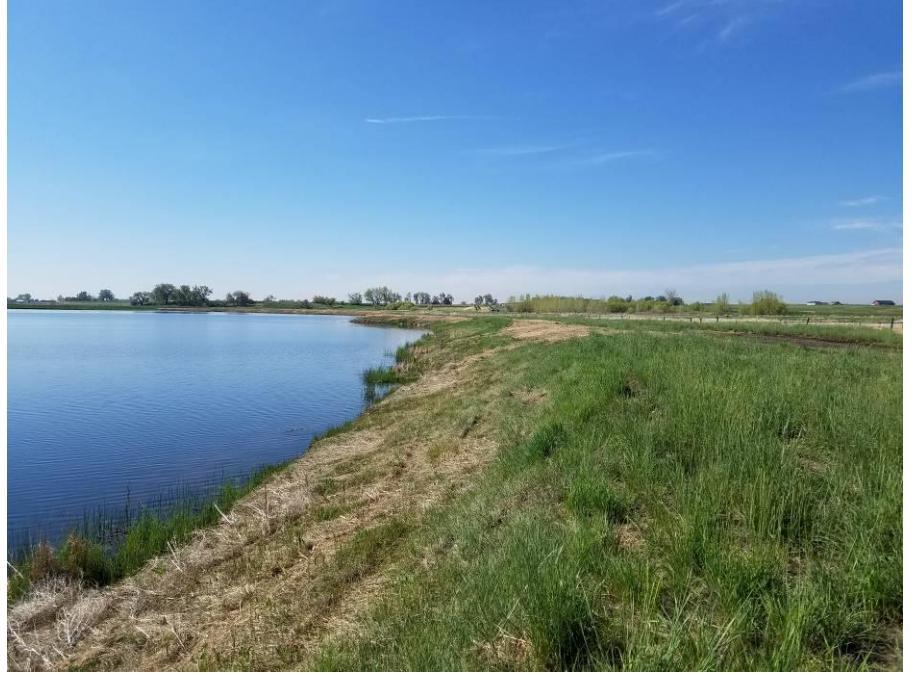
Figure 1. From the northwest corner of the site looking south.

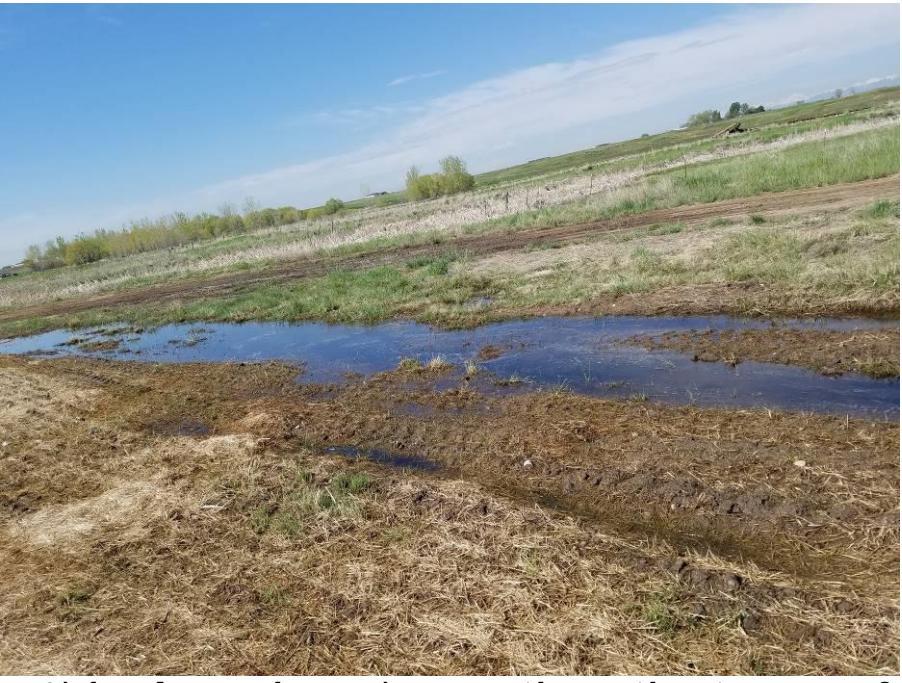
The Christensen's pointed out several low spots in the affected area where water has pooled. They called these areas "sink holes". There are some small depressions particularly along the western side of the lake. Some of these areas were holding water likely due to the recent precipitation and appeared to be about a half a foot to two feet deep. These areas were not of significant size and some of them may be the result of vehicle's driving over them during moist conditions. Along the southern shore, in the southwest corner of Cell No. 4 one small crack in the soil just above the water line was observed (see Figure 5). This crack may been the expansion of the crimping line when the area was mulched. LRM should monitor this area to insure the crack does not expand.

Figure 2. "Sink Hole" or depression near the northwest corner of the site.

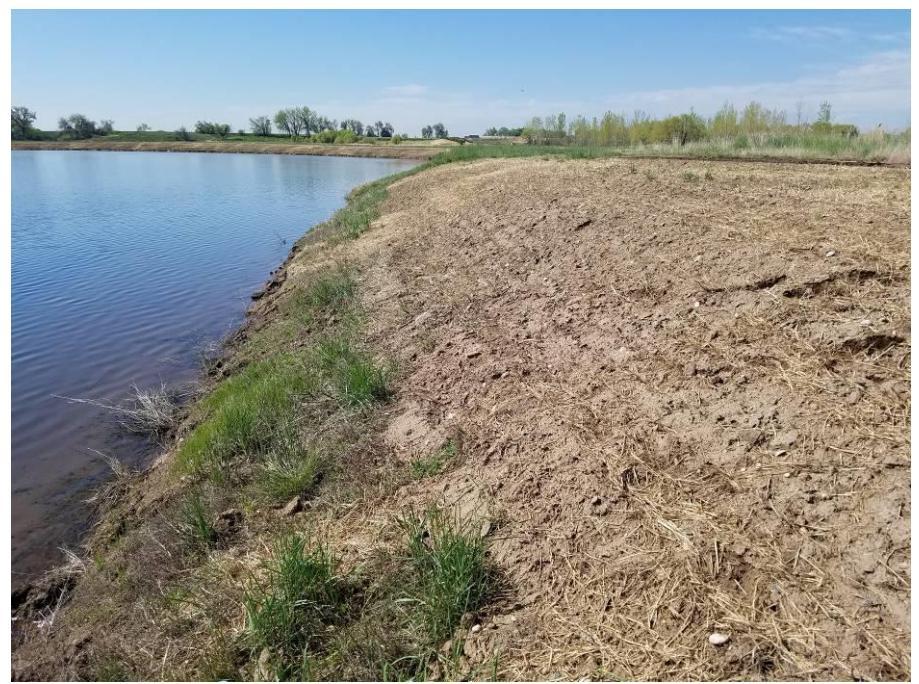
LRM has recently reseeded and mulched several areas around the Cell No. 4 lake area. Some grassy vegetation has begun to germinate in this area but is not well developed to date. Otherwise, the remaining portions of the affected land have fairly dense grass established. While it is a little early in the season, it appears several types of wheatgrasses have established primarily. The Christensen's are concerned about the amount of Kochia that has grown at the site over the last few years. It does appears Kochia is beginning to germinate in areas around the Cell No. 4 lake. The Christensen's mentioned they were concerned about the frequency of mowing at the site to control weeds, especially Kochia. The permit for this site does not require LRM to mow for weed control at a specific frequency. Overall, the vegetation established at the site is in keeping with what would be expected for an alluvial mining/reclamation operation with only two or three growing seasons since the initial seeding. Given the drought conditions last year, it is to be expected that reseeding/inter-seeding would be necessary. While Kochia can be a nuisance, it is not a state listed noxious weed, and given the amount of grassy vegetation established, the density of Kochia should diminish.

Figure 3. Recently reseeded area on the west side of the site.

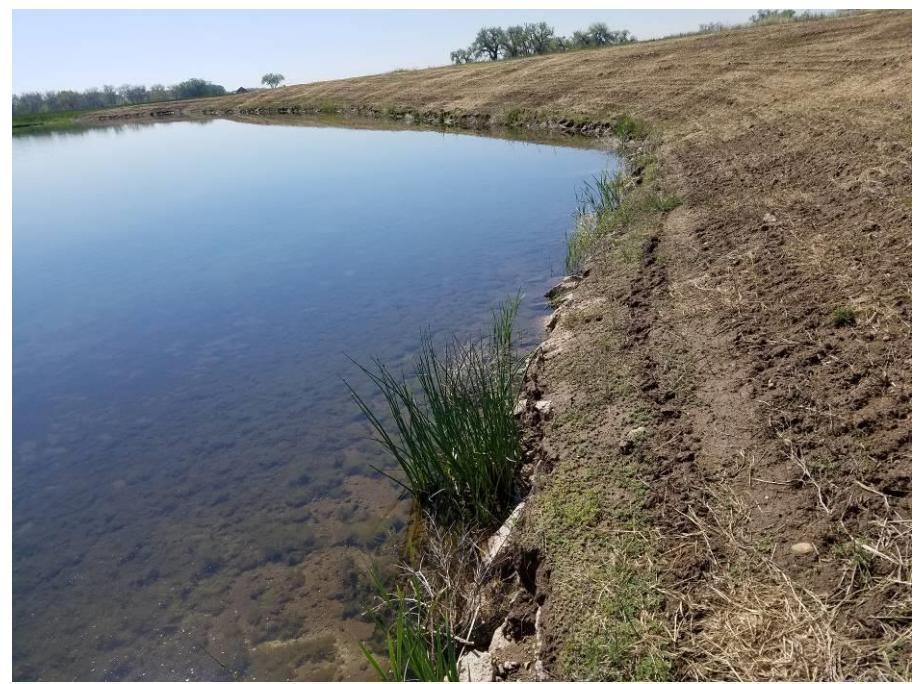
Figure 4. From the southwest corner of the site looking east.

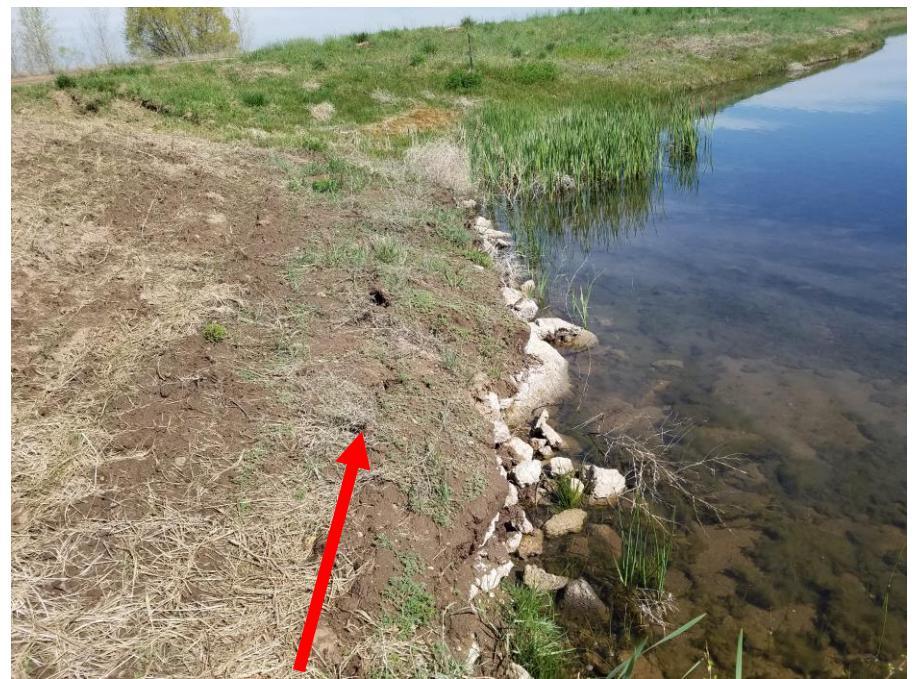
Figure 5. Small crack in the southwest corner of Cell No. 4.

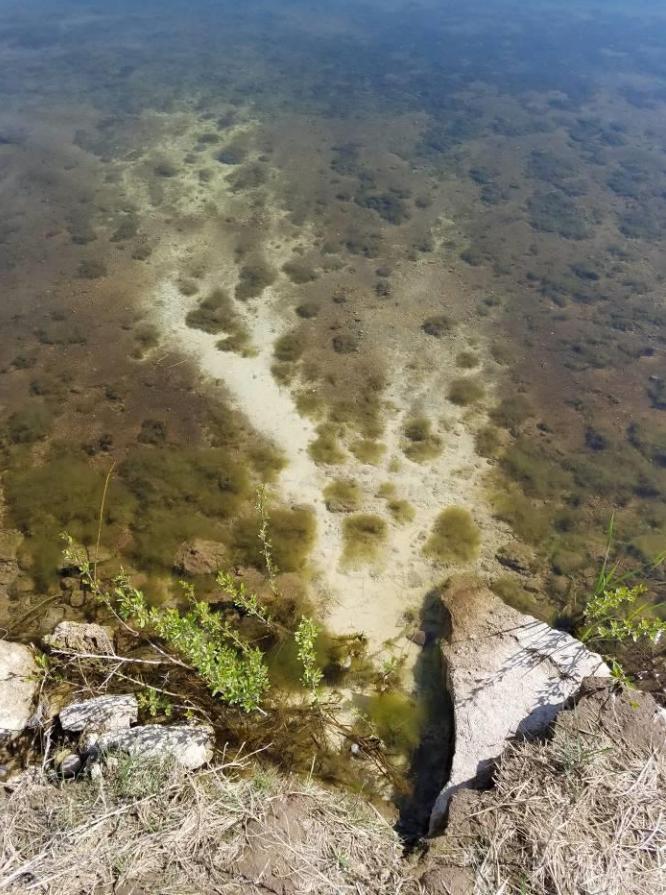
The Christensen's noted in their May 12, 2021 email a white substance observed in the water along the south shore where LRM placed concrete rip-rap in 2019. These white spots were observed. DRMS believes these white spots are fine sediment from the backfilled material and rip-rap. The water table is not far below the ground surface given the wetland type vegetation observed west and south of the Cell No. 4 lake. Groundwater is flowing into the lake and likely collecting fine sediment from the more porous rip-rap and settling out into the pond. The Christensen's indicated they plan to take water samples of the area and have them tested to evaluate possible impacts to water quality. I requested they share their results with the Division as well as their sampling plan.

Figure 6. "White Spot" along southern shore where water is likely seeping in from the adjacent wetland through the concrete rip-rap depositing fine sediment.

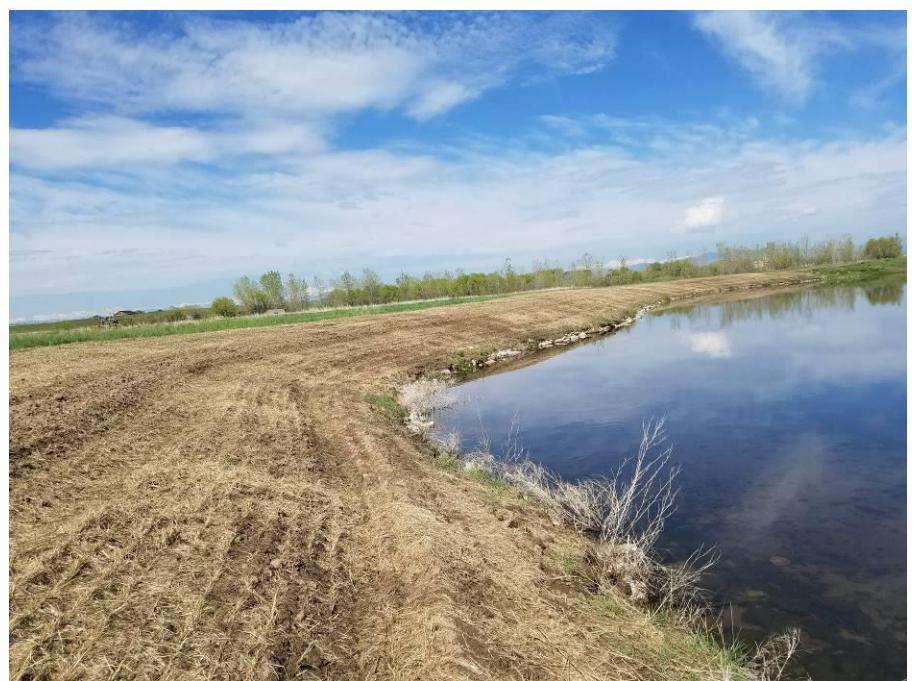
Figure 7. From the southeast corner of the site looking west. Recently reseeded slopes.

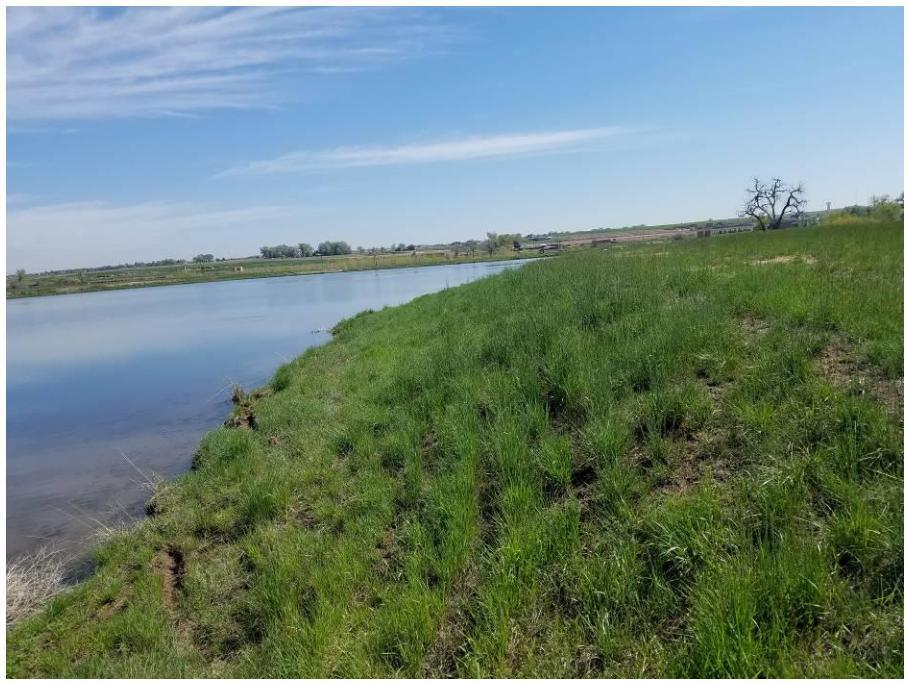
Figure 8. From the southeast corner of the site looking north.

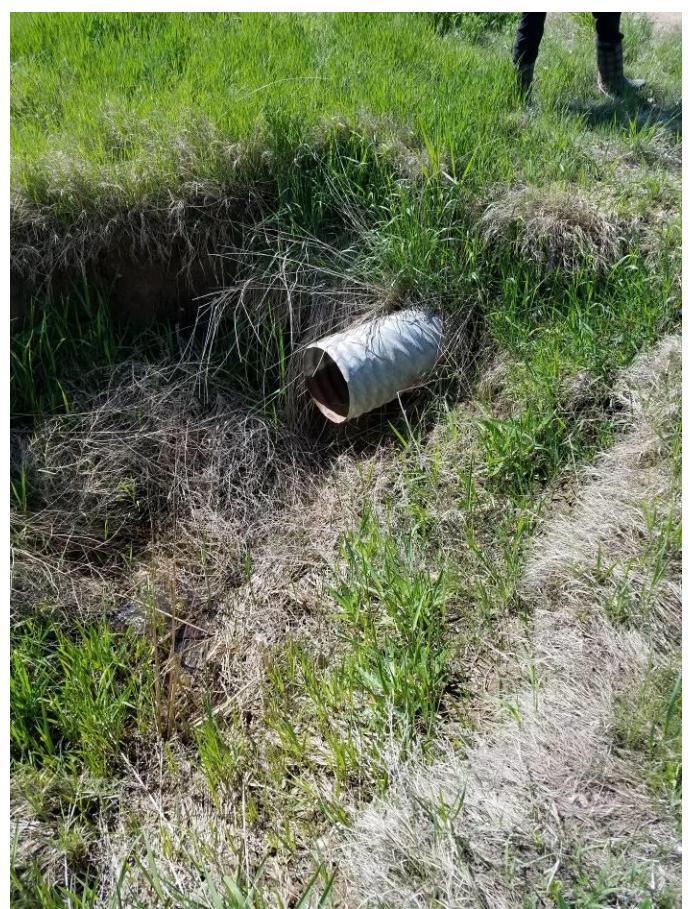
The Christensen's pointed out a culvert that protrudes into the adjacent Big Thompson River from the Cell No. 4 area. According to Mrs. Fancher-English this culvert was used as a discharge point for the dewatering operation during when the site was being excavated. Mining is complete at the site and therefore the culvert should no longer be used for that purpose. There is a basin that formed below the culvert, however the basin and the slopes around the culvert were vegetated and appeared stable.

Figure 9. Culvert from the Cell No. 4 area to the Big Thompson River.

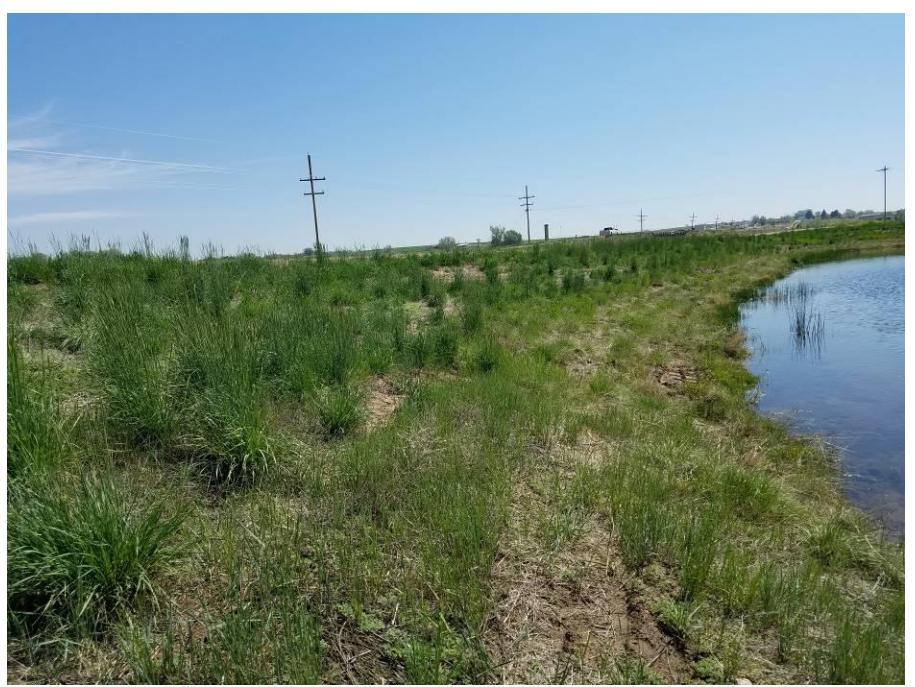
Figure 10. View from near the northwest corner of the Cell No. 4 looking east.
