## Explanation of Slope on Map on our request for reconsidering your decisions

### **Narrative of Slope Analysis Processes**

This is not a Land Survey Plat or an Improvement Survey Plat. The purpose of these exhibits is to depict the areas where the side slopes exceed 33.33% (3:1 Slope).

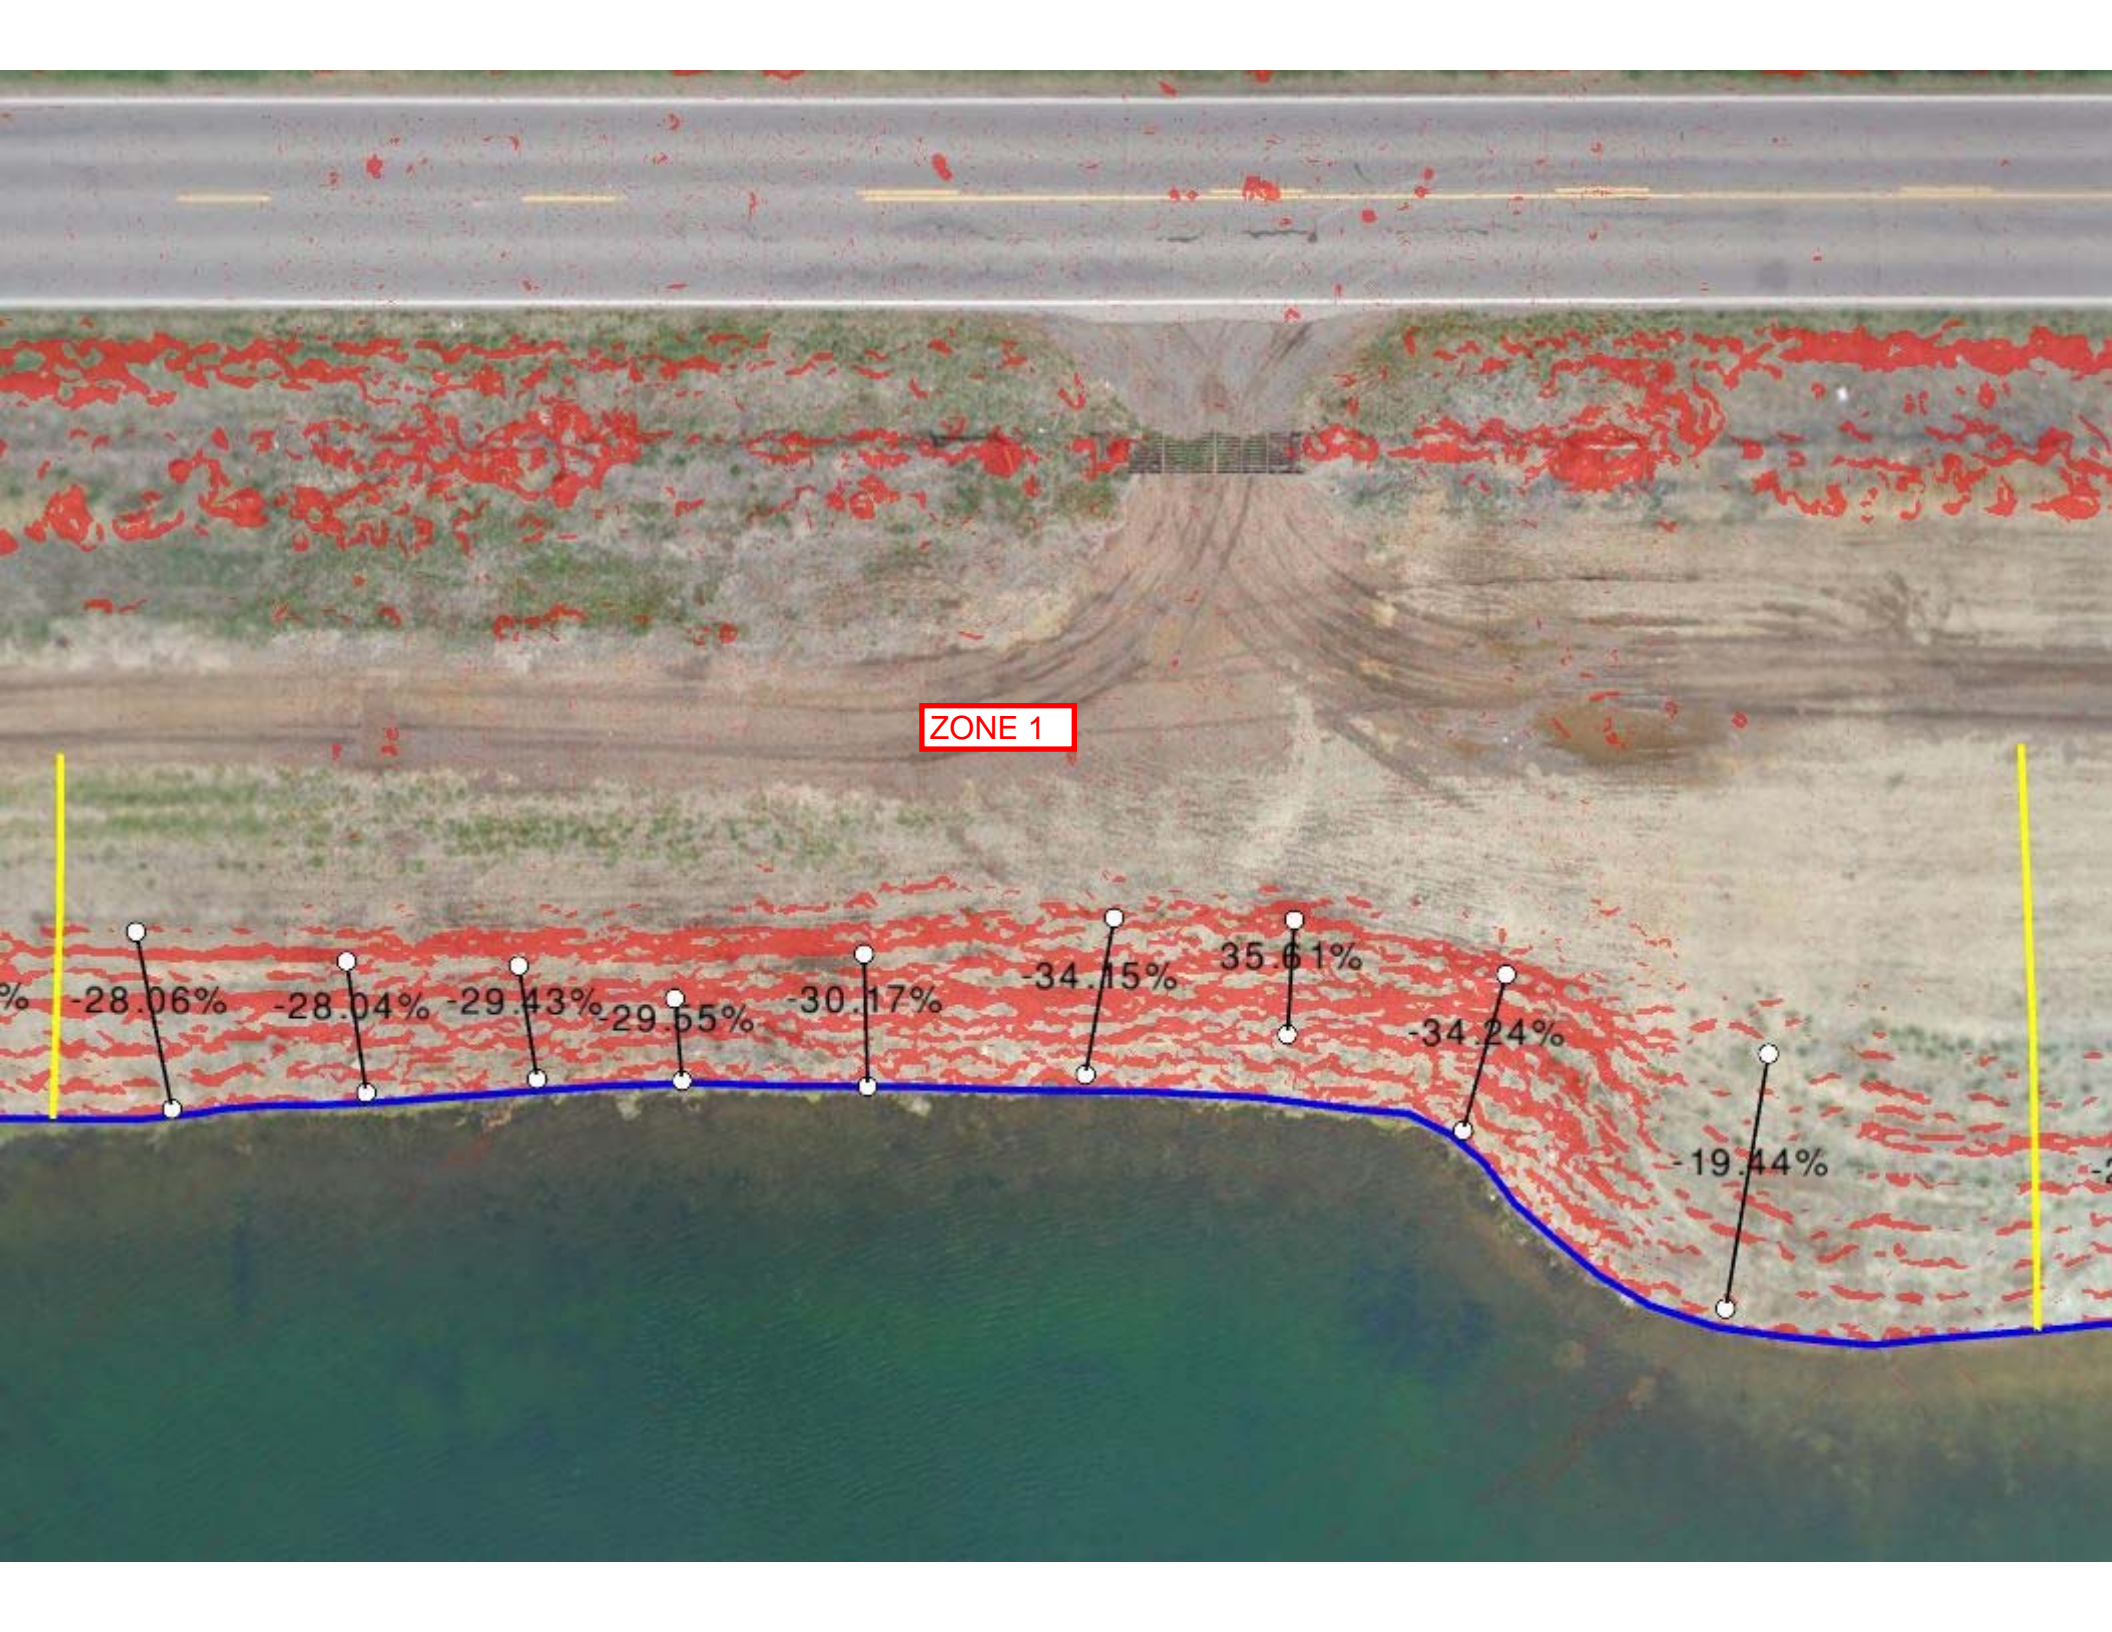
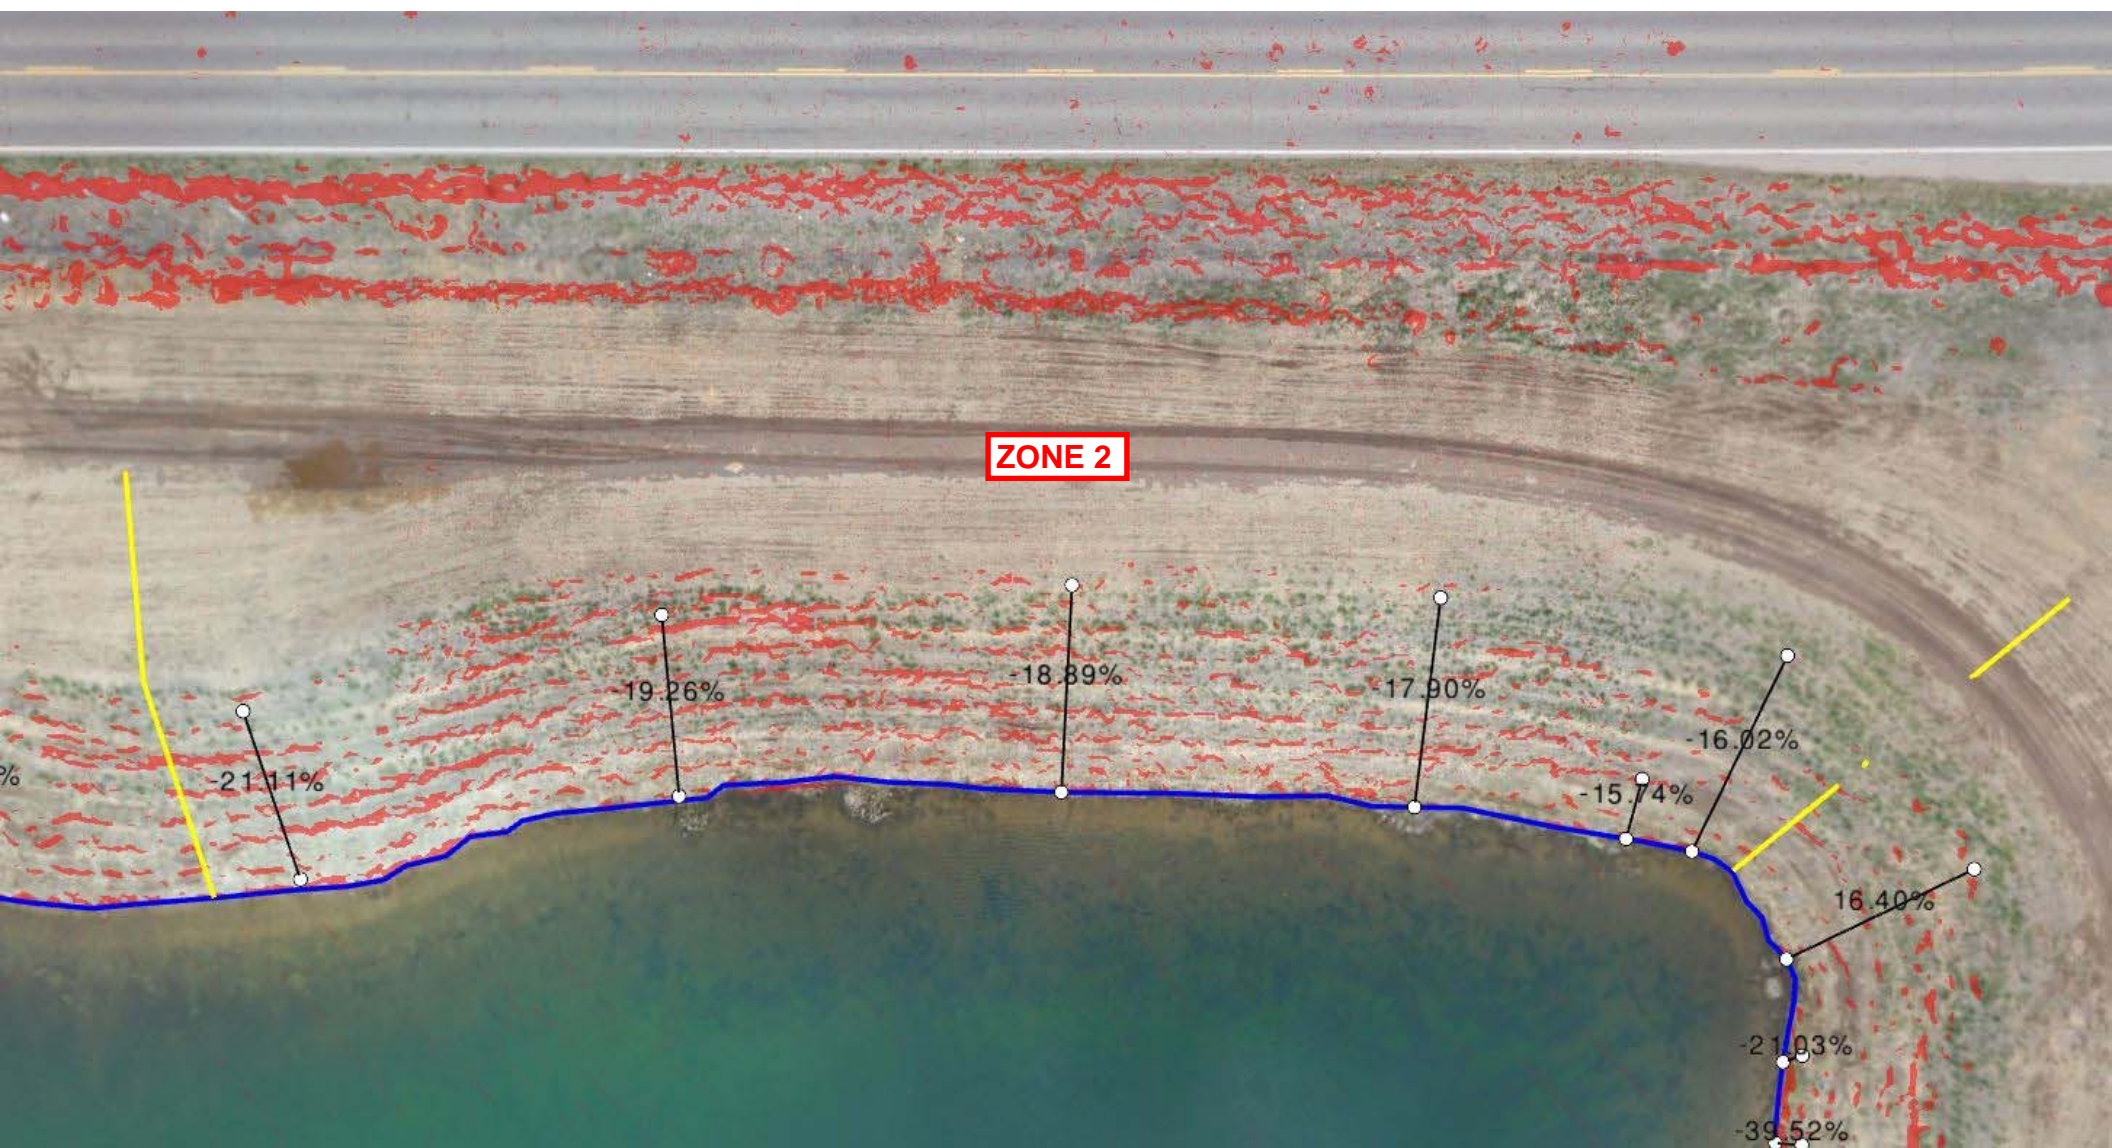
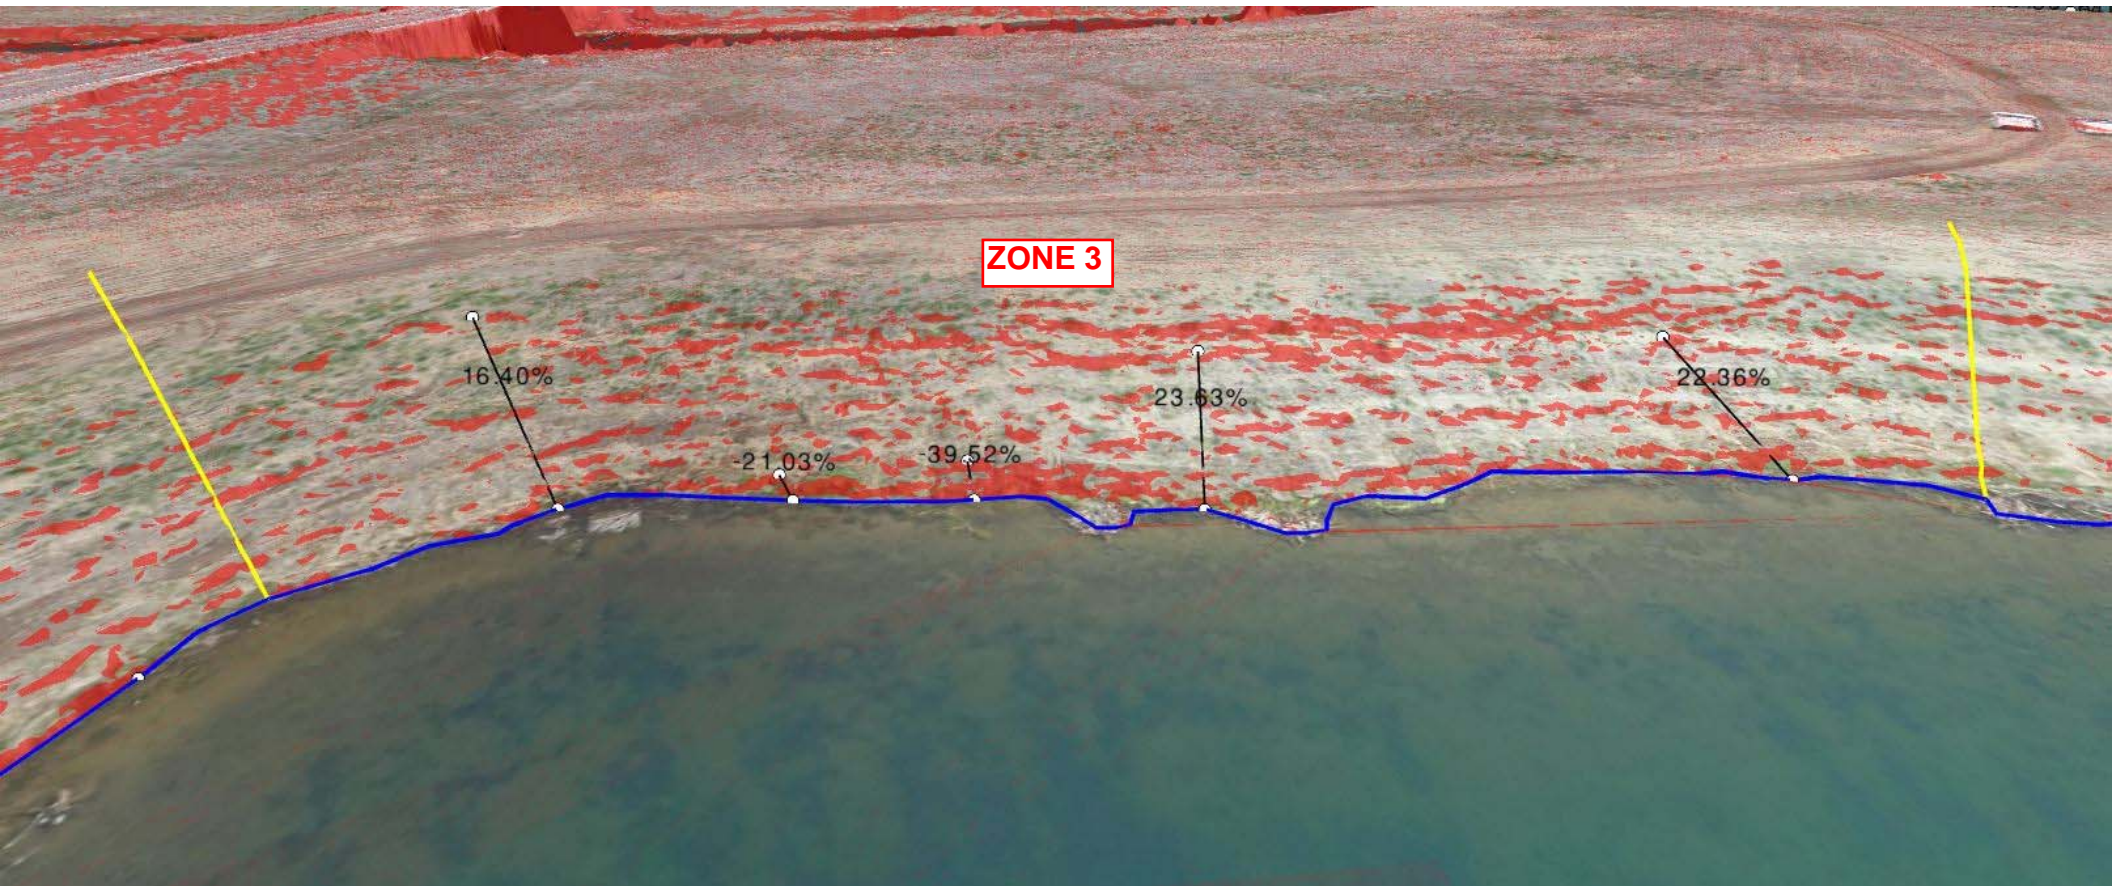
The computer generated analysis shows areas where the slope exceeds 3:1 in RED.

The model indicates wind and wave erosion on the graded slopes along the waters' edge resulting in near vertical faces in some areas. Additionally, there are long slopes where it exceeds 3:1.

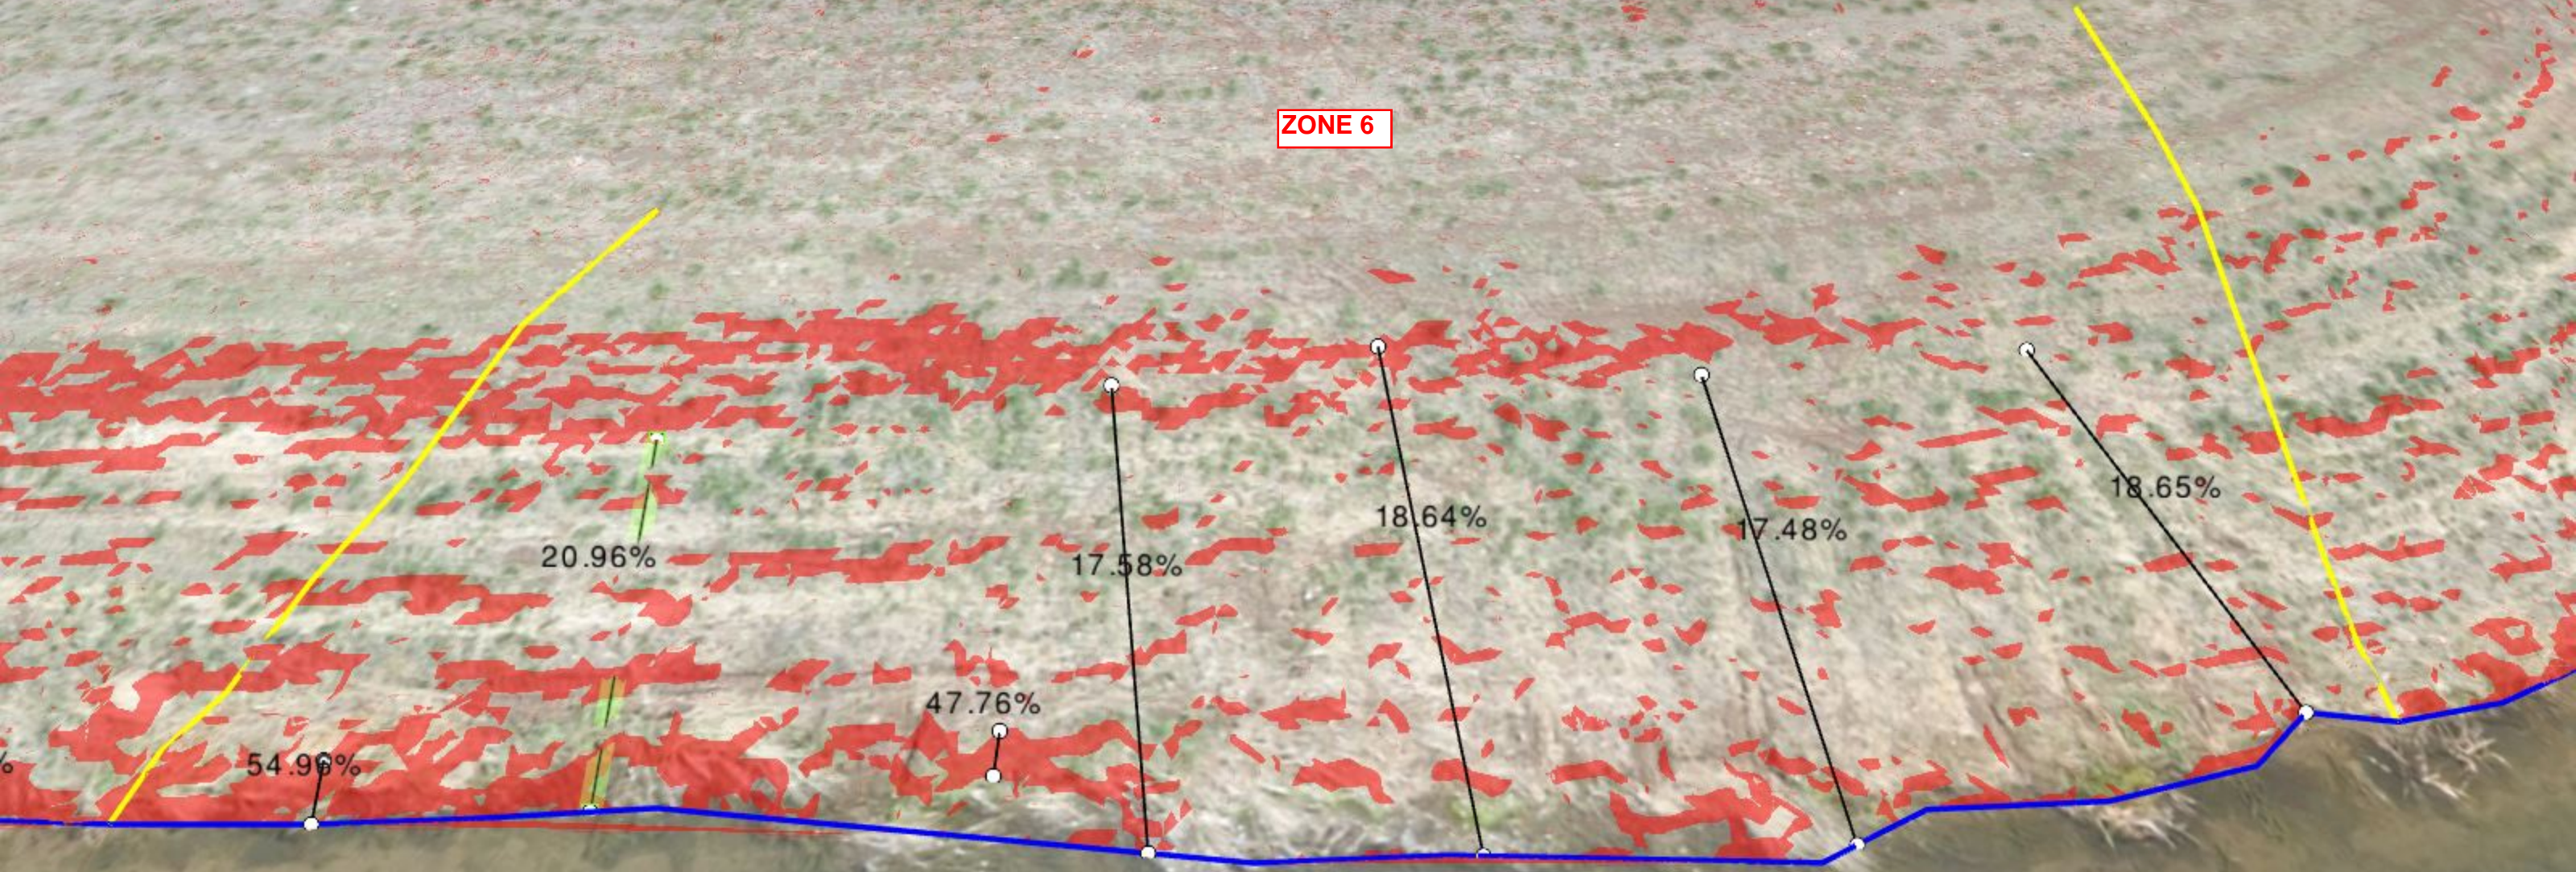
ZONE 6

54.96%

20.96%

47.76%

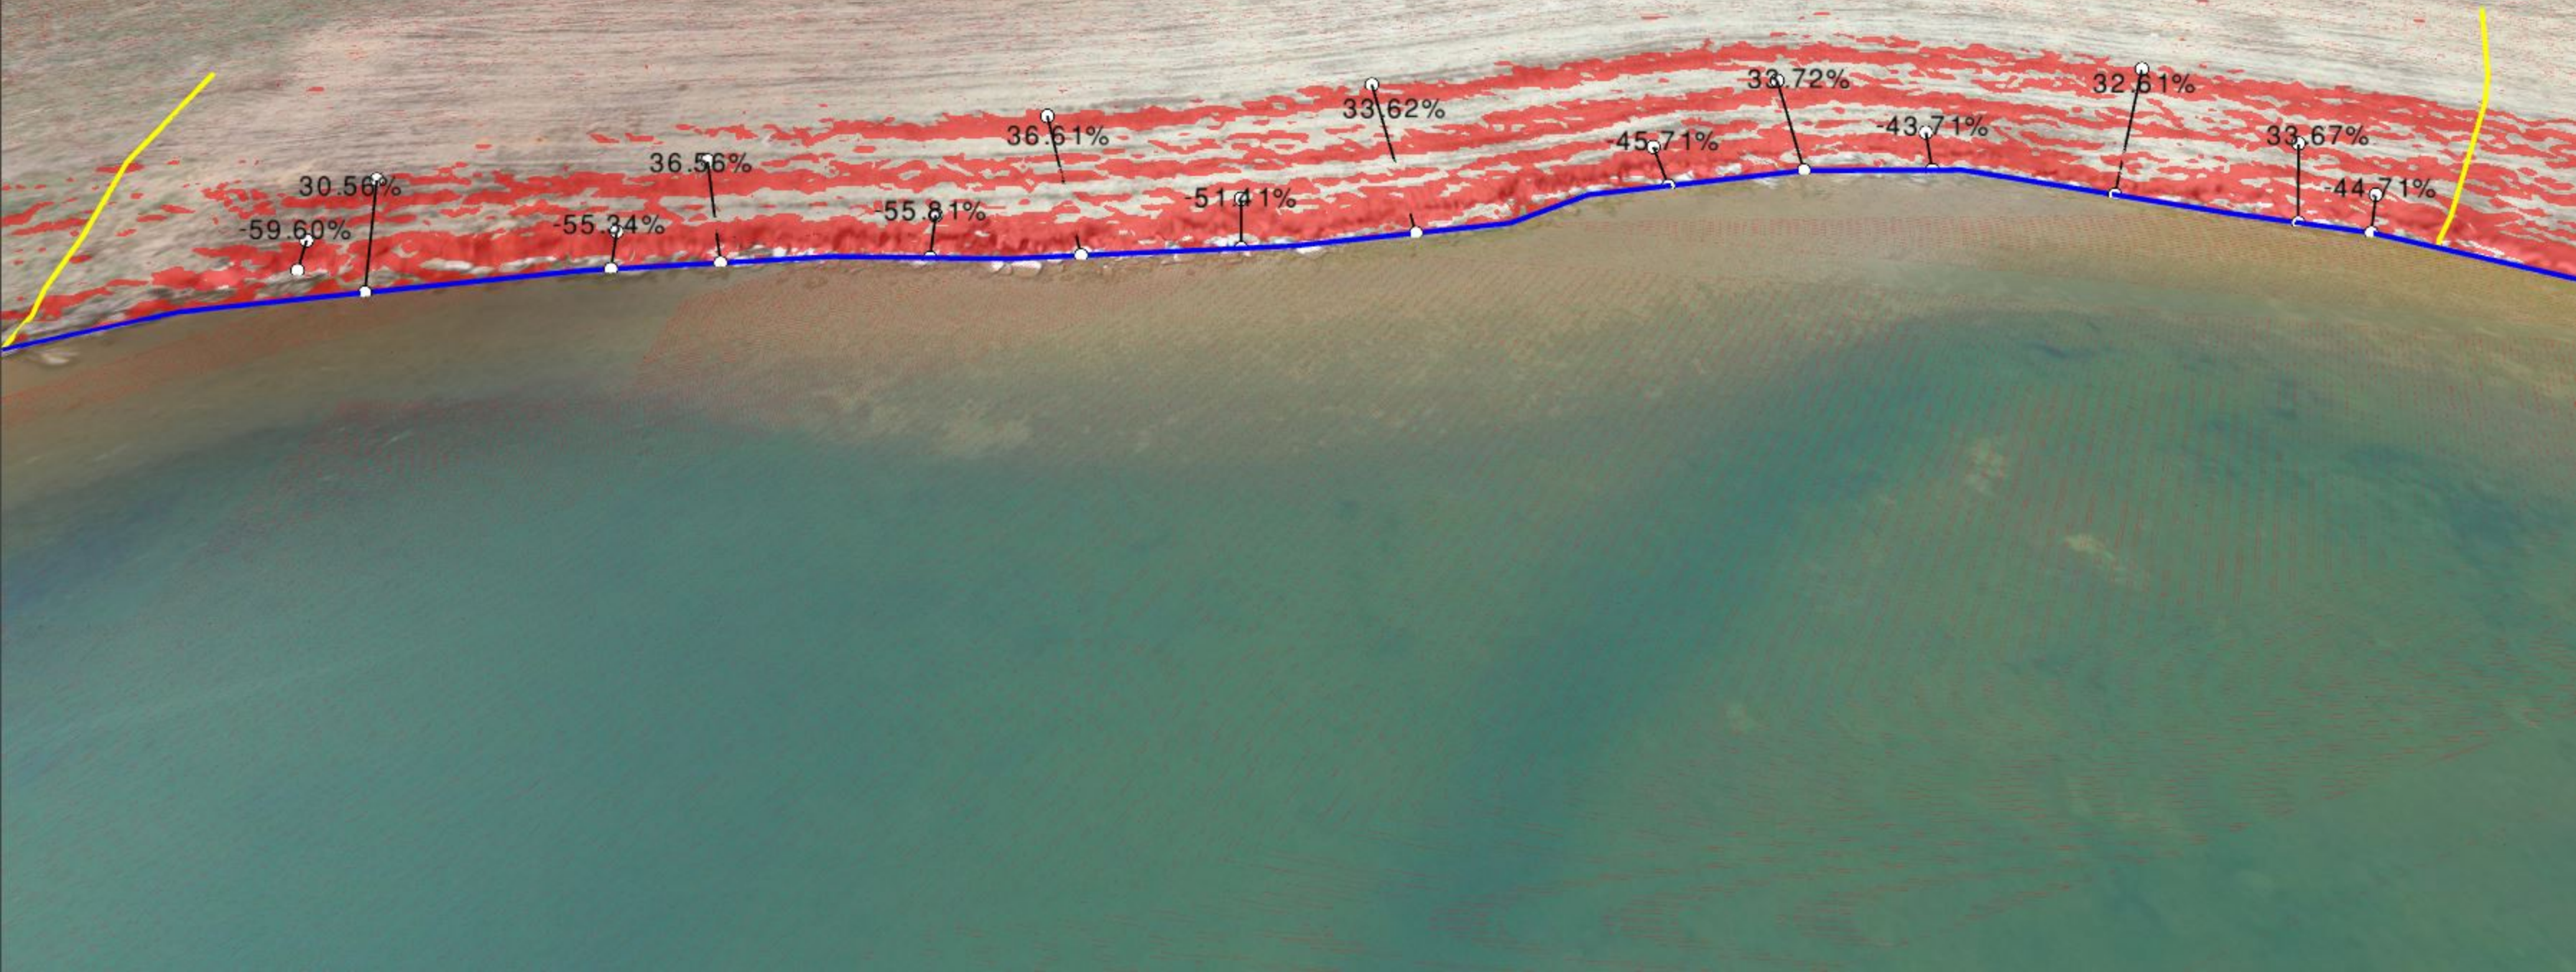
ZONE 19

Zones 19,20,21,22,23 is where the violation on the June 24th report was asked to be corrected as you can see it has not been corrected to the standard of 3:1 set by state.

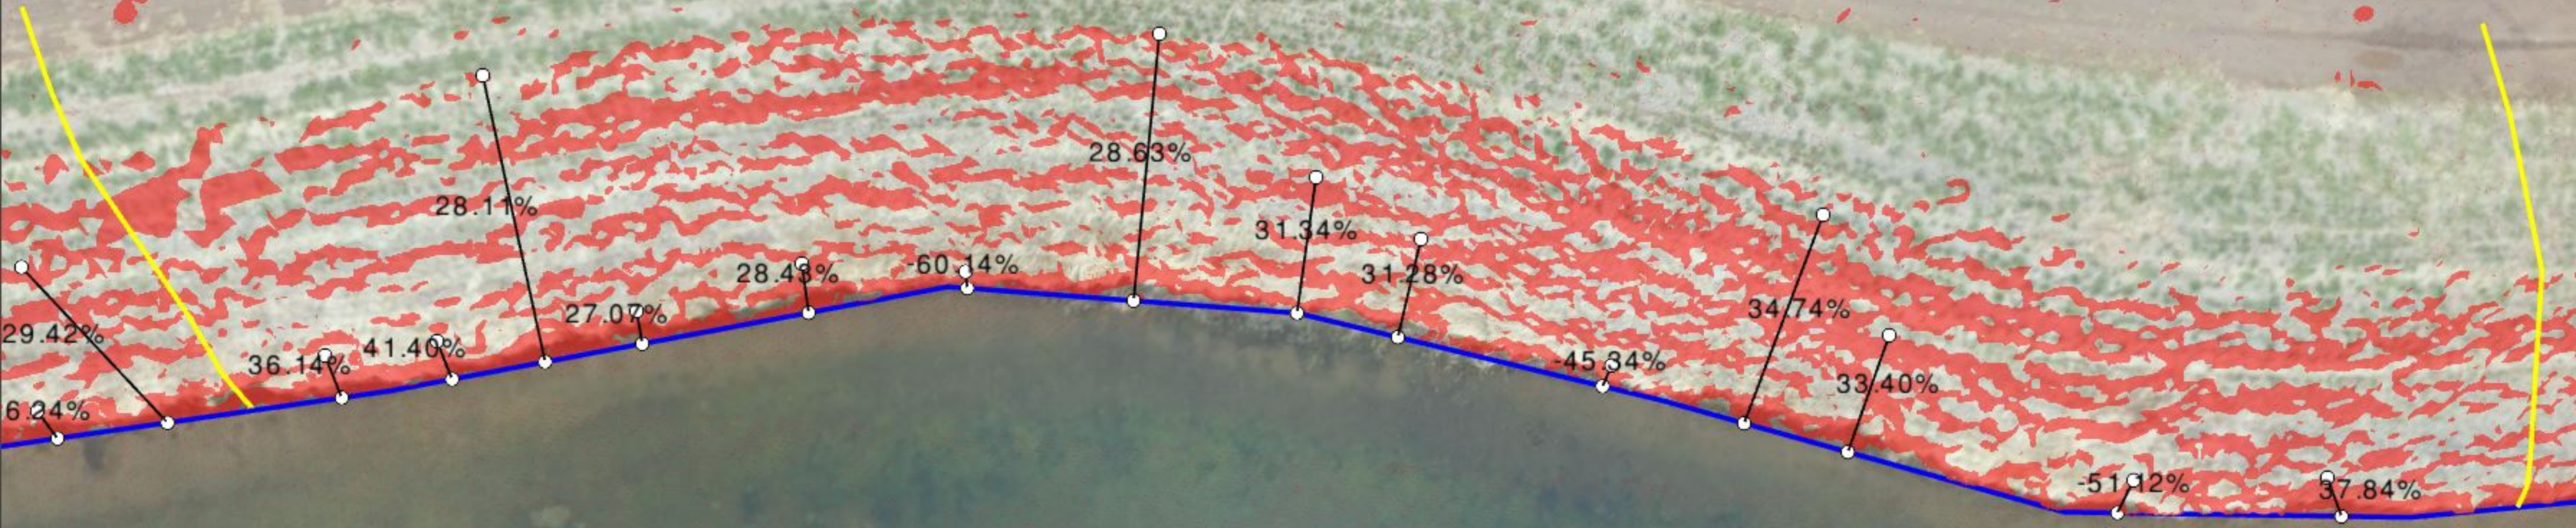
ZONE 24

Here are the final pictures and these areas are actually dangerous. There are 3 feet of straight drop off of shoreline into the lake making impossible to reach the waters edge without falling in.
