## QUARTERLY SEDIMENTATION POND INSPECTION REPORT

Mine: Lorencito

Inspection Period: Second Quarter 2021

**QUARTERLY SEDIMENTATION POND INSPECTION REPORT**  
**Lorencito Canyon Mine- June 30, 2021**

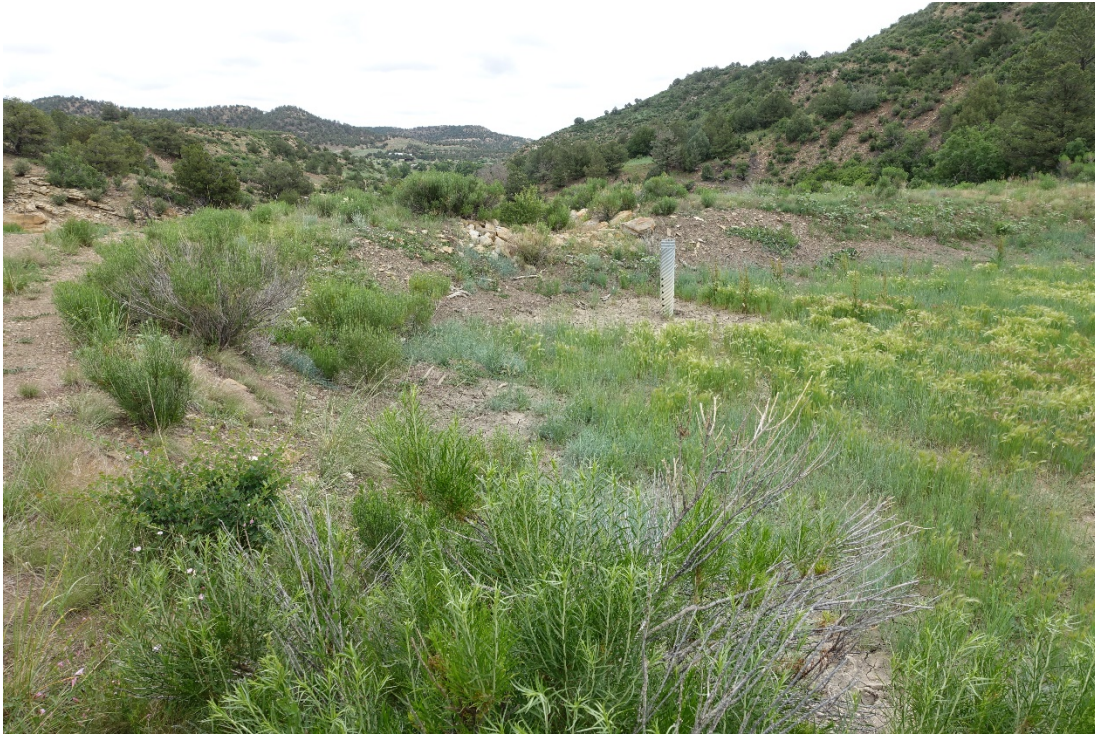
**Pond 5**

Pond was empty at time of inspection.

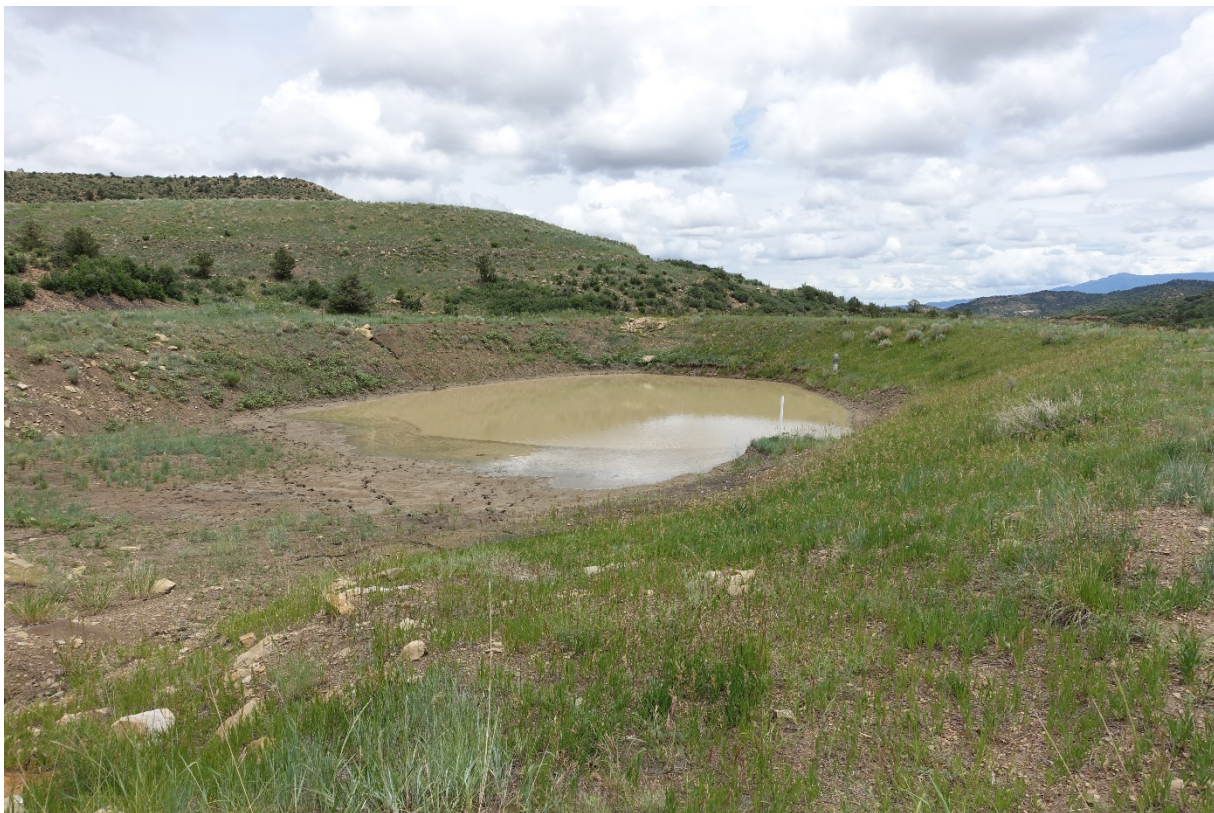
**Pond 6**

Pond was holding water but not near the decant.

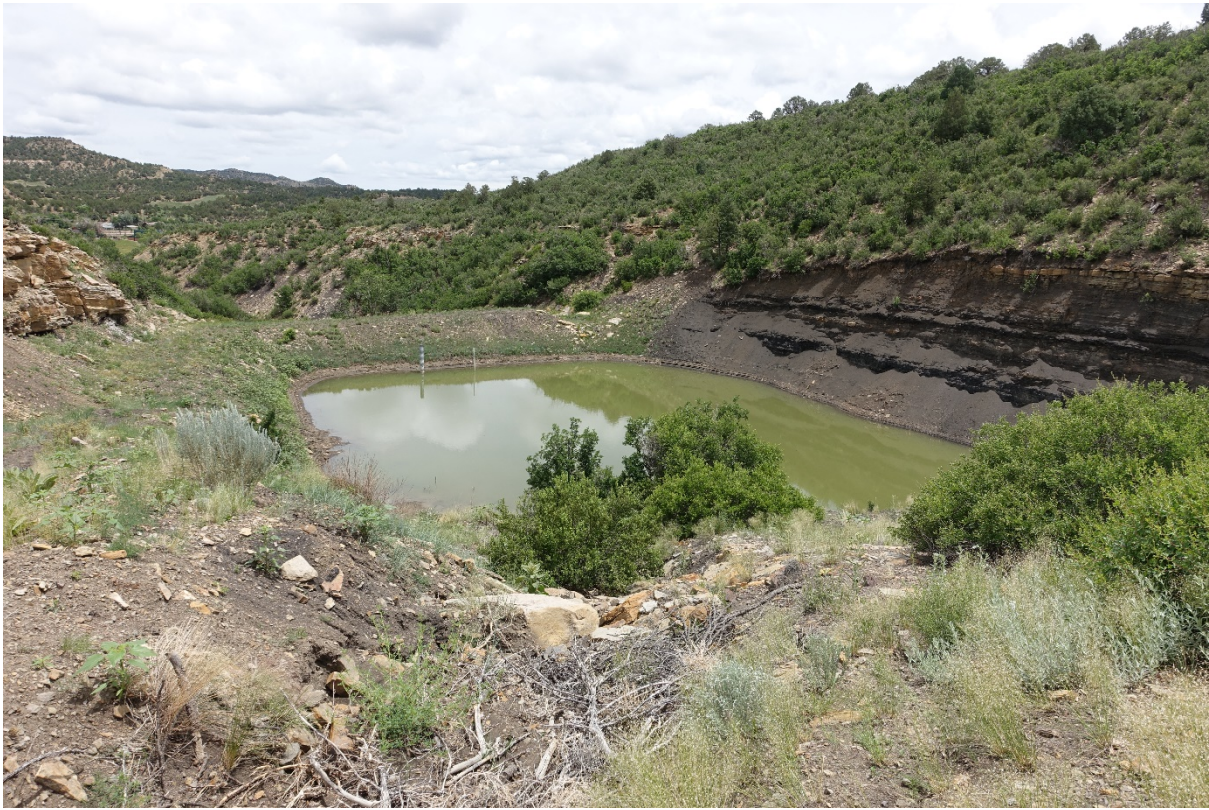
**Pond 8**

Pond was holding water but the level of water was not near the decant.

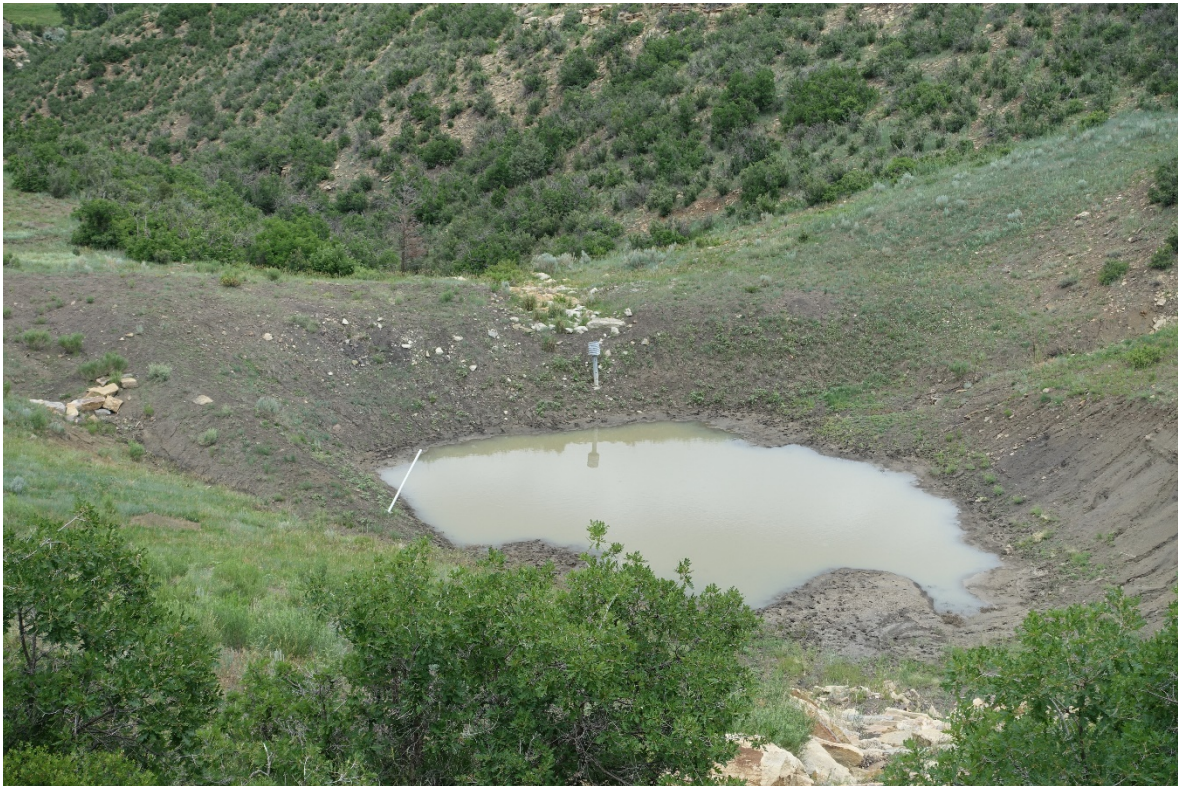
**Pond 9**

Pond was holding water but not near discharging at time of inspection.

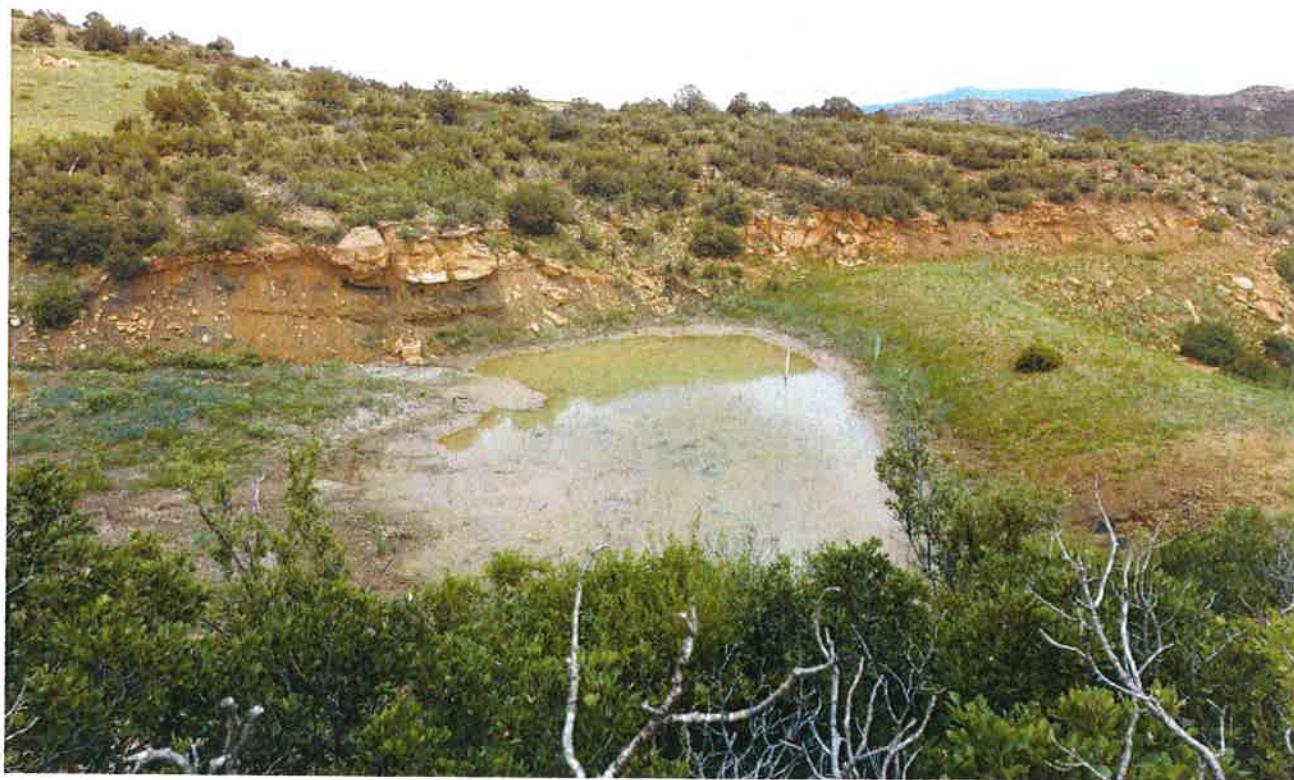
Pond 9a

Pond was holding water but not near discharging at time of inspection.
