MINERALS PROGRAM INSPECTION REPORT PHONE: (303) 866-3567

MINE NAME:		MINE/PROSPECTING ID#:	MINERAL:	COUNTY:		
Burnham Property Borrow		M-2021-019	Aggregate	Weld		
INSPECTION TYPE:		INSPECTOR(S):	INSP. DATE:	INSP. TIME:		
Surety-Related Inspection		Patrick Lennberg	July 9, 2021	09:30		
OPERATOR:		OPERATOR REPRESENTATIVE:	TYPE OF OPERATION:			
Ames Construction, Inc.		Damien Chavarria, Steve Lange	111 - Construction by Goverment Agency			
REASON FOR INSPECTION:		BOND CALCULATION TYPE:	BOND AMOUNT:			
Surety Release Requested		None	No Bond Held			
DATE OF COMPLAINT:		POST INSP. CONTACTS:	JOINT INSP. AGENCY:			
NA		None	None			
WEATHER:	INSPECTOR'S SIGNATURE:		SIGNATURE DATE:			
Clear	Patrick Stor		July 12, 2021

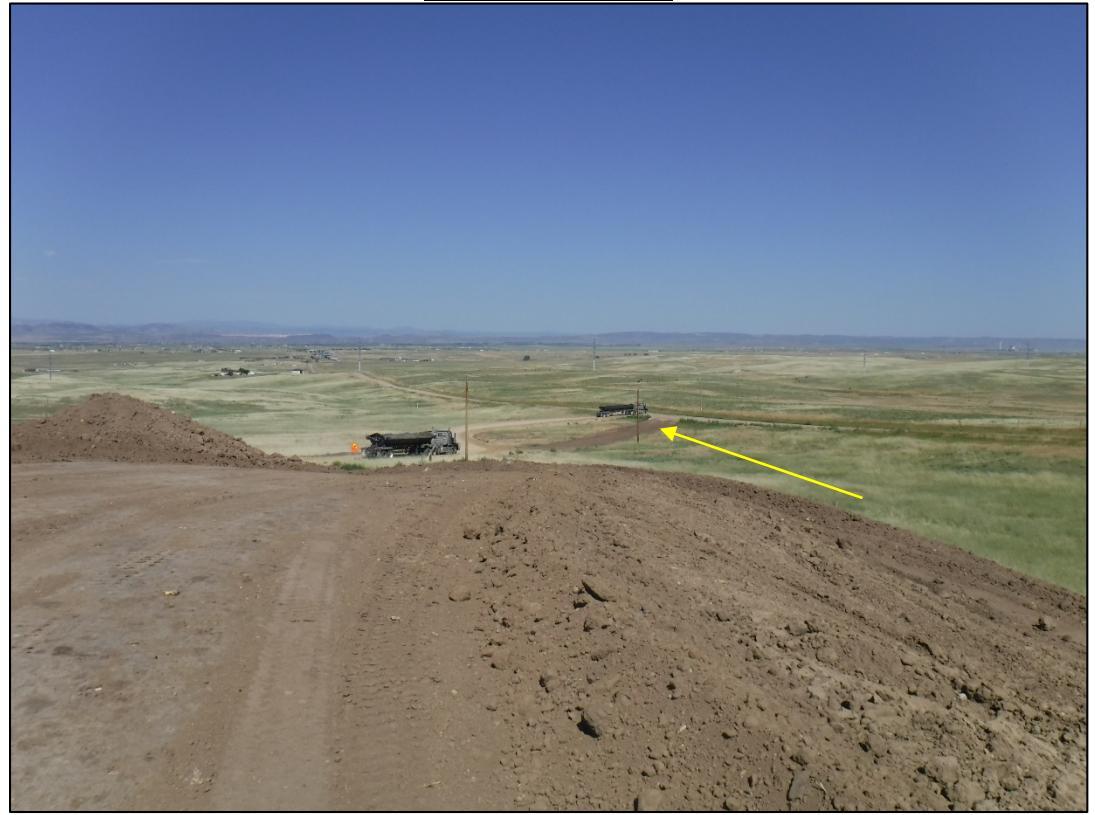
After permit issuance Weld County demanded a change in the orientation of the western haul road exiting to Colorado Road 110. This change occurred after the operator initiated mining activities related to the approved permit haul road. Since the new haul road alignment would require adding acreage to the approved permit and 111 permits do not allow for acres to be added to an already approved permit, the operator permitted a new 111 (M2021-031) over the old permit (M2021-019) and included the new haul road alignment. All areas affected by mining under M2021-019 are now covered by permit M2021-031.

Photo 1: Looking west from pit, haul trucks on Weld County approved haul road leaving pit, arrow points to haul road affected prior to county realignment request

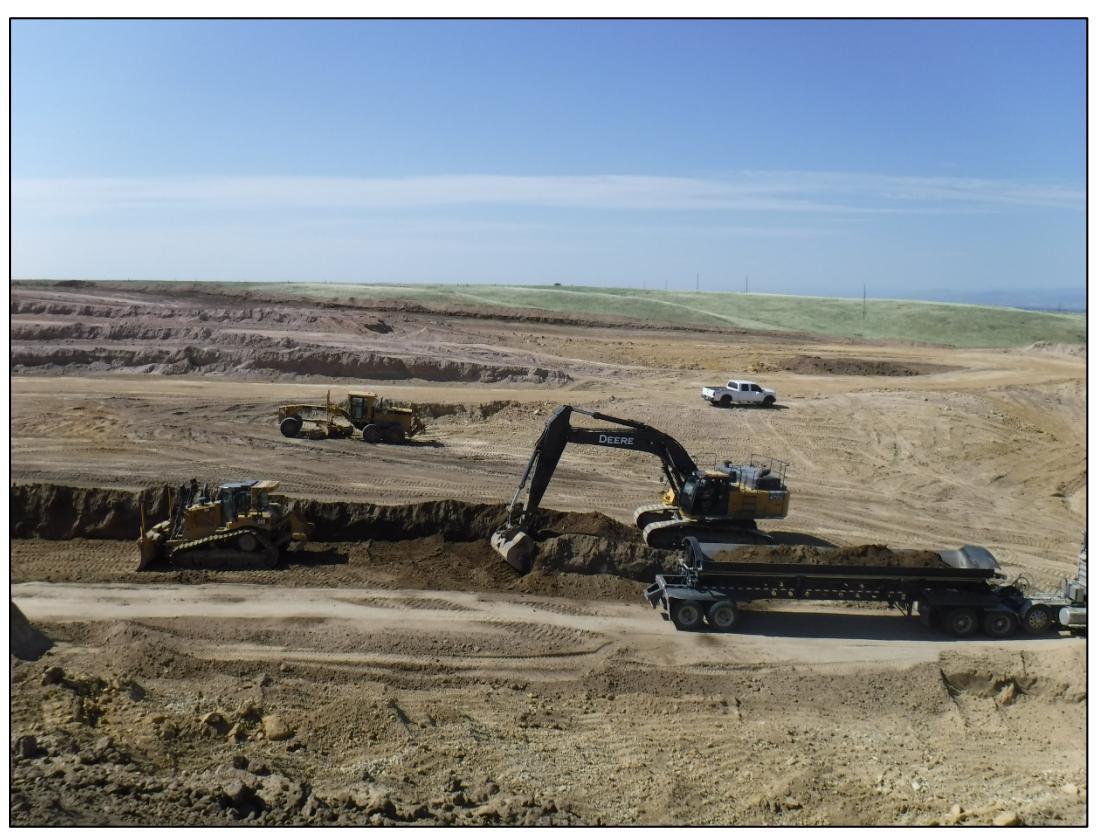
Photo 2: Current mining activities being performed under M2021-031

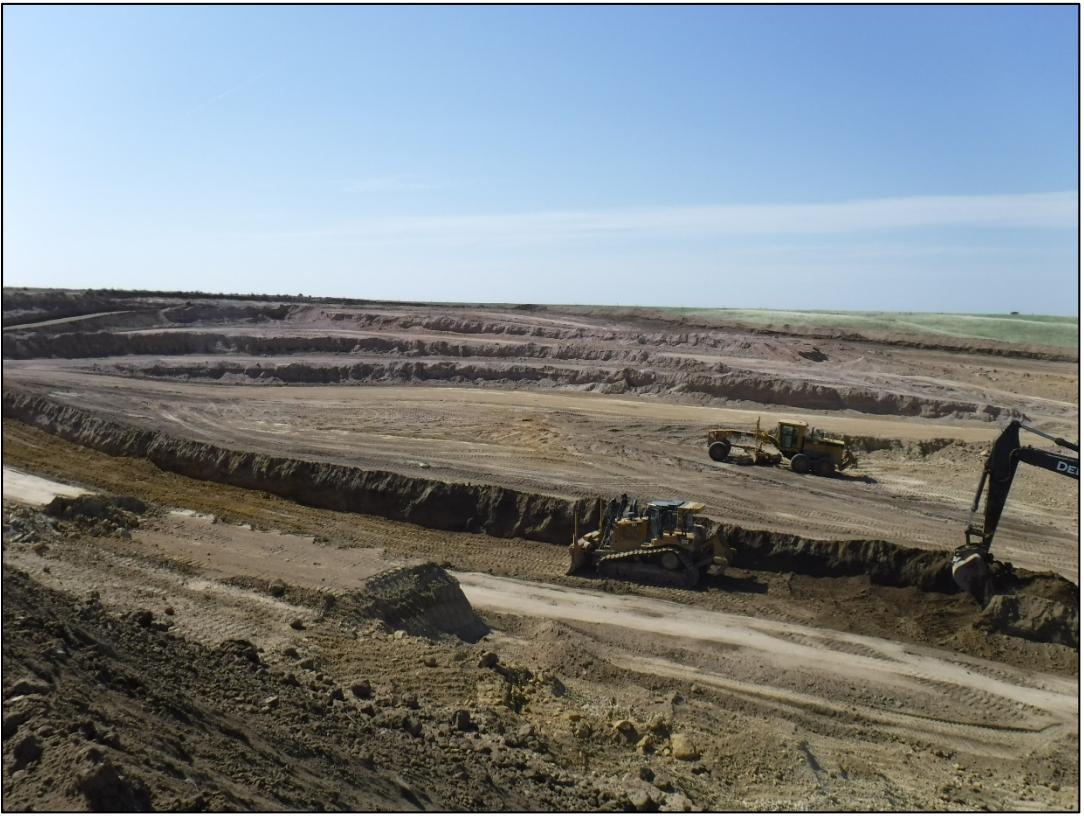
Photo 3: Lighter colored material in center of picture will be the last material removed prior to beginning reclamation

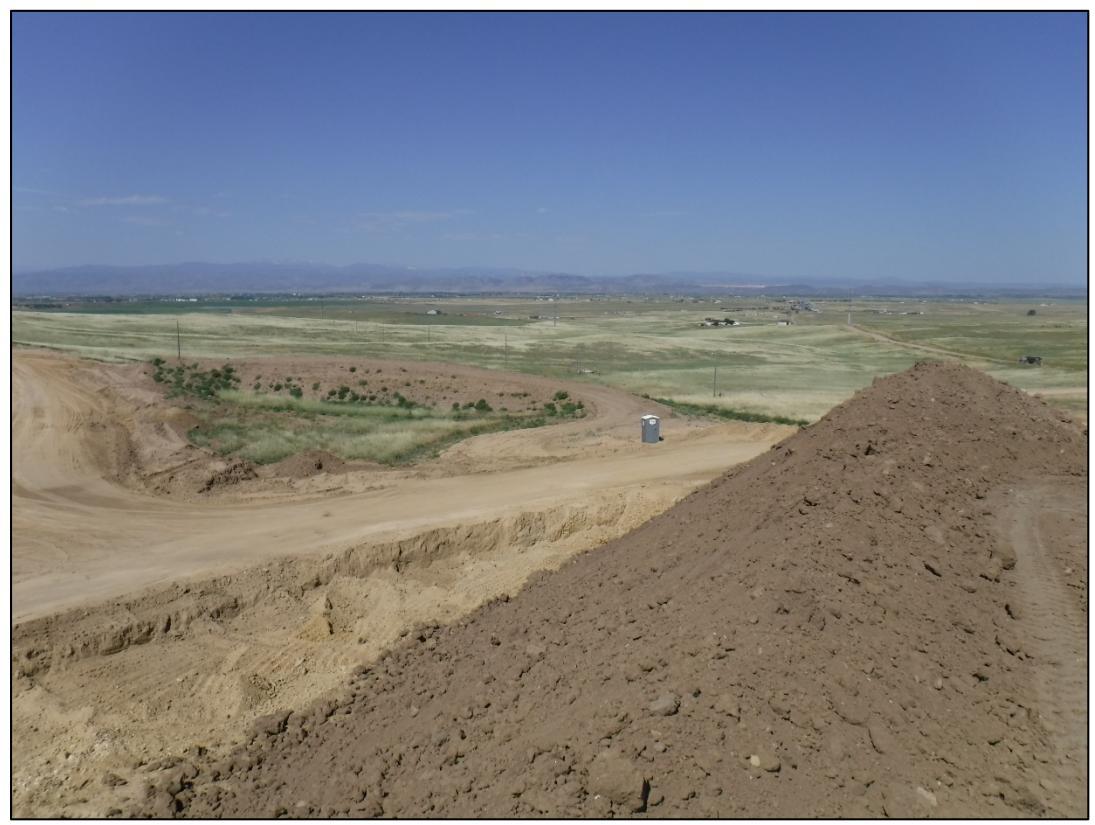
Photo 4: Darker material to the right of picture is going to be incorporated into reclamation as a growth medium
