## MINERALS PROGRAM INSPECTION REPORT PHONE: (303) 866-3567

MINE NAME:	MINE/PROSPECTING ID#:	MINERAL:		COUNTY:
Young Ranch Resource Quarry	M-2021-009	Granite, granite gneiss and gravel		Gilpin
<b>INSPECTION TYPE:</b>	INSPECTOR(S):	INSP. DATE:		<b>INSP. TIME:</b>
Preoperation Inspection	Amy Eschberger, Michael Cunningham,	August 4, 2021		09:00
	Rob Zuber, Zach Trujillo	_		
OPERATOR:	<b>OPERATOR REPRESENTATIVE(S):</b>	TYPE OF OPERATION:		
Young Ranch Resource LLC	Robert Young Jr., Katie Todt	112c - Construction Regular Operation		
<b>REASON FOR INSPECTION:</b>	BOND CALCULATION TYPE:		BOND AMOUNT:	
Preoperation Inspection	Complete Bond		No Bond Held	
DATE OF COMPLAINT:	POST INSP. CONTACTS:		JOINT INSP. AGENCY:	
NA	None		None	
WEATHER:	INSPECTOR'S SIGNATURE:		SIGNATURE DATE:	
Clear	Clarry Exchanger		August 19, 2021

#### PERMIT #: M-2021-009 INSPECTOR'S INITIALS: AME INSPECTION DATE: August 4, 2021

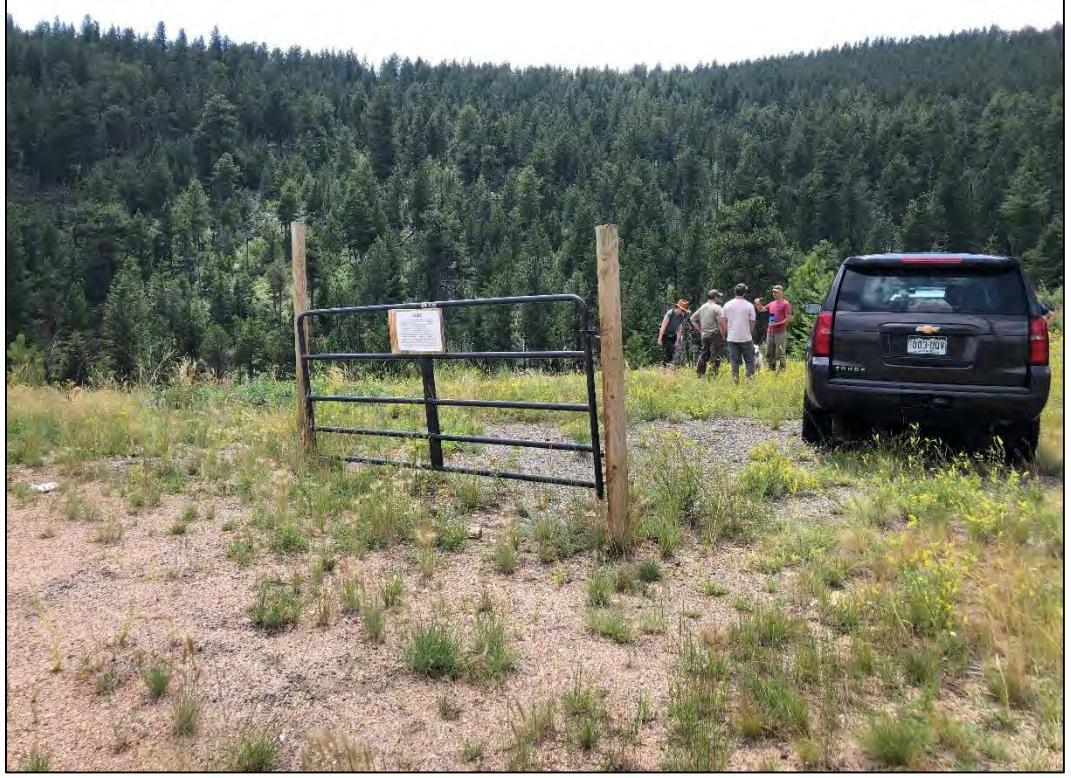
**Photo 1.** View of proposed quarry entrance on west side of CCP. Note gate present at entrance with public notice sign posted in accordance with Rule 1.6.2(1)(b).

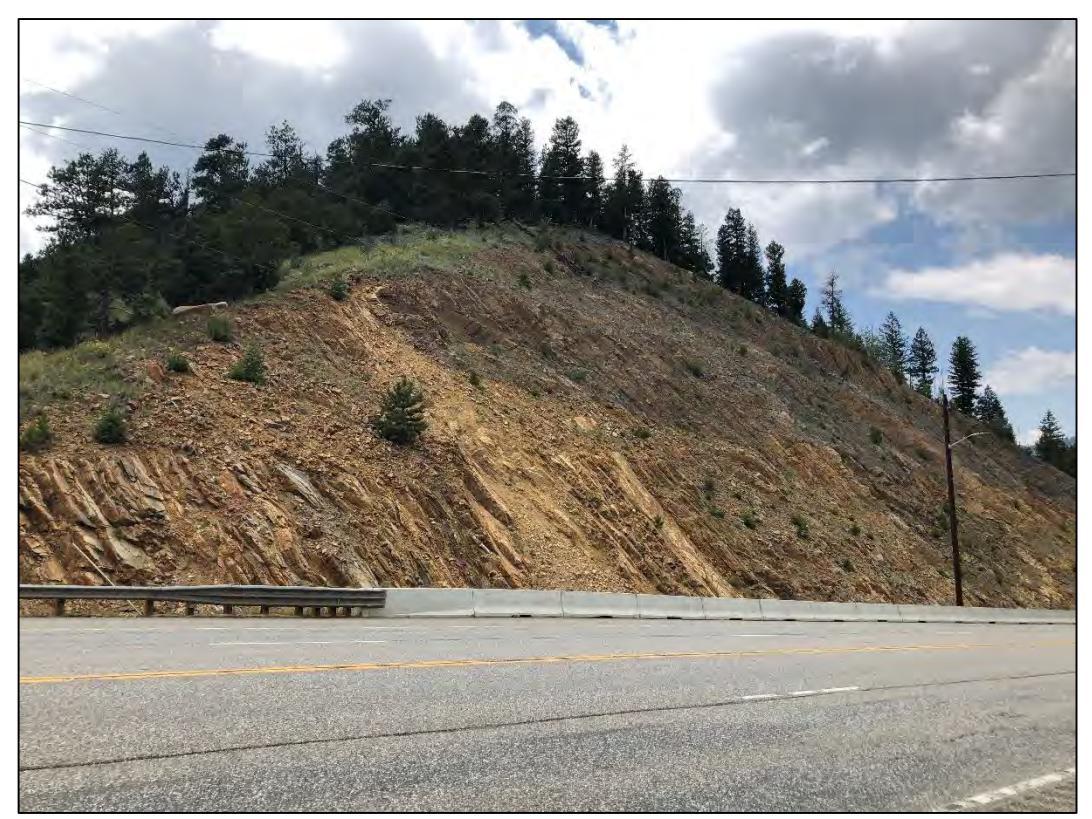
**Photo 6.** View looking west (across CCP) at east-facing slope of ridge to be mined during Phase 1, which was cut during CCP construction in 2004. This side slope is steep with very sparse vegetative cover.

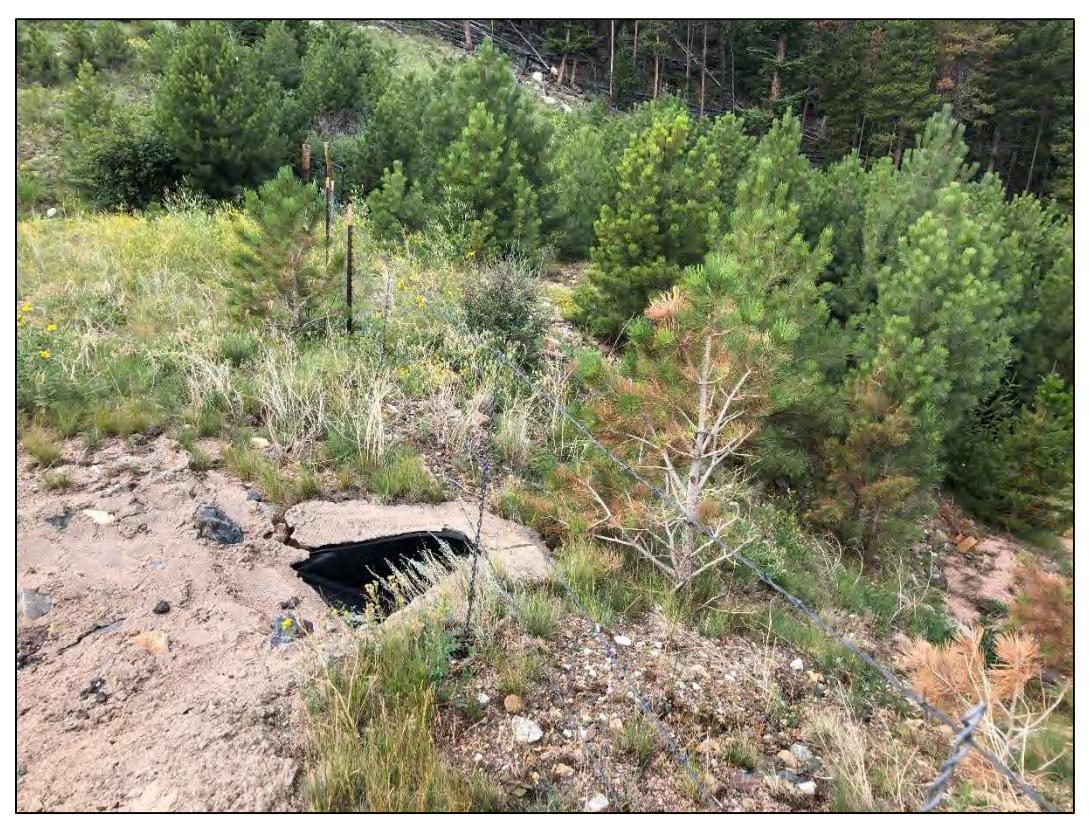
**Photo 16.** View looking south at existing water intake structure with concrete apron (at bottom left) located directly west of CCP, near eastern edge of proposed wildlife mitigation corridor. Also note barbed wire fence present in this area.

From the ridgeline, the Division observed the approximate location where the access corridor would be constructed for the realigned CCP. This corridor would begin at the southern edge of the permit area where the permit boundary and existing CCP arch slightly to the north. The Division observed a few structures on the west side of the CCP (near the county line) which were not identified on Figure C-1, including a gate, a barbed wire fence, and a water intake structure (the outlet was not observed). These structures should be located and their owner(s) identified on Figure C-1.

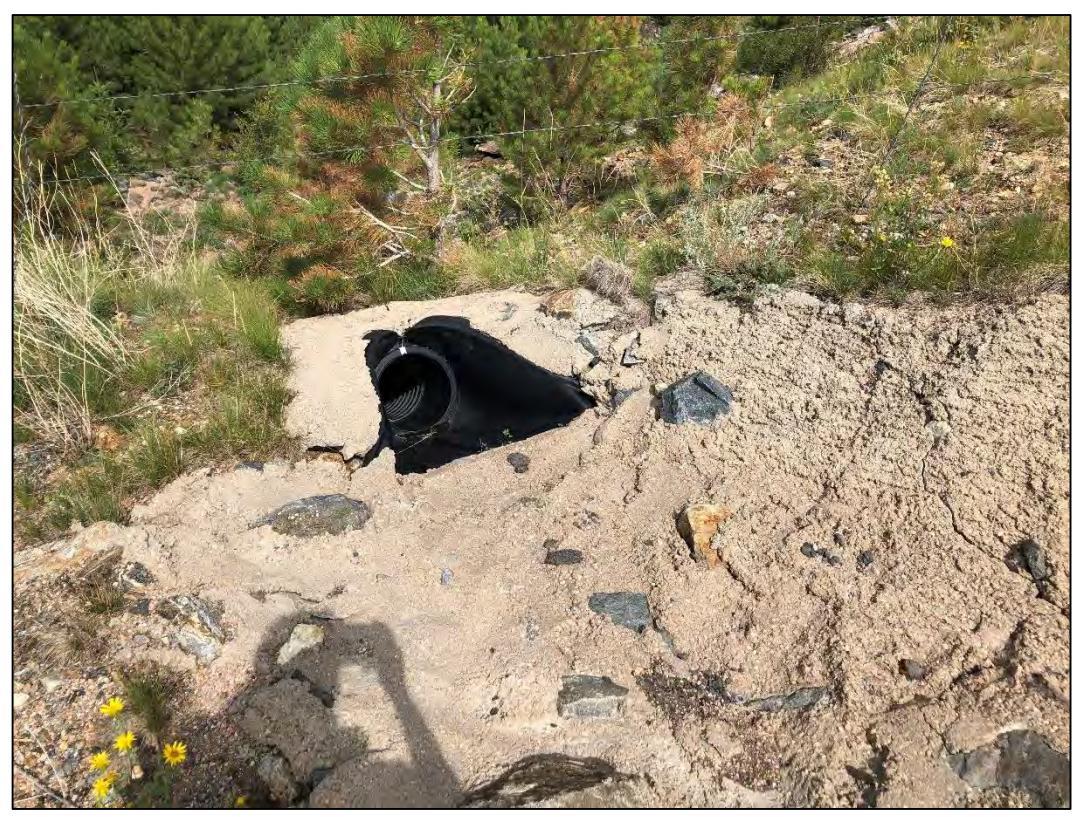
Photo 17. Closer view of water intake structure with concrete apron shown in Photo 16.

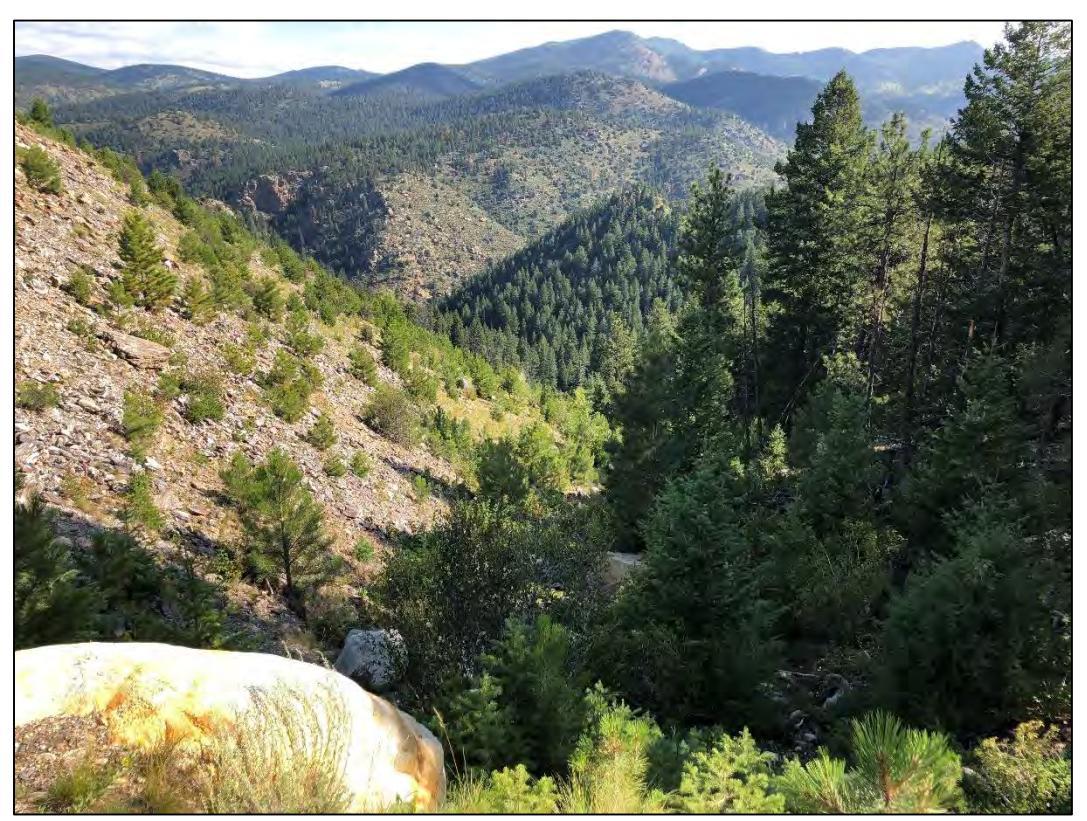
**Photo 20.** View looking north across upper portion of larger (east) drainage located east of CCP proposed for WRL. Note scree slope (at left) from fill material placed in upper western portion of drainage during CCP construction in 2004.

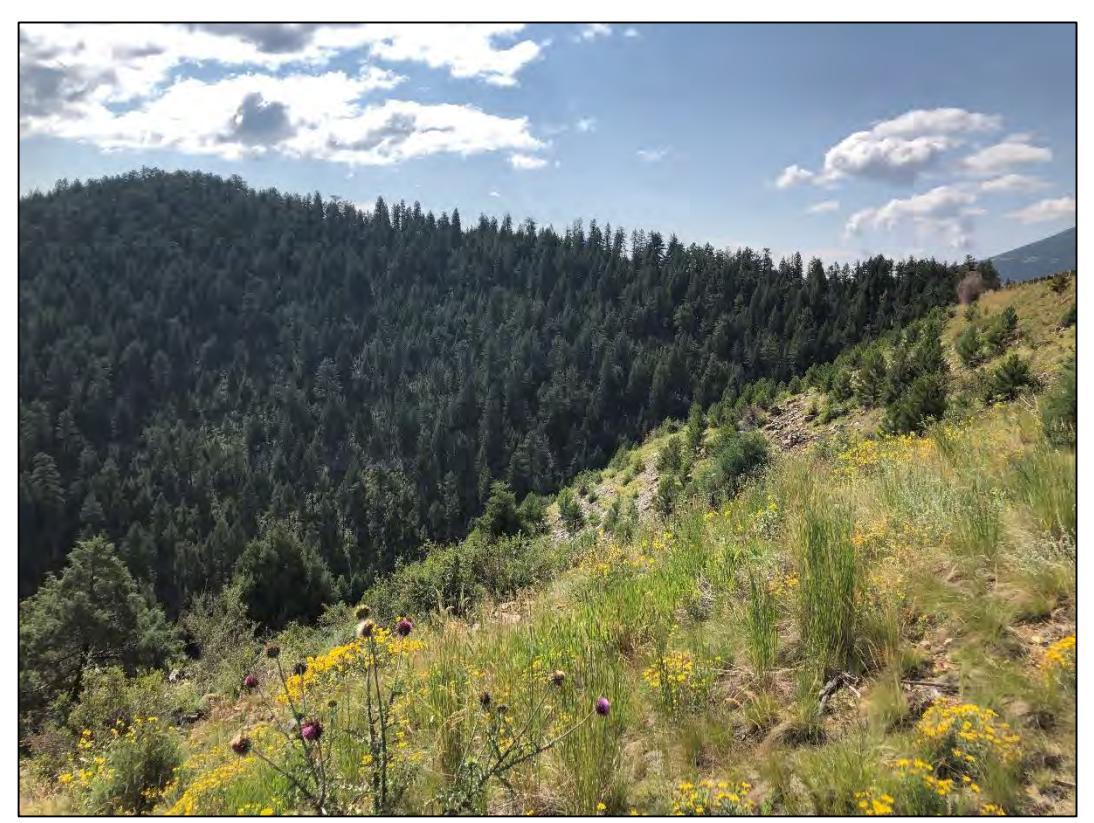
It should be noted, several patches of Canada thistle and some Common mullein plants were observed on the proposed affected lands during the inspection. Some patches of Downy brome (cheat grass) were also observed on site. These weeds are all state-listed noxious weed species. The applicant will need to ensure the proposed weed control plan submitted in the application specifically addresses any existing noxious weed species on site as well as any expected species during operations or reclamation.

**Photo 22.** View looking southeast at larger (east) drainage located east of CCP proposed for WRL. Note Canada thistle, a noxious weed species, present in this area (visible in foreground).

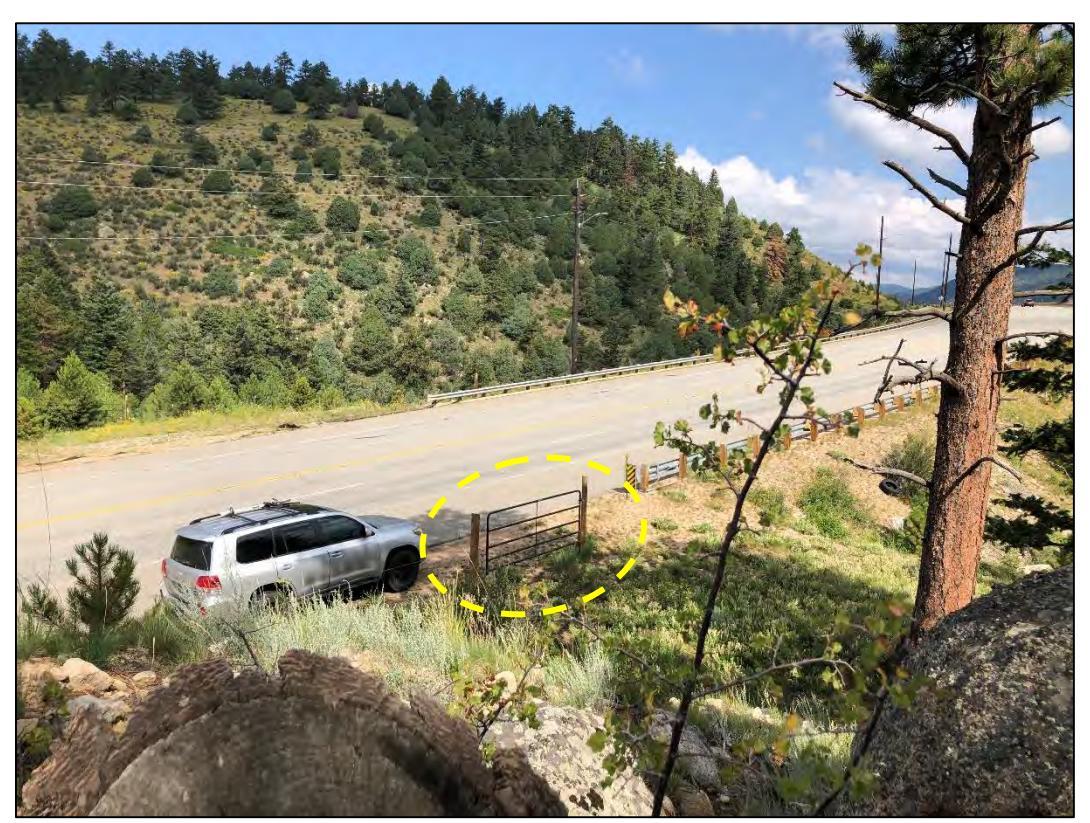
The Division walked the larger (east) drainage all the way down to the gate at the northern property line. This gate and its owner(s) will need to be identified on Figure C-1. No other existing structures were observed in this drainage. However, the Division did observe a gate and barbed wire fence at the top of the drainage, adjacent to the CCP. These structures and their owner(s) must also be included on Figure C-1. The Division did not walk the smaller (west) drainage proposed for WRL during the inspection. However, this drainage could be viewed from above off of the CCP. As with the larger drainage, any known seeps in the west drainage must be identified in the application and the location and owner name(s) of any permanent, man-made structures located in this drainage (e.g., fences, gates, stormwater control structures) must be identified on Figure C-1.

**Photo 24.** View looking northwest at access off east side of CCP to top of larger (east) drainage proposed for WRL. Note gate present in this area (circled). A barbed wire fence is also present in this area (attached to south end of gate), but is difficult to differentiate in this photo.

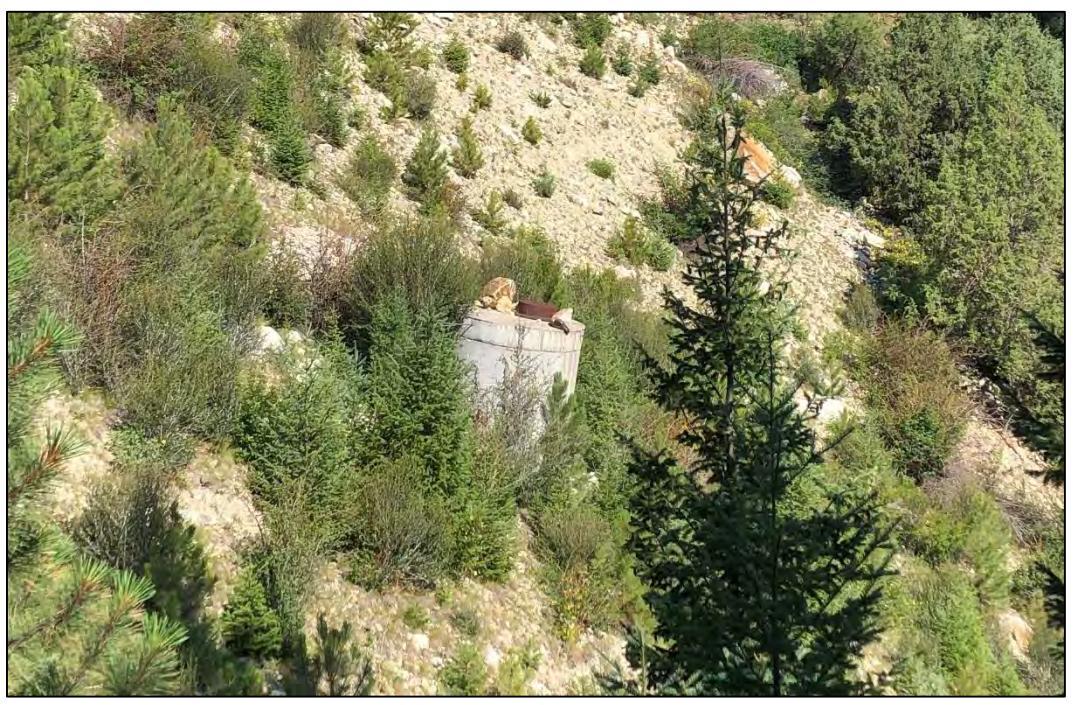
The Division noted the presence of a stormwater (manhole) drop structure in each of the drainages proposed for the WRL. These structures are located at the toe of the fill areas which were created during initial construction of the CCP in 2004. The applicant stated during the inspection these drop structures are owned by Central City and were designed to divert stormwater from the basins located west of the CCP. From the point of each drop structure, stormwater drops approximately 20 feet before discharging from a culvert. The Division was unable to observe these culverts during the inspection. The applicant indicated during the inspection the drop structures would remain in place and eventually be covered by the WRL. Additionally, the culverts would be extended beyond the toe of the proposed WRL. The details of this stormwater management plan must be provided in the application for Division review. Additionally, the location and owner's name for all existing structures, including the drop structures and associated culverts, must be shown on Figure C-1. For any structures (not owned by the applicant) that will be impacted by the operation (e.g., removed, relocated, modified, rendered inoperative), the applicant must provide a notarized agreement with the structure owner stating their acceptance of the proposed impacts to their structure(s).

**Photo 25.** View of stormwater (manhole) drop structure present in larger (east) drainage proposed for WRL. A similar structure was also observed in upper portion of smaller (west) drainage.

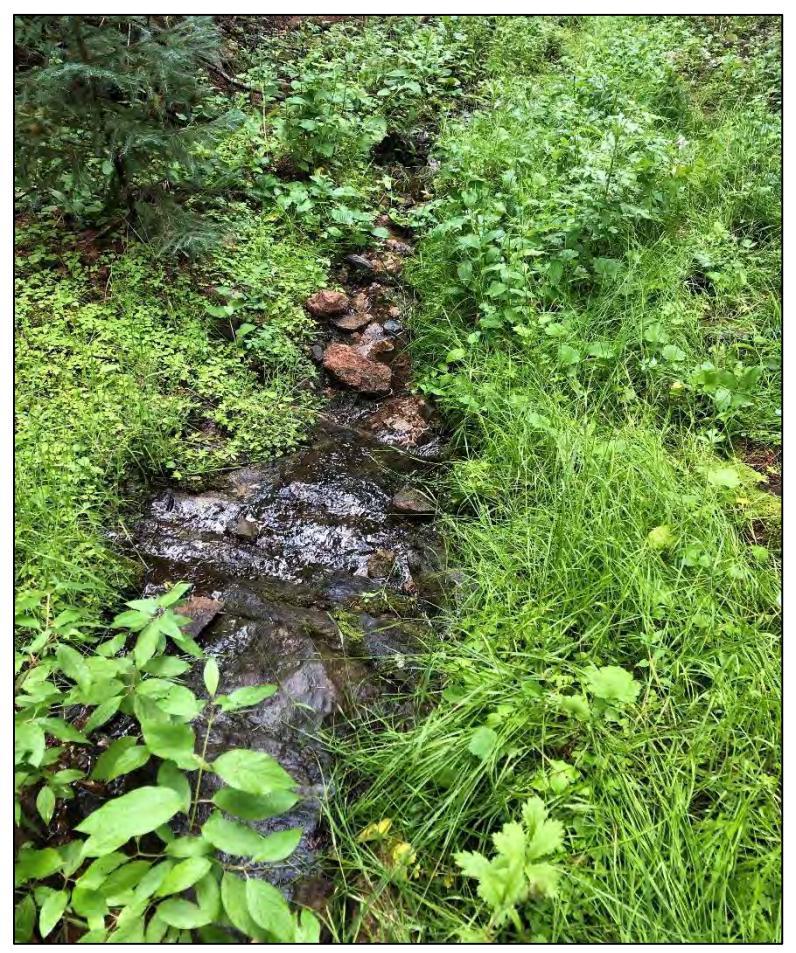
During the inspection, the Division observed multiple areas within the larger (east) drainage proposed for the WRL that had saturated conditions. It was difficult to determine whether these saturated conditions were due to the recent precipitation events, to natural seeps occurring in the drainage, or potentially to both. However, the presence of riparian plant species (i.e., rushes, mosses) indicates prolonged saturation occurs in these areas. The Division observed a seep at the bottom of the drainage which had a discernible flow, with a visually estimated flow rate of approximately 1-2 gpm. The applicant indicated during the inspection the seep(s) is seasonal, and much more prominent this year with the significant amount of precipitation received in the area this spring. The applicant will need to provide more information on any seeps located within the proposed affected lands, including identifying them on the appropriate application map(s). Additionally, the applicant will need to describe how water from any seeps will be managed during operations and reclamation.

**Photo 26.** View of seep with discernible flow observed at base of larger (east) drainage proposed for WRL.

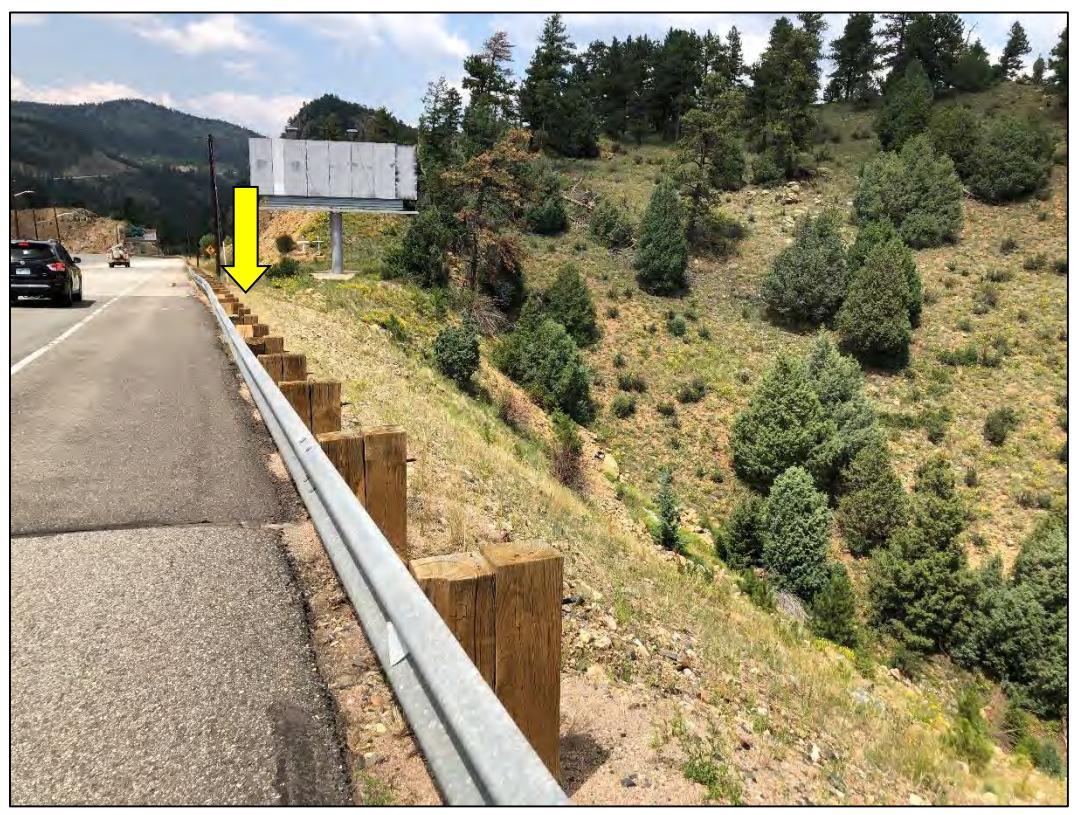
**Photo 30.** View looking northwest showing closer view of proposed WRL entrance off east side of CCP (approximate location indicated). Note existing structures present along CCP including guardrails, power line poles (in background), and billboard.

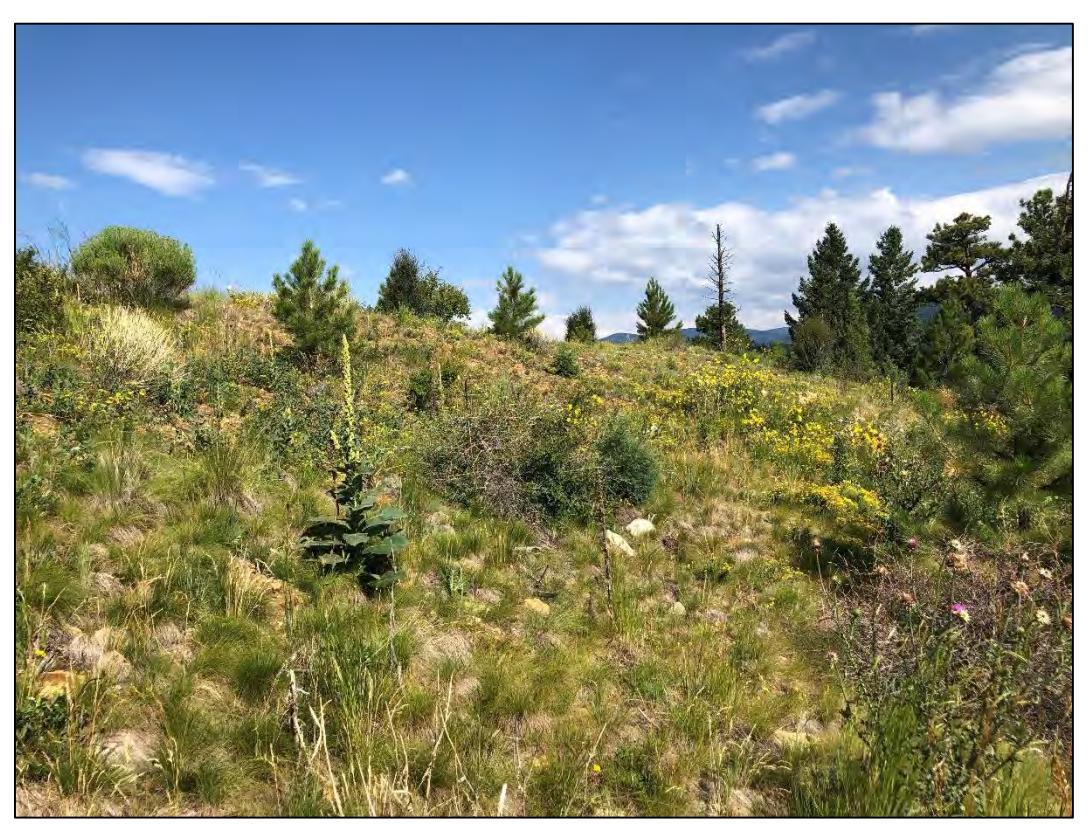
**Photo 32.** View looking northwest across area directly east of CCP where noxious weed species were observed, including Common mullein (visible near center) and Canada thistle (visible at bottom right).
