## **Inspection report for Delta Paving Gravel Pit**

# MINERALS PROGRAM INSPECTION REPORT PHONE: (303) 866-3567

MINE NAME:		MINE/PROSPECTING ID#:	MINERAL:	COUNTY:
Delta Paving Gravel Pit		M-1998-105	Gravel	Delta
INSPECTION TYPE:		INSPECTOR(S):	INSP. DATE:	INSP. TIME:
Monitoring		Robert Zuber, P.E.	August 17, 2021	09:00
OPERATOR:		<b>OPERATOR REPRESENTATIVE:</b>	TYPE OF OPERATION:	
Grand Junction Pipe & Supply Co.		Jon Mueller, Jim Doody	112c - Construction Regular Operation	
		•	-	
REASON FOR INSPECTION:		BOND CALCULATION TYPE:	BOND AMOUNT:	
Normal I&E Program		None	\$69,581.00	
DATE OF COMPLAINT:		POST INSP. CONTACTS:	JOINT INSP. AGENCY:	
NA		None	None	
WEATHER:	INSPECTOR'S SIGNATURE:		SIGNATURE DATE:	
Clear			September 2, 2021	
	Phot D. Zh

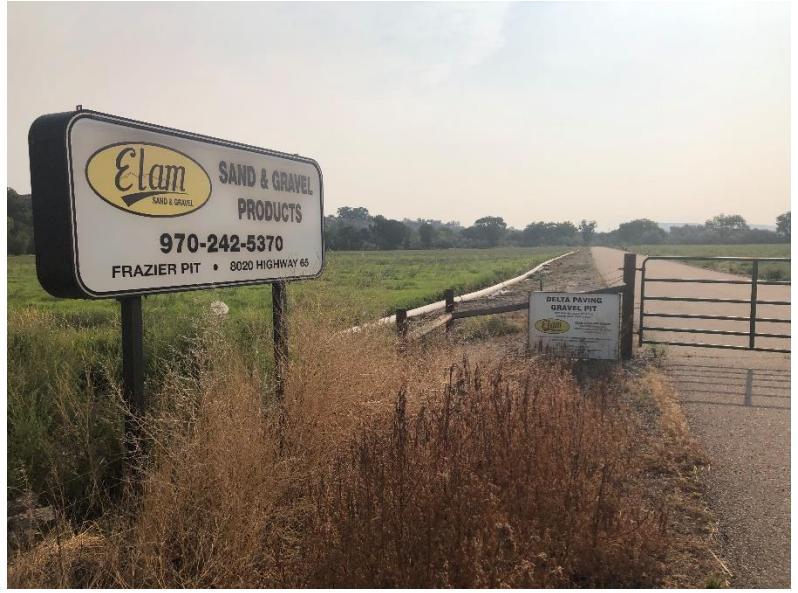
The entrance sign meets the requirements of Rule 3.1.12. However, additional markers are needed around the approved affected area. Note that the permit area is not the same as the affected area at this site.

Entrance sign

**CORRECTIVE ACTIONS:** The boundaries of the affected area must be marked by monuments or other markers that are clearly visible and adequate to delineate such boundaries. The Operator shall demonstrate compliance by submitting photographs of the markers. The Operator may also request a follow up inspection. **CORRECTIVE ACTION DUE DATE:** 11/19/21

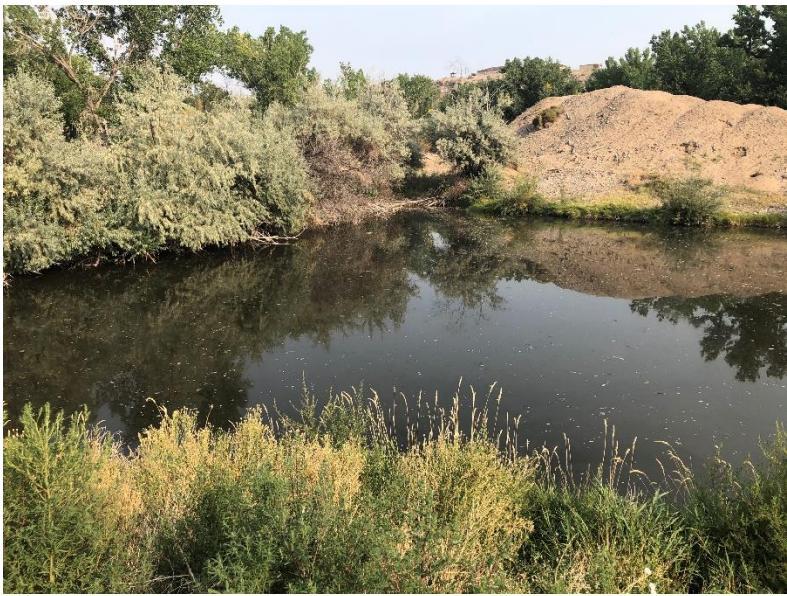
**PROBLEM/POSSIBLE VIOLATION:** Problem: There are state-listed noxious weeds present on site. These include knapweed, tamarisk, Russian olive, Canada thistle, and bindweed. This is a problem for failure to employ weed control methods for state listed noxious weed species within the permitted area, and to reduce the spread of weeds to nearby areas as required by Section 3.1.10 (6) of the Rules.

Weeds were seen around the site: knapweed, tamarisk, Russian olive, Canada thistle, and bindweed. These should be treated per Rule 3.1.10(6) and the Noxious Weed Management plan approved in 2005. Dead plants indicate that some of the knapweed has been treated.

Weeds at north pond – Russian olive, tamarisk, knapweed

**CORRECTIVE ACTIONS:** Implement approved weed control plan and provide proof to the Division that this has been done by submitting seed tags, a bill of sale, or photographs of seeding activities. The Operator may also request a follow up inspection.

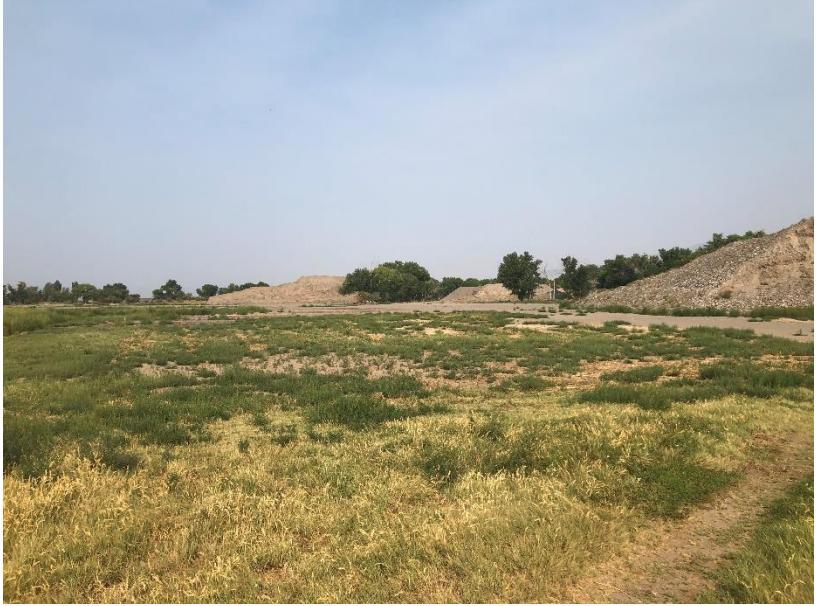
Pasture and stockpiles at southest side of site

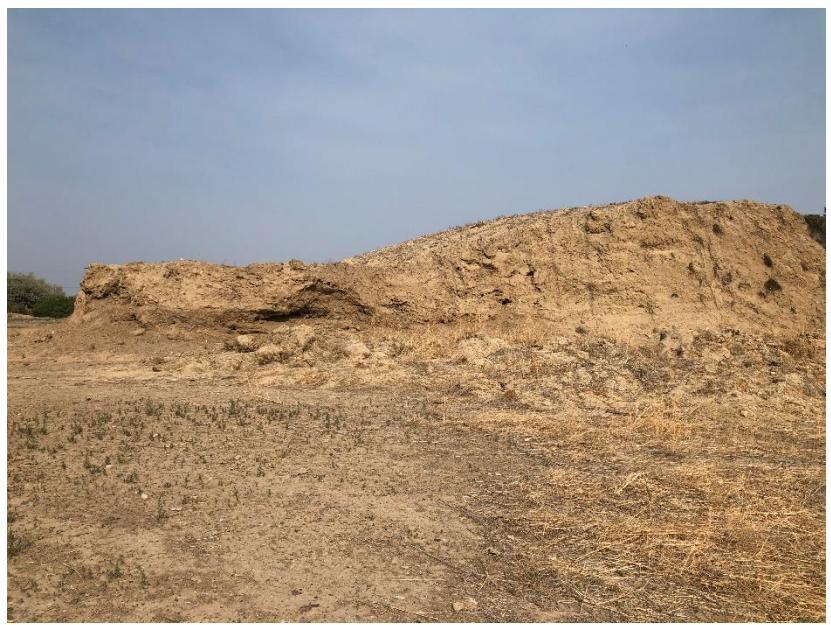
**PROBLEM/POSSIBLE VIOLATION:** Problem: The topsoil stockpiles do not have established vegetation on them and are therefore susceptible to erosion. Rule 3.1.9(1) states if topsoil is not replaced into the backfill area within a time short enough to avoid deterioration of the topsoil, vegetative cover or other means shall be employed so that the topsoil is protected from erosion.

The topsoil pile southwest of the pond is not protected with vegetation or BMPs. This problem needs to be addressed by the permittee per Rule 3.1.9(1).

Topsoil pile requires protection from erosion

**CORRECTIVE ACTIONS:** The operator shall seed the stockpiles with the seed mix that was submitted as part of the approved Reclamation Plan. The Operator shall demonstrate compliance by submitting seed tags, a bill of sale or photographs of seeding activities. The Operator may also request a follow up inspection. **CORRECTIVE ACTION DUE DATE:** 11/19/21

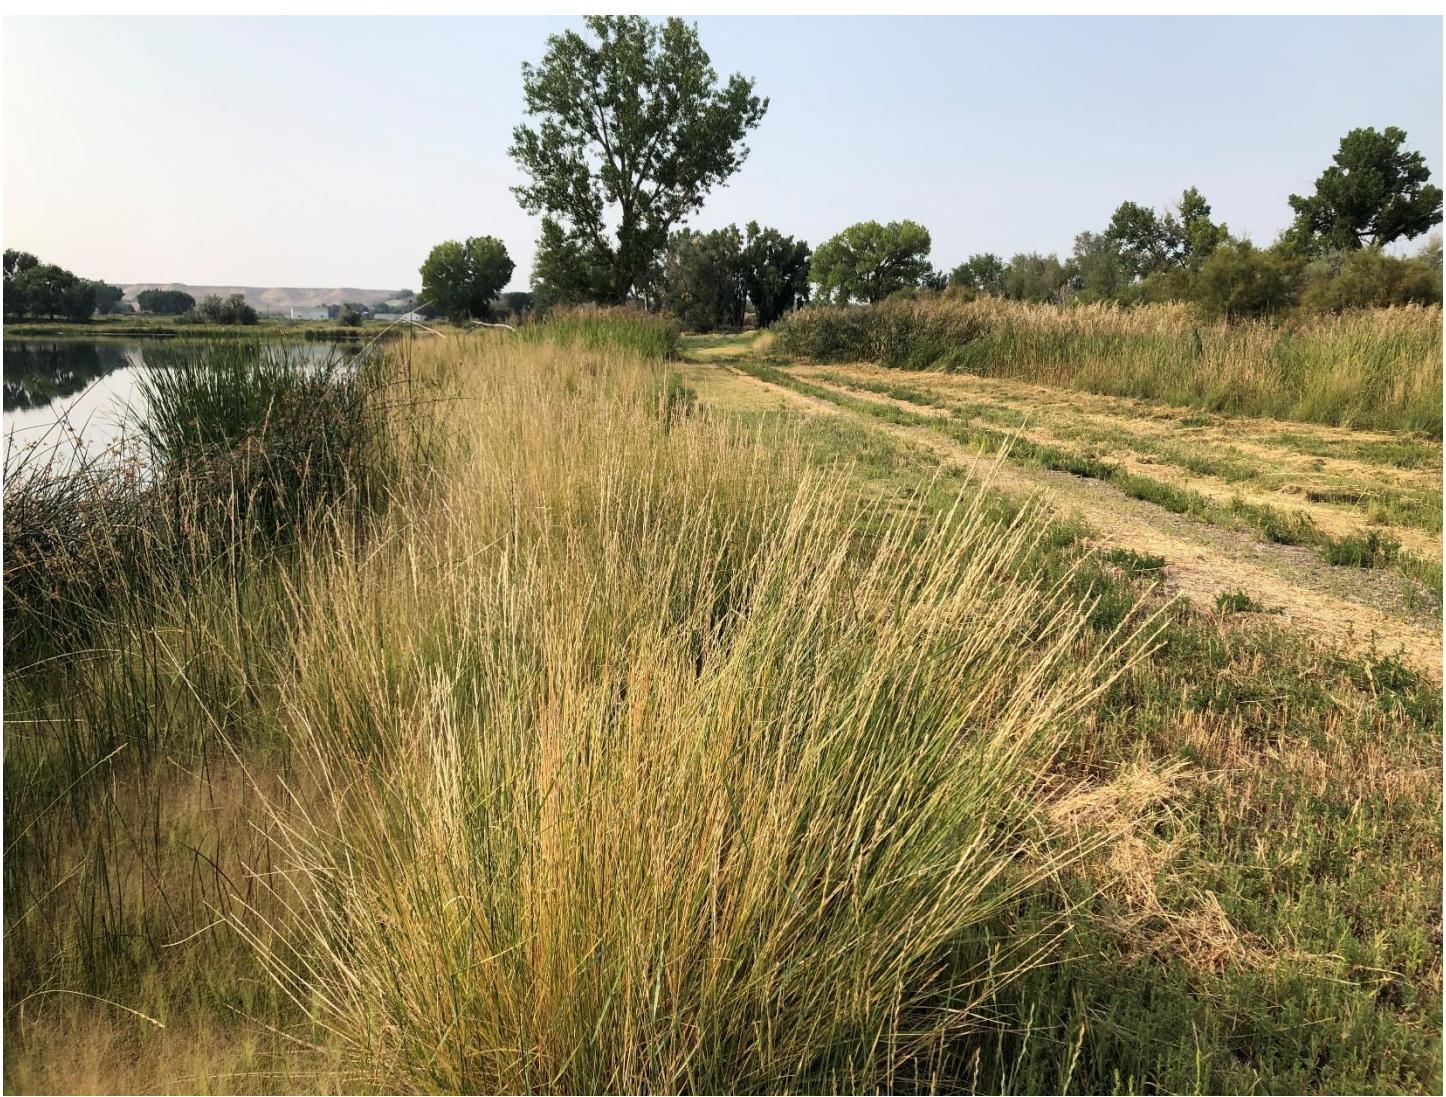
The reclaimed area near the southwest corner of the site is in acceptable condition except for the weeds mentioned in the Revegetation section of this report.

Reclaimed area at southwest side of pond
