MINERALS PROGRAM INSPECTION REPORT PHONE: (303) 866-3567

MINE NAME:		MINE/PROSPECTING ID#:	MINERAL:	COUNTY:		
State Pit		M-1990-112	Gravel	Pueblo		
INSPECTION TYPE:		INSPECTOR(S):	INSP. DATE:	INSP. TIME:		
Monitoring		Patrick Lennberg	August 26, 2021	10:30		
OPERATOR:		OPERATOR REPRESENTATIVE:	TYPE OF OPERATION:			
Fremont Paving & Redi-Mix, Inc.		Jodi Schrieber	112c - Construction Regular Operation			
REASON FOR INSPECTION:		BOND CALCULATION TYPE:	BOND AMOUNT:			
Priority		None	\$503,234.00			
DATE OF COMPLAINT:		POST INSP. CONTACTS:	JOINT INSP. AGENCY:			
NA		None	None			
WEATHER:	INSPECTOR'S SIGNATURE:		SIGNATURE DAT	E:		
Clear	Patrick Ly		September 2, 2021

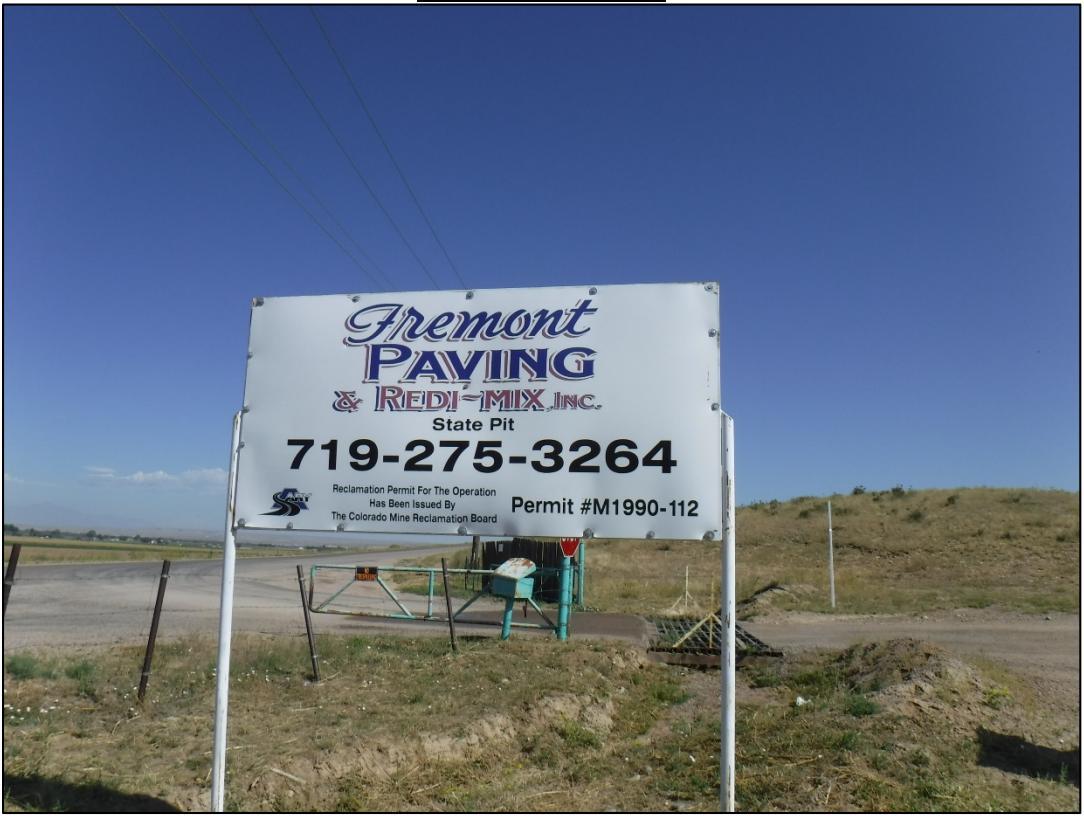
Photo 1: Mine sign at mine entrance location

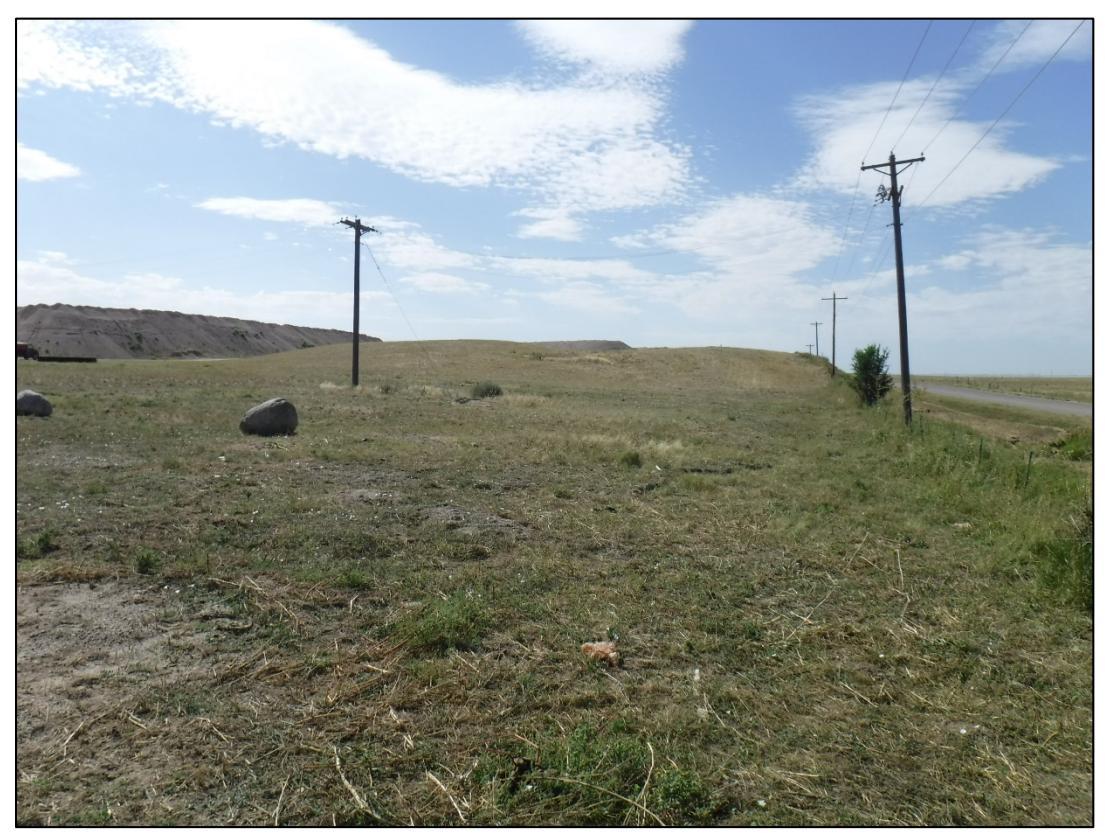
At the site entrance the areas to the south had been mowed and the vegetation consisted of mostly native grass with a few annual weeds. The complaintant stated that Kochia was a major problem at the site. Kochia was present mainly outside the fence along 36th Lane right-of-way, scattered on the side slopes of product stockpiles and in an area that is planned for seeding later this year. Kochia is an annual weed that is common in rangelands, disturbed areas, roadsides and ditchbanks. Kochia is not a listed a noxious weed in Colorado. Also, the complaintant expressed concern that large stands of Kochia represented a fire hazard at the site. The Division does not jurisdiction over fire mitigation measures that responsibility would be under the rural fire district or similar. Most of the Kochia present at the site had been mowed where it was accessible.

Photo 2: Looking south from the mine entrance, road at the center right of picture is 36th Lane

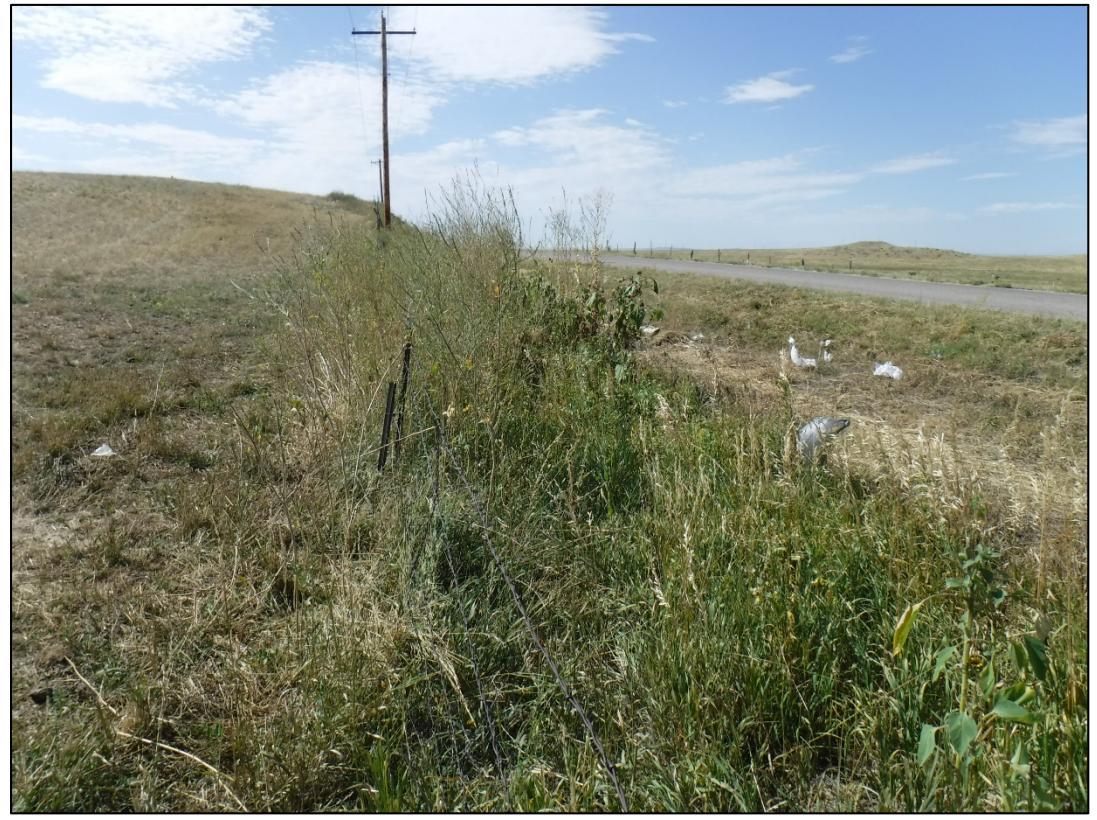
The inspector did note the right-of-ways bordering the site did have large stands of Kochia. It appears that mowing operations had recently taken place but stands of Kochia were still common. Additionally, Kochia was noted in the various properties around the site that support grazing, agriculture, and rural residential.

Photo 3: Partially mowed right-of-way along permit boundary

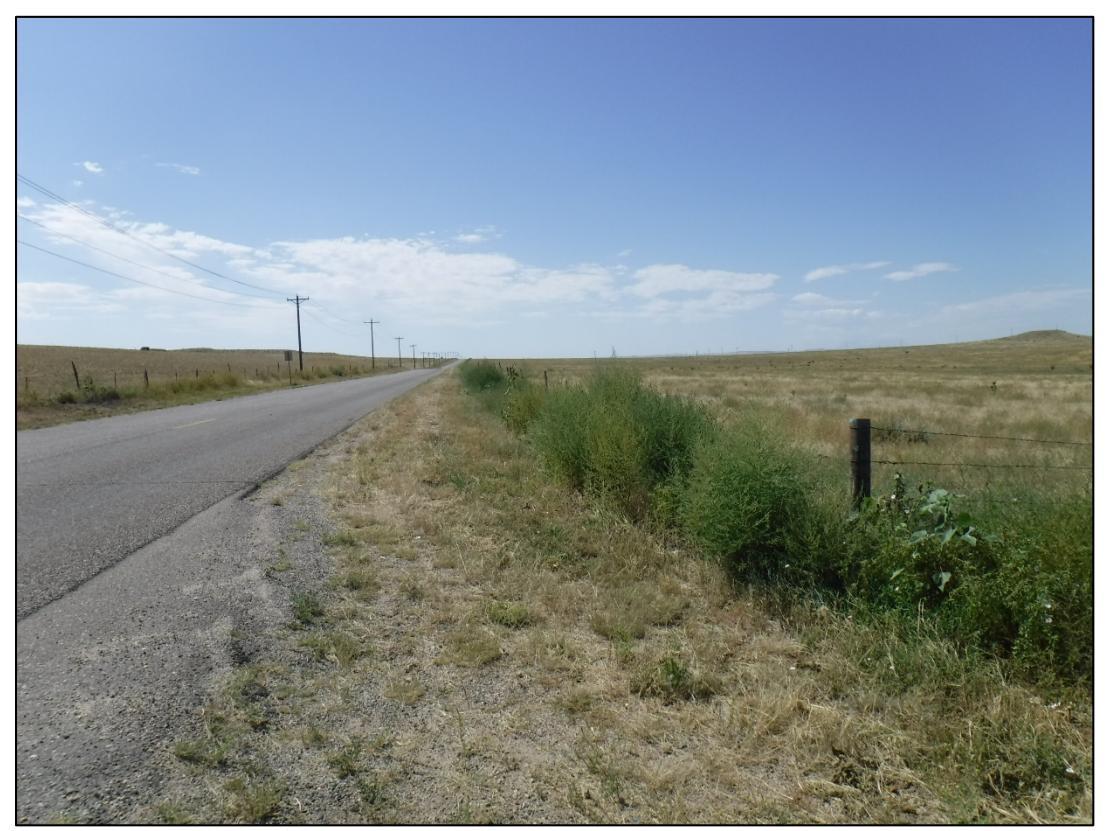
Photo 4: Kochia along mowed right-of-way across 36th Lane from State Pit

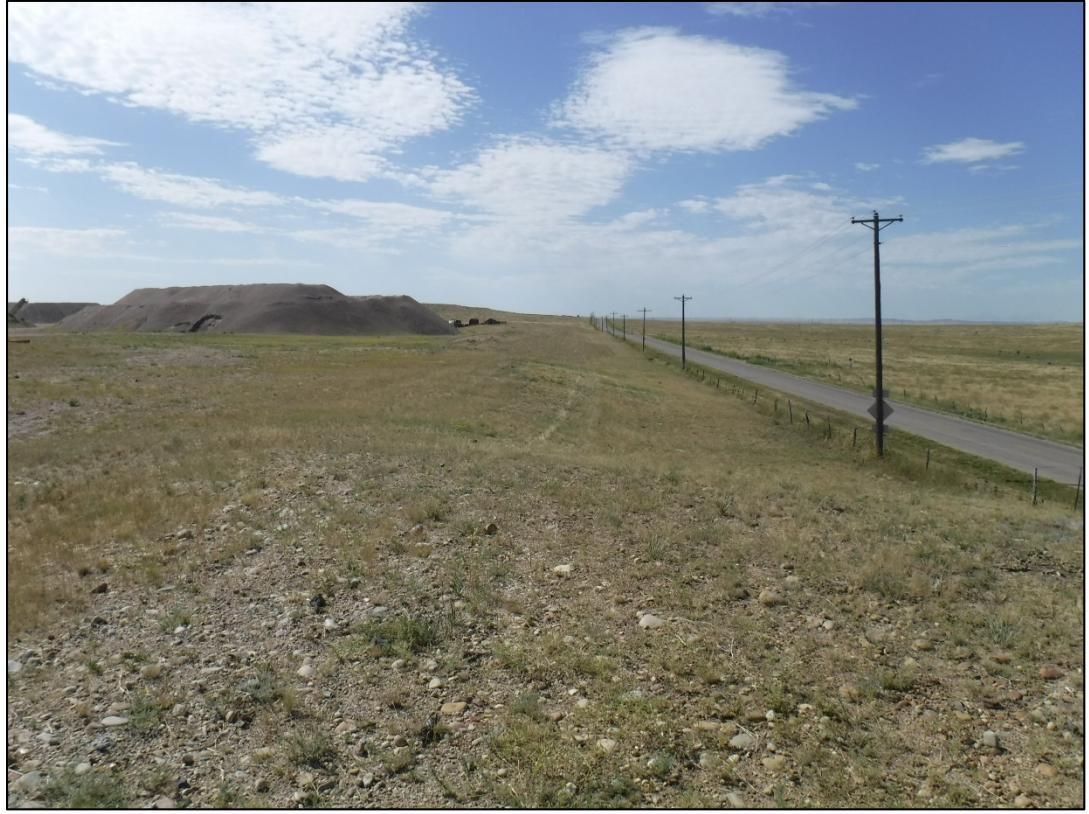
Photo 5: Typical conditions within permit boundary

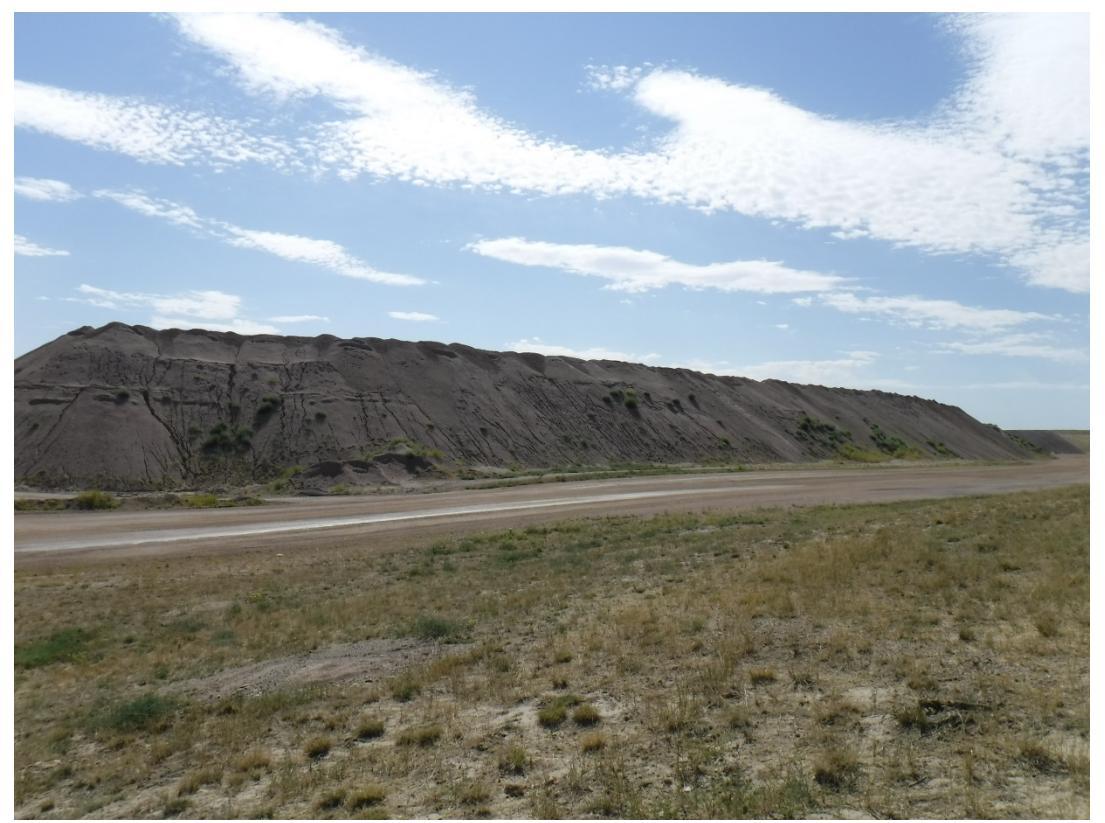
Photo 6: Kochia on stockpile

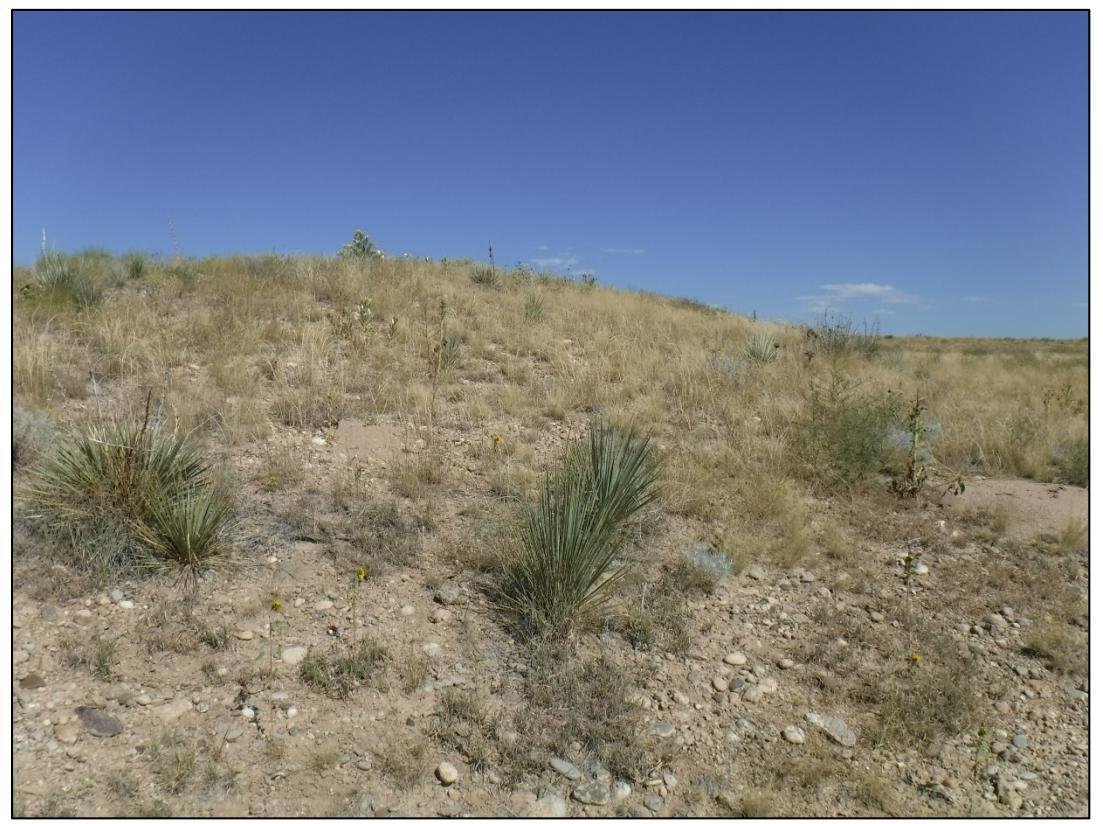
Photo 7: Typical vegetation in reclaimed areas

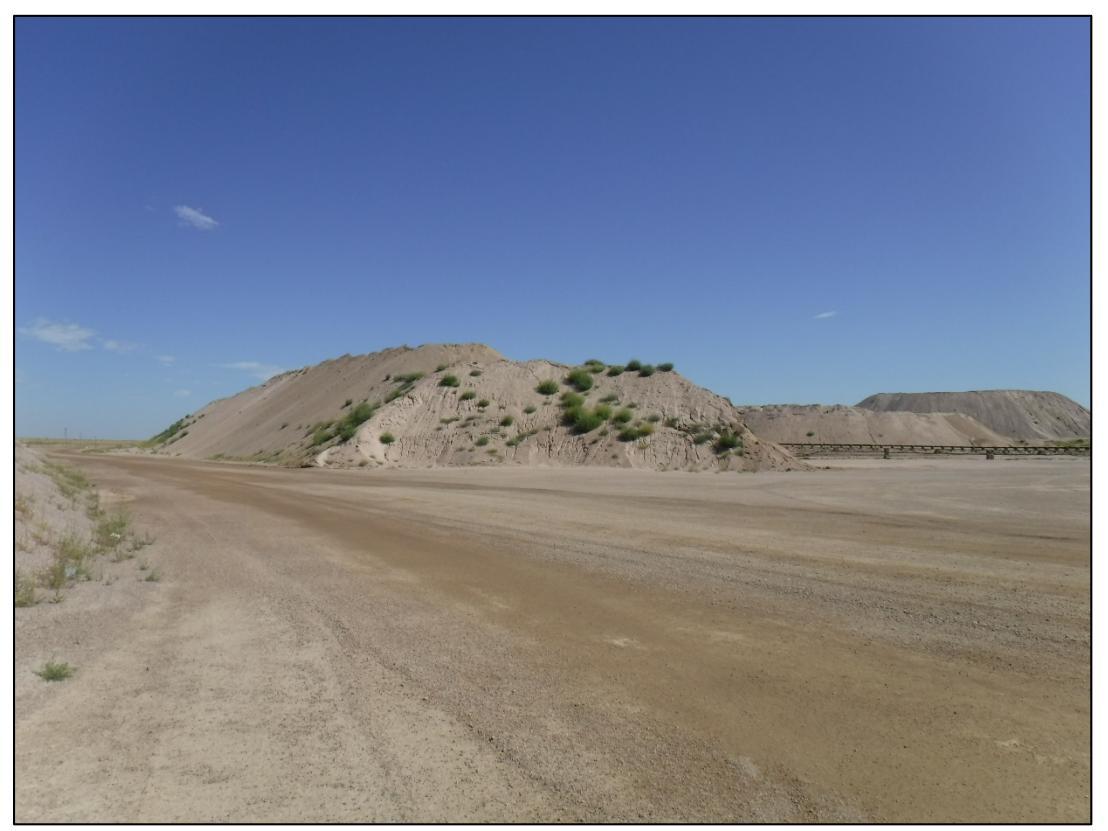
Photo 8: Kochia on stockpile

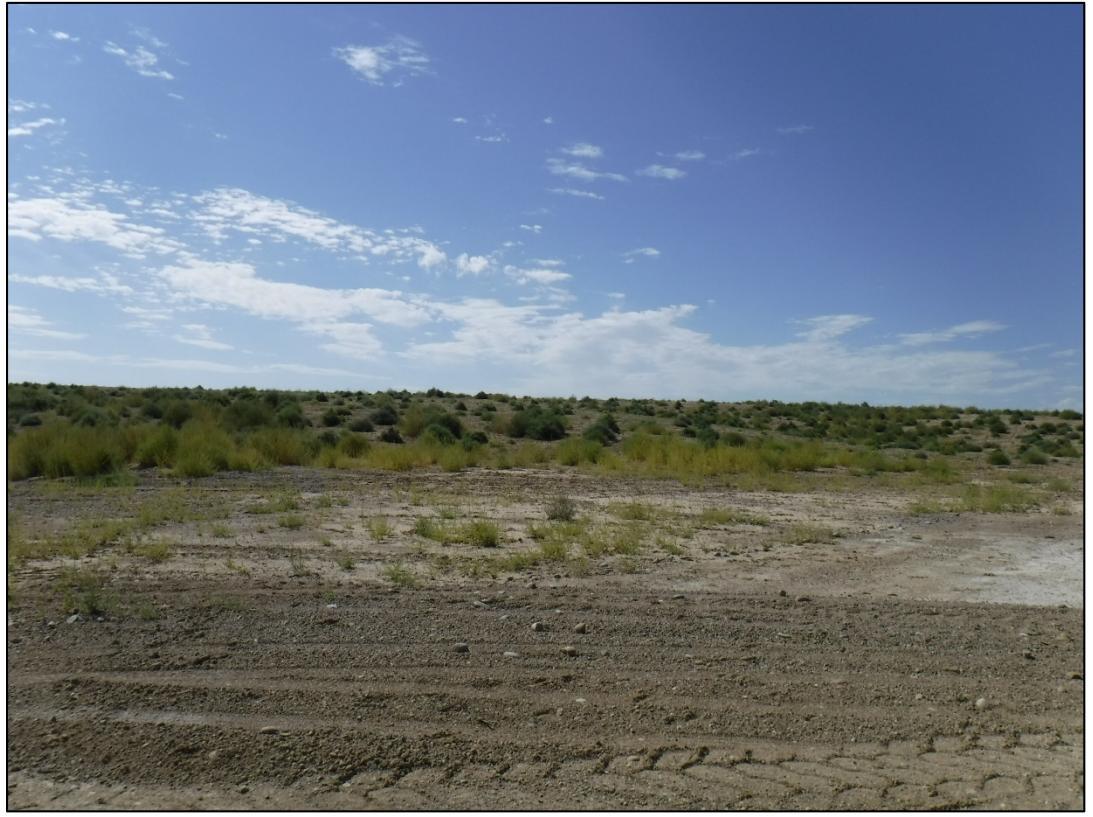
Photo 9: Kochia in an area to be seeded

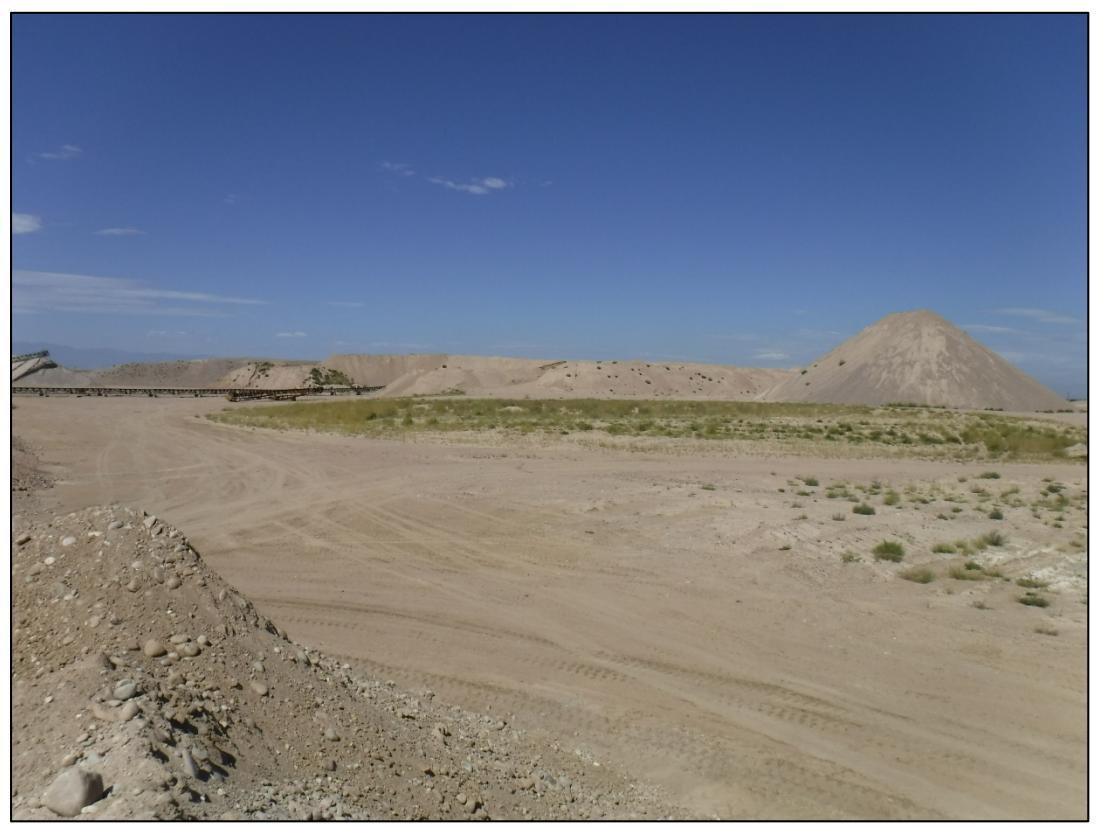
Photo 10: Typical conditions on the west side of processing area
