**Re: Albert Frei & Sons, Inc.; Walstrum Quarry; File No. M-1983-033; Amendment
Application (AM-09); Third Geotechnical Review Memo**

RE: Walstrum Quarry AM-09, DRMS File No. M-1983-033
Slope Stability Review

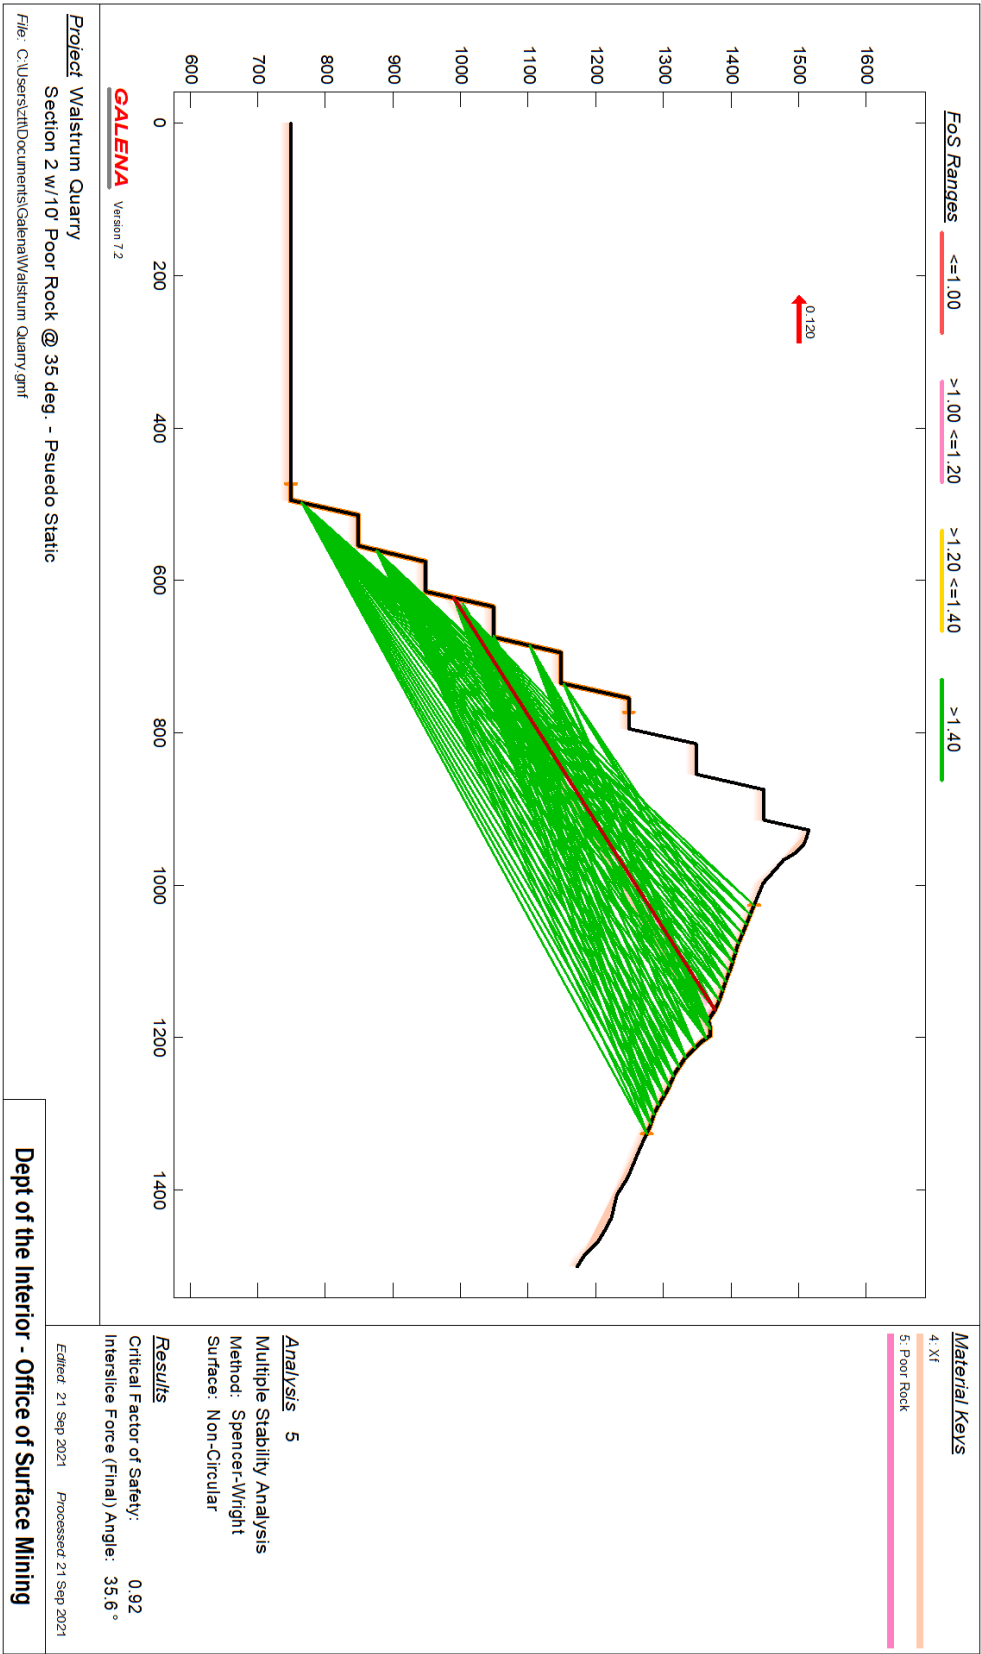
Division’s Sensitivity Analysis

With confirmation of the slope angle error for the low strength rock (Xb) discussed in the Exhibit, the Division reconstructed the slope profile for 10-ft-thick Xb at a 35 degree angle under seismic conditions (Sensitivity Analysis) in the slope stability software, GALENA. However, the factor of safety result of the Division's slope stability analysis is still below the Division's requirement under Section 30 of the Policies of the Mined Land Reclamation Board.

- **Please have Walstrum confirm that the appropriate seismic condition was applied to the Sensitivity Analysis provided in the Exhibit.**
- **If the appropriate seismic condition was applied to the Sensitivity Analysis provided in the Exhibit, please have Walstrum provide the numerical results that outline all parameters, variables and results for the Sensitivity Analysis for the Division's review.**

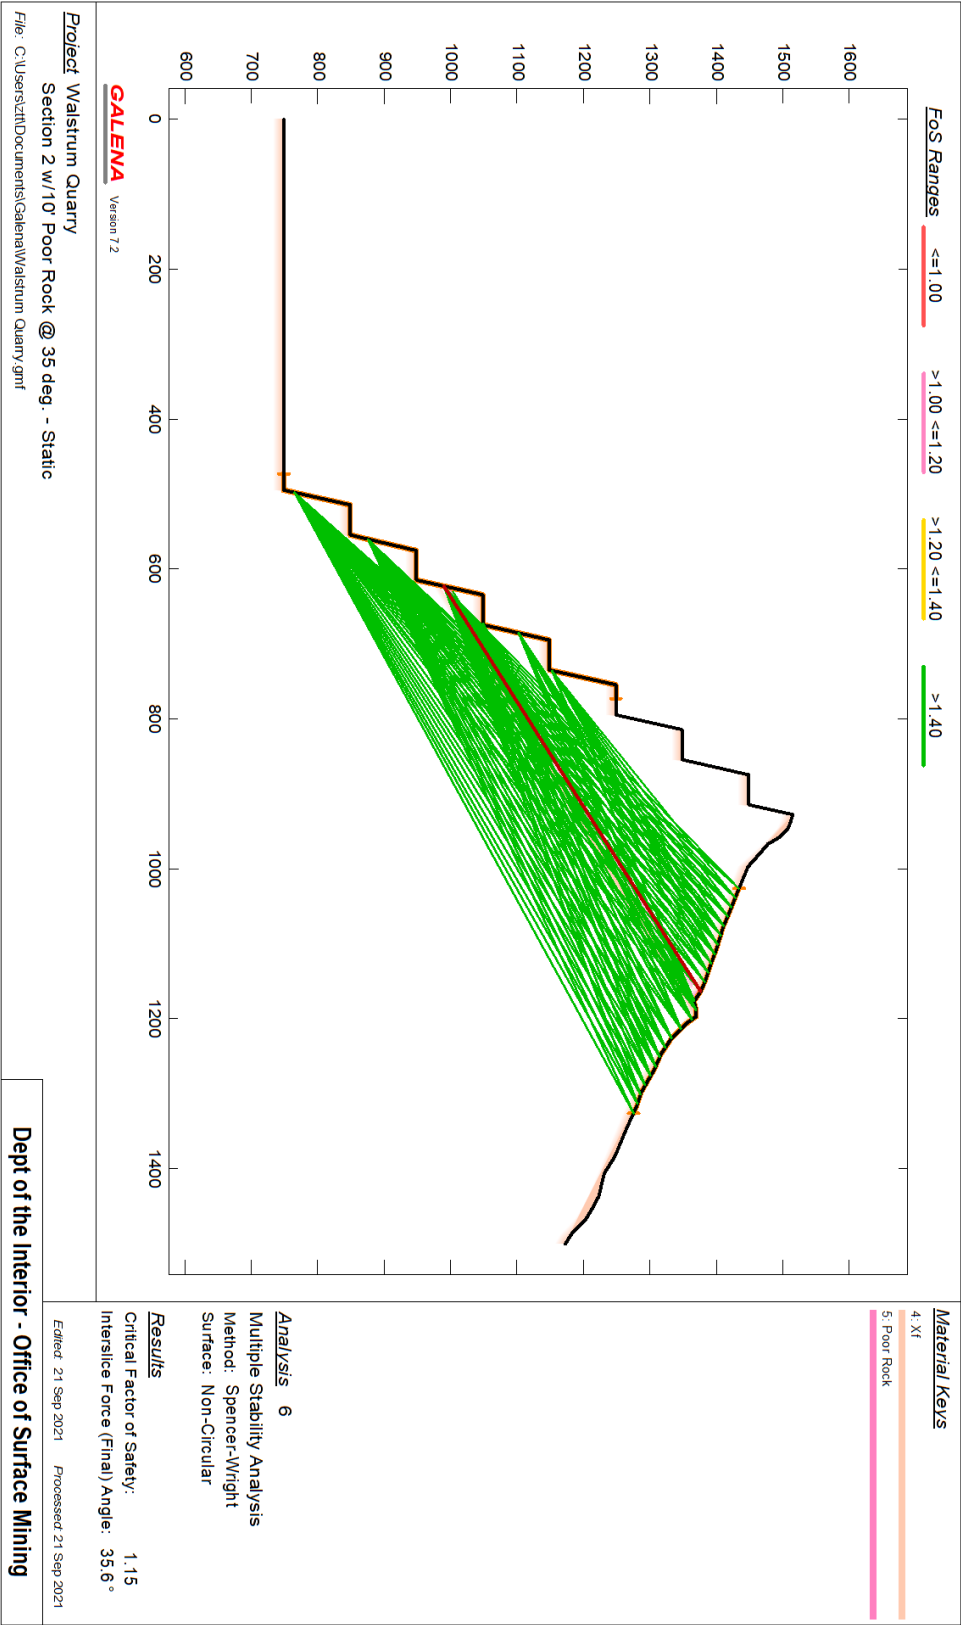
Division's Sensitivity Analysis (static condition)

Additionally, the Division performed an additional slope stability analysis for the same slope profile but under static conditions. The resulting factors of safety is summarized below in comparison to the results provided by Walstrum and the requirements of the Division for the updated GALENA model.

As shown in the above table, the Division model for the slope profile of 10-ft-thick Xb at a 35 degree angle under static conditions resulted in a factor of safety of 1.15. The results summarized above leads the Division to believe the difference in results is either from 1) differing modeling software and methodology and/or 2) seismic conditions were potentially not included in the Walstrum sensitivity analysis. When reviewing Walstrum's resulting slope stability profile visual for the Sensitivity Analysis found in Appendix I, there is no indication a seismic coefficient of 0.12 was applied to the model outside of the associated title. At the moment, there is no way for the Division to confirm the application of a seismic condition to the Sensitivity Analysis.

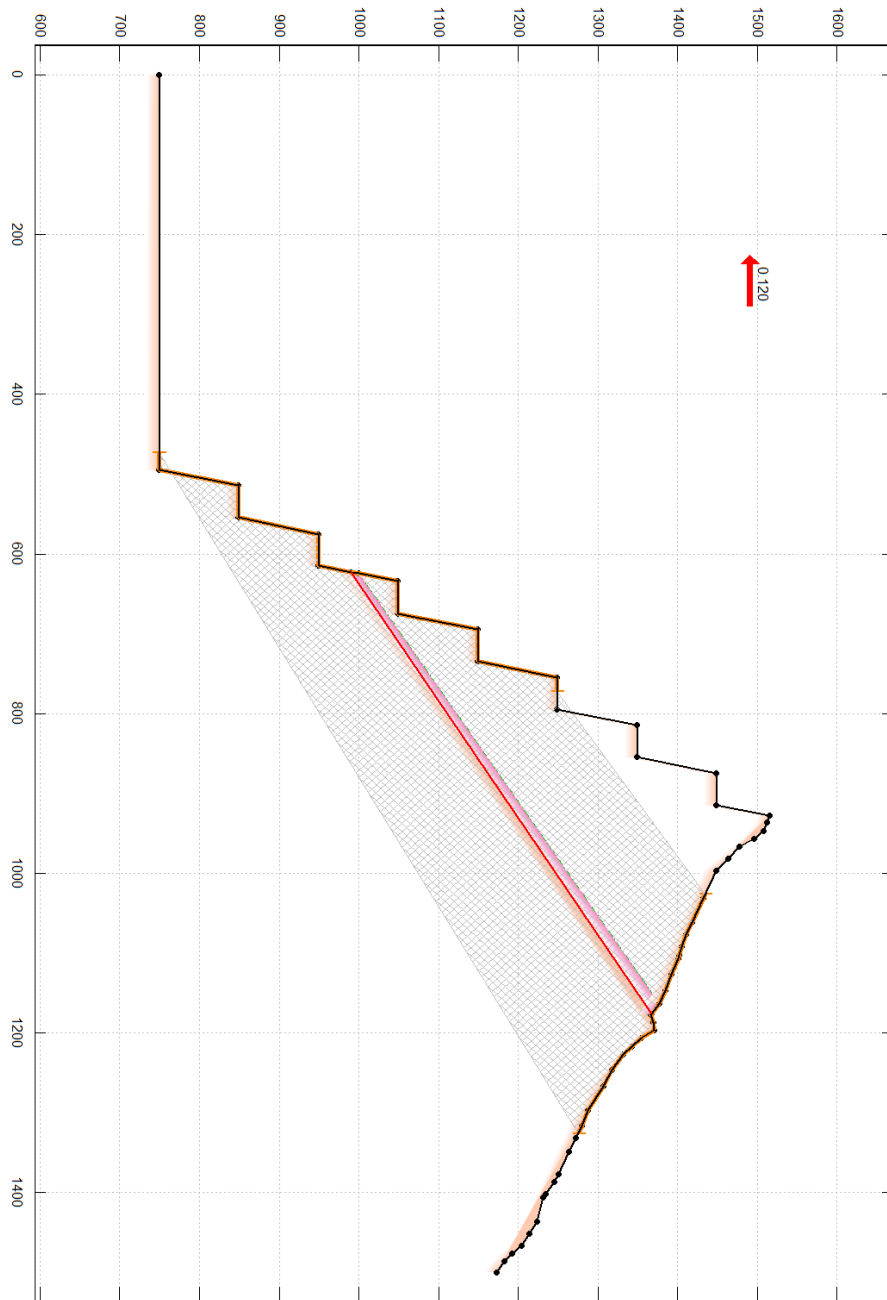
Division's Slope Profile for Sensitivity Analysis

When comparing the Division's slope profile to that of the provided profiles with the supplemental information, it appears that the angle of slope used for the low strength rock do not match. Using a 45 degree angle for the low strength rock, the Division's slope profile appears to be angled steeper than that which was provided with the supplemental information. When measuring the provided slope angles within AutoCAD, the maximum angle discovered was 40 degrees. This difference in a higher angle would result in the lower factor of safety as observed with the Division's results for the sensitivity analysis. This leads the Division to believe that perhaps there is a typo in Table 5 within the Exhibit and a lesser angle of slope was used for the sensitivity analysis to result in a factor of safety of 1.15 under pseudo-static conditions.
