**MINERALS PROGRAM INSPECTION REPORT**  
**PHONE: (303) 866-3567**

<b>MINE NAME:</b> Logan Wash	<b>MINE/PROSPECTING ID#:</b> M-1977-424	<b>MINERAL:</b> Oil shale	<b>COUNTY:</b> Garfield
<b>INSPECTION TYPE:</b> Surety-Related Inspection	<b>INSPECTOR(S):</b> Amy Yeldell	<b>INSP. DATE:</b> September 7, 2021	<b>INSP. TIME:</b> 08:00
<b>OPERATOR:</b> Occidental Oil Shale, Inc.	<b>OPERATOR REPRESENTATIVE:</b> Bruce Smith	<b>TYPE OF OPERATION:</b> 112 - Hard Rock Regular Operation	
<b>REASON FOR INSPECTION:</b> Citizen Complaint	<b>BOND CALCULATION TYPE:</b> None	<b>BOND AMOUNT:</b> \$570,428.00	
<b>DATE OF COMPLAINT:</b> NA	<b>POST INSP. CONTACTS:</b> DRMS	<b>JOINT INSP. AGENCY:</b> None	
<b>WEATHER:</b> Clear	<b>INSPECTOR'S SIGNATURE:</b>

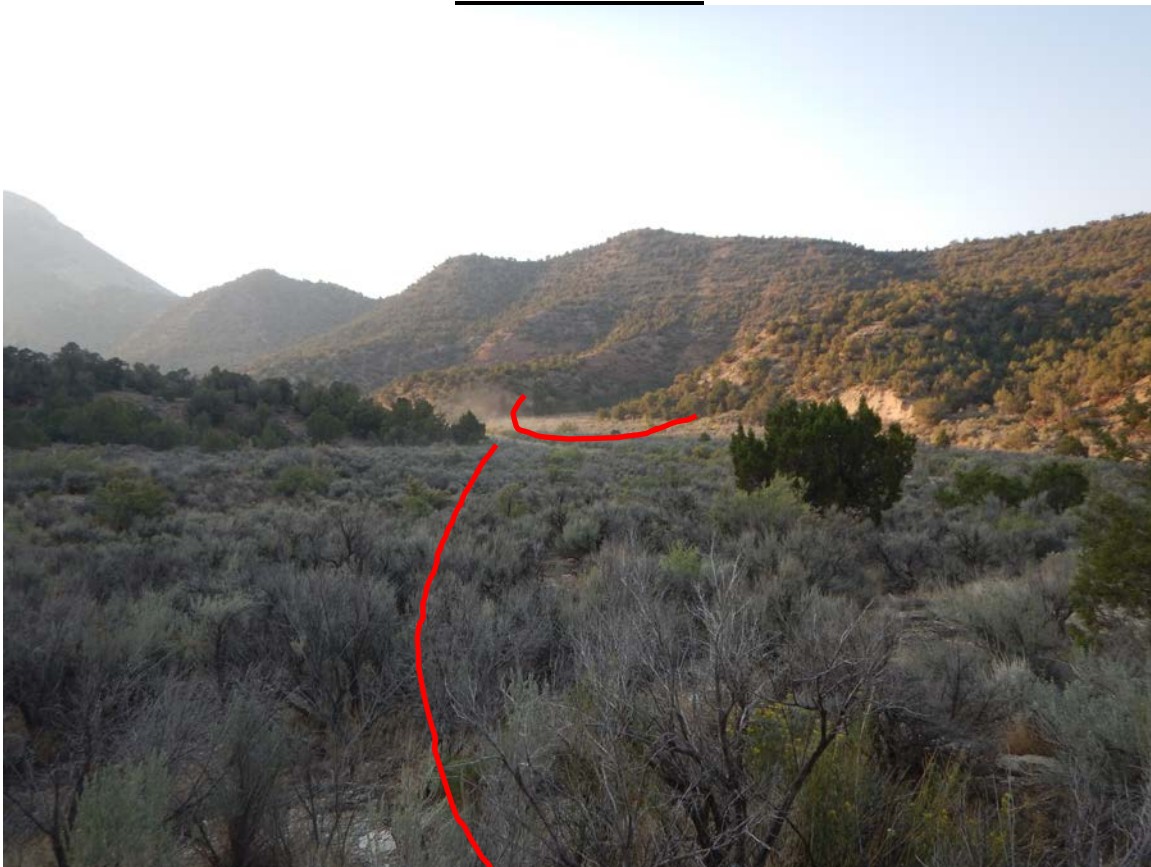
The road realignment areas B2, B3, B5, B5A, B7, B8A, and B8 were inspected. They are located within Area 13 and are generally on BLM. Dirt work naturally blends with undisturbed topography. Vegetation is generally comprised of mature sagebrush with limited grass understory growth. Vegetation is comparable to adjacent areas. Little to no weeds were observed. Reference satellite images were necessary to locate and delineate the affected lands. Overall road realignment areas are indistinguishable from unaffected areas.

Road re-alignment area B2 with B8 in the foreground

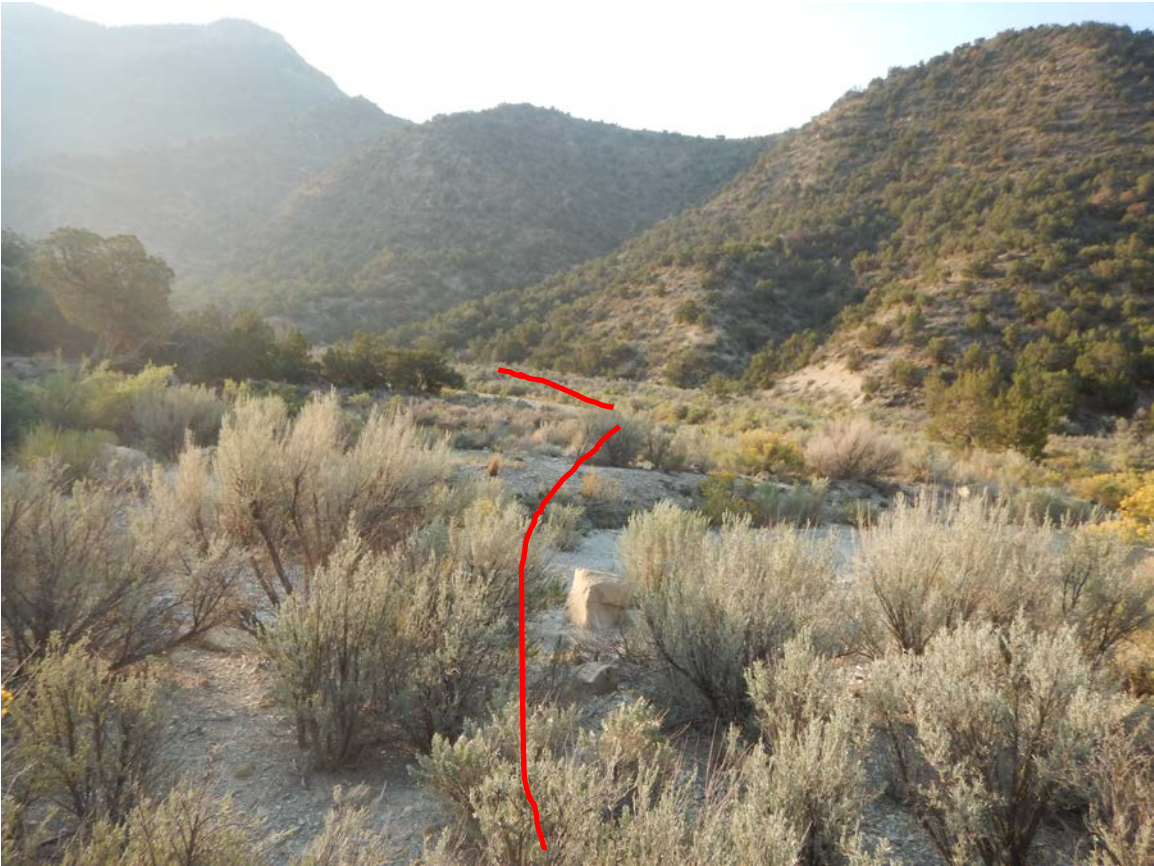
Road re-alignment area B3 with B8A in the foreground

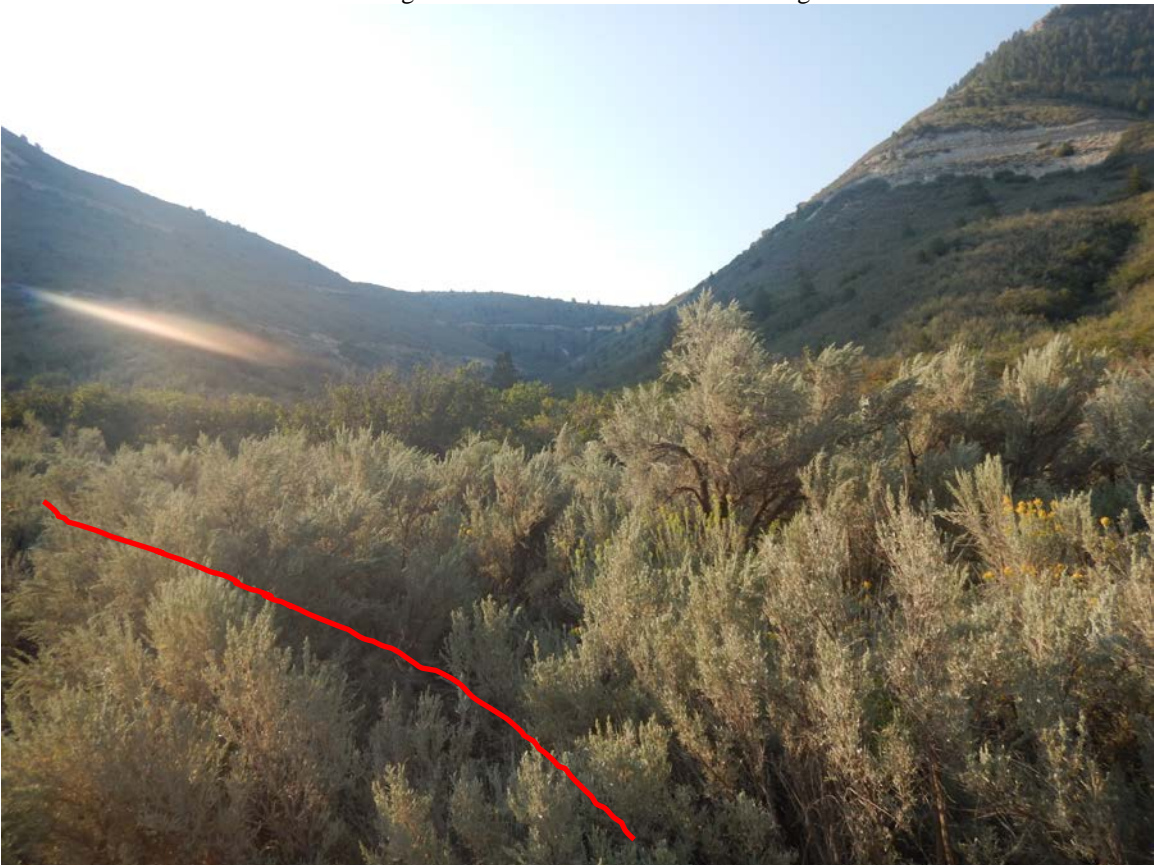
Road re-alignment area B5

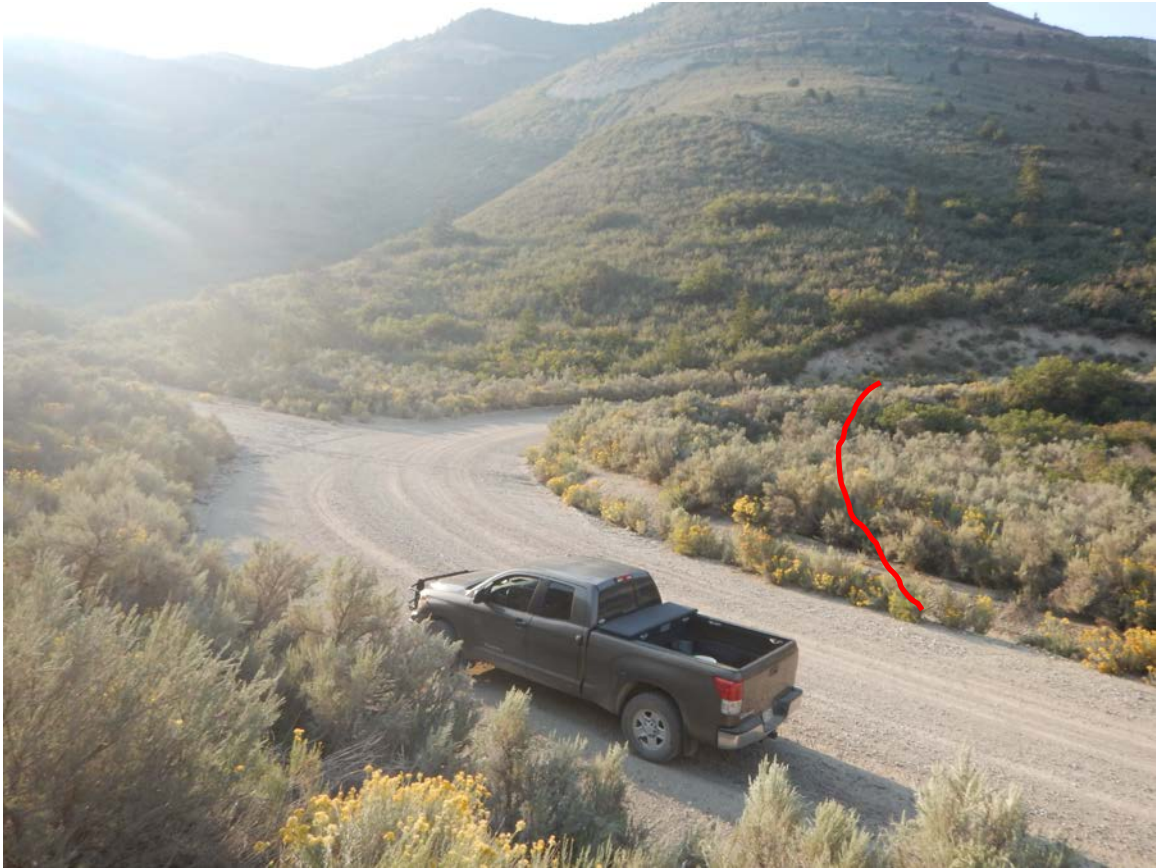
Road re-alignment area B5A

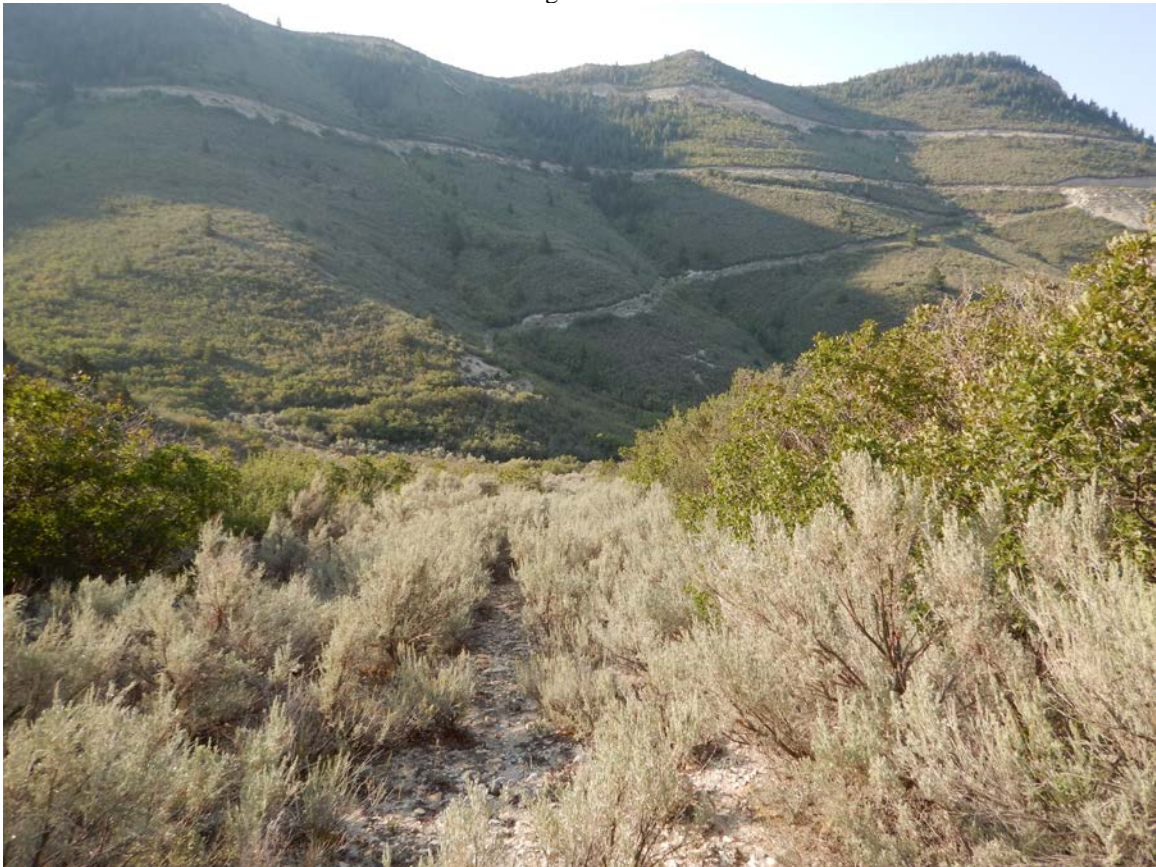
The upper portion of the lower access road is located within Area 13 and is on BLM. The lower access road was reclaimed in 2004. The lower part is frequently grazed and used for access. The lower portion is not being requested for release, only the upper portion is at this time. The upper portion of the access road consists of 80% mature sagebrush that is chest high. A small access foot path has been cut to maintain access to the flume and monitoring well. The uppermost portions comprise of more grass with lower forms of sagebrush and other native shrubs. Mr. Smith indicated that once no longer required, the monitoring well would be plugged. Material could be carried in via backpack and plugging and abandonment measures would be done by hand with virtually no disturbance. Reclamation of the flume would be slightly more invasive. It is located in a natural low point and consists of a small liner and metal flume. Presumably these materials could also be removed by hand followed by hand seeding of an approximately 10 ft x 10 ft area.

Upper portion of the lower access road

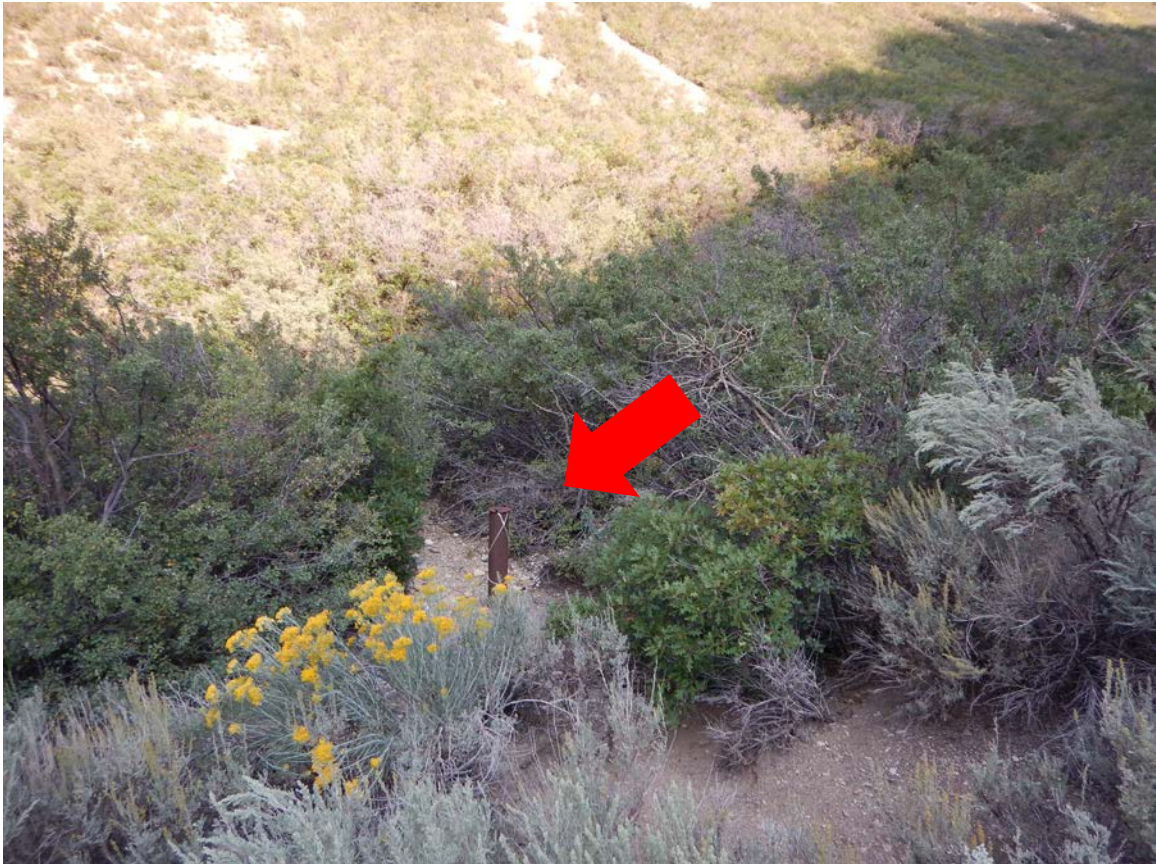
Remaining monitoring well along upper portion of the lower access road.

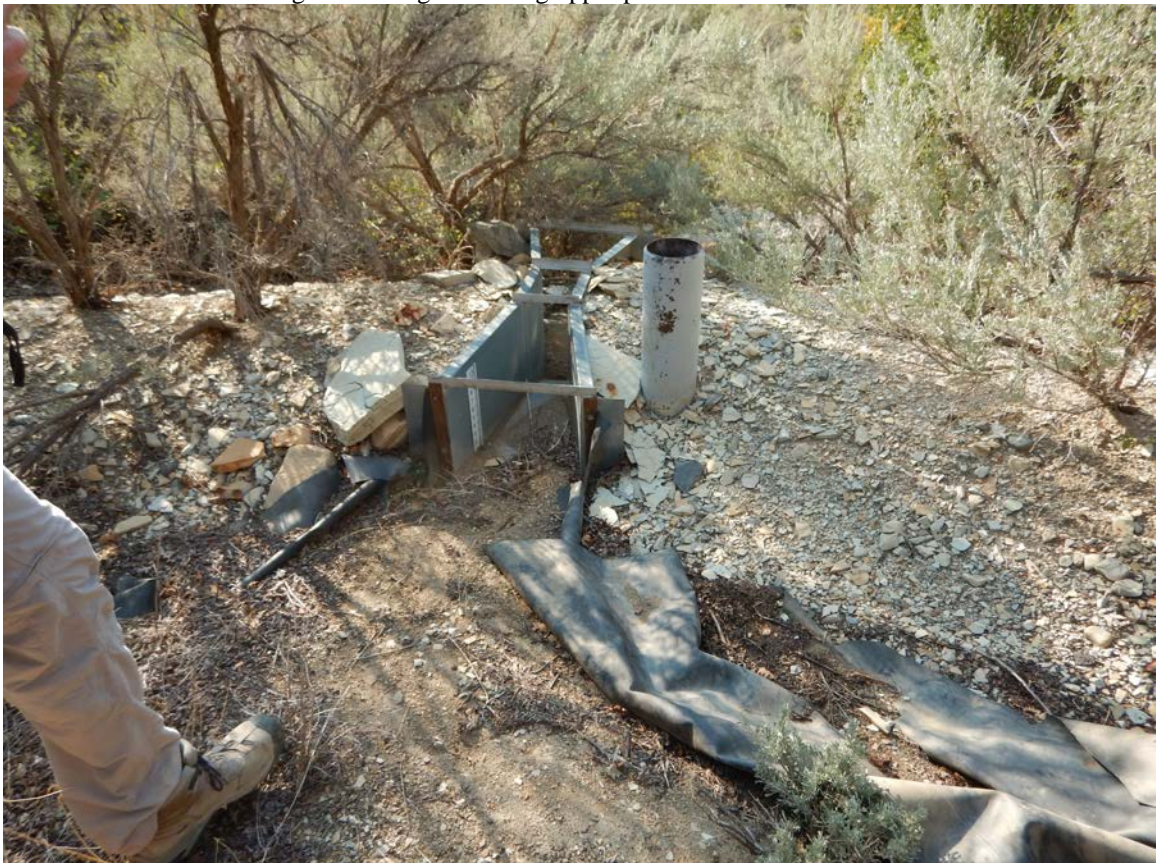
Flume still in place along upper portion of the lower access road.

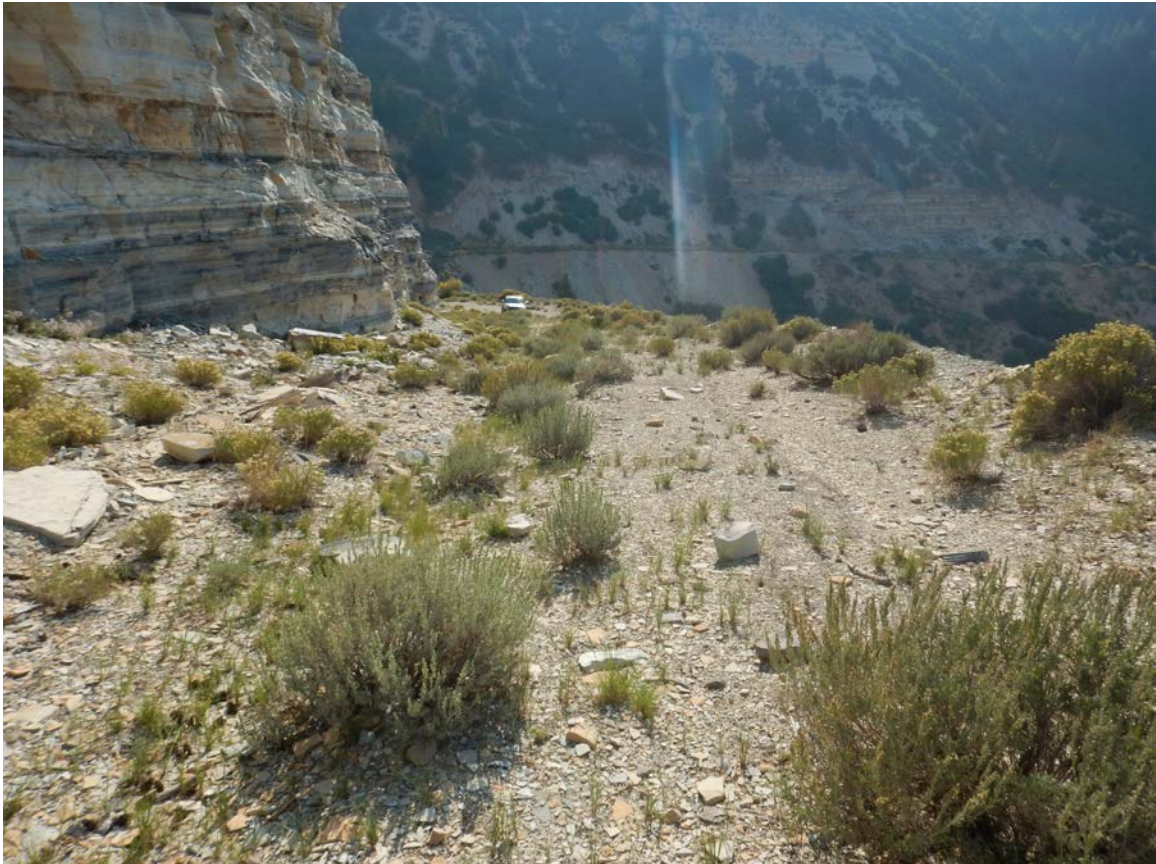
Upper access road to the upper bench (Area 2) is extremely rocky. Evidence of frequent rock fall is evident by the varying sized of rocks on the previously graded reclaimed road. Some vegetation has established and is primarily grasses and forbs. Areas of direct southern exposure have limited vegetative cover, approximately 30%. As you approach the upper mine bench and the more westerly exposure, plant cover significantly

Upper access road to the upper bench

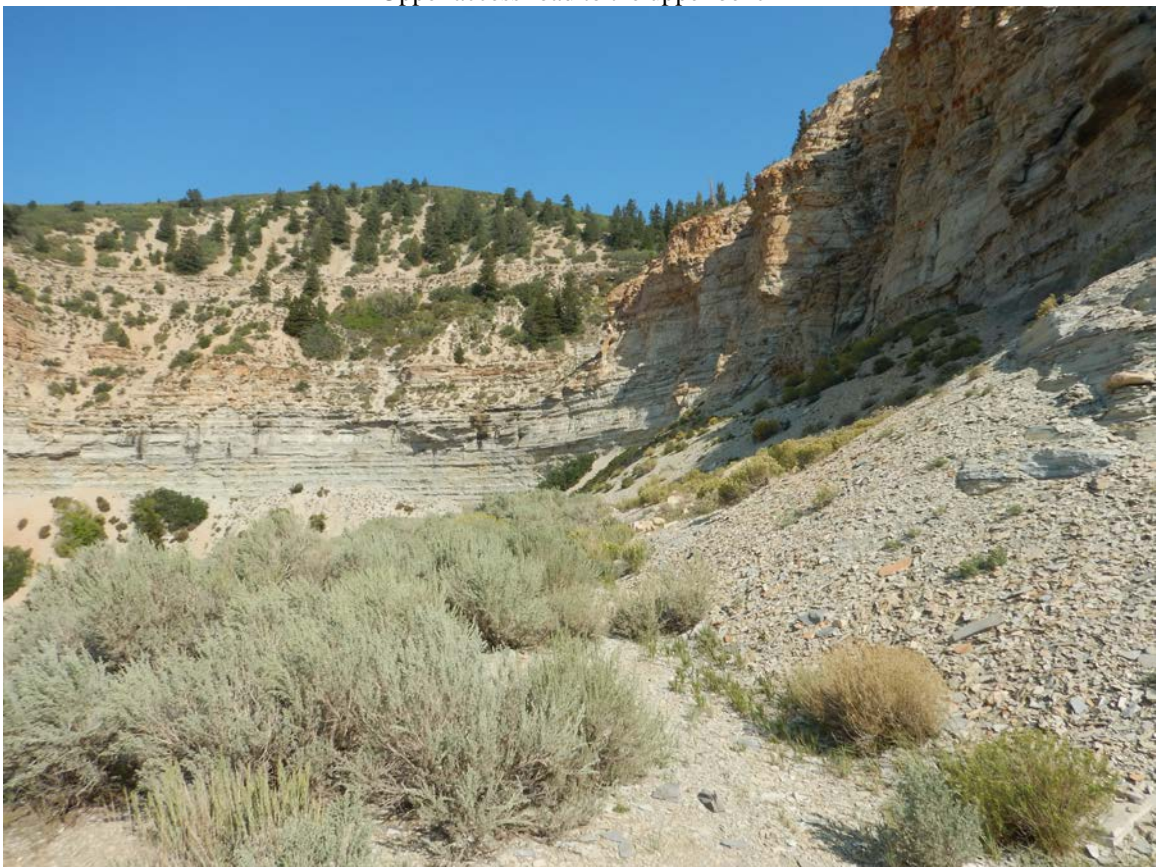
Upper access road to upper bench. Backfilled portals.

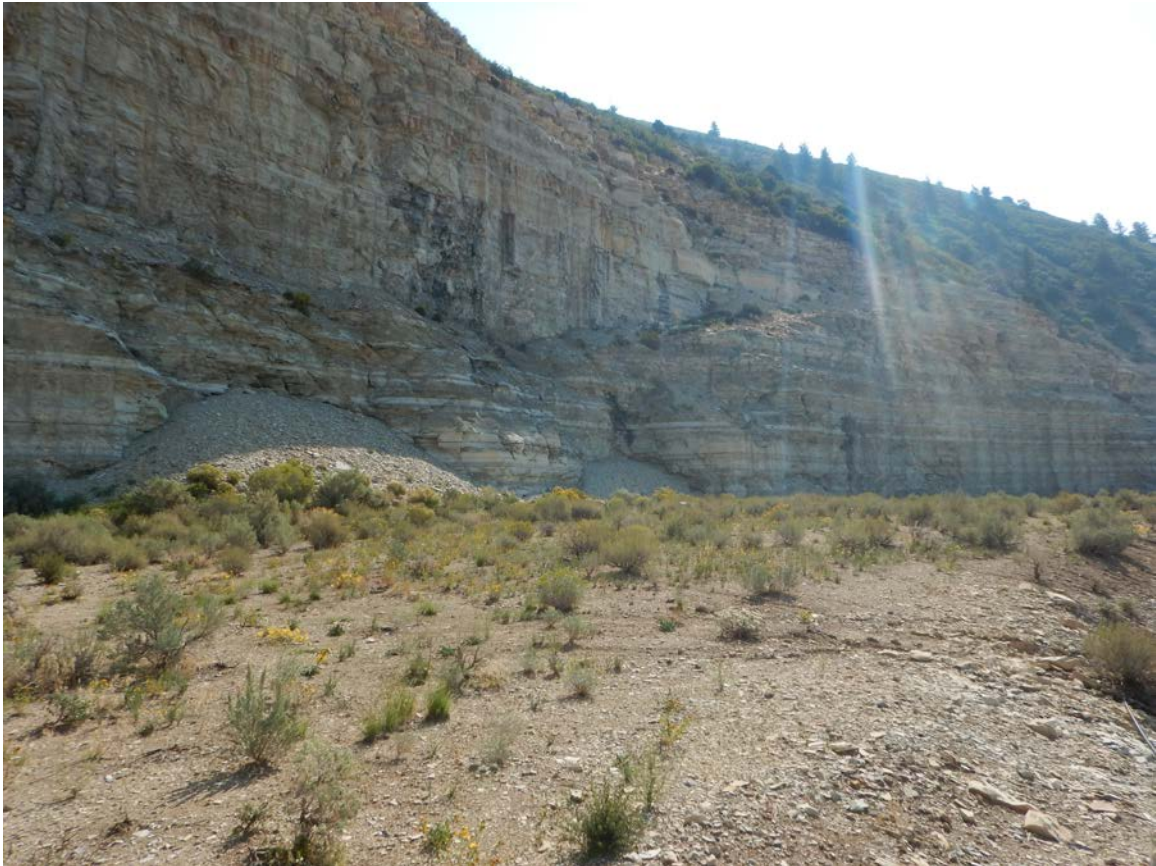
improves. Once on the upper mine bench overall plant cover is approximately 65% with no weeds observed. Given the lack of topsoil this is considered sufficient vegetative cover. On the upper bench all rock netting has been removed, a few rock anchors still remain as removal is impractical. All portal and other underground storage areas have been closed using an earthen backfill. No equipment or mining related debris remains on site. The PVC irrigation lines used for the upper mine bench/dump (slope between the upper and lower portals) remains in place as do the t-posts used for anchors to establish vegetative islands. According to Mr. Smith the irrigation piping is planned to be removed in fall of 2021. The vegetation islands are thriving and appear well established. Due to safety only visual estimations from the mine benches were made, no up close inspections were made.

Upper mine bench with backfilled portals

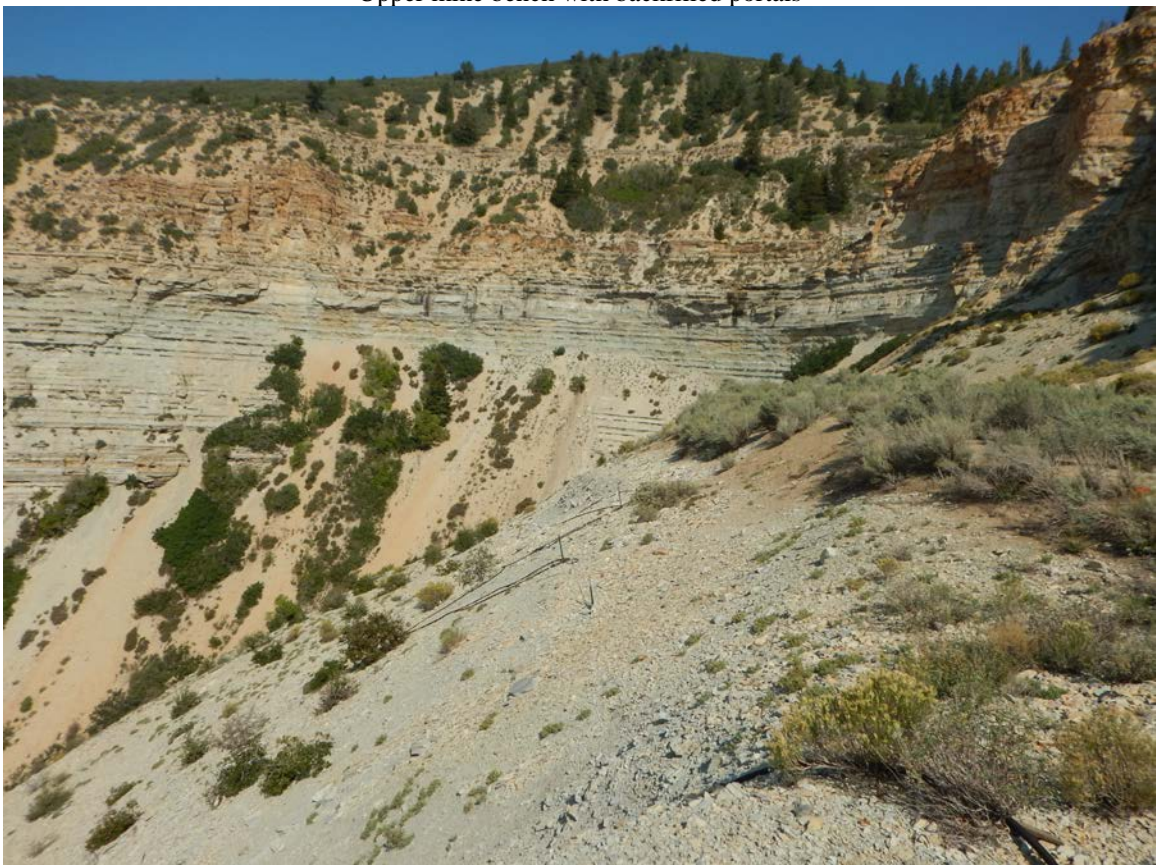
Vegetation islands on the upper mine bench/dumps. Irrigation and t-post since removed

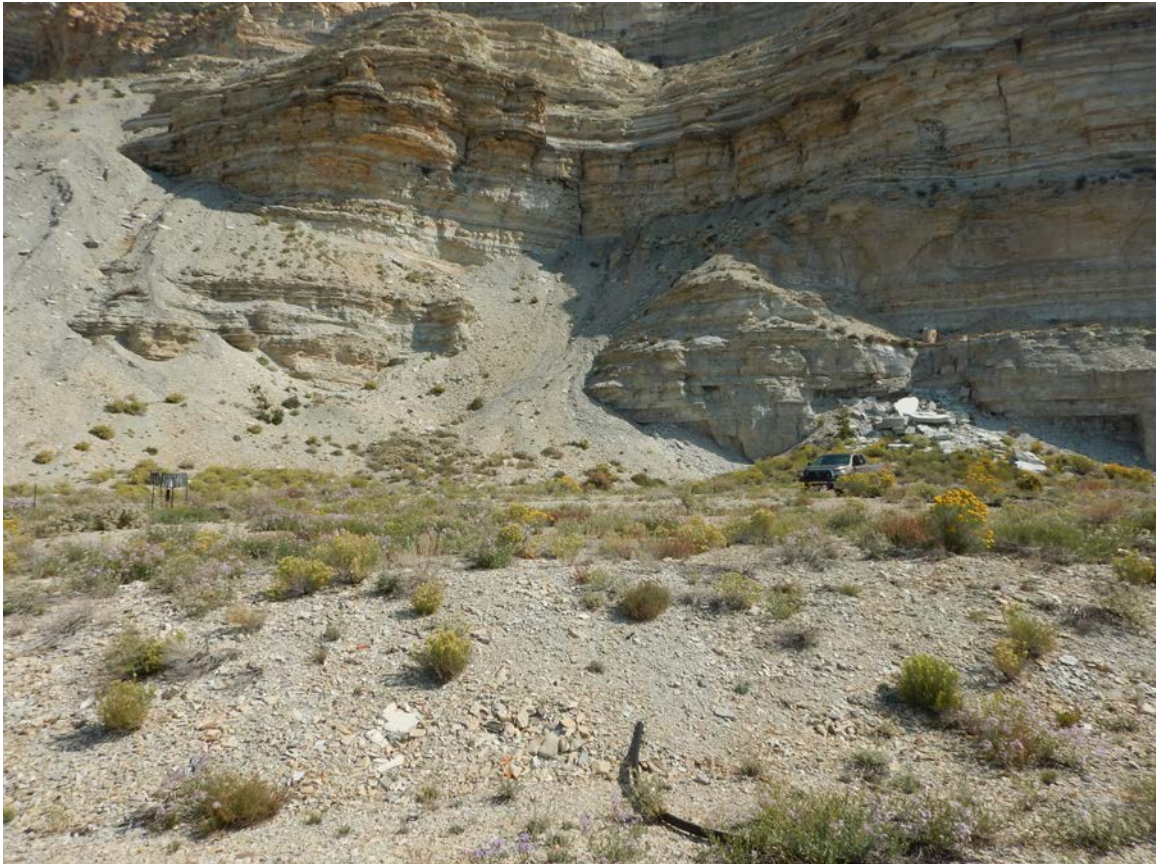
The lower mine bench (Area 3) is mostly reclaimed. The access road is well vegetated on the sides but due to frequent use the center of the road is still bare. Located within the lower mine bench on the eastern side is the retort vault and a weather station. Along the western side is an armored rock ditch which includes an overflow pipe from the research mine portal. Overall the eastern side is completely reclaimed with a diverse establishment of native plants including forbs and shrubs. The eastern side near the monitoring areas has lower densities of plants but still a good establishment considering the harsh conditions. Given that the lower access road and monitoring areas of the mine bench are still in use these areas are not being considered for release.

Lower min bench overview, weather station, backfilled portal

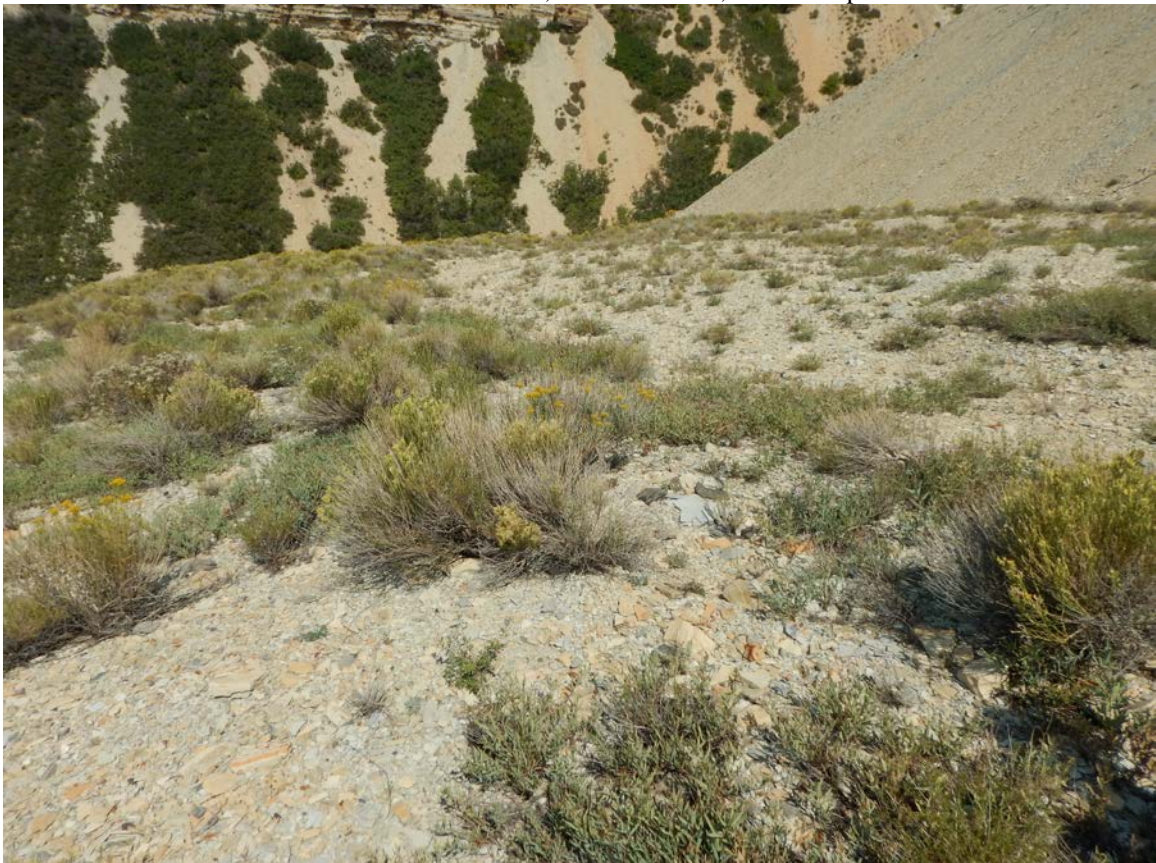
Lower mine bench

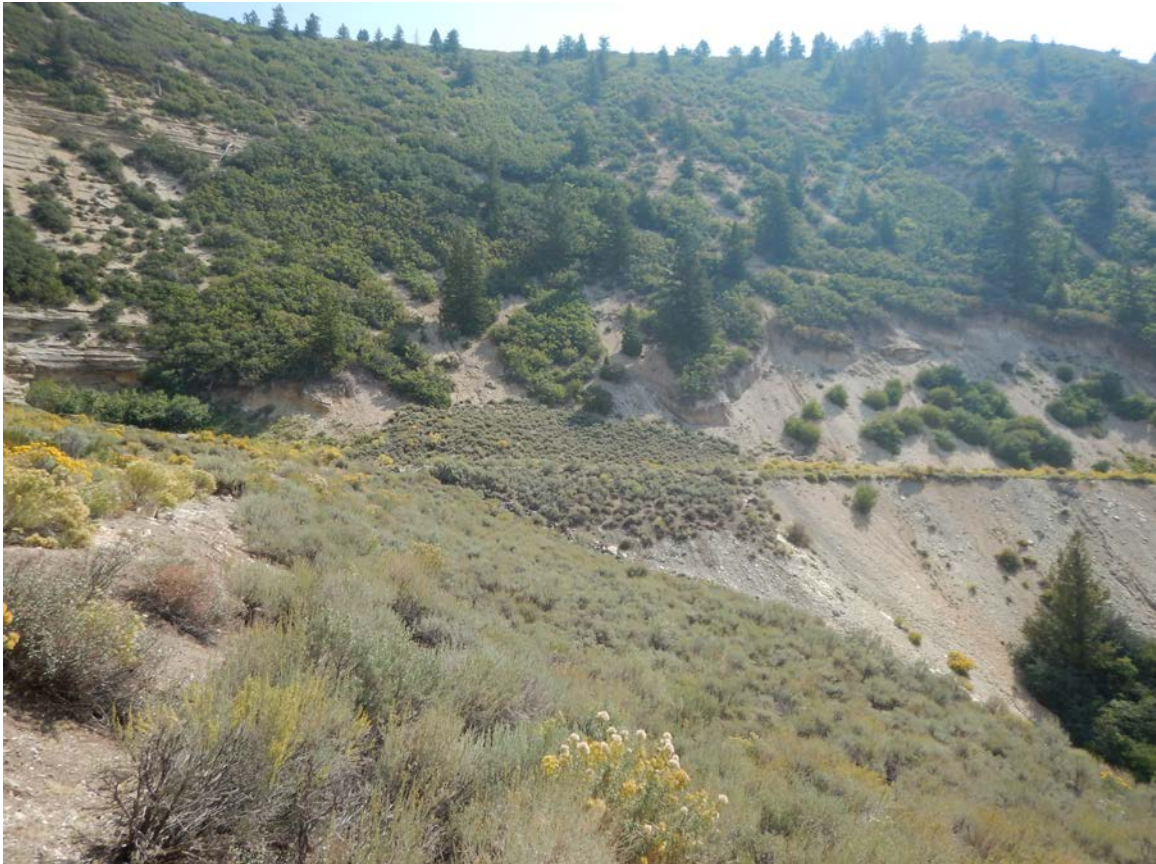
The research mine area (Area 4) is located along upper access road. The portal has been sealed with an earthen backfill. A pipe was installed to carry water from the research mine to the main mine retort water via a PVC pipe that runs along the lower bench road. On the south side of the access road is the research mine dump area and an armored channel to prevent washouts. Both areas have well established vegetation. Topsoil was imported for the research mine dump.

Research mine, backfilled portal, dump and soil borrow area

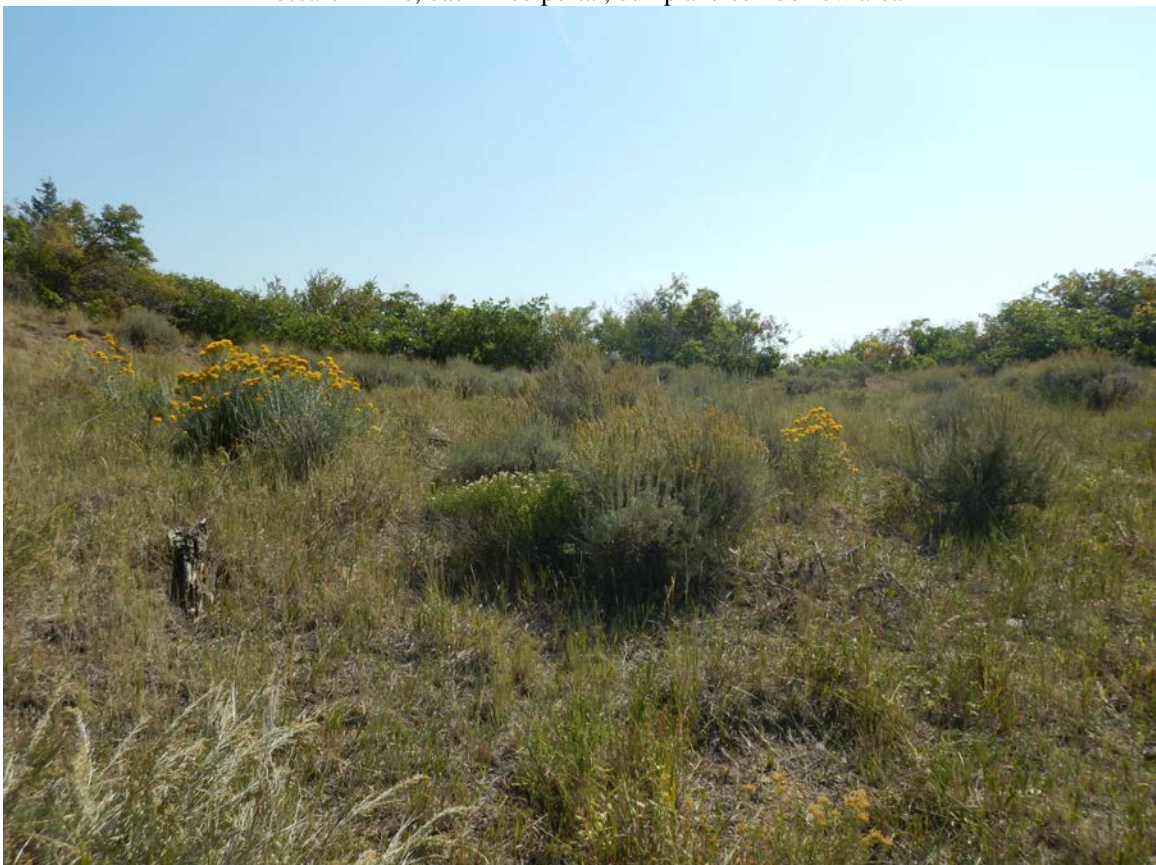
Road re-alignment area B7

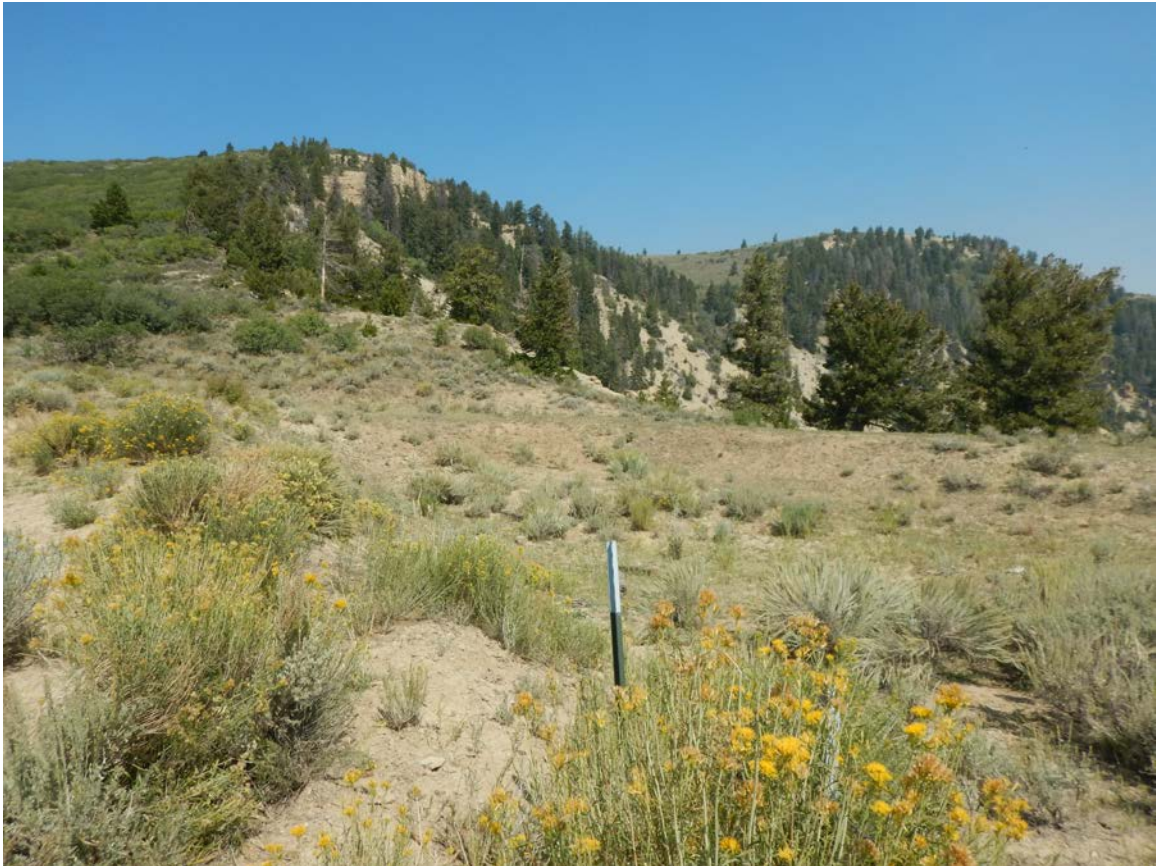
The helo pad (Area 10) has been converted to a stormwater retention basin. It consists of a vegetated depression with a flat bottom. Overall this feature blends naturally with the surrounding topography and vegetation appears well established and diverse. Very little residual sediment was observed and the feature appears to be functioning correctly with adequate storage capacity.

Repurposed helo pad as sediment pond

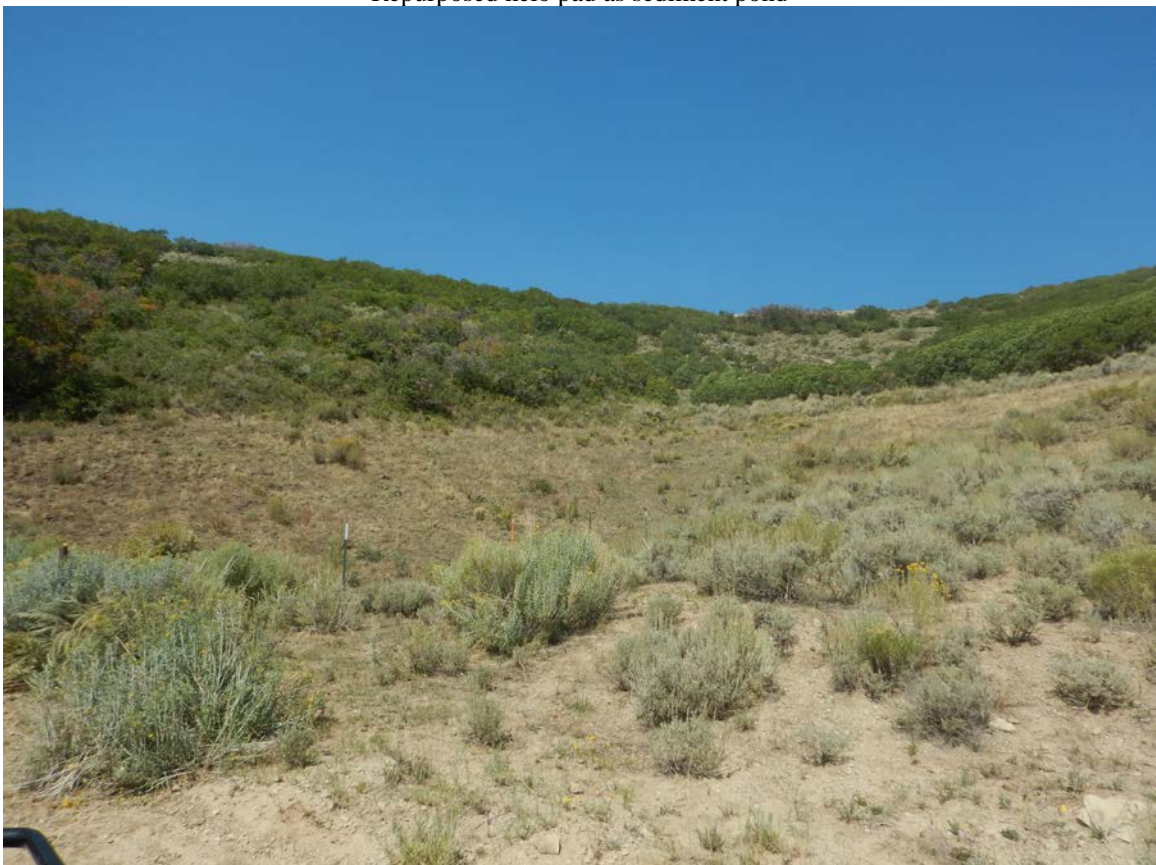
The soil borrow area appears as a natural clearing within the mature scrub oak. Slopes blend naturally and do not appear as though excavations were made. Vegetation is comprised of both well-established grasses and some mature shrubs and forbs. The site is weed free and appears stable.

Soil borrow area

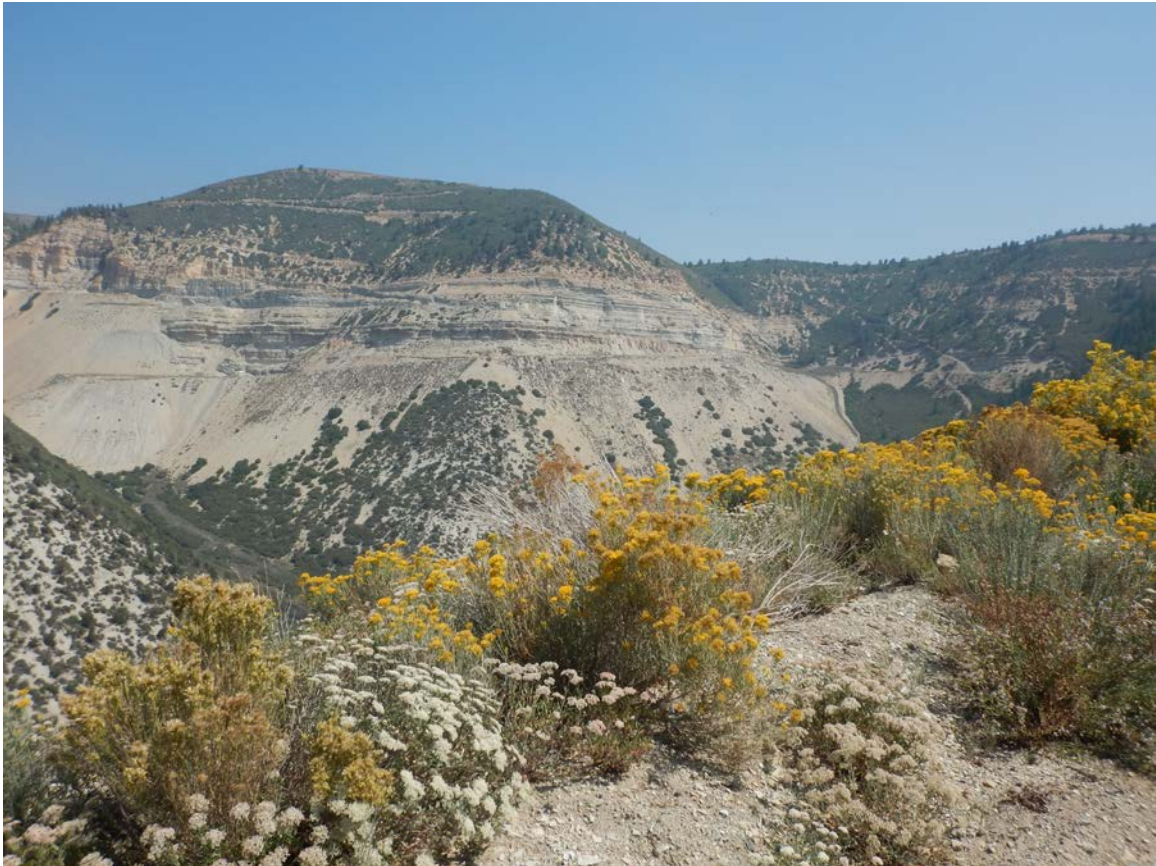
Overall site overview form Logan Wash road.

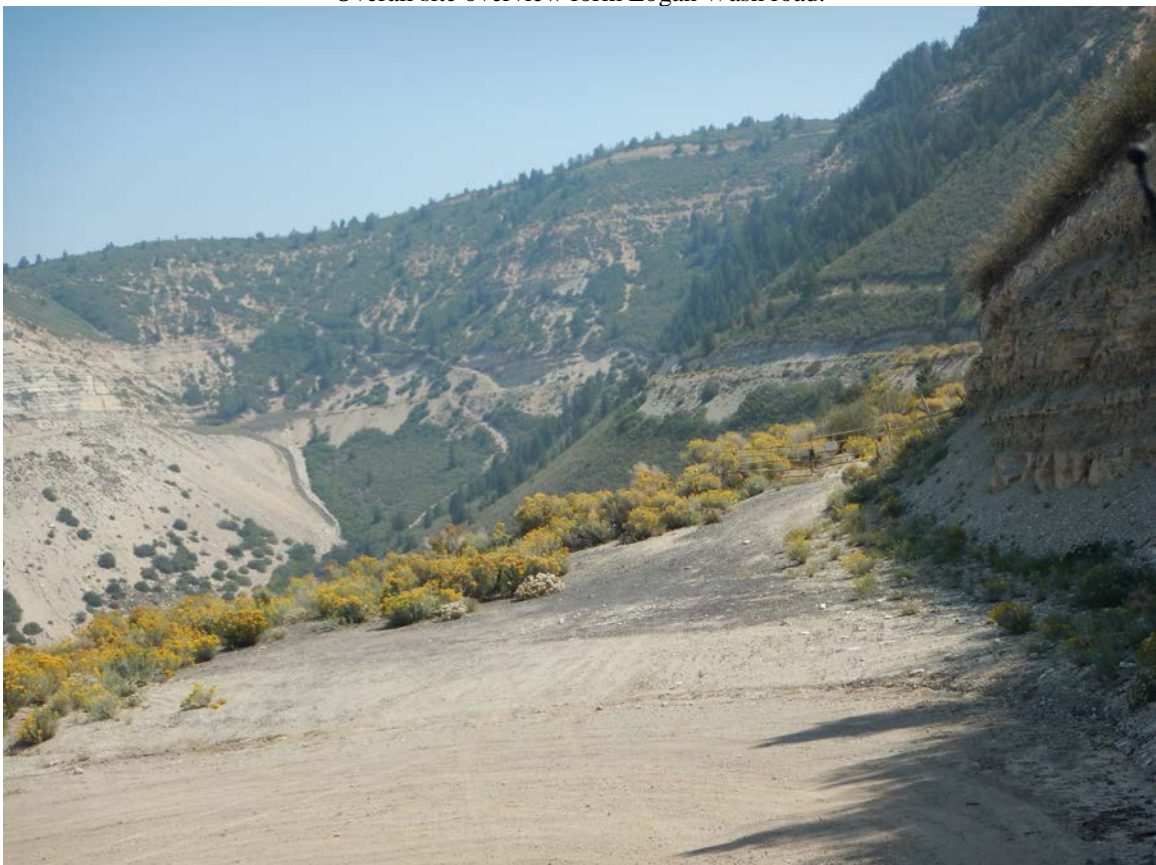
Site overview of upper access road and research mine area

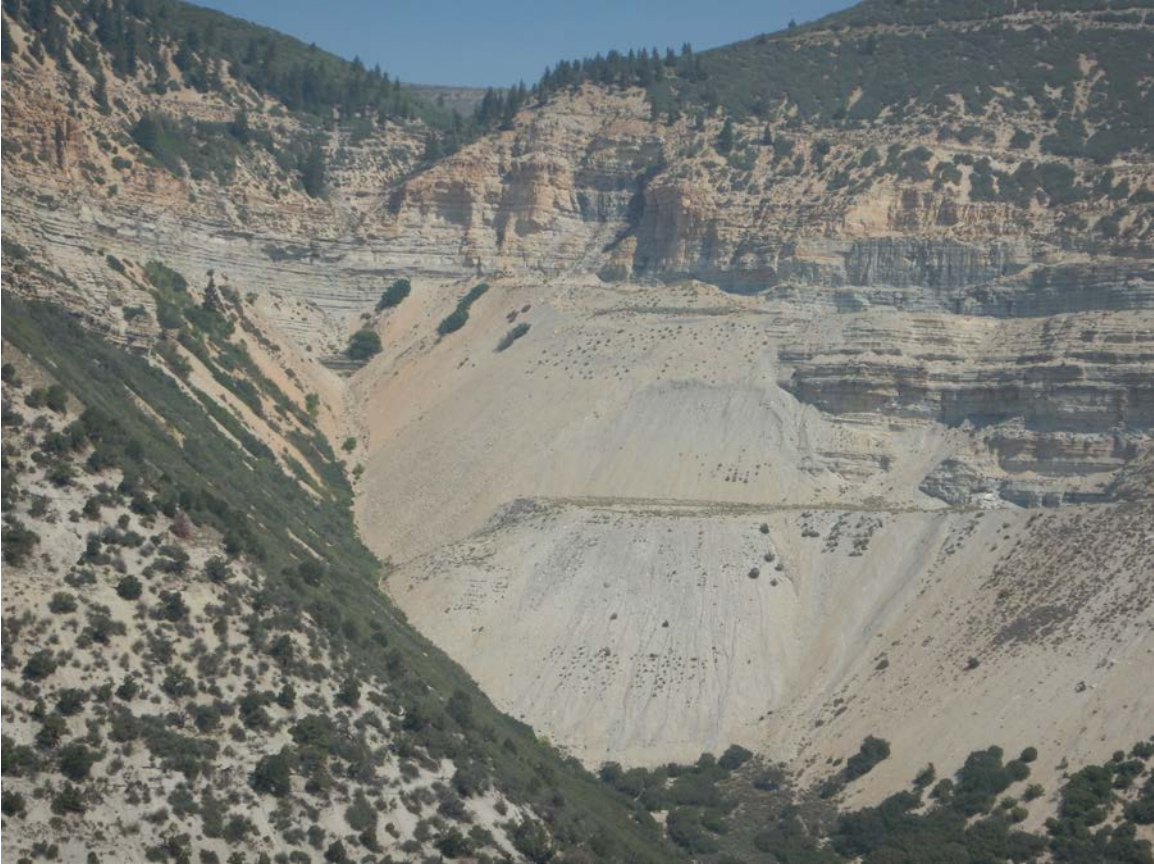
Site overview of upper access road and mine benches
