**MLRB Permit M-77-534 comments on Golden's Oct. 1 letter Technical Revision No. 4;**

**Evaluation Report  
Review Reclamation on the  
Guanella Ranch**

March 2018

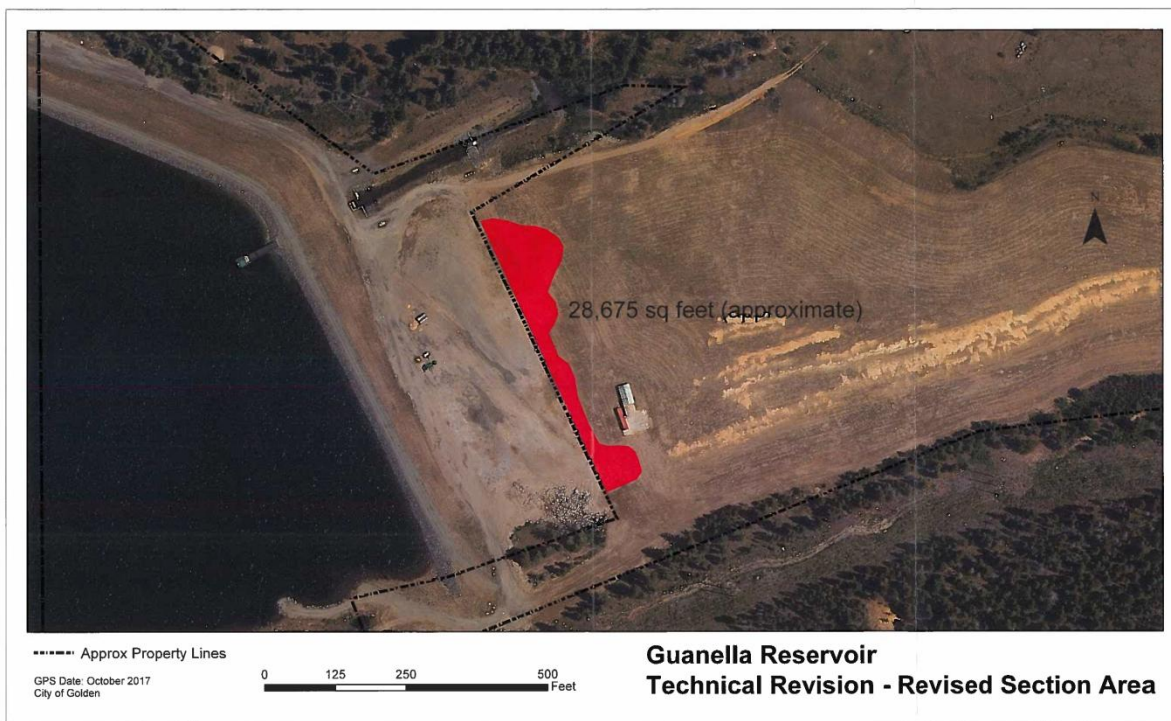
Golden is proposing to remove saline soils on 28,675 ft<sup>2</sup> (0.66 acres, 2/3 acres) to a depth of 18 inches on the southwest side of the pit adjacent to the reservoir dam (see Photo 1 copied from the TR application to DRMS). Twelve inches of clay subsoil will then be applied topped with six inches of topsoil.

Photo 1. Area to be changed as proposed in the Technical Revision,

There are several concerns with this approach to reclamation and revegetation on this alluvial terrace along Clear Creek. The six inches of topsoil is inadequate to support pasture land vegetation since the original topsoil and viable subsoil was 13 to 20 inches thick with abundant roots and organic matter (Unit 27, Lone Rock-Breece, gravelly sandy loam, USRCS 1983, Empire, Colorado soil survey). The shallow low permeability clay subsoil will restrict root growth, and reduce plant productivity. The site will not support rangeland pasture, and allow grazing.

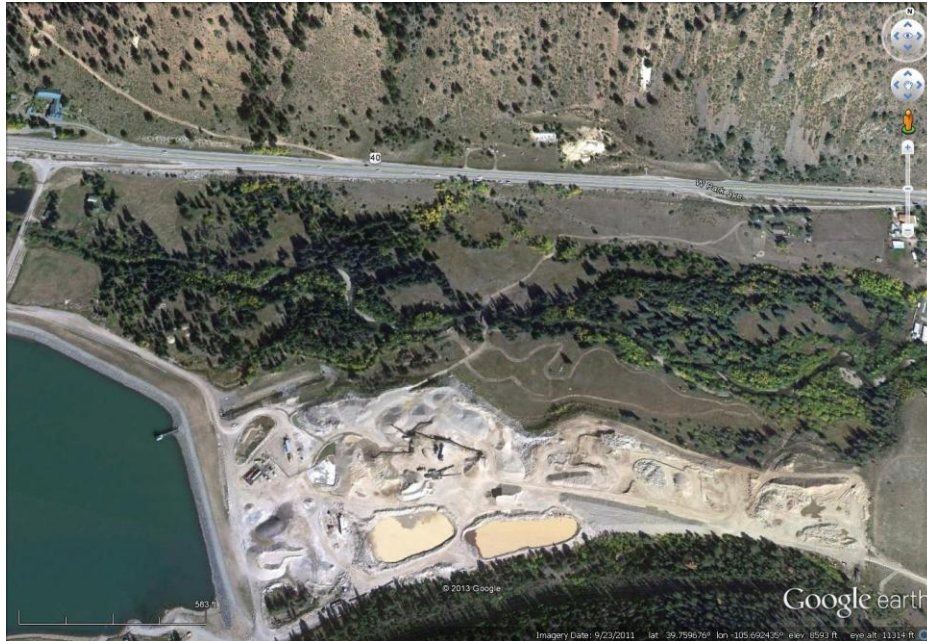
Photo 2. Gravel pit site in 2011.

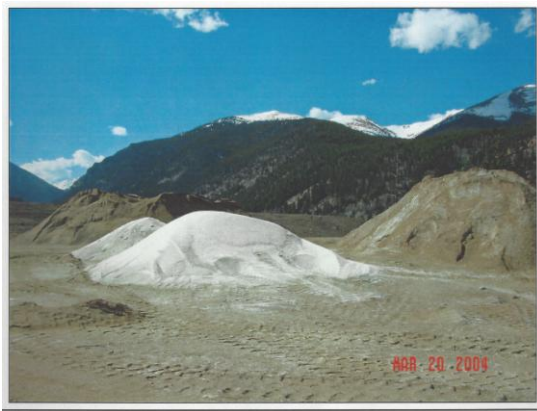
Salt and other road material (asphalt) were stored onsite, and used for road construction and sanding roads in winter. Photo 3 shows the salt and sand stored onsite during operations, and Photo 4 shows salt being buried onsite.

Photo 3. Salt and sand onsite in 2009.

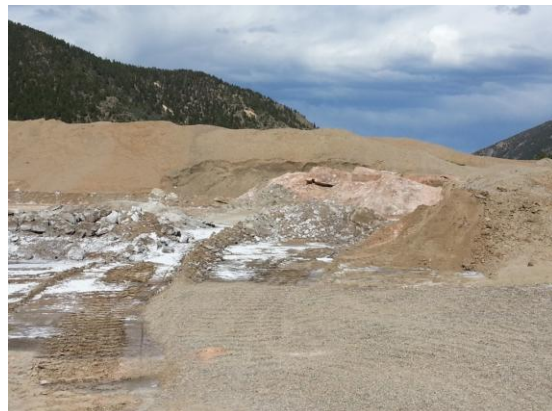
Photo 4. Salt buried onsite in 2013.

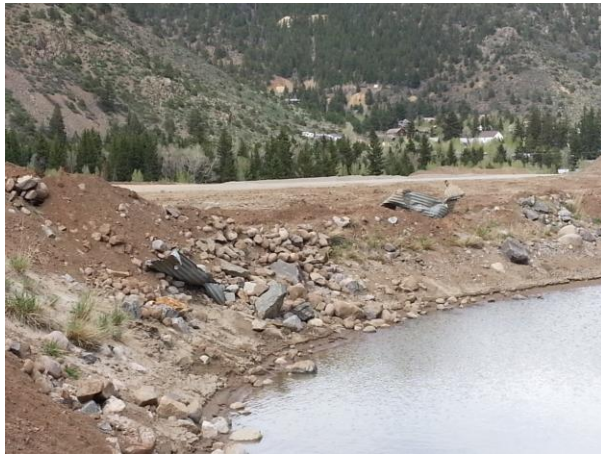
The pit was reclaimed in fall 2013 by grading to bury onsite contamination, debris and asphalt, and then topsoil applied and seeded. Photo 5 shows debris being buried in a pond, and Photo 6 shows topsoil with large stones that was applied.

Photo 5. Debris and rock buried in pond.

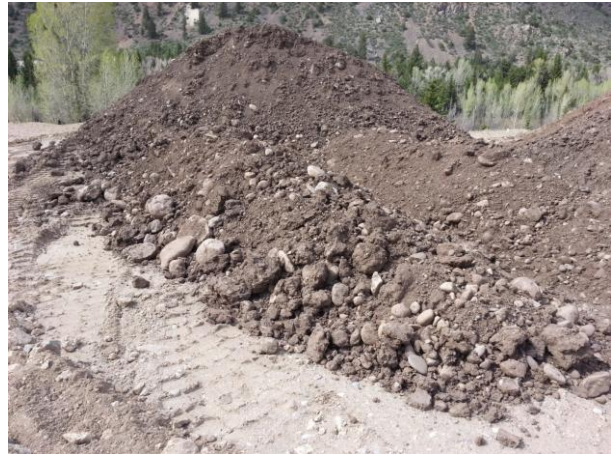
Photo 6. Imported topsoil used to cover dirt.

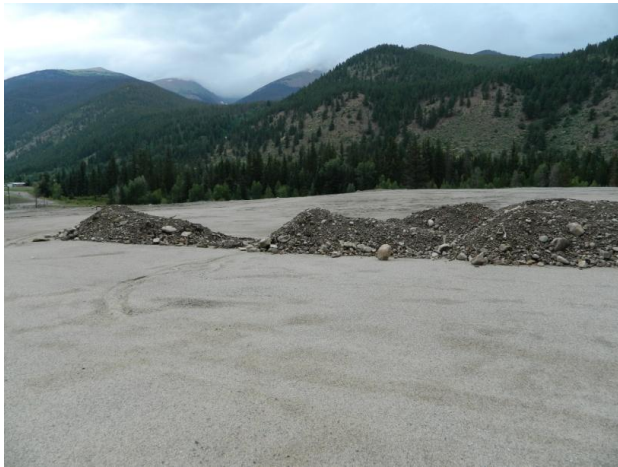
The pit was graded smooth, topsoil moved on the surface, and rocks segregated on the edges (see Photos 6 and 7). The topsoil contained large rocks and stones that reduce the quality of the soil as good growth media.

Photo 6. Imported topsoil on graded surface

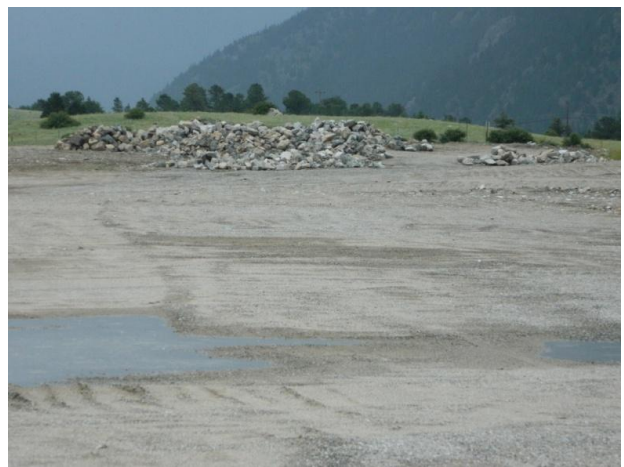
Photo 7. Rock sorted and stored on edge of soil.

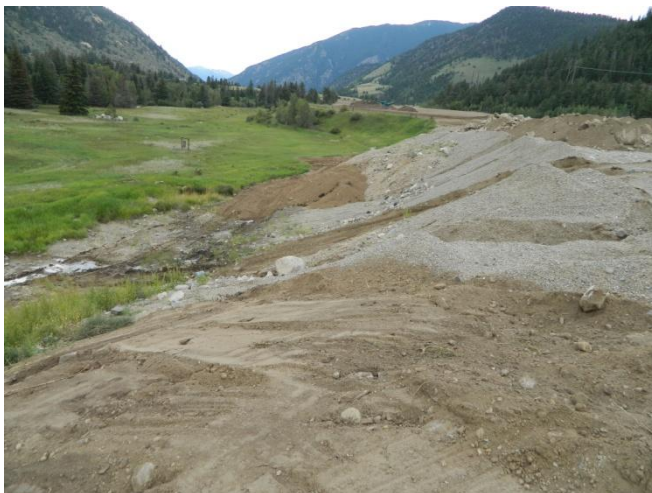
Topsoil was spread on the soil surface and graded to an estimated 4 to 6 inches (see photos 8 and 9). There was little or no humus or organic matter in the soil, and the texture was gravelly and sandy with little loam.

Photo 8. Topsoil spread on the prepared surface.

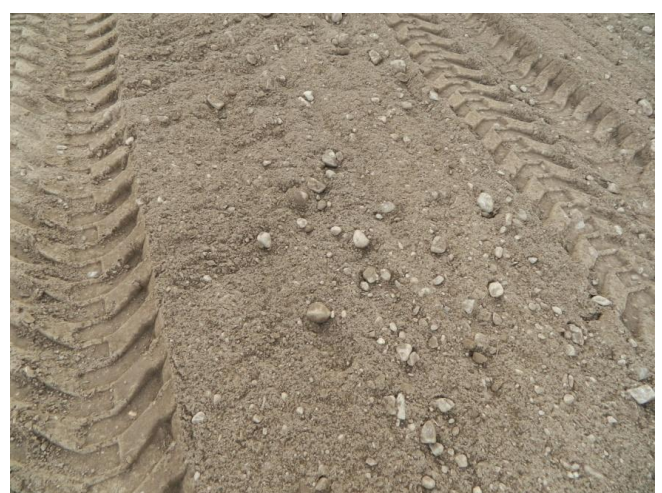
Photo 9. Imported soil surface with stones.

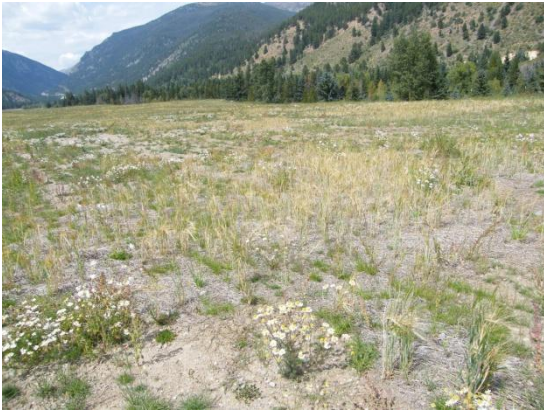
The vegetation that germinated had plant growth that was sparse and not productive. Photo 10 shows sparse plant growth in 2015, and Photo 11 show mostly bare soil and a rock/gravel surface in 2017. Photo 12 shows asphalt on the soil surface, and poor plant productivity, and Photo 13 shows bare soil in the salty soil in 2017.

Photo 10. Sparse plant growth in 2015.

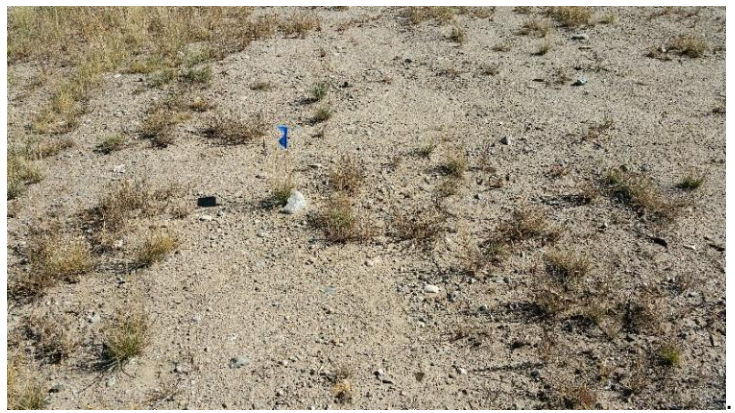
Photo 11. Bare soil with sparse plant growth in 2017

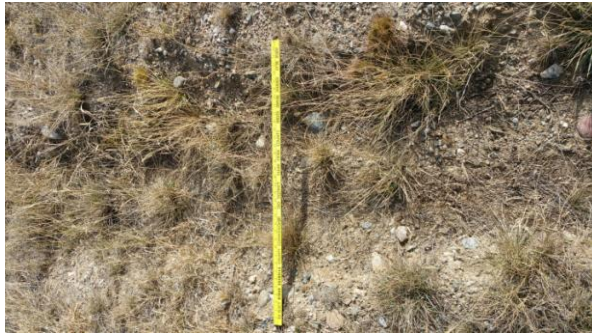
Photo 12. Asphalt surface with sparse growth.

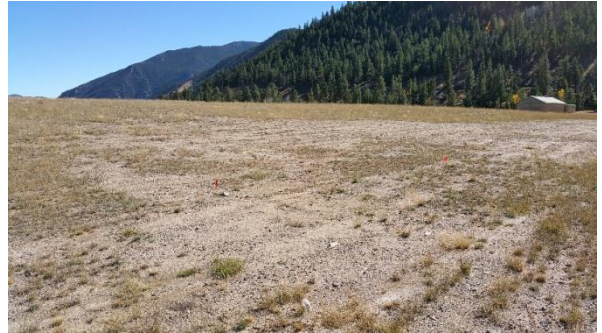
Photo 13. Bare soil in salty soil.

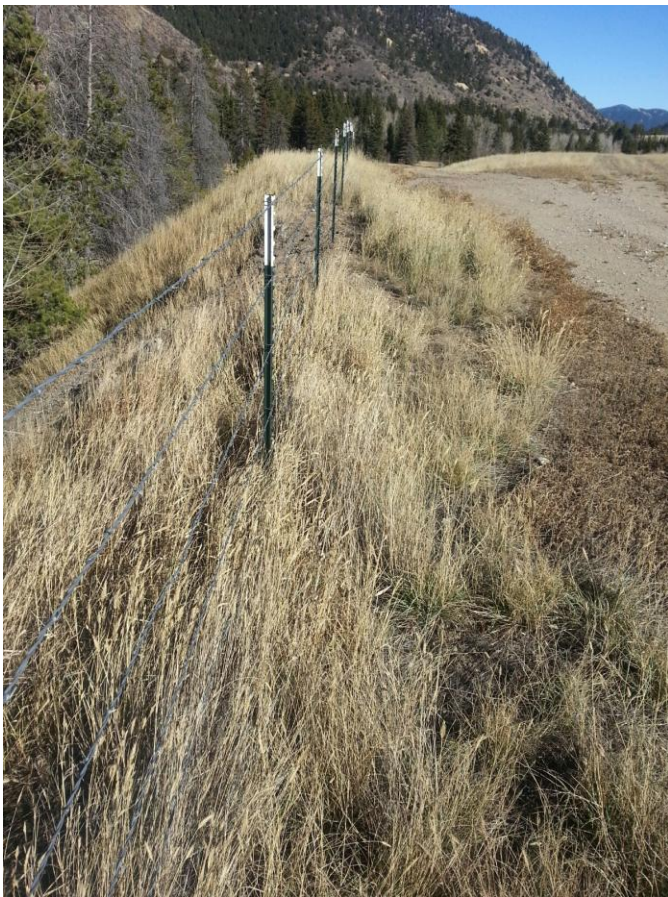
In Photo 14 the native soil on the bank shows excellent growth, while the imported soil was mostly bare. As show in Photo 15 weeds are dominant with little grass on portions of the reclaimed soils.

Photo 14. Example of Good plant growth on native soil used on reclaimed area.

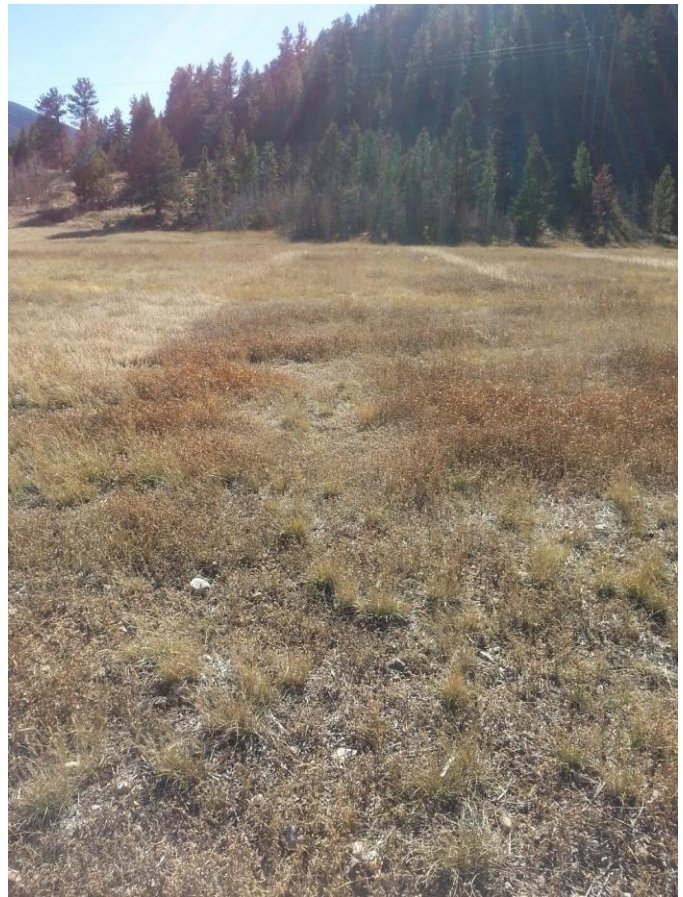
Photo 15. Weeds dominant in the vegetation.

The remedy and solution to poor reclamation is to correct the deficiencies. The soil can be improved by adding supplement organic matter and humus, or additives containing a carbon source such as biochar and a bacteria and fungi source such as MycorrPlus. Reseeding with a good seed mix containing native adapted plant seed with the supplement will improve plant growth and productivity.
