## MINERALS PROGRAM INSPECTION REPORT PHONE: (303) 866-3567

MINE NAME:	MINE/PROSPECTING ID#:	MINERAL:	COUNTY:
Weaver Quarry	M-1989-010	Sand	Larimer
INSPECTION TYPE:	INSPECTOR(S):	INSP. DATE:	INSP. TIME:
Monitoring	Brock Bowles	September 29, 2021	13:00
OPERATOR:	<b>OPERATOR REPRESENTATIVE:</b>	TYPE OF OPERATION:	
Pete Lien & Sons, Inc.	Dana Mellage	112c - Construction Regular Operation

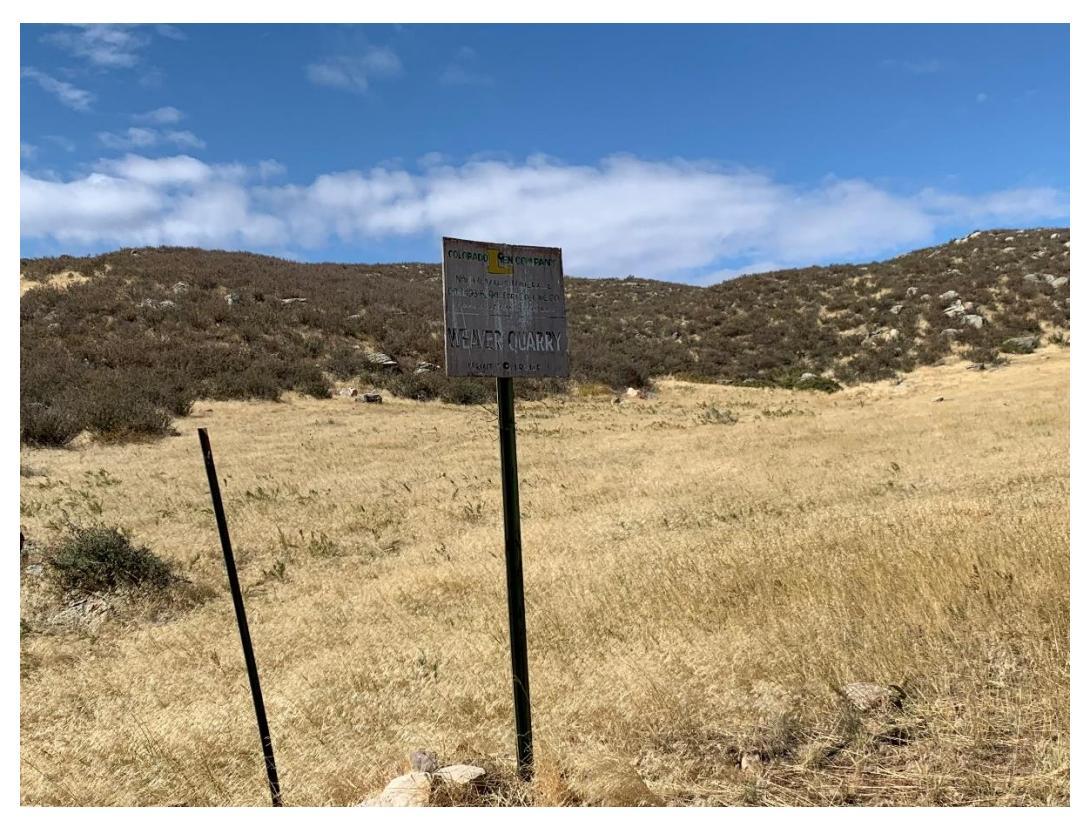
**PROBLEM/POSSIBLE VIOLATION:** Problem: The mine identification sign was not legible at the entrance of the mine site. This is a problem for failure to post a mine identification sign as required by Section 3.1.12(1) of the rule. The Operator shall, at the entrance of the mine site post a sign, which shall be clearly visible from the access road, with a minimum size equaling one hundred and eighty-seven (187) square inches, such as eleven (11) inches in height and seventeen (17) inches in width, with appropriate font size, with the following: the name of the Operator, a statement that a reclamation permit for the operation has been issued by the Colorado Mined Land Reclamation Board; and the permit number.

The mine entrance sign in hard to read and does not have all the required information (photo 1). The sign needs to be update. See the corrective actions section of this report for more information.

Photo 1 Mine entrance sign needs to be update with required information

**CORRECTIVE ACTIONS:** The operator shall, at the entrance of the mine site, post a sign which shall be clearly visible from the access road with the following: the name of the operator, a statement that a reclamation permit for the operation has been issued by the Colorado Mined Land Reclamation Board; and the permit number. The operator shall submit photo documentation that a proper sign has been posted by the corrective action date.

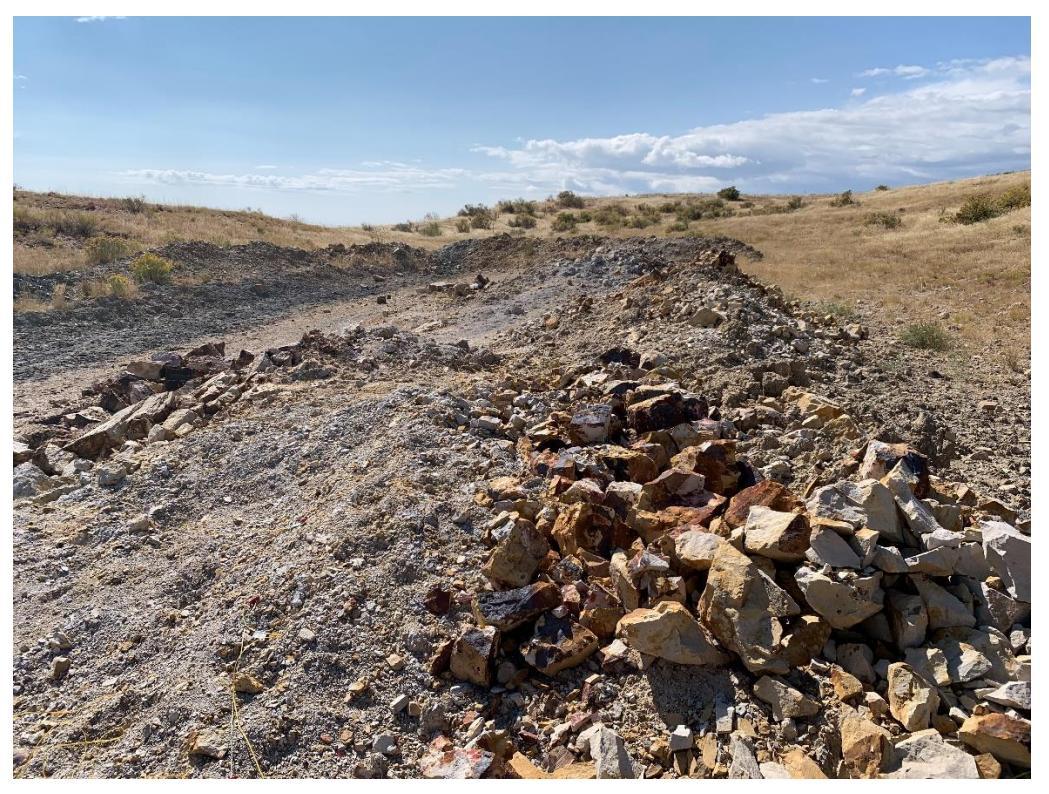
No mining equipment was on site. The current disturbance is about 2 acres in size (photo 2). A small section in the disturbed area had been recently blasted. The blasted area is approximately 1/8 acre. The purpose of the blast was to get some material samples. The blasted material was still in its original position and had not been stockpiled.

Photo 2 - Disturbed area, blasted area in foreground
