Bowie 2 inspection report

Permit Number: C-1996-083 Mine Name: Bowie No. 2 Mine Operator: Bowie Resources, LLC Operator Address: Mr. Basil Bear P.O. Box 1488 Paonia, CO 81428 County: Delta Operation Type: Underground Permit Status: Active Ownership: Private

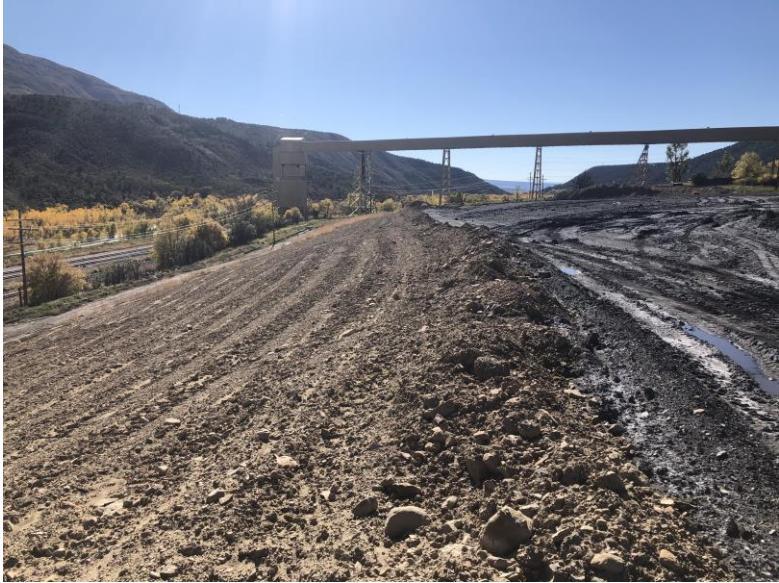
BRL continues to focus their efforts on Gob Pile #3. During the inspection, the crew was moving cover material from the pile at the east side of Gob Pile #3 and moving it to the southwest corner. Other recent efforts have been to prepare the pile for winter, adjusting material to prevent ponding or other issues.

Gob Pile #3 – southwest corner where coverfill material has been recently placed

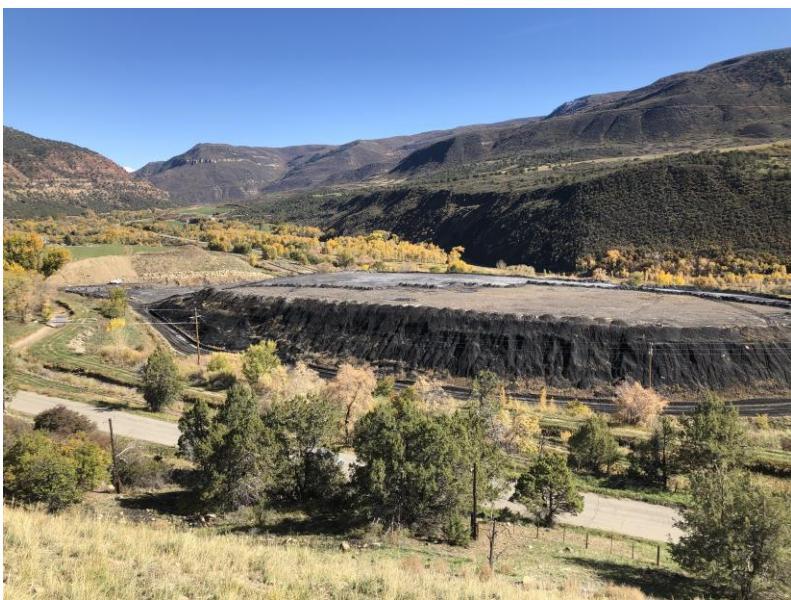
No issues were seen at Gob Pile #3, where BRL staff have been focusing their reclamation activities. All material has been removed from the drying area on the east side, and this area has been graded to achieve positive drainage. Small puddles on top are due to recent rains, but these do not appear to be problematic.

Gob Pile #3 from road above

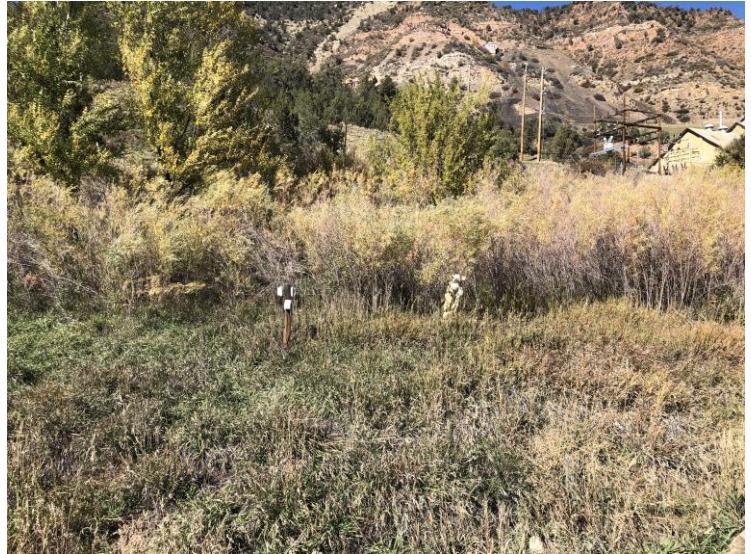
Basil Bear pointed out the location north of Gob Pile #3 where data is collected for the vibrating wire piezometers that are within the pile.

Data collection location for VWPs under Gob Pile #3

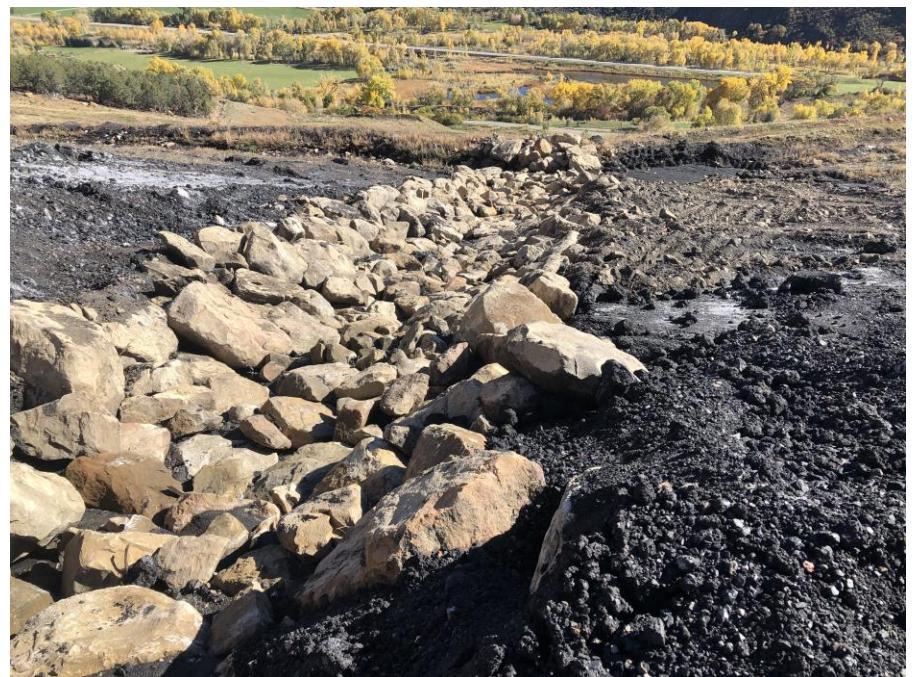
All gob piles looked stable, with no significant erosion. No puddles were observed on Gob Pile #2. Channel T-F1, which replaced a "smart" ditch on Gob Pile #2 and is the subject of MR-206, appeared to be constructed well.

Ditch T-F1 on Gob Pile #2 (recently constructed to replaced "smart" ditch)

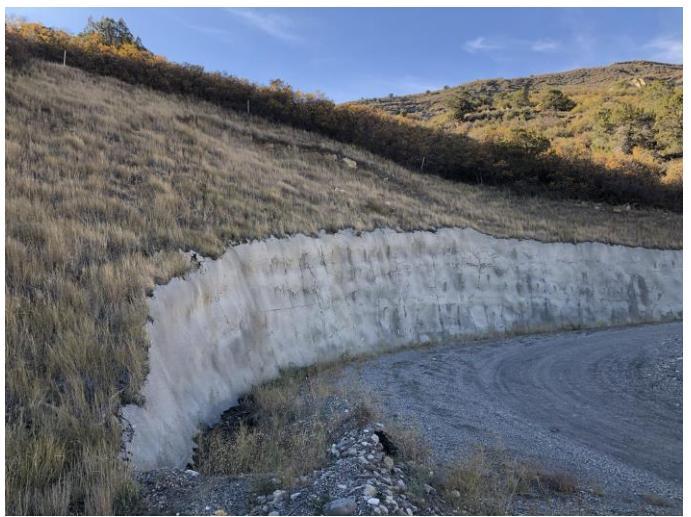
Slump at Curve 11

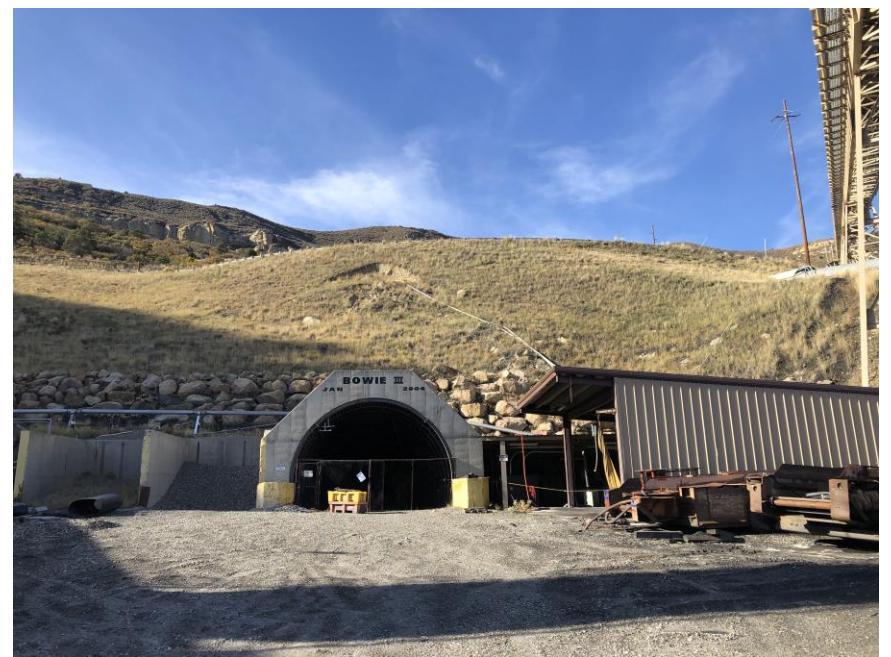
Please see attached report for the Bowie No. 2 Mine. I did not remember to discuss this with you yesterday, but please look at the slump above the B Portal. It looks to me like it is getting worse and requires maintenance.

It appears that the slump above the B Portal has gotten worse. This requires attention by BRL.

Slump above B Portal bench – appears to be worse
