MINERALS PROGRAM INSPECTION REPORT PHONE: (303) 866-3567

MINE NAME:	MINE/PROSPECTING ID#:	MINERAL:	COUNTY:	
Lyons Pit	M-2021-018	Gravel	Fremont	
INSPECTION TYPE:	INSPECTOR(S):	INSP. DATE:	INSP. TIME:	
Preoperation Inspection	Timothy Cazier, P.E.	July 21, 2021	14:30	
OPERATOR:	OPERATOR REPRESENTATIVE:	TYPE OF OPERATION:		
Mountain Valley Excavating LLC	Ed & Vi Lyons	110c - Construction Limited Impact		
REASON FOR INSPECTION:	BOND CALCULATION TYPE:	BOND AMOUNT:		
Preoperation Inspection	Complete Bond	No Bond Held		
DATE OF COMPLAINT:	POSTINSP. CONTACTS:	JOINT INSP. AGE	NCY:	
NA	U.S.BLM	U.S.BLM		
WEATHER:	INSPECTOR'S SIGNATURE:	SIGNATURE DAT	E:	
Cloudy	Thing alf-	November 4, 2021

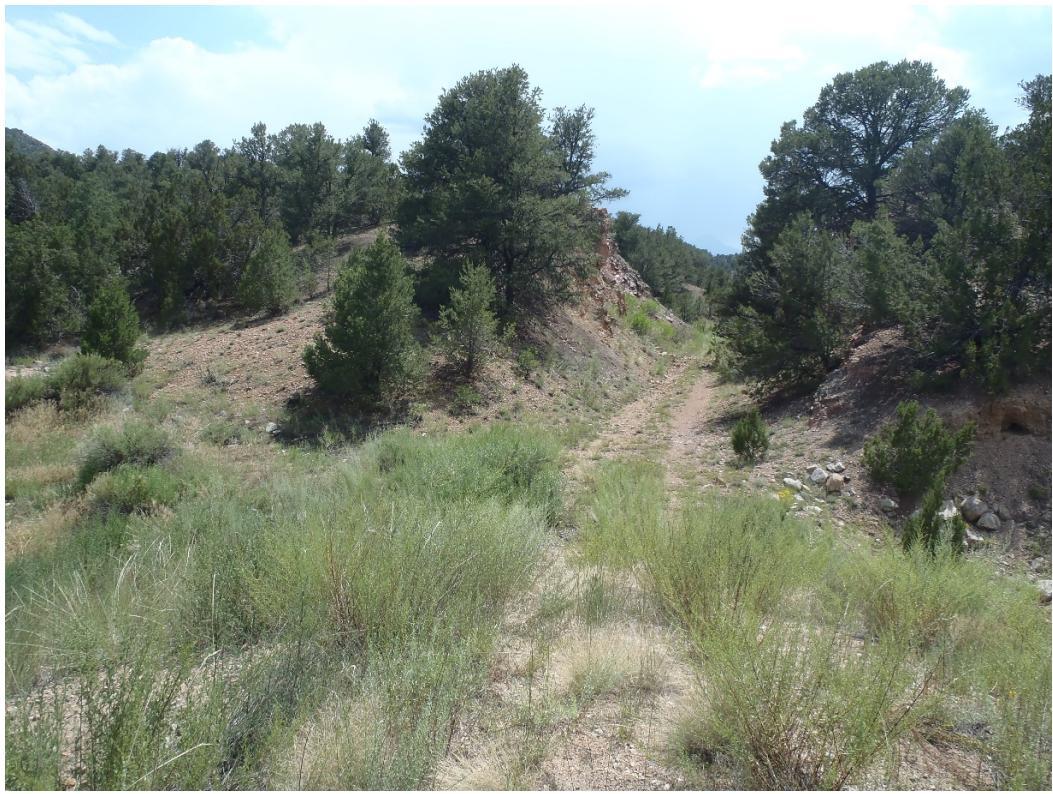
<u>Roads:</u> The site was accessed via existing two-track roads (see **Photo 1**) that are not in the permit boundary. MVE has proposed a new, more direct access road from Hwy 69 (see **Photos 2** and **3**).

Photo 1. Existing two-track road from near NW corner of permit area (looking SW).

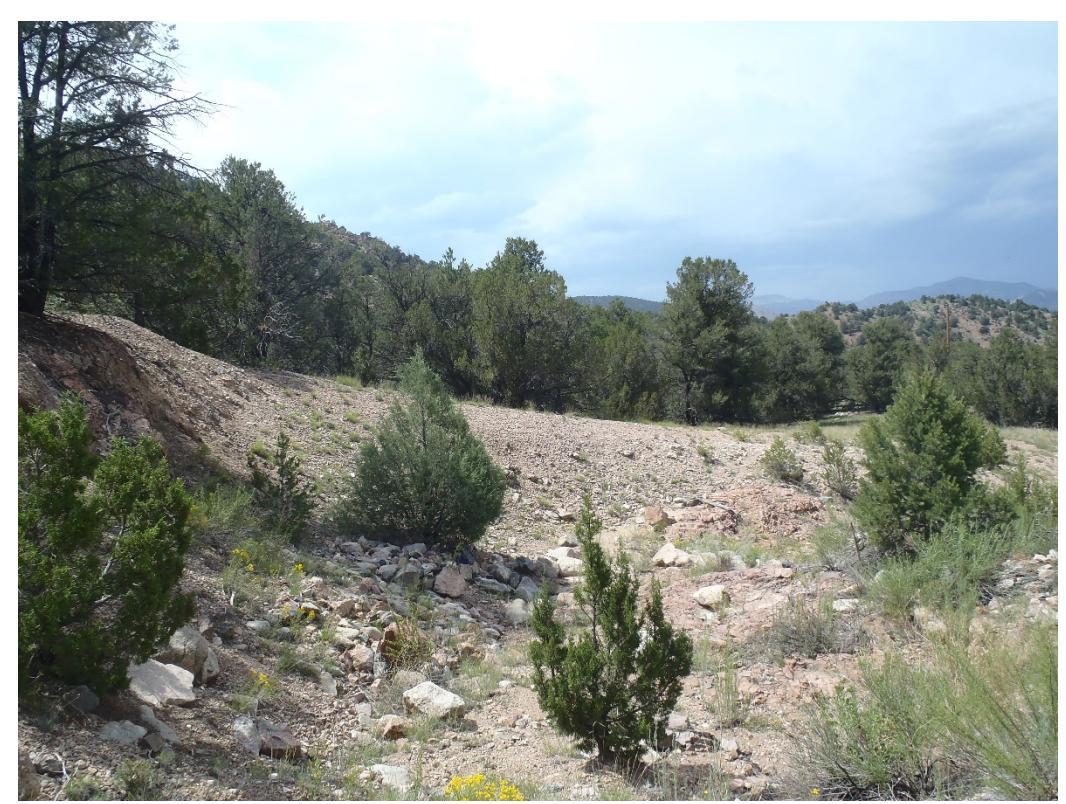
Photo 2. Proposed new access from Hwy 69 (looking NW from RR grade near NW permit corner).

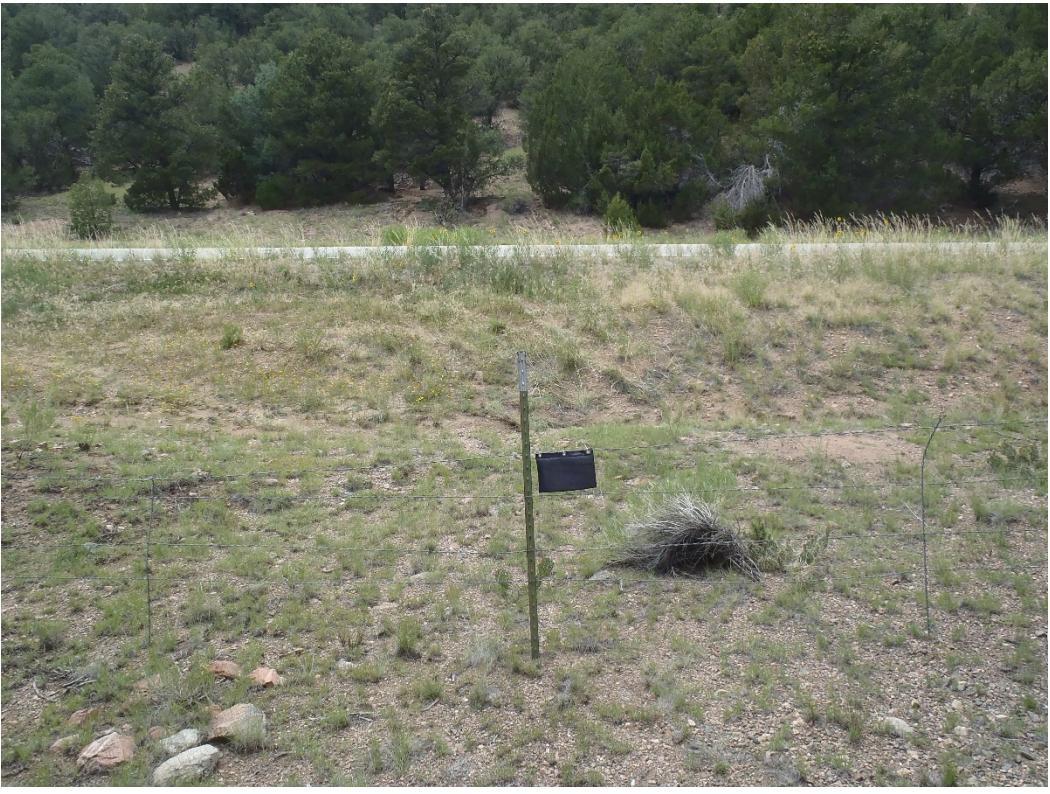
Photo 3. Proposed new access from Hwy 69 (looking west towards Hwy 69).

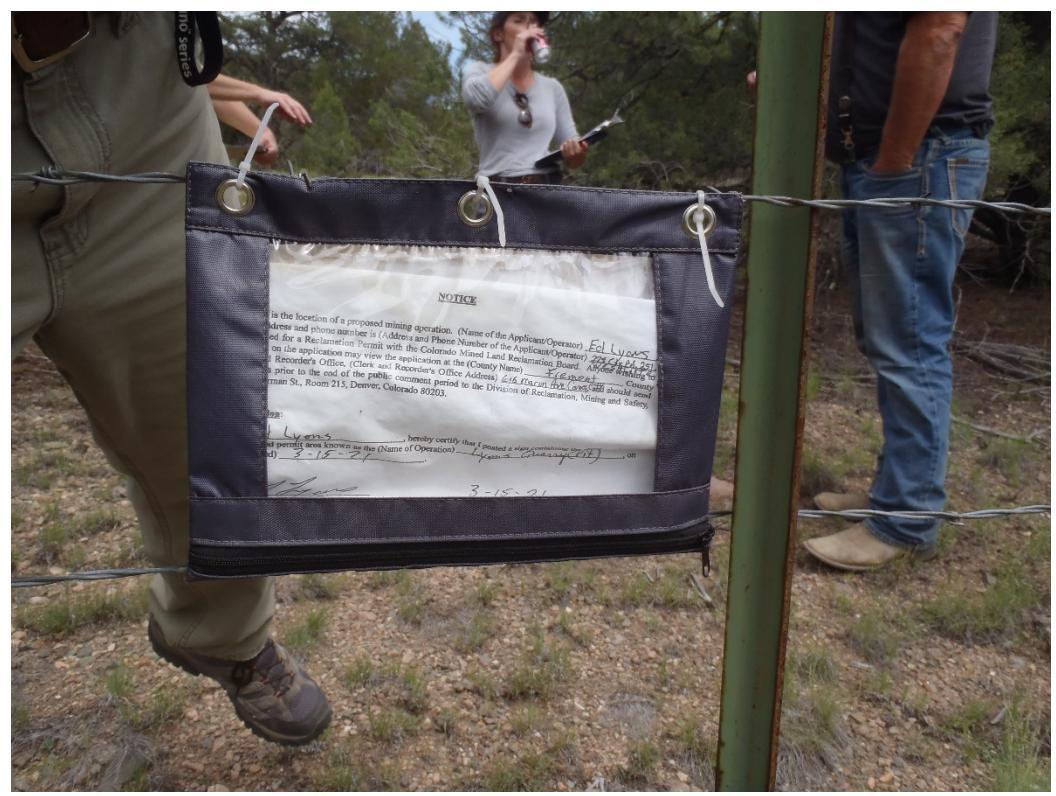
Signs and Markers: The notice was properly posted (see Photo 4) at the proposed new entrance.

Photo 4. Notice at proposed site entrance (looking east).

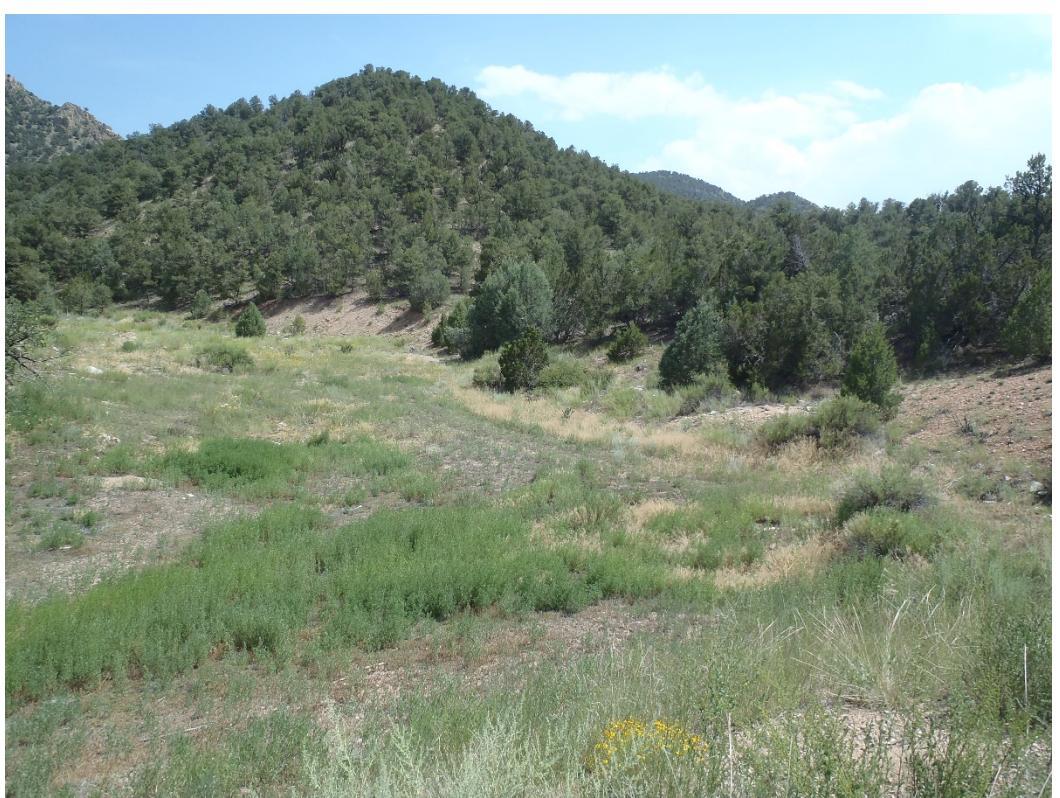
<u>Topsoil</u>: Topsoil in the proposed mine area (see **Photo 5**) was observed to be considerably less than 18 inches as indicated by the soils report submitted with the application.

Photo 5. Area to be mined - essentially treed area, note bare soil between grassed and treed areas (looking SE from railroad grade on the NW corner of permit area).
