# MINERALS PROGRAM INSPECTION REPORT PHONE: (303) 866-3567

MINE NAME:		MINE/PROSPECTING ID#:	MINERAL:	COUNTY:
Hokestra Gravel Pit		M-1980-149	Sand and gravel	Weld
INSPECTION TYPE:		INSPECTOR(S):	INSP. DATE:	INSP. TIME:
Monitoring		Peter Hays	December 16, 2021	13:00
OPERATOR:		<b>OPERATOR REPRESENTATIVE:</b>	TYPE OF OPERATION:	
Weld County Public Works		Jeff York	112c - Construction Regular Operation	
<b>REASON FOR INSPECTION:</b>		BOND CALCULATION TYPE:	<b>BOND AMOUNT:</b>	
Normal I&E Program		None	\$0.00	
DATE OF COMPLAINT:		POST INSP. CONTACTS:	JOINT INSP. AGENCY:	
NA		None	None	
WEATHER:	INSPECTOR'S SIGNATURE:		SIGNATURE DATE:	
Clear	Athy		February 7, 2022

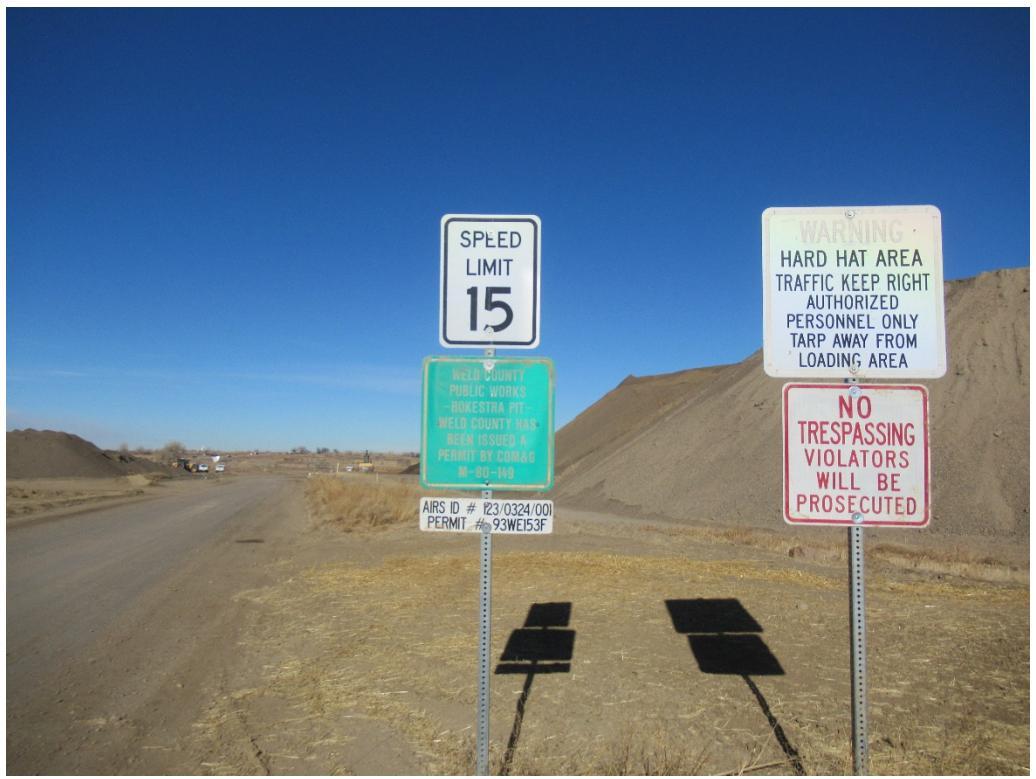
The mine sign and boundary markers were observed as required by Rule 3.1.12. A financial warranty is not held by the Division for the site.

Hokestra Gravel Pit mine sign

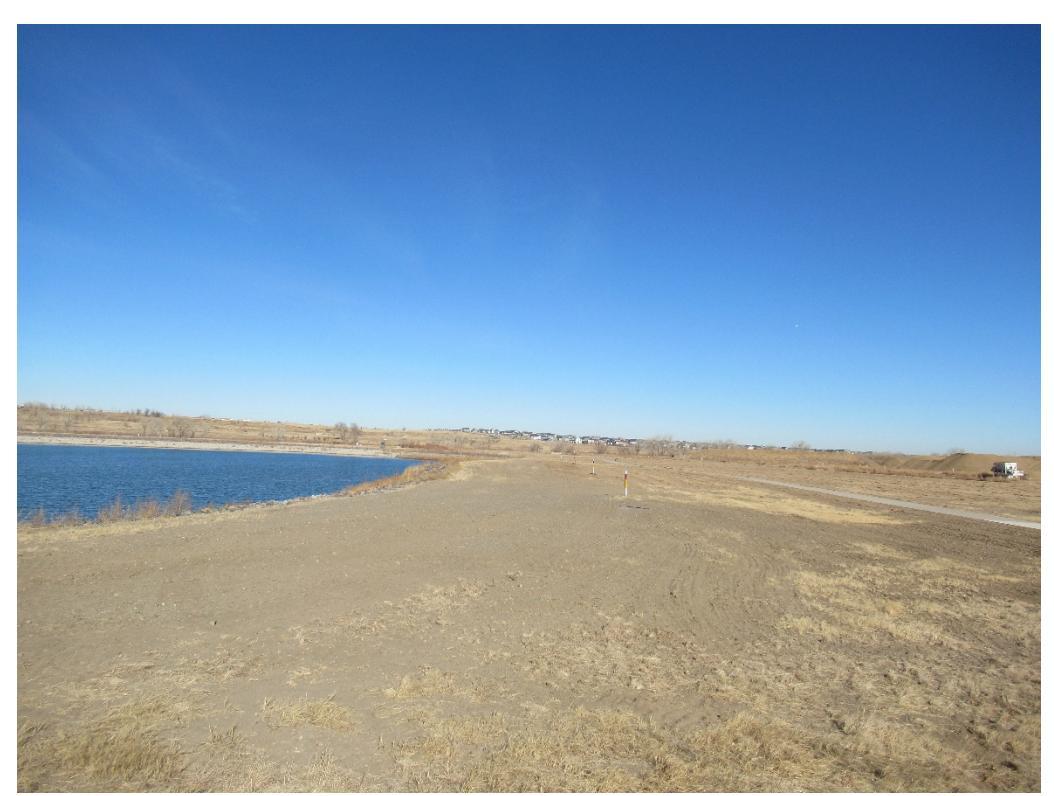
Phase 2 is located in the northwest corner of the site and consists of a clay lined reservoir. The Operator has not submitted the Office of the State Engineer (SEO) approval letter for the clay liner to the Division. The reservoir was partially filled at the time of the inspection. The perimeter of the reservoir has been riprapped with the exception of the eastern shoreline. The riprap is required as part of the flood mitigation measures for the site. The required spillways between Phase 2 and 4 and Phase 4 and the St. Vrain River have not been constructed to date. The upland areas around the reservoir are vegetated with reclamation grasses. The vegetation on the north and south sides of the reservoir appeared to be well-established in the current dormant and recently mowed status. The vegetation on the east and west side of the reservoir consisted of poorly established grasses with bare areas. The Operator reported the areas were reseeded three weeks ago. The perimeter drain along the western side of the phase is installed as indicated in construction report by Brierley Associates dated October 30, 2014.

View of the Phase 2 eastern upland area from the southeast corner looking north

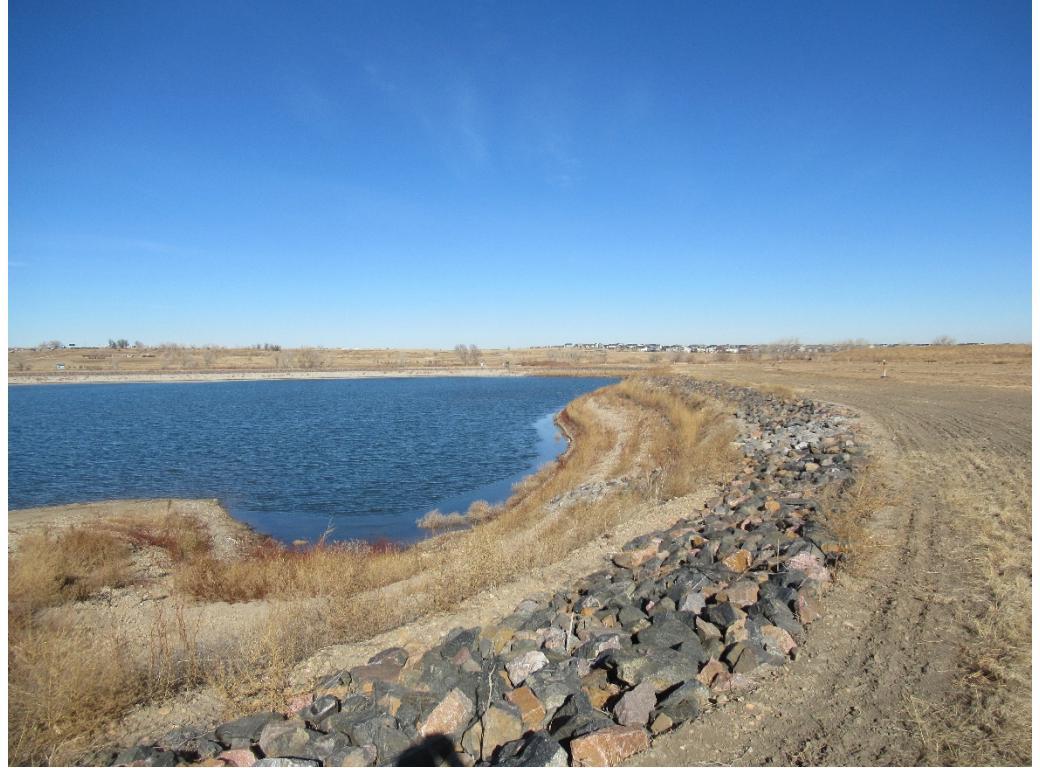
View of the Phase 2 shoreline from the southeast corner looking north

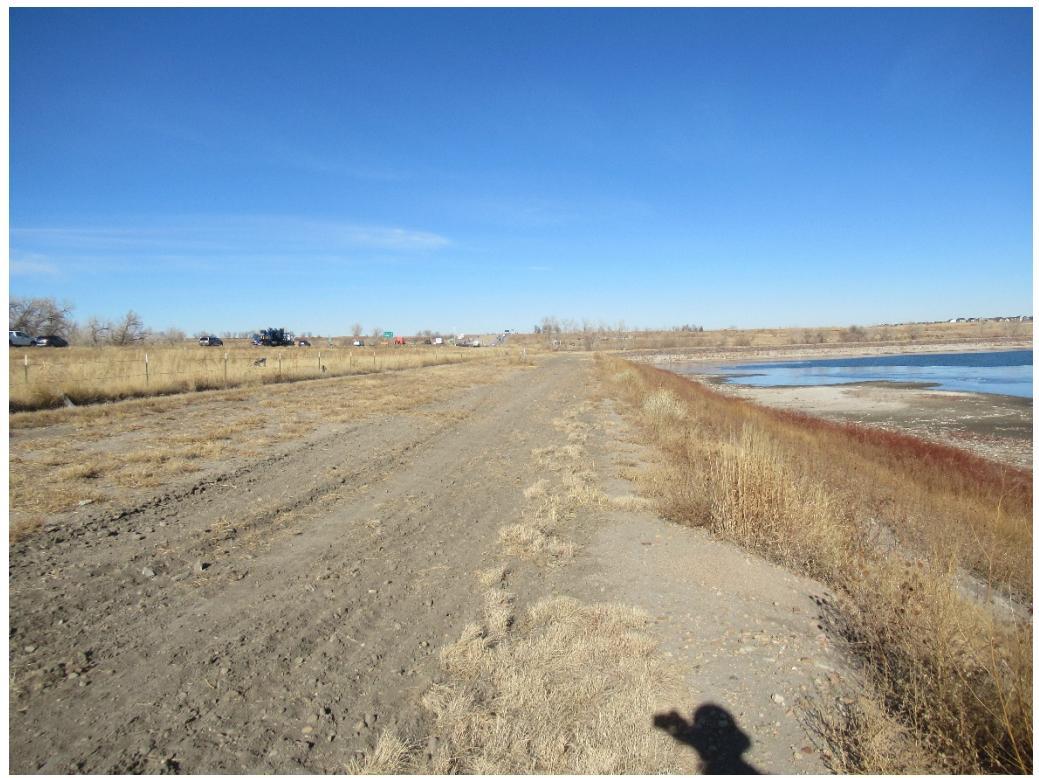
View of the Phase 2 western upland area from the southwest corner looking north

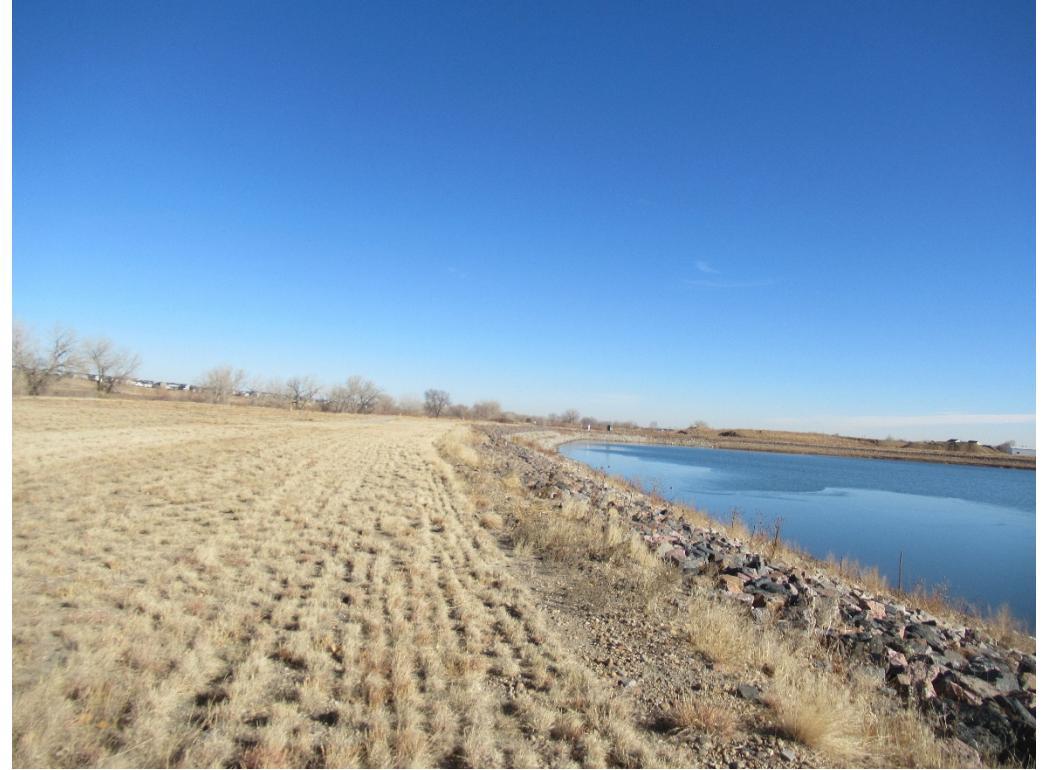
View of the Phase 2 northern upland area from the northwest corner looking east

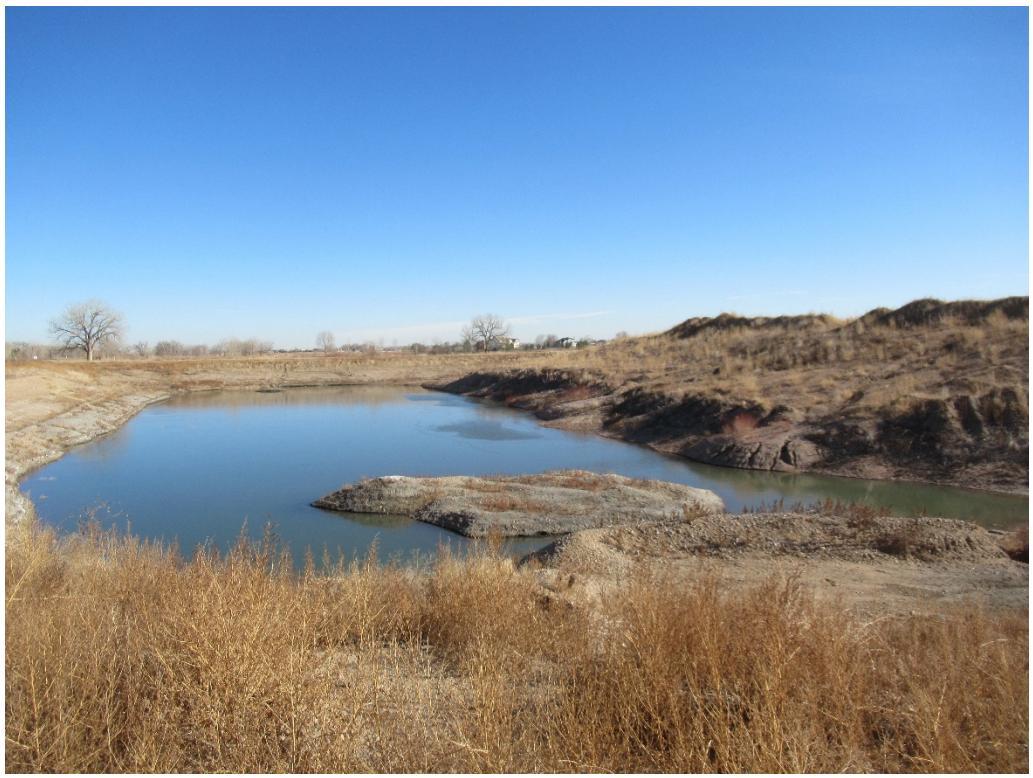
Phase 4 is located east of Phase 2 and north of Phase 3 in the northeast corner of the site and consists of a slurry wall lined reservoir. The Operator has not submitted the SEO approval letter for the slurry wall to the Division. The location of the slurry wall centerline was marked on all sides with white posts. The phase was inactive at the time of the inspection. The northern portion of the phase is partially mined and was partially filled with water. The current pit floor contained a stockpile of imported material for another Weld County mine site. A topsoil stockpile was observed in the southwest corner of the phase.

View of Phase 4 from the northwest corner looking east

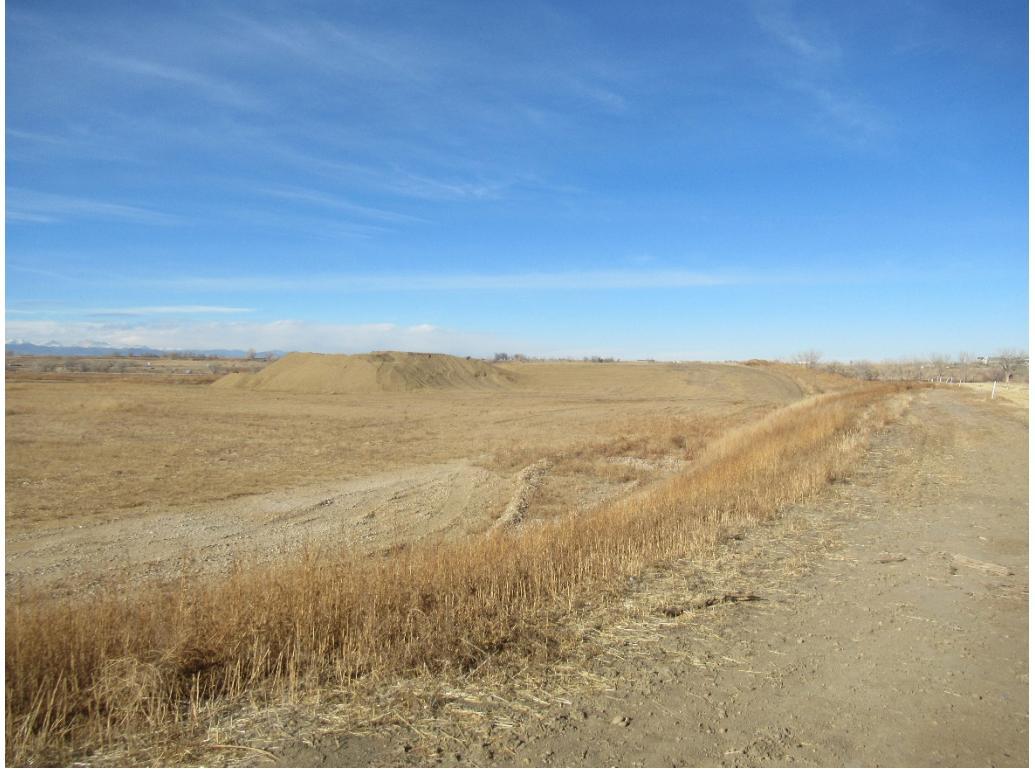
View of Phase 4 from the southeast corner looking northwest

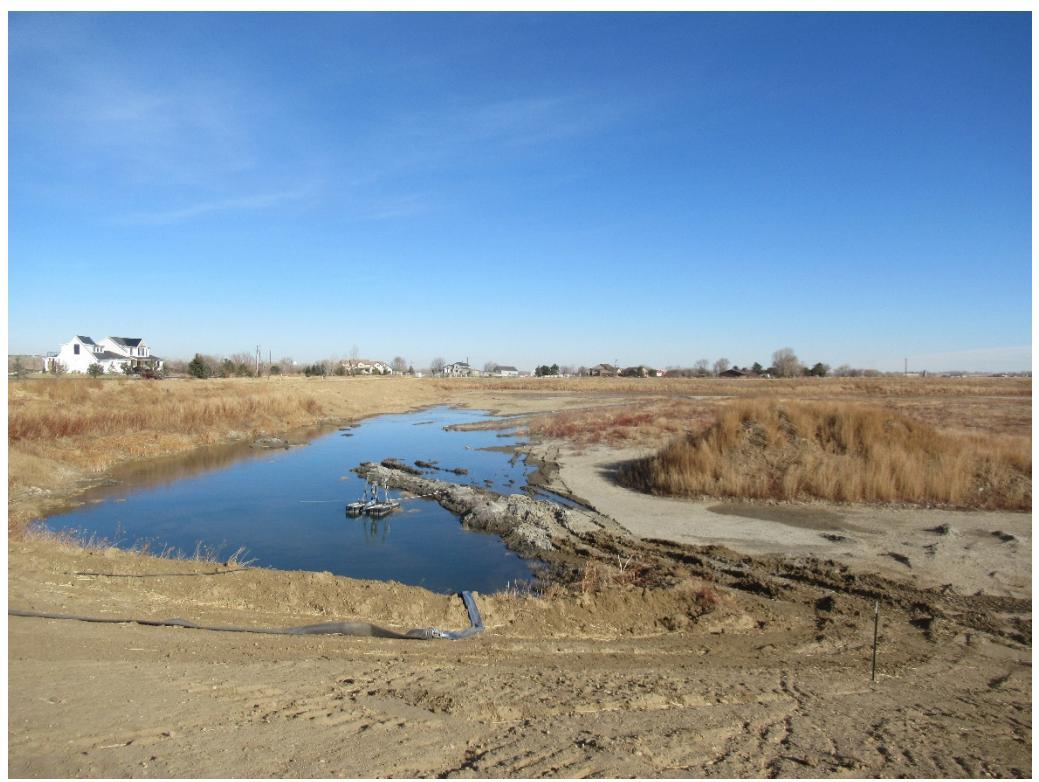
The parcel east of Phase 3 (Phases 5 and 6) was mined and reclaimed to slurry lined reservoir several years ago. The Operator has not submitted the SEO approval letter for the slurry wall to the Division. The Division will require proof of SEO approval for the slurry wall prior to consideration of any future release requests. The area has been re-mined to create a single reservoir instead of two separate reservoirs. The reservoir was dewatered at the time of the inspection to allow the reservoir owner to complete repair to the leaking slurry wall along the southern portion of the reservoir. The upland areas around the reservoir were recently seeded by the Operator.

View of Phases 5 and 6 from the northwest corner looking east

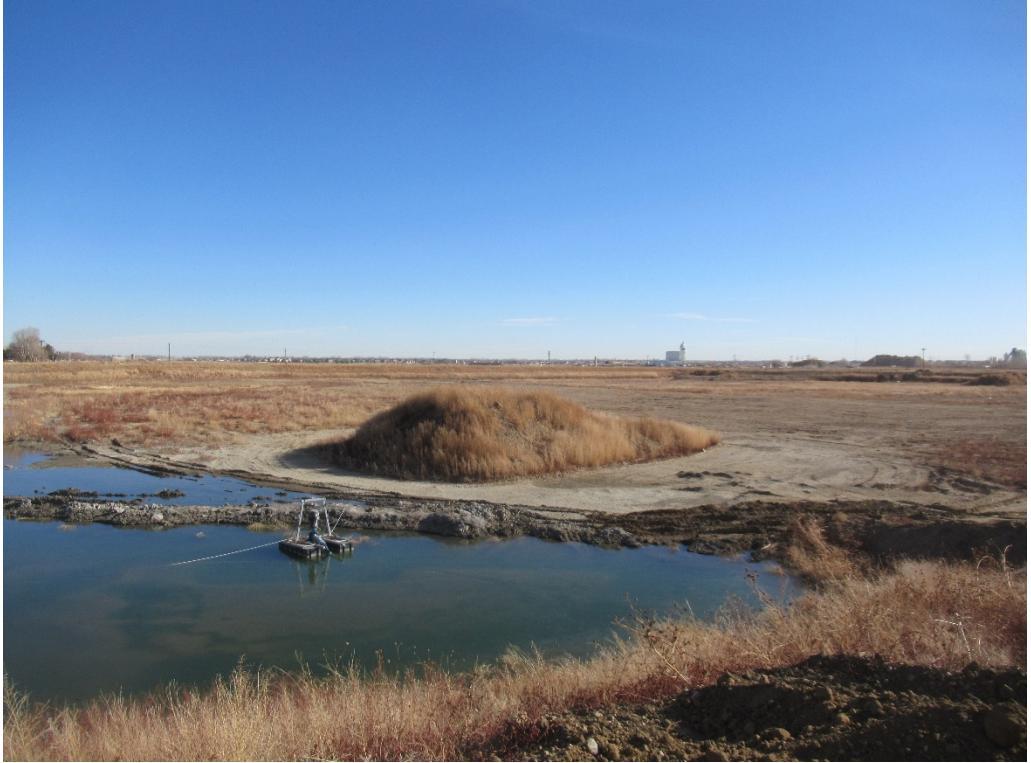
View of Phases 5 and 6 from the northwest corner looking southeast

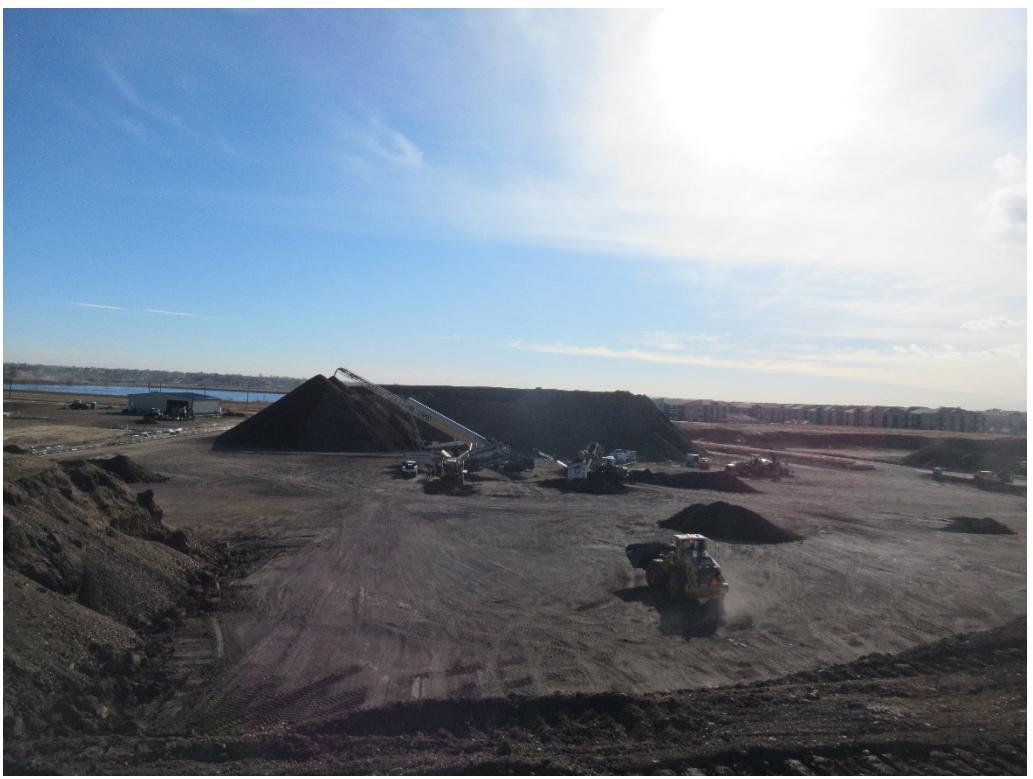
Phase 3 is located in the southeast corner of the site and consists of a slurry wall lined reservoir. The Operator has not submitted the SEO approval letter for the slurry wall to the Division. The location of the slurry wall centerline was marked on all sides with white posts. The phase has been stripped of topsoil and overburden, however mining excavation has not started in the phase. The phase is currently being utilized as a stockpile and processing area by the Operator. The stockpiles consisted of imported and native materials. The reservoir to the east of the phase will need to be dewatered before Phase 3 is mined, since the two areas are surrounded by a single slurry wall.

View of Phase 3 from the stockpile looking south
