MINERALS PROGRAM INSPECTION REPORT PHONE: (303) 866-3567

| MINE NAME: | | MINE/PROSPECTING ID#: | MINERAL: | COUNTY: |
|---|---|---|---|---|
| Wattenberg Lakes | | M-2004-051 | Aggregate | Weld |
| Monitoring | | Peter Hays | January 13, 2022 | 11:00 |
| Aggregate Industries - WCR, Inc. | | Neil Whitner, Wyatt Webster | 112c - Construction Regular Operation | |

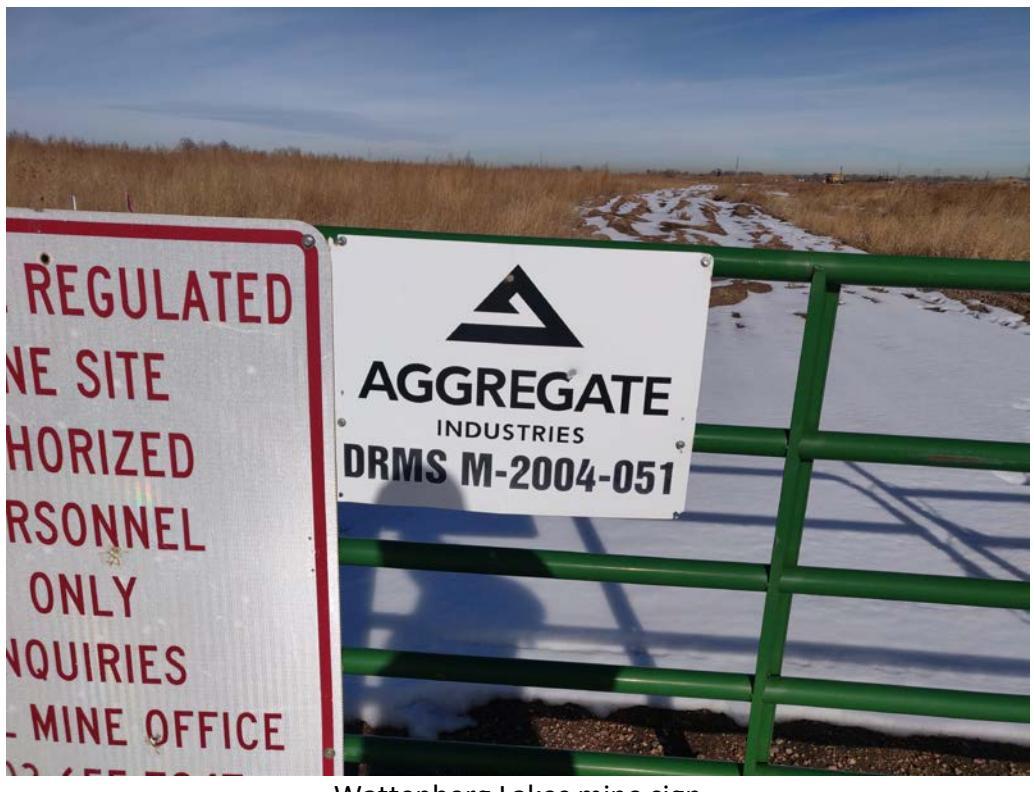
Wattenberg Lakes mine sign

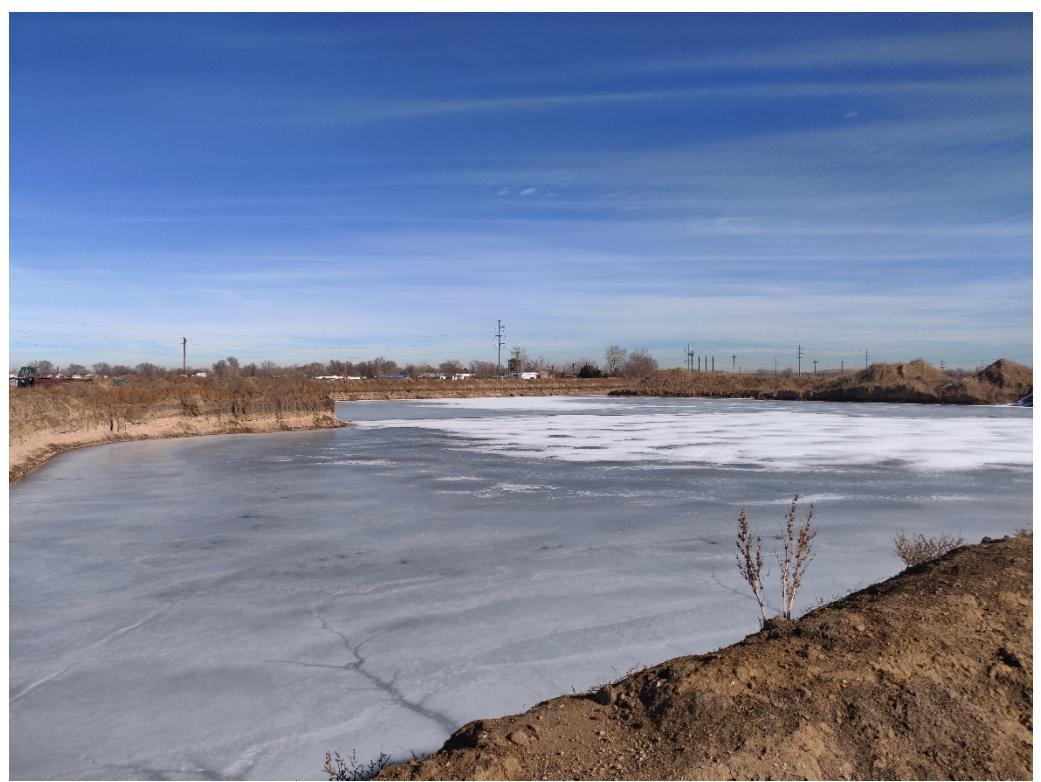
Phase 1 / Pond 2 Mining Area – The mining excavation in the area is mostly complete. The Operator stated the slurry wall was being designed by their consultant. The area was observed from the oil & gas pad during the inspection. The mining area was full of water at the time of the inspection.

View of the north portion of Phase 1 / Pond 2 Mining Area from the oil & gas pad

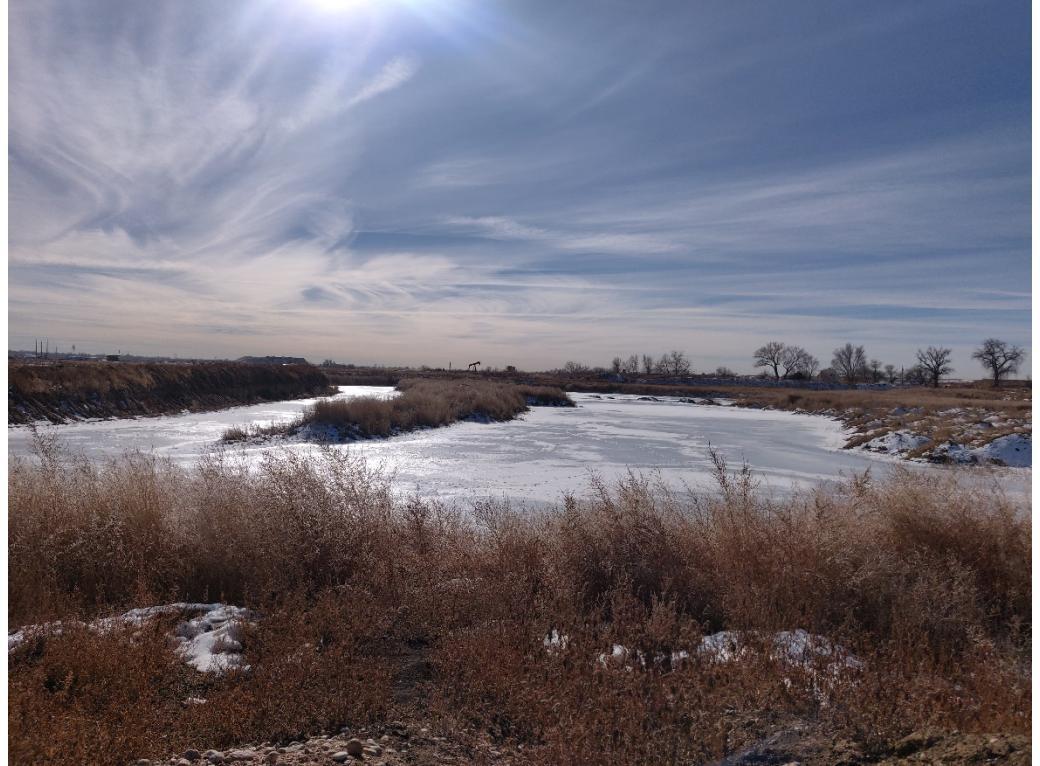
View of the south portion of Phase 1 / Pond 2 Mining Area from the oil & gas pad

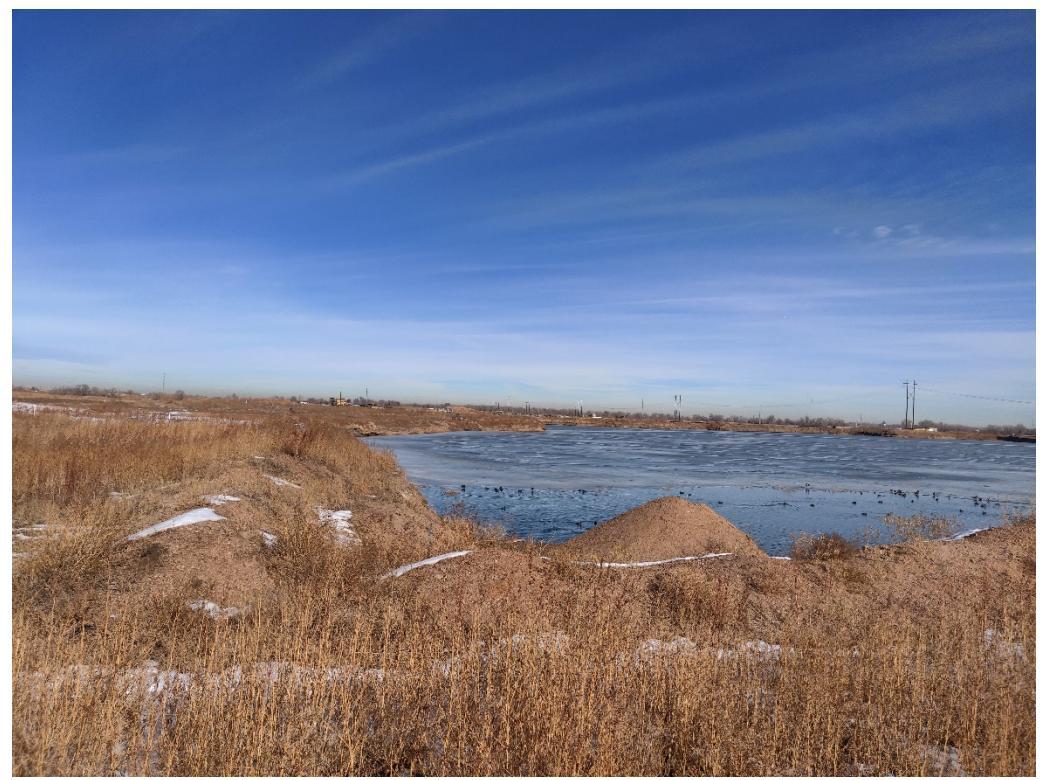
Phase 2 / Pond 1 Mining Area – The mining excavation in the area is mostly complete. The Operator stated the slurry wall was being designed by their consultant. The mining area was full of water at the time of the inspection.

View of the Phase 2 / Pond 1 Mining Area from the southwest corner looking north

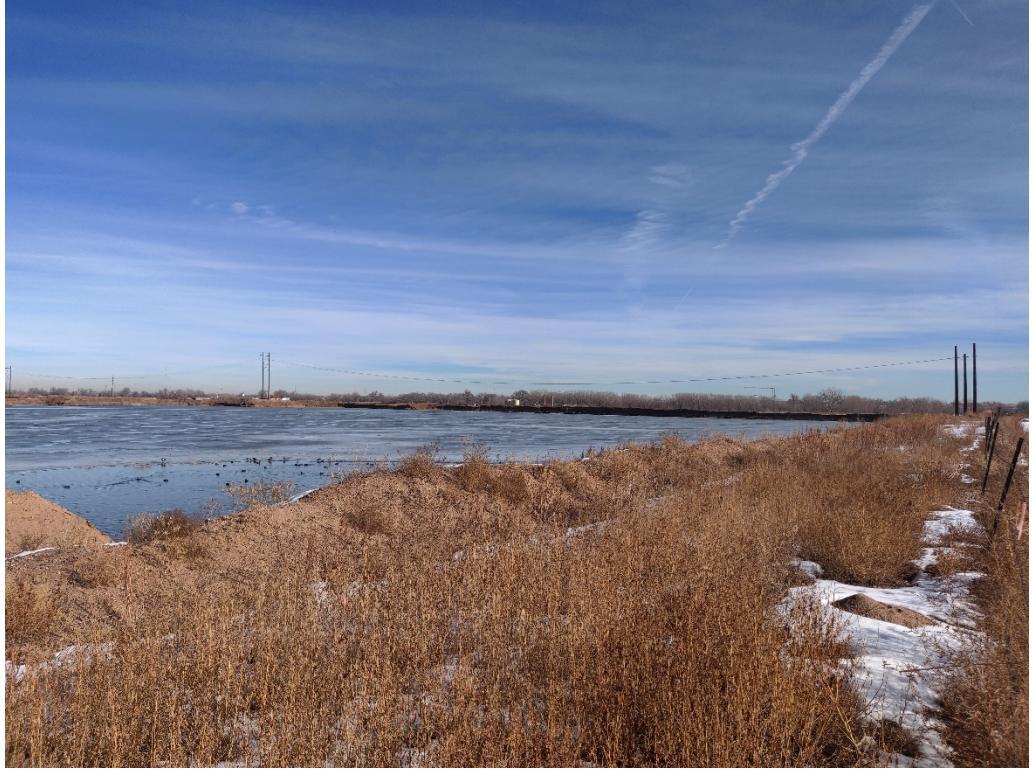
View of the Phase 2 / Pond 1 Mining Area from the southwest corner looking northeast

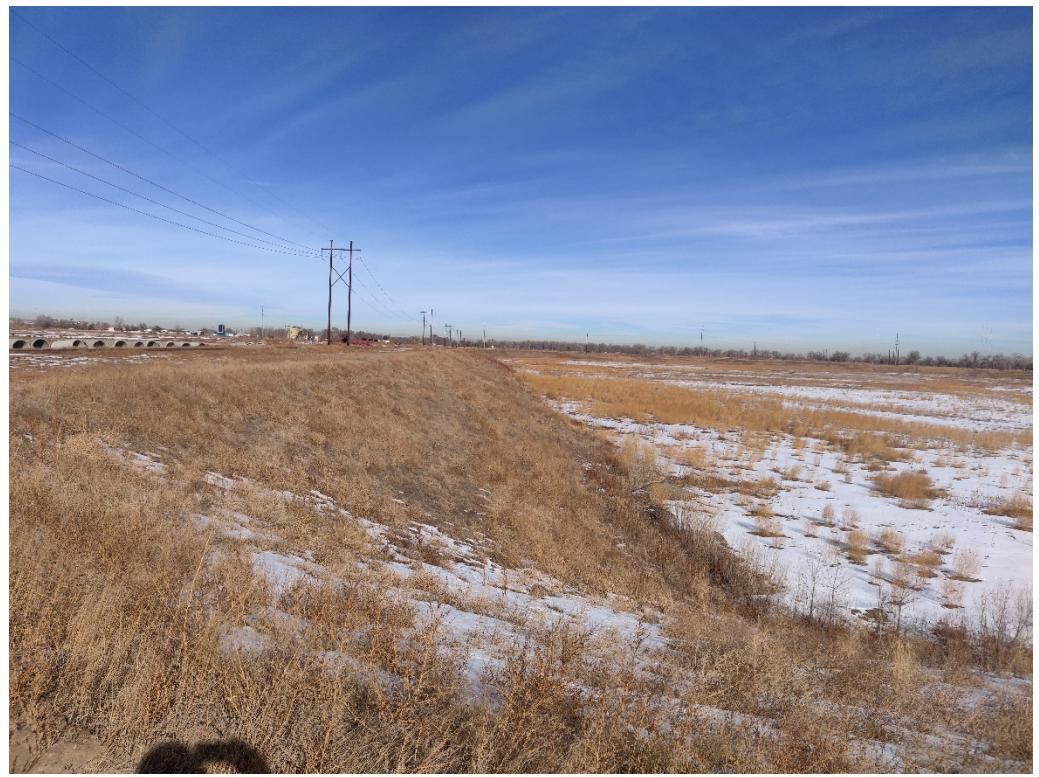
Phase 3 / Pond 3 Mining Area – The mining excavation is complete and the area is in final reclamation. The power line through the mining area was relocated and the powerline islands were mined by the Operator since the last inspection. The perimeter slopes were graded to the final 3H:1V slope. The slurry wall around Phase 3 / Pond 3 was installed in 2013. T-posts indicating the centerline of the slurry wall were observed during the inspection. The Division does not have proof of SEO approval of the slurry wall. The Operator will be require to provide the approval letter prior to any future release request for the mining area.

View of the Phase 3 / Pond 3 Mining Area from the southwest corner looking north

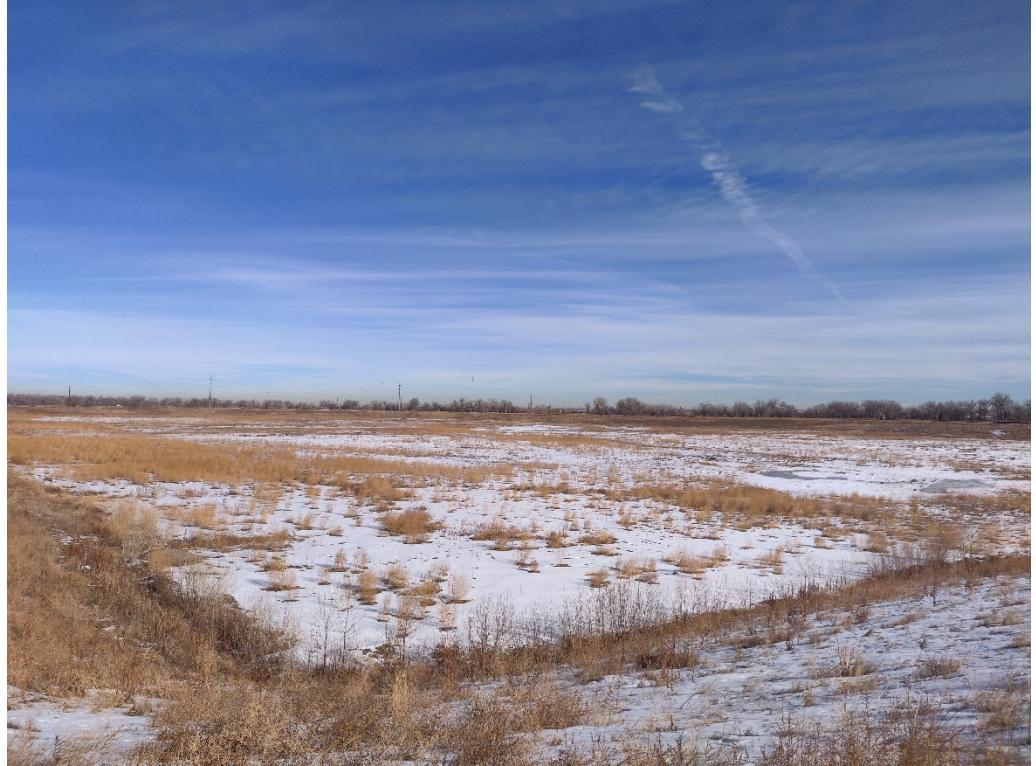
View of the Phase 3 / Pond 3 Mining Area from the southwest corner looking northeast

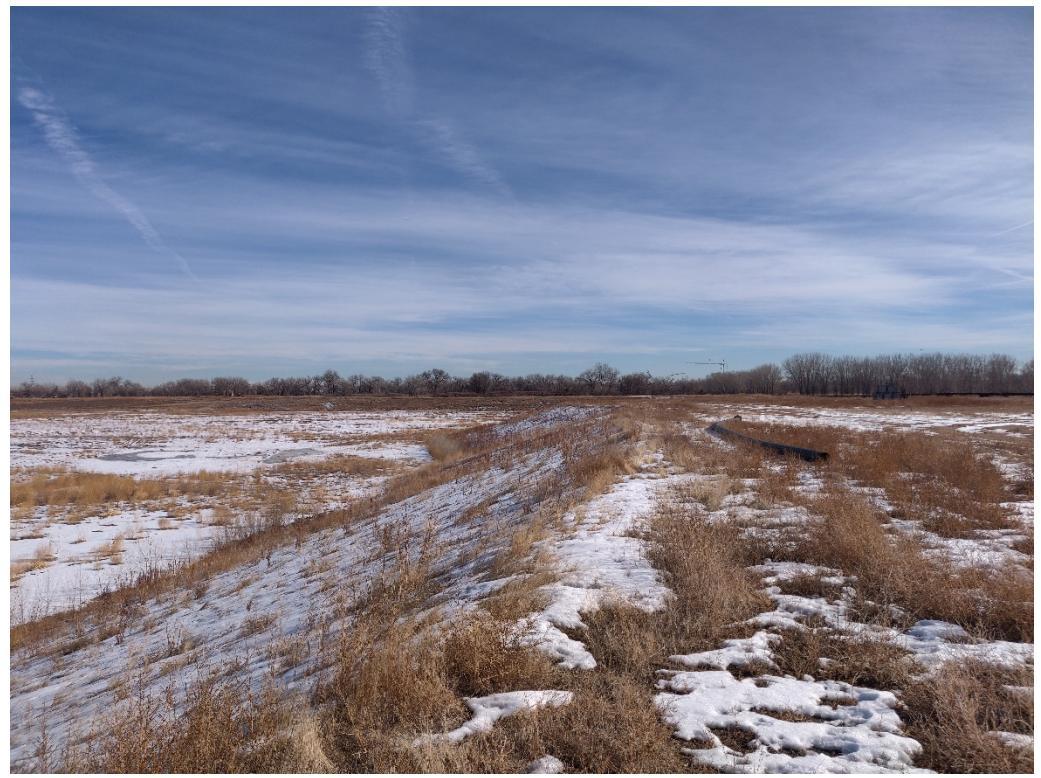
View of the Phase 3 / Pond 3 Mining Area from the southwest corner looking east

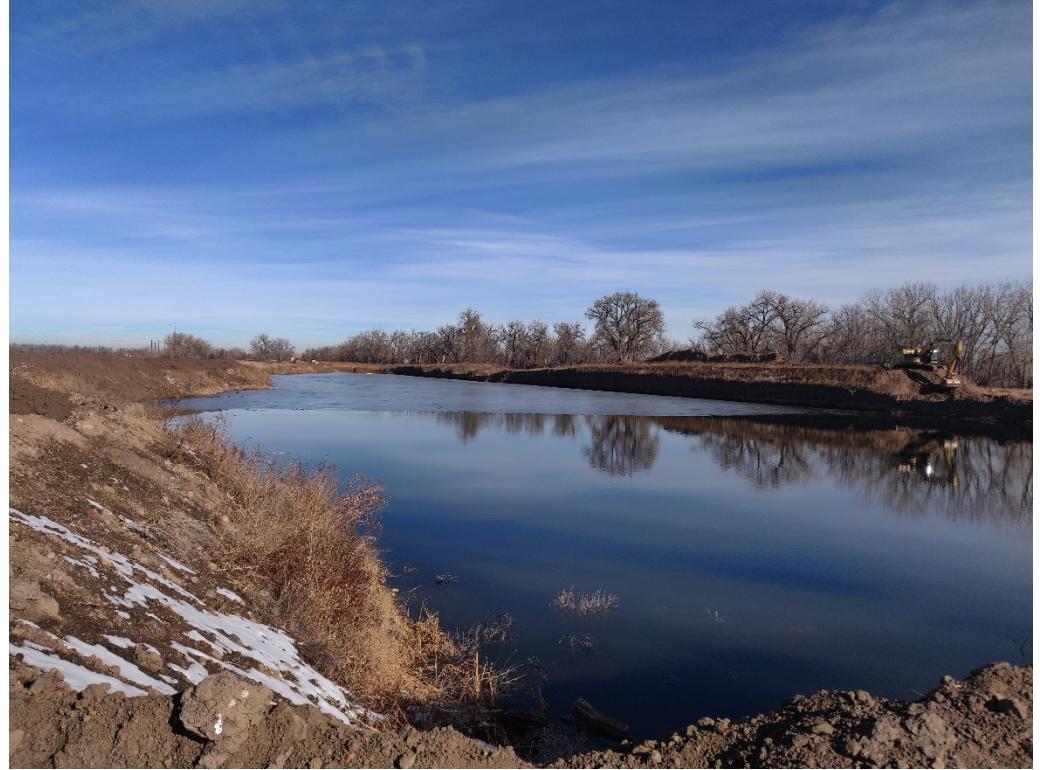
Phase 2 / Mining Area 1 – The mining excavation is complete and the area is being backfilled by the Operator. The final grading to create the approved wetland mitigation area will occur during final reclamation of the site. The Division perform a separate inspection of the area to investigate a complaint of off-site impacts occurring in the area. See the inspection report for CT1 for more information. The approved post-mining land use for the site is Developed Water Resource. As stated above, the slurry wall has been completed around the Phase 3 / Pond 3 Mining Area. The approved Reclamation Plan states all reservoir slopes will be reclaimed to at least a 3H:1V final grade. The slopes around the perimeter of Phase 3 / Pond 3 Mining Area appeared to be graded to 3H:1V, however the slopes were not measured by the Division. The Operator stated survey control was used while creating the slopes. The Division will require the Operator to verify the required 3H:1V slopes for the reservoirs by submitting survey data verifying the grading prior to Division consideration of any future final or partial release requests at the site.

View of the Phase 2 / Mining Area 1 area from the southwest corner looking northeast
