# MINERALS PROGRAM INSPECTION REPORT PHONE: (303) 866-3567

MINE NAME:		MINE/PROSPECTING ID#:	MINERAL:	COUNTY:
OakBrush Hill Gravel		M-2021-064	Aggregate, gravel an	Archuleta
INSPECTION TYPE:		INSPECTOR(S):	INSP. DATE:	INSP. TIME:
Monitoring		Lucas West	January 25, 2022	11:50
OPERATOR:		<b>OPERATOR REPRESENTATIVE:</b>	TYPE OF OPERATION:	
C & J Gravel Products, Inc.		Hank Boeschert	112c - Construction Regular Operation	
<b>REASON FOR INSPECTION:</b>		<b>BOND CALCULATION TYPE:</b>	BOND AMOUNT:	
Citizen Complaint		None	No Bond Held	
DATE OF COMPLAINT:		POST INSP. CONTACTS:	JOINT INSP. AGENCY:	
NA		None	None	
WEATHER:	INSPECTOR'S SIGNATURE:		SIGNATURE DAT	E:
Clear	AAM		February 9, 2022	
			- · ·	
	2

### PERMIT #: M-2021-064 INSPECTOR'S INITIALS: LJW INSPECTION DATE: January 25, 2022

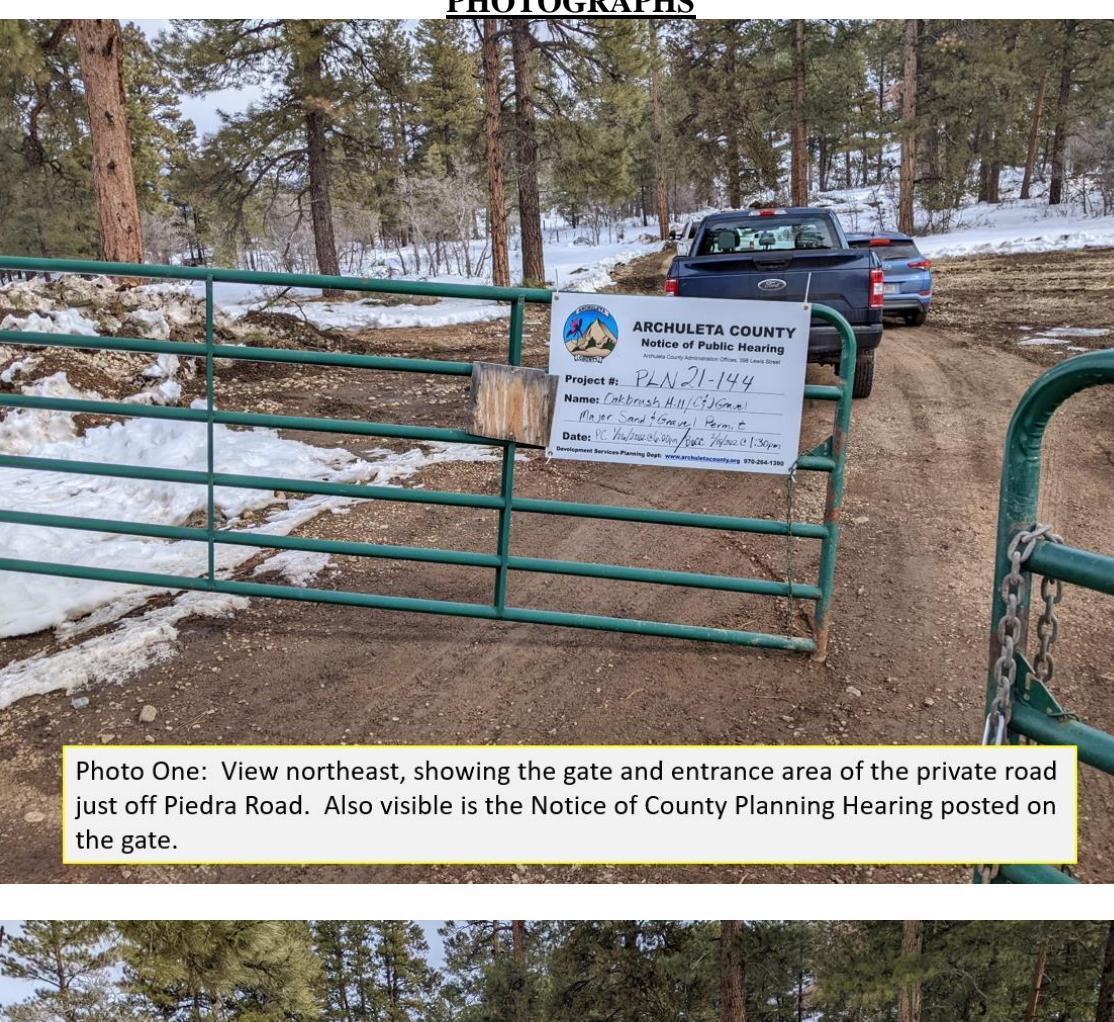
Access to the site is a locked gate off Piedra Road providing access to the private property. The entrance area can be seen in Photo One. The access road leads approximately 2,500 feet into the property leading to the area of excavation. Evidence of material being placed on the road to mitigate muddy conditions was observed, and examples can be seen in Photos Two and Three. During the inspection, conversations with the Applicant confirm that approximately 600 tons of material had been laid on the road, using the front end loader on site. No Dump or haul trucks were used in this activity. Evidence of dump or haul truck traffic was not observed on the road. All tracks observed appear to be from standard sized pickup trucks. The proper notice signs for the pending application were posted on the gate, at the entrance to the site as is required for the application process. The access road winds along the base of the ridge, turning south leading to the area of excavation.

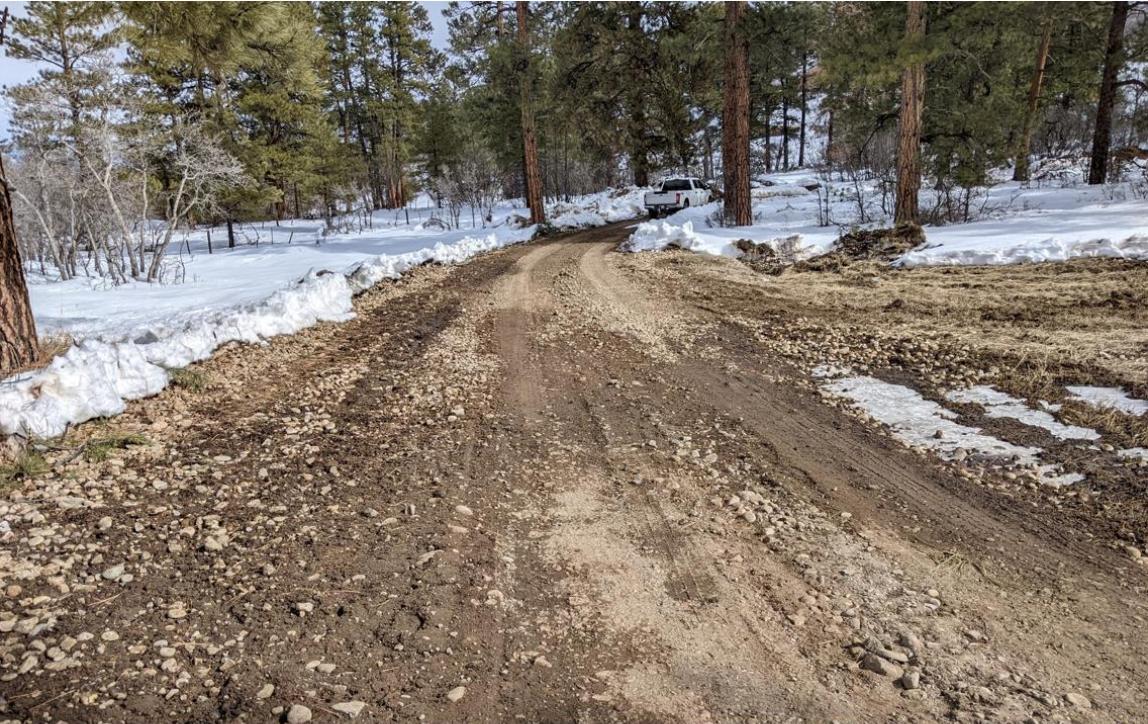
Photo Two: View northeast, showing the lower reaches of the access road. Evidence of application of crushed rock can be seen, however no evidence of dump or haul truck traffic was observed.

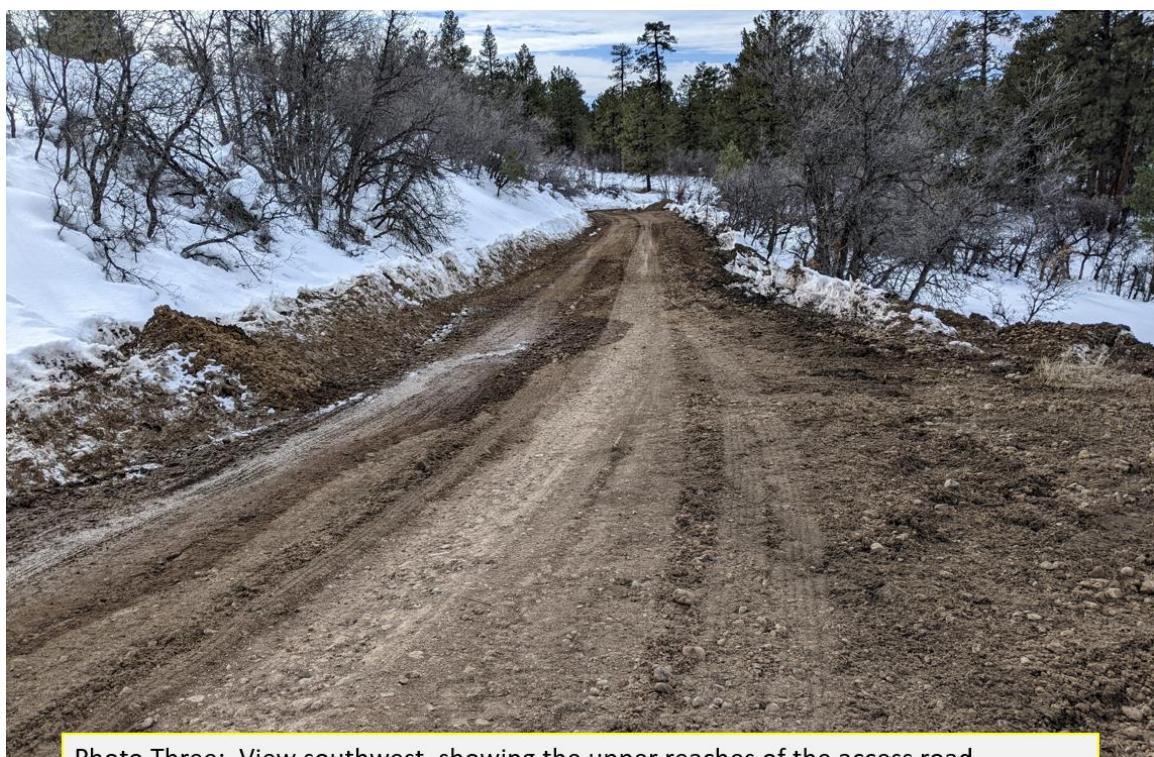
Photo Three: View southwest, showing the upper reaches of the access road. Evidence of material application was noted, and the road was in good condition at the time of inspection.

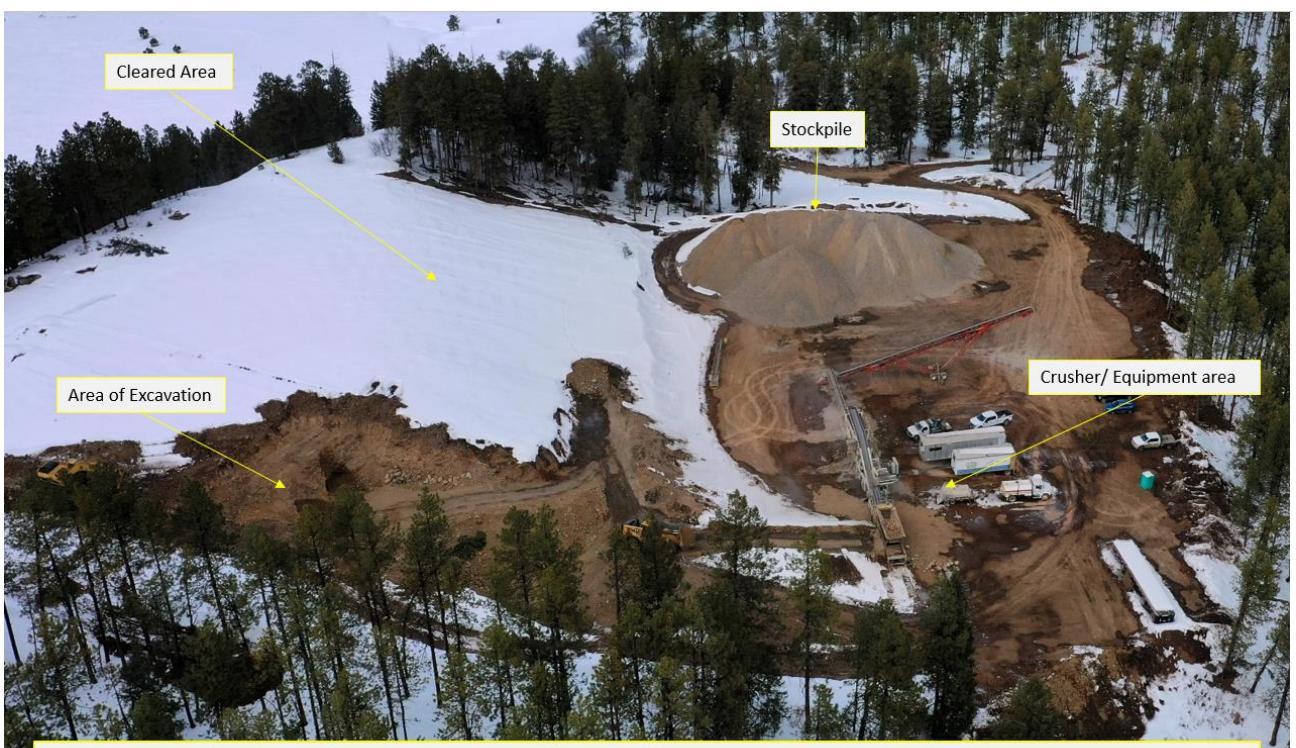
Photo Five: View north, showing an aerial image of the site as of the date of the inspection. The major features include; the area of excavation, crusher and equipment site, stockpiled material and area cleared for future excavation.

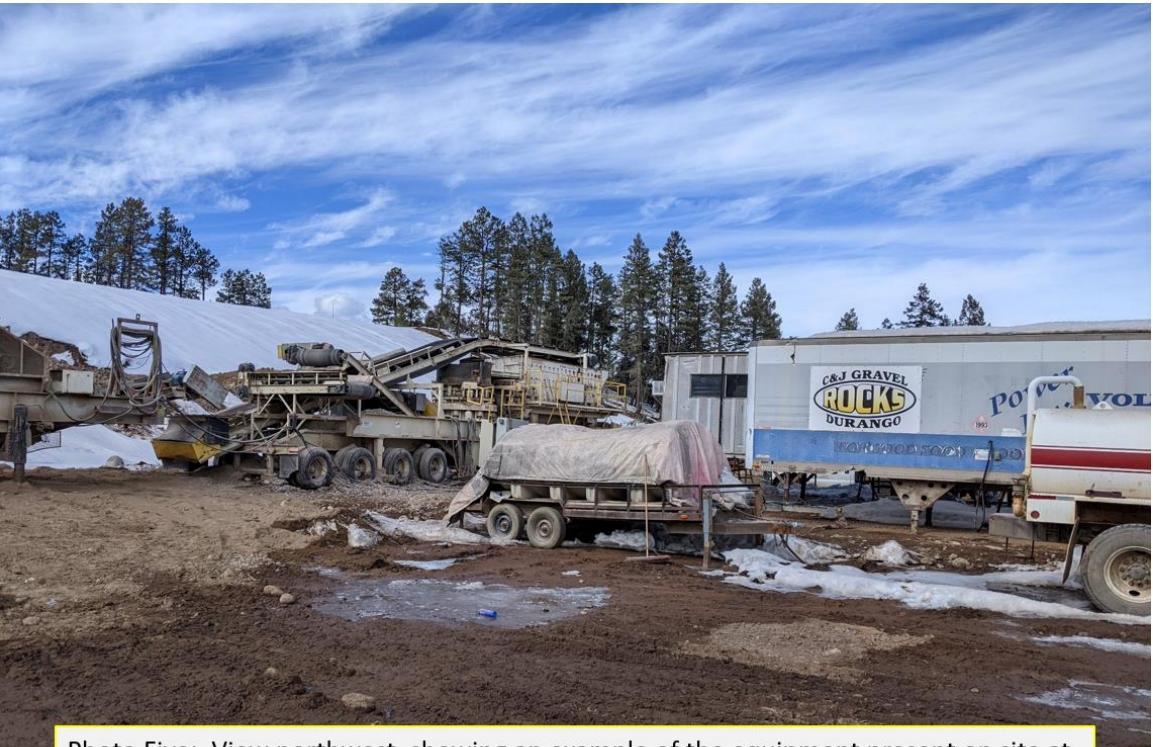
Photo Five: View northwest, showing an example of the equipment present on site at the time of the inspection. All equipment is typical of active material excavation and all equipment is in good condition.

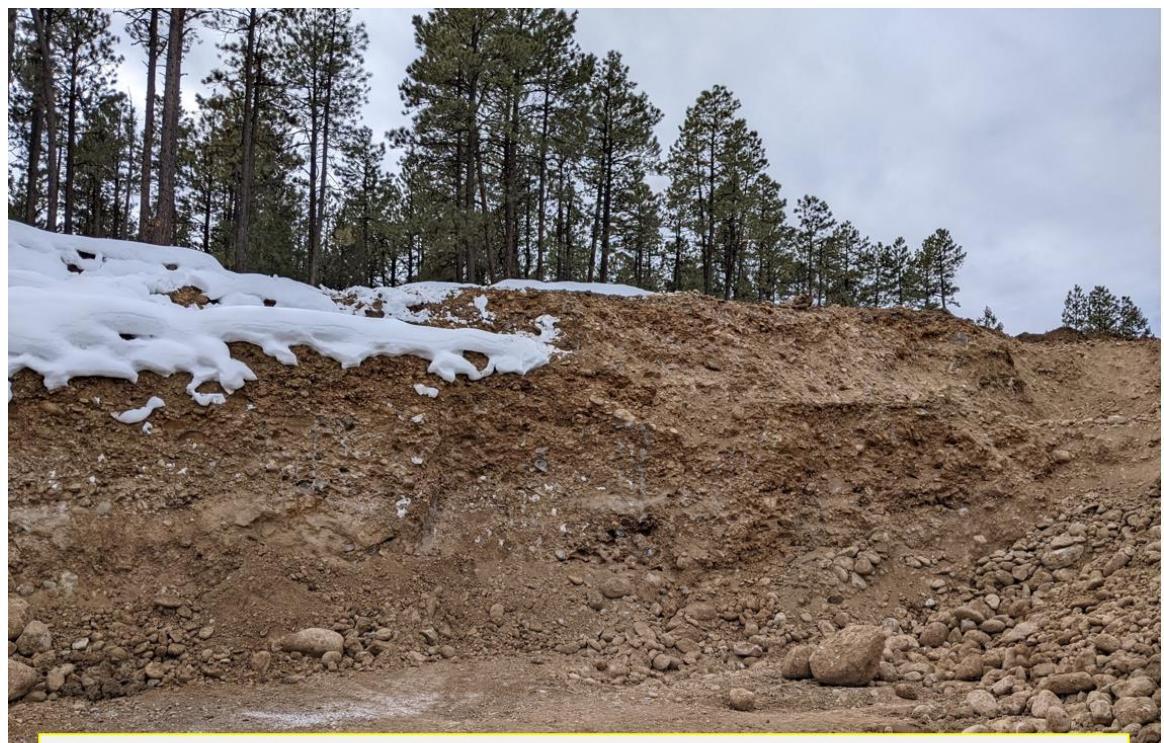
Photo Seven: View southwest, showing the lower highwall within the area of excavation. This highwall is approximately 20 feet tall and 40 linear feet long. The lower highwall appeared stable at the time of the inspection.

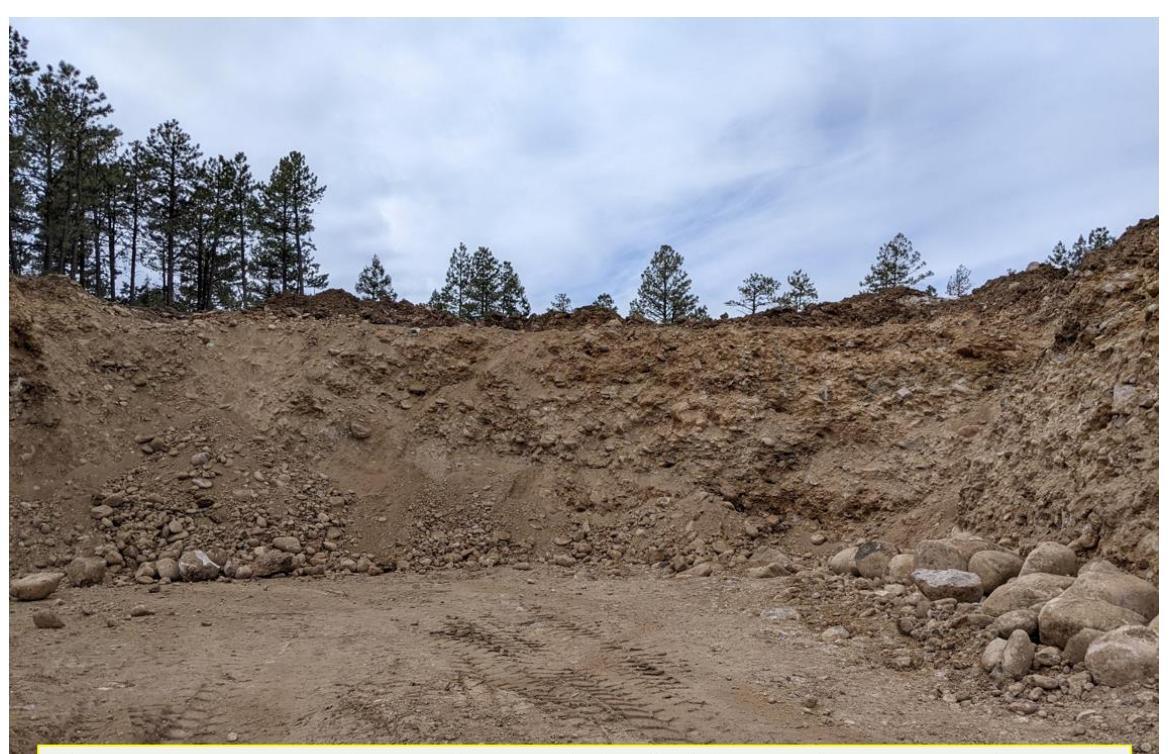
Photo Eight: View west, showing the upper highwall of the area of excavation. This highwall is also approximately 20 feet tall, with approximately 60 linear feet exposed. The upper highwall was also stable at the time of the inspection.

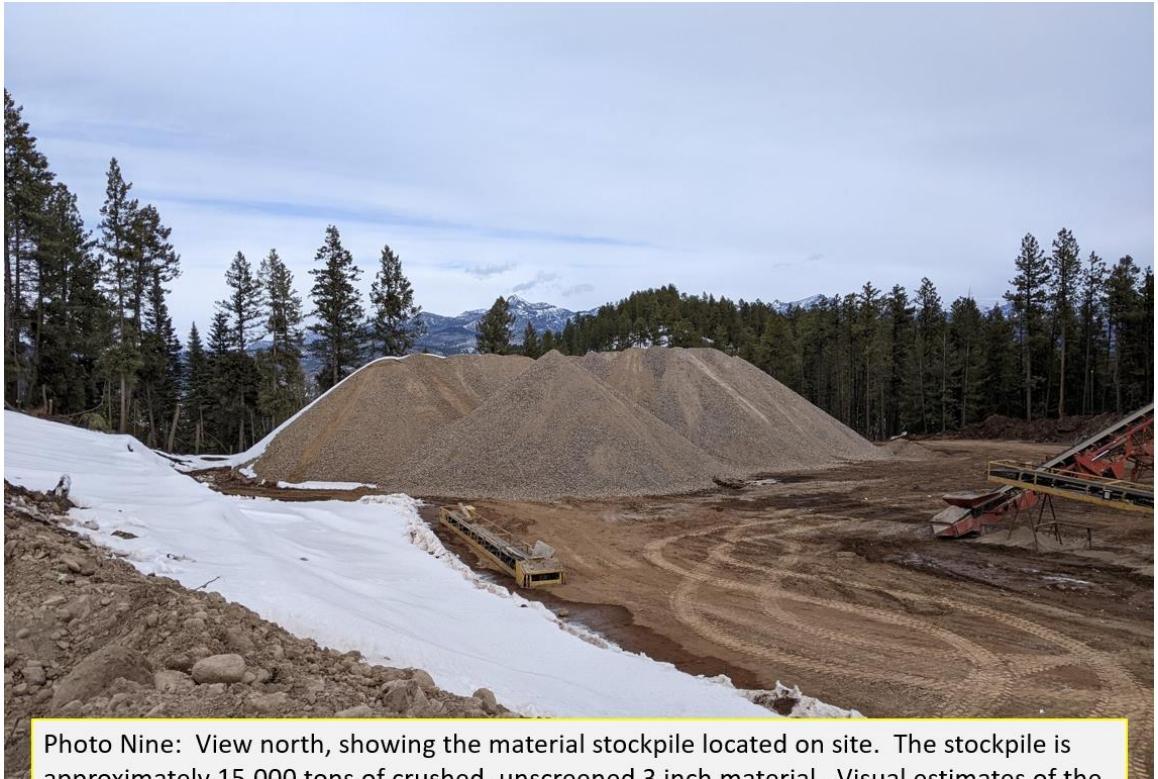
The crusher area was orderly, and free from trash and debris. The conveyors and stackers lead to a large stockpile of crushed three inch material. Based on visual observations and conversations with the Applicant the estimated volume of material crushed is approximately 15,000 tons. The stockpile can be seen in Photo Nine. The volume of stockpiled material appeared to be consistent with the void volume of the area of excavation. The stockpile appeared stable at the time of the inspection and was in good condition. The pit floor contained some standing water from melting snow, and no evidence of groundwater, seeps or springs being encountered was noted.

Photo Nine: View north, showing the material stockpile located on site. The stockpile is approximately 15,000 tons of crushed, unscreened 3 inch material. Visual estimates of the volumetric of the pile appear to match the void of the area of excavation.
