PERMIT INFORMATION

INSPECTION INFORMATION

Inspection Start Date: February 10, 2022 Inspection Start Time: 15:00 Inspection End Date: February 10, 2022 Inspection End Time: 15:30			Inspection Type: Coal Complete Inspection Inspection Reason: Normal I&E Program Weather: Clear
Joint Inspection Agency:		Joint Inspection Contacts:	
None			
Post Inspection Agency:		Post Inspection Contacts:	
None			
Inspector(s):	Inspecto	r's Sig	gnature: Signature Date:
Leigh Simmons	K	g.	February 15, 2022

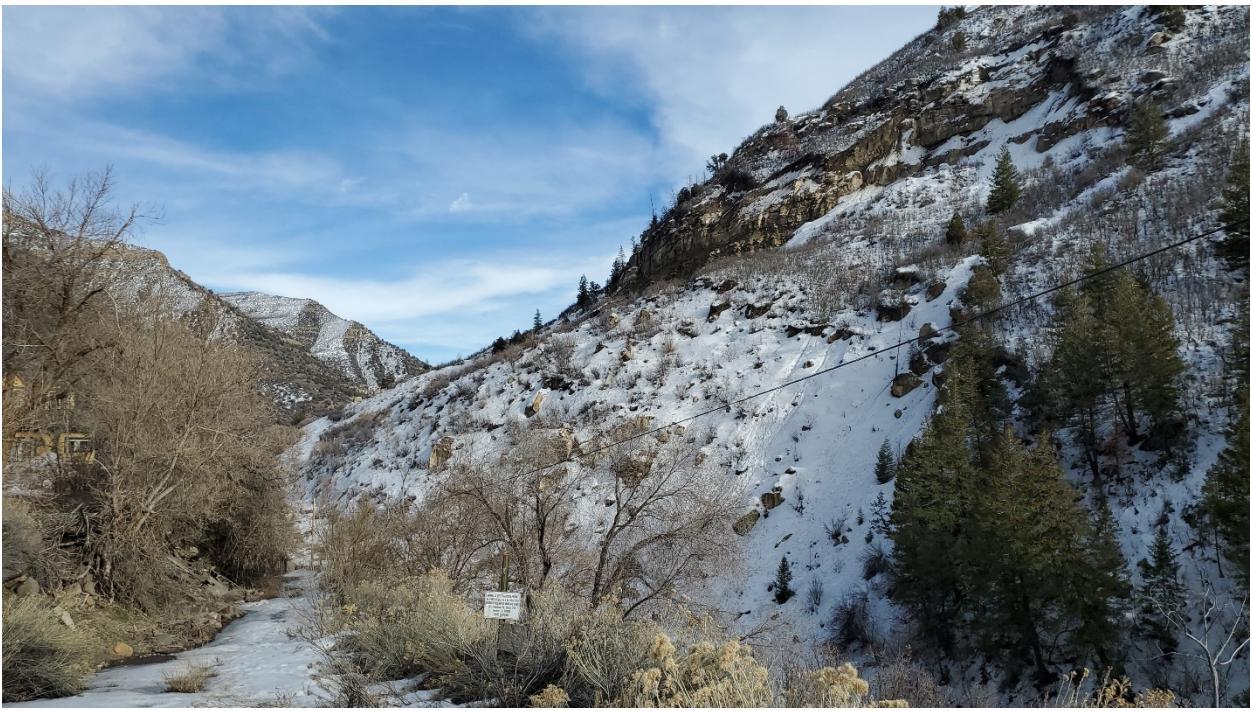
Figure 1: Access to the site

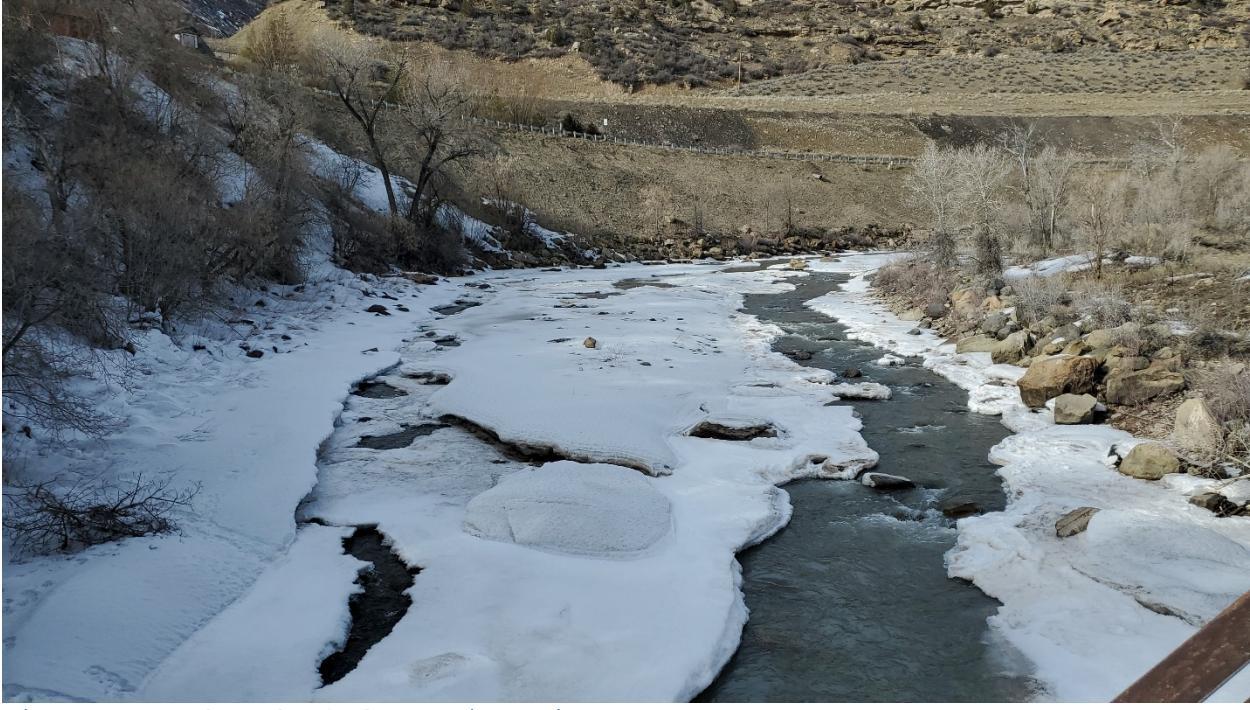
Figure 2: North Fork of the Gunnison River

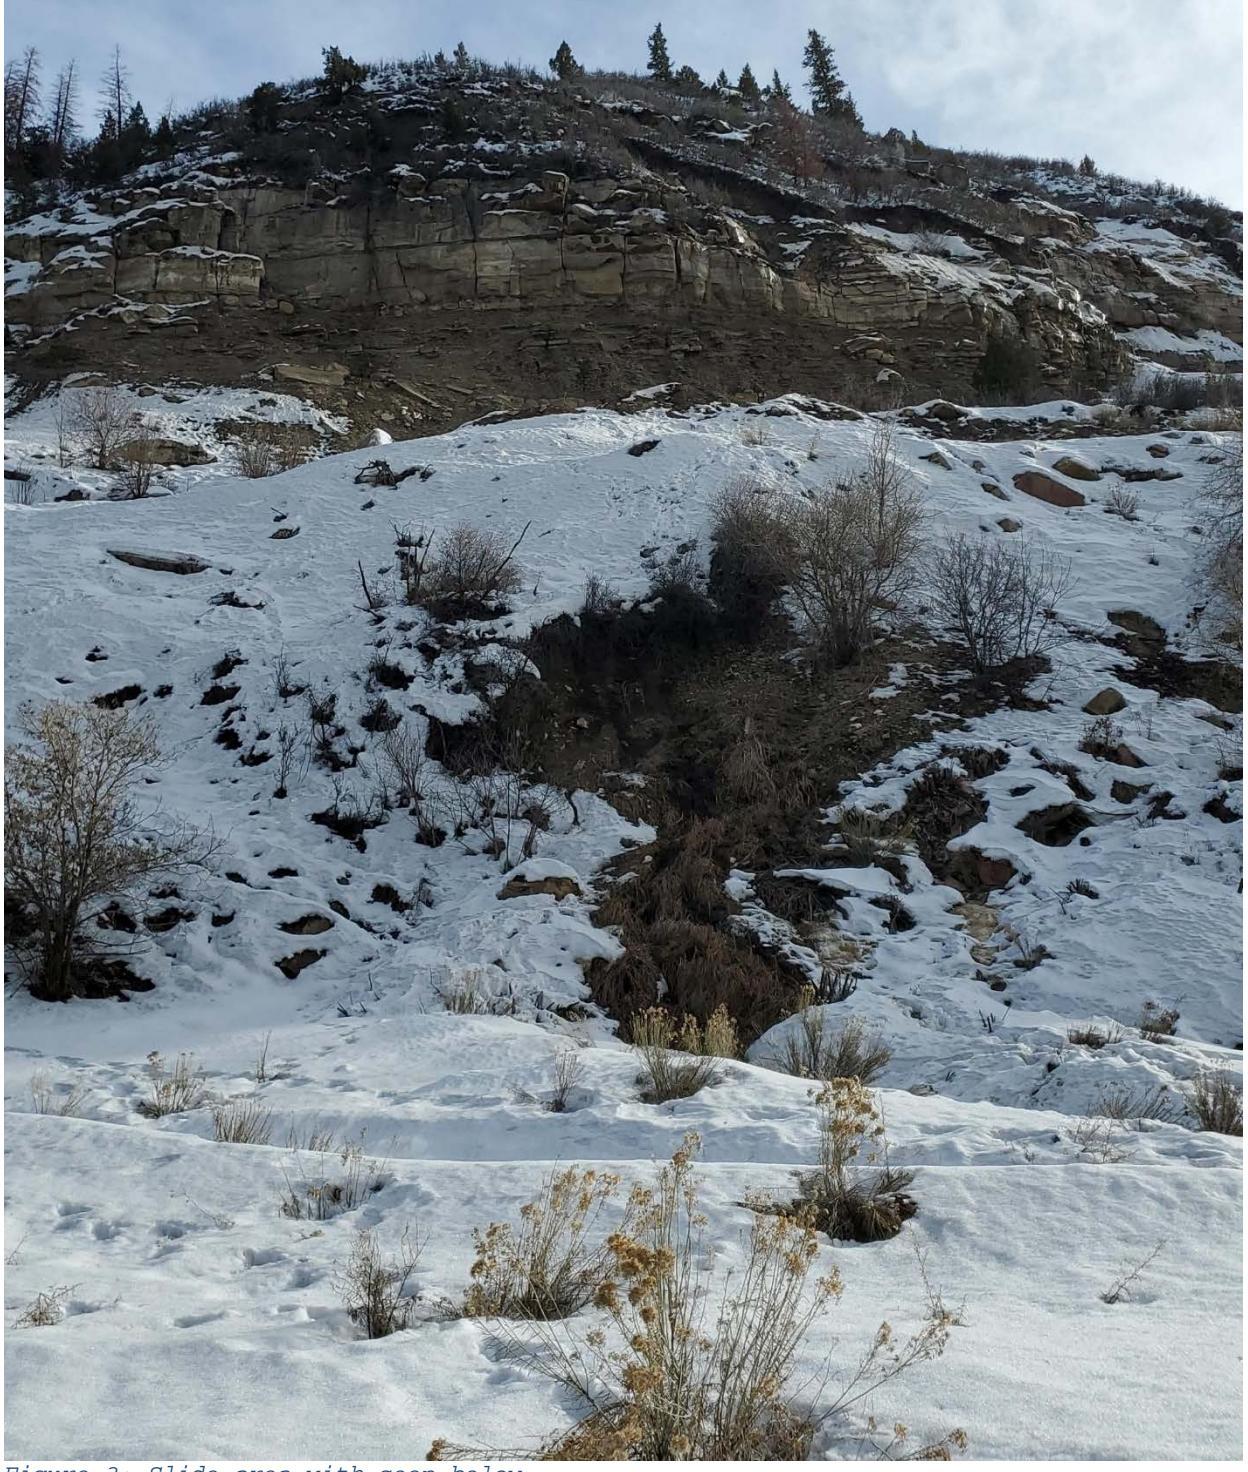
Water was seeping from the ground below the slide area, as usual. The snow around the seep had melted, indicating the elevated temperature of the groundwater.

Smoke/steam was visible issuing from several vents above the slide escarpement. There was no obvious evidence of any new slide activity.

Figure 3: Slide area with seep below
