MINERALS PROGRAM INSPECTION REPORT PHONE: (303) 866-3567

MINE NAME:	MINE	/PROSPECTING ID#:	MINERAL:	COUNTY:	
Speer Mining Resource	M-198	33-176	Gravel	Adams	
INSPECTION TYPE:	INSPI	ECTOR(S):	INSP. DATE:	INSP. TIME:	
Monitoring	Patricl	k Lennberg	March 3, 2022	10:00	
OPERATOR:		RATOR REPRESENTATIVE:	TYPE OF OPERA	TYPE OF OPERATION:	
Asphalt Specialties Co., Inc.		Geras and Miles Buescher	112c - Construction	112c - Construction Regular Operation	
REASON FOR INSPECTION:		O CALCULATION TYPE:		BOND AMOUNT:	
Normal I&E Program	Partial	Bond	\$678,169.00		
DATE OF COMPLAINT:		INSP. CONTACTS:	JOINT INSP. AGE	JOINT INSP. AGENCY:	
NA	None		County		
WEATHER:	INSPECTOR'S SIGNATURE:		SIGNATURE DATE:		
Clear	Patrick Stor		March 11, 2022

PERMIT #: M-1983-176 INSPECTOR'S INITIALS: JPL INSPECTION DATE: March 3, 2022

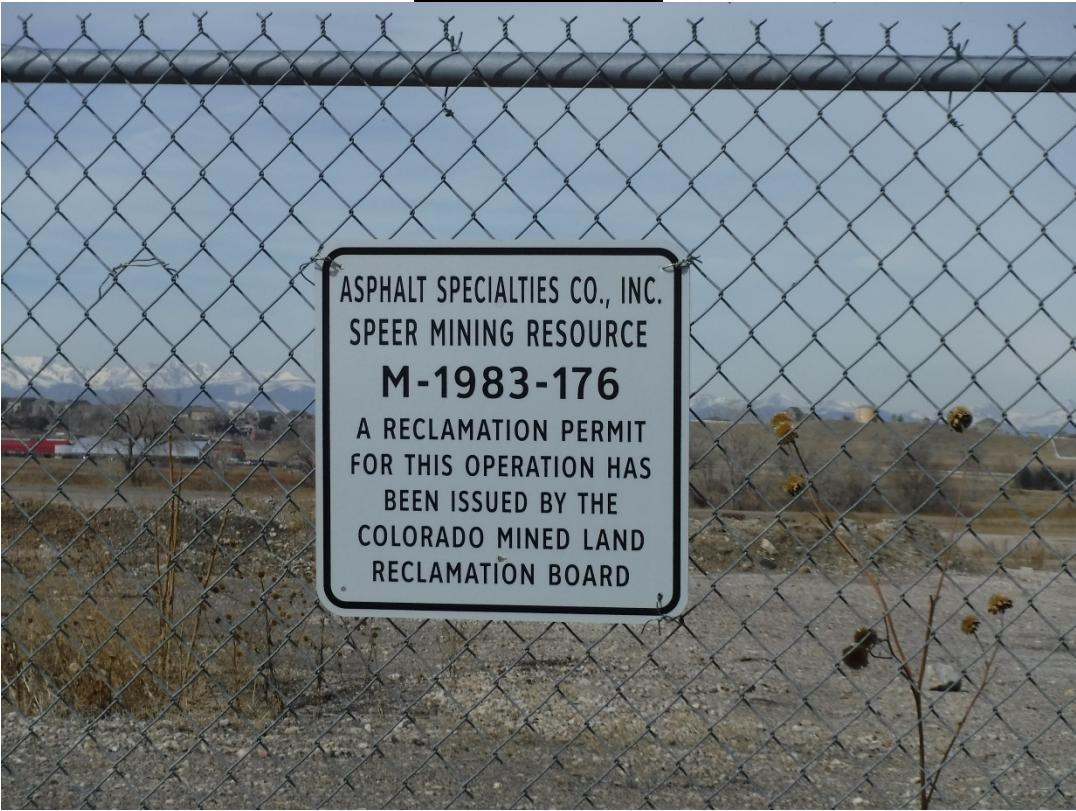
The Speer Pit is a 112c operation that is permitted for 75.5 acres with all acres approved to be affected. The permit is on property owned by both the Operator and a residential Raymond Crom. The pit is located in Adams County. The site entrance is located 330 feet north from the intersection of 120th Ave and Brighton Road along the west side of Brighton Road. The approved post-mining land use was changed in 2010 to general agriculture with the approval of AM-4. A mine sign was posted at the mine entrance pursuant to Rule 3.1.12.

Photo 1: Mine sign at mine entrance location

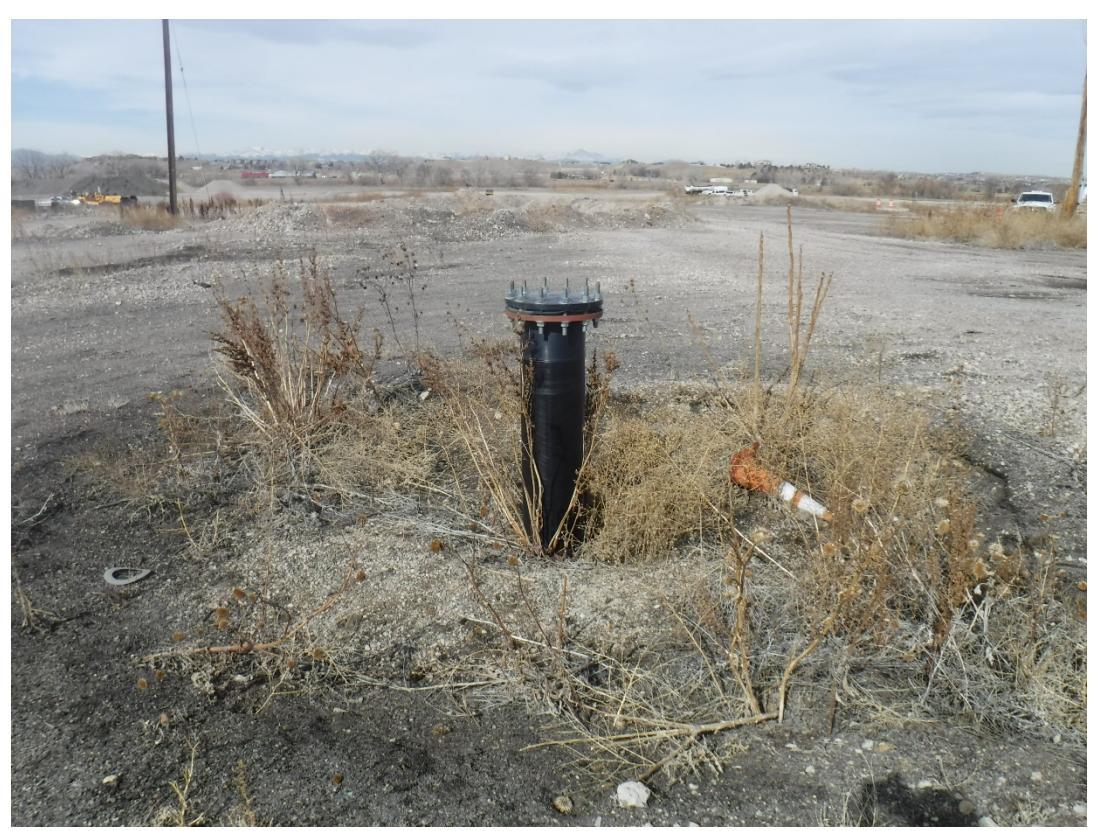
The Division observed stand pipes associated with the French Drain Phase 1 and parts of Phase 2. The drain is located along the eastern side of the permit area running north and south. Towards the northern permit area the Phase 1 portion of the drain enters the pond and at the north end of the pond the Phase 2 portion of the drain conveys water to an outfall at the South Platte River. Additionally, there is a trench that has been dug to drain additional water from the pond. During the 2018 inspection the Division requested as-built drawings for the Phase 2 portion of the French Drain. Those requested as-built drawings have not been received. Also during the 2018 inspection it was stated a Technical Revision was needed to address both the size of the new pond that will be left after reclamation and the final alignment of the French Drain as it differs from the current approved plan.

Photo 2: Stand pipe for French Drain near the mine entrance

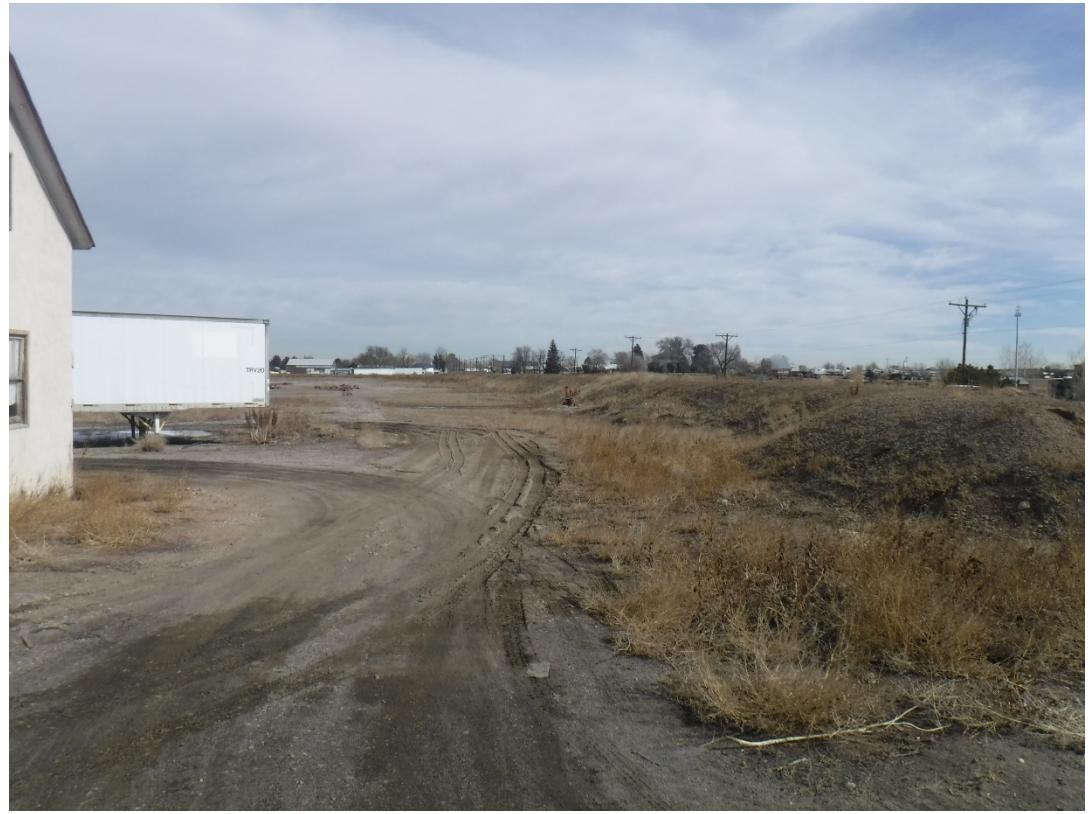
Photo 3: Topsoil stockpiles along eastern permit boundary adjacent to Brighton Road, looking north

The Operator still needs to spread 18-inches of topsoil/growth medium across the site and seed in accordance with the approved reclamation plan.

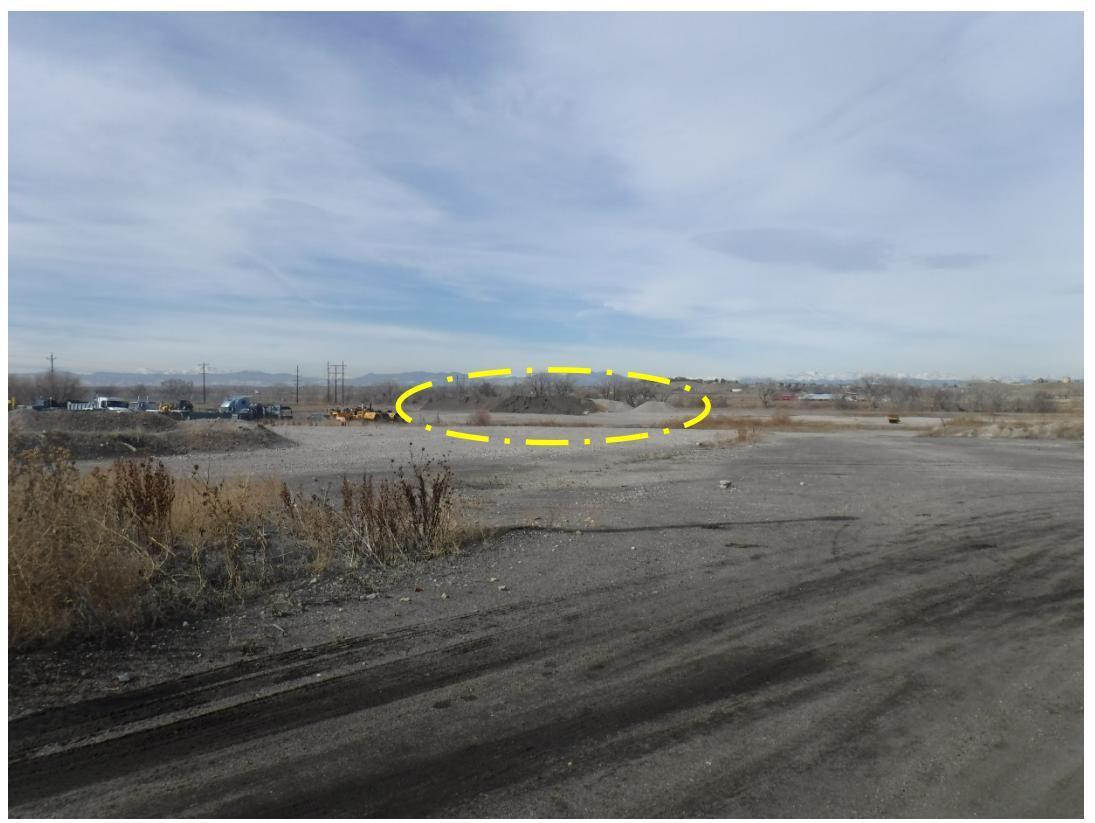
The site was not active at the time of inspection. However, there were several stockpiles of material located in the southern end of the permit area that are periodically used for various purposes. The remaining areas of the site have been backfilled with inert fill. In the northern area of the permit there is an approximately 2.5 acre groundwater pond. In AM-4 the approved reclamation plan allowed for a 7 acre pond and it was to be a clay lined. During the 2018 inspection the Operator stated they would not be lining the pond as approved in AM-4. However, during this inspection the Operator stated they would be lining the 2.5 acre pond. A review of the current Substitute Water Supply Plan indicates they are going to line the pond. An aerial review of the site using Google Earth indicates the unlined exposed groundwater pond may be larger than the 2.5 acres currently allowed. The Division recommends the Operator perform a ground survey to ensure they are in compliance with SWSP.

Photo 4: Current stockpiles on site

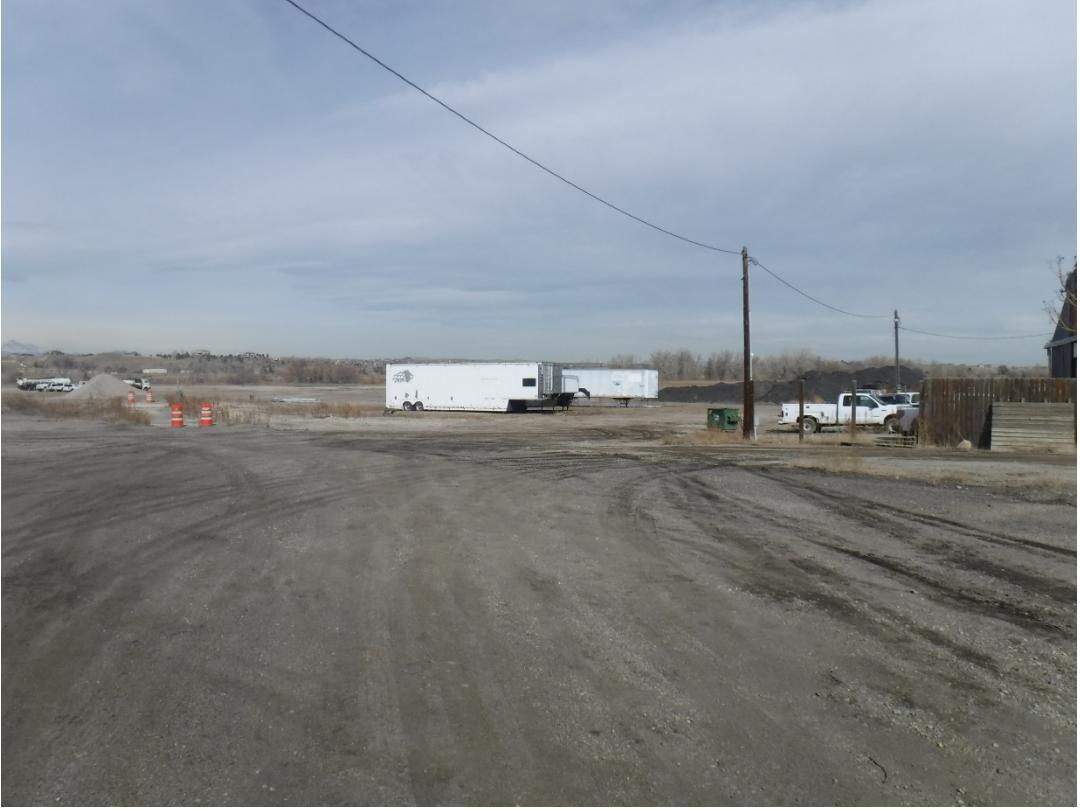
Photo 5: Miscellaneous equipment being stored onsite along with what appears to be a recycled asphalt pile

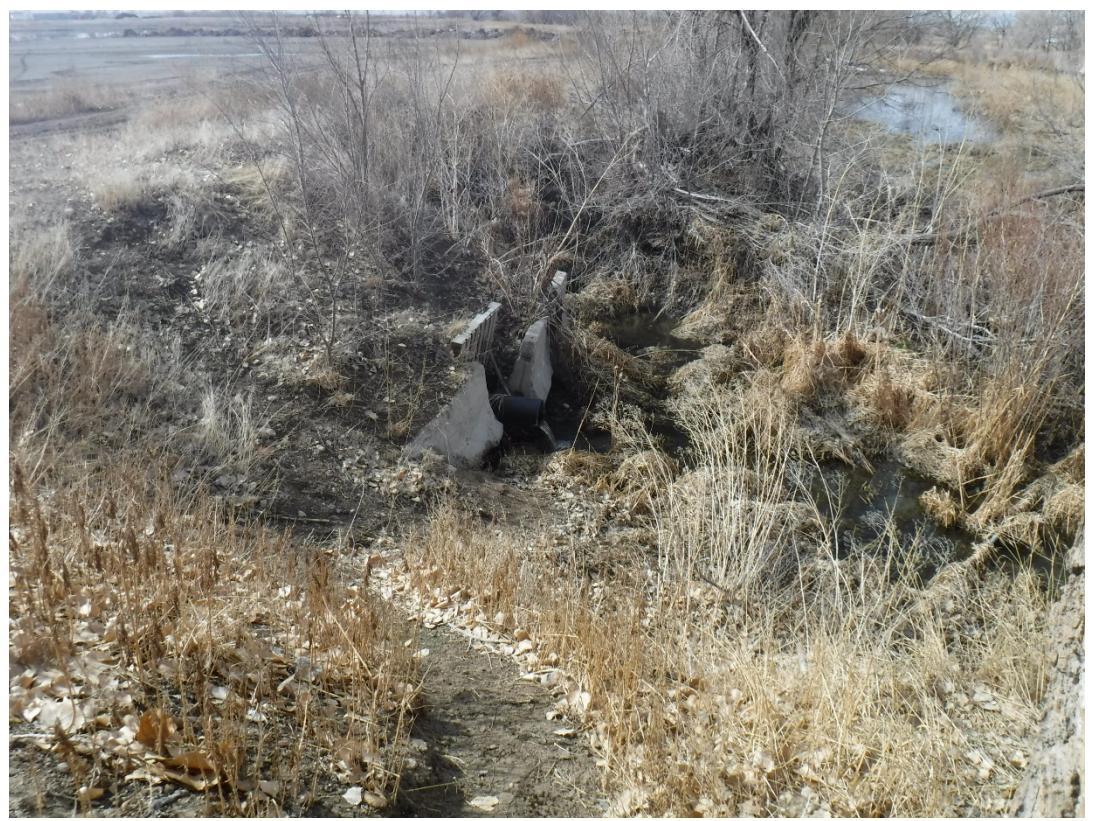
Photo 6: Outfall of French Drain to South Platte River

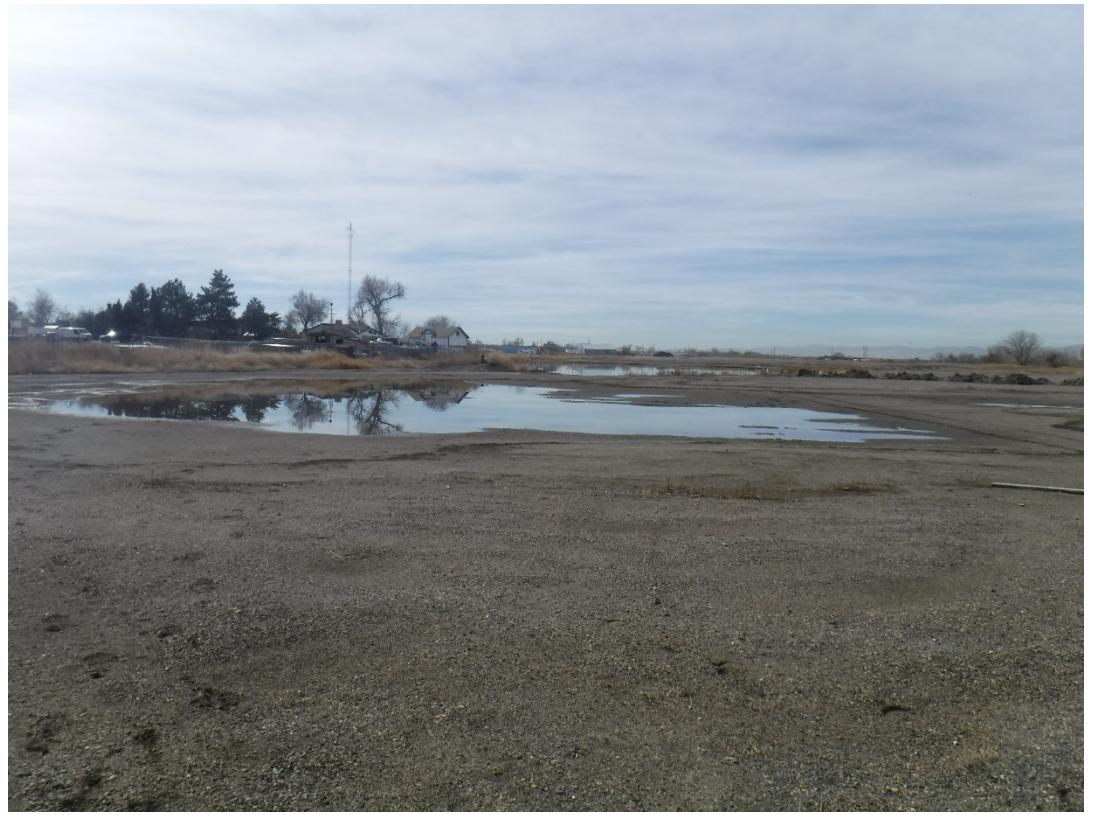
North of the pond there is an area, approximately 0.5 acres, that had standing water in it. Prior to the inspection weather had been cold with snow on the ground then rapid warming. The Operator was informed they are not allowed to detain storm water for longer than 72 hours according to the Department of Water Resources unless permitted to do so.

Photo 7: Area detaining storm water located north of the unlined pond

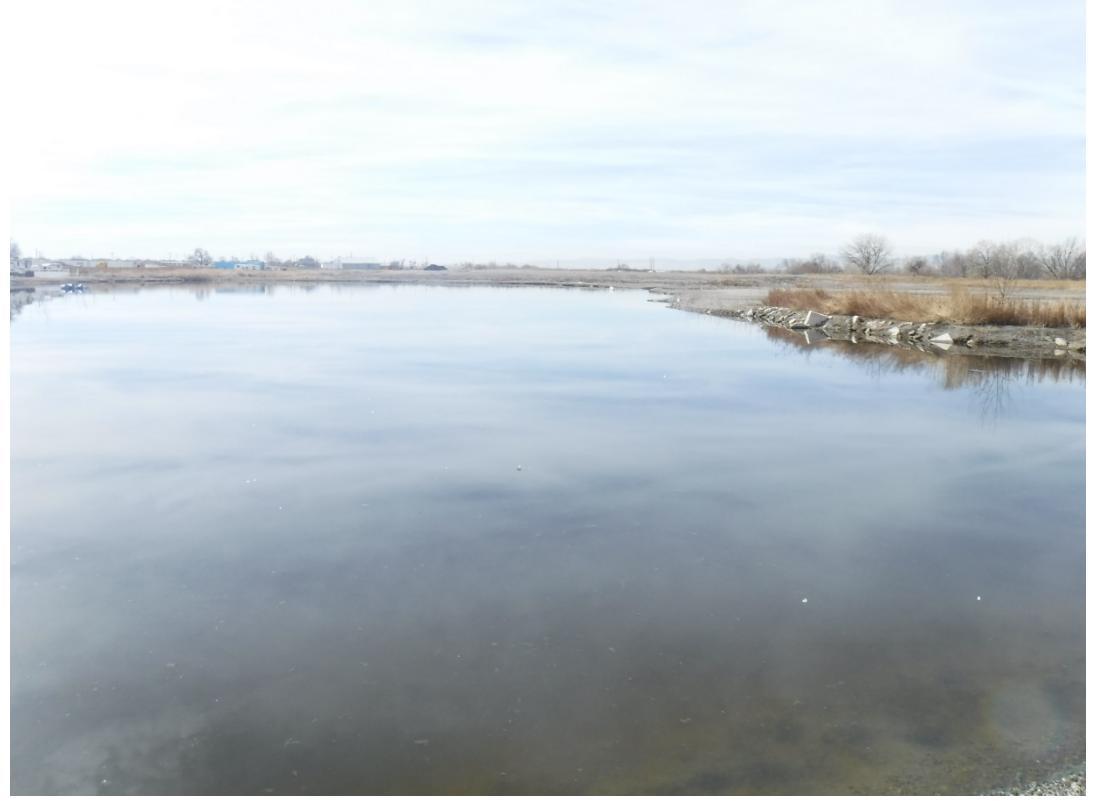
Photo 8: Looking north to south across the unlined pond

Drain, lining the 2.5 acre pond, filling the area where storm water was collecting, submitting a Technical Revision(s) to update the permit to be consistent with field conditions and when topsoil and seeding would occur. The Operator committed in the field to providing a tentative schedule when these activities are to be initiated. The Division is concerned the Operator will not achieve reclamation in the five year period pursuant to Rule 3.1.3.
