MINERALS PROGRAM INSPECTION REPORT PHONE: (303) 866-3567

MINE NAME:		MINE/PROSPECTING ID#:	MINERAL:	COUNTY:
Strode Pit		M-2021-002	Sand	Kit Carson
INSPECTION TYPE:		INSPECTOR(S):	INSP. DATE:	INSP. TIME:
Monitoring		Elliott Russell	November 9, 2021	09:30
OPERATOR:		OPERATOR REPRESENTATIVE:	TYPE OF OPERATION:	
Castle Rock Construction Company of Colorado, LLC		None	112c - Construction Regular Operation	
REASON FOR INSPECTION:		BOND CALCULATION TYPE:	BOND AMOUNT:	
Normal I&E Program		Partial Bond	\$74,825.00	
DATE OF COMPLAINT:		POST INSP. CONTACTS:	JOINT INSP. AGENCY:	
NA		None	None	
WEATHER:	INSPECTOR'S SIGNATURE:		SIGNATURE DATE:	
Clear	At Pull		November 24, 2021

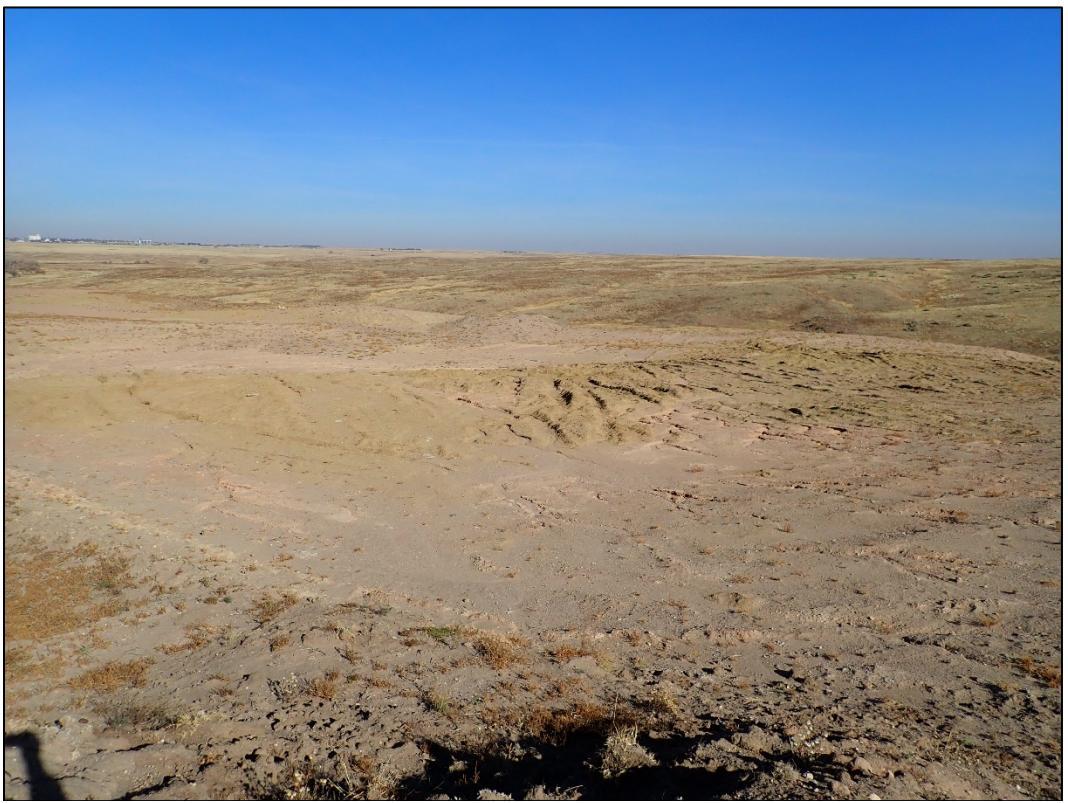
<u>Backfilling and Grading</u>: The majority of the slopes have been partially backfilled and graded. Remaining stockpiled overburden material and/or topsoil is located along the western permit boundary.

Photo 1. Southern portion of the permit area, backfilled and rough graded; looking northeast.

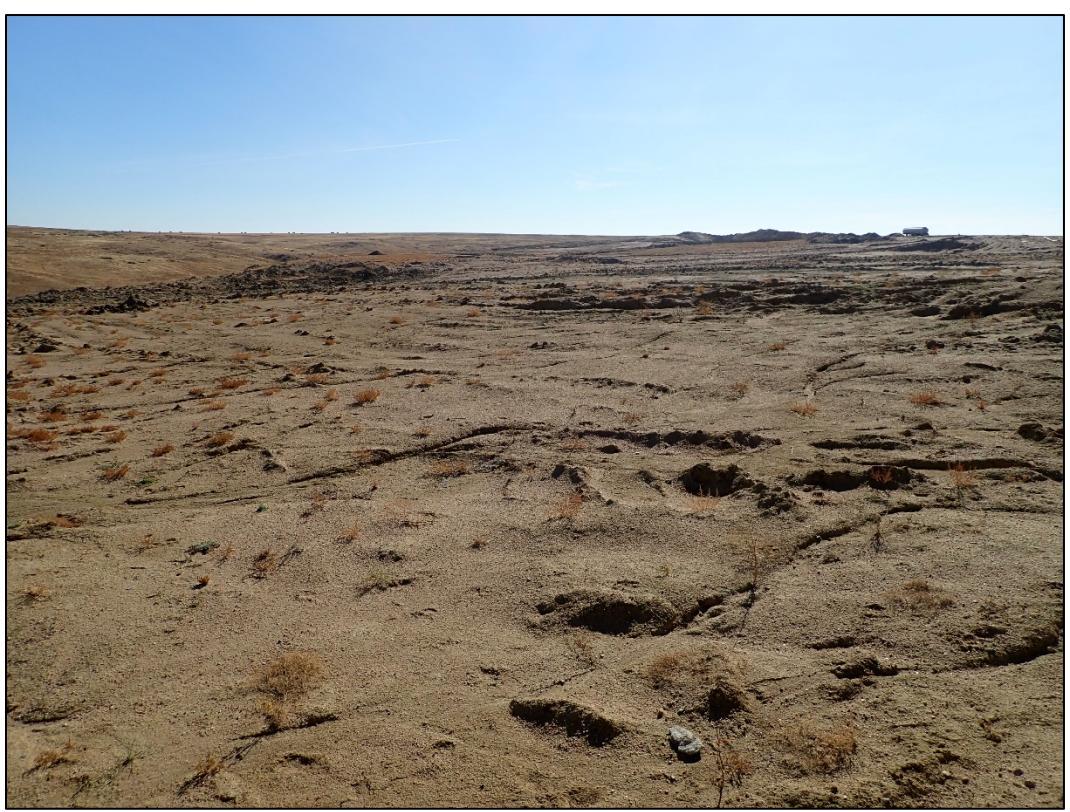
Photo 2. Northern portion of the permit area, backfilled and rough graded; looking southeast.

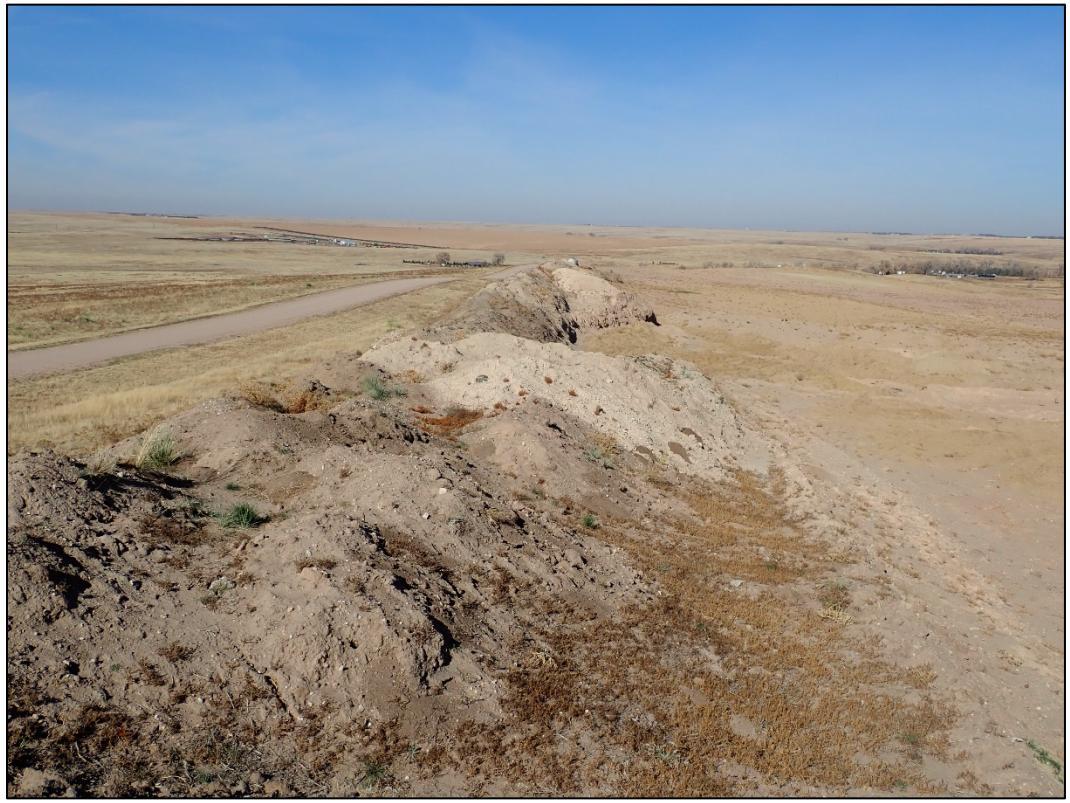
Photo 3. Overburden and topsoil stockpiled along County Road 6; looking northwest.

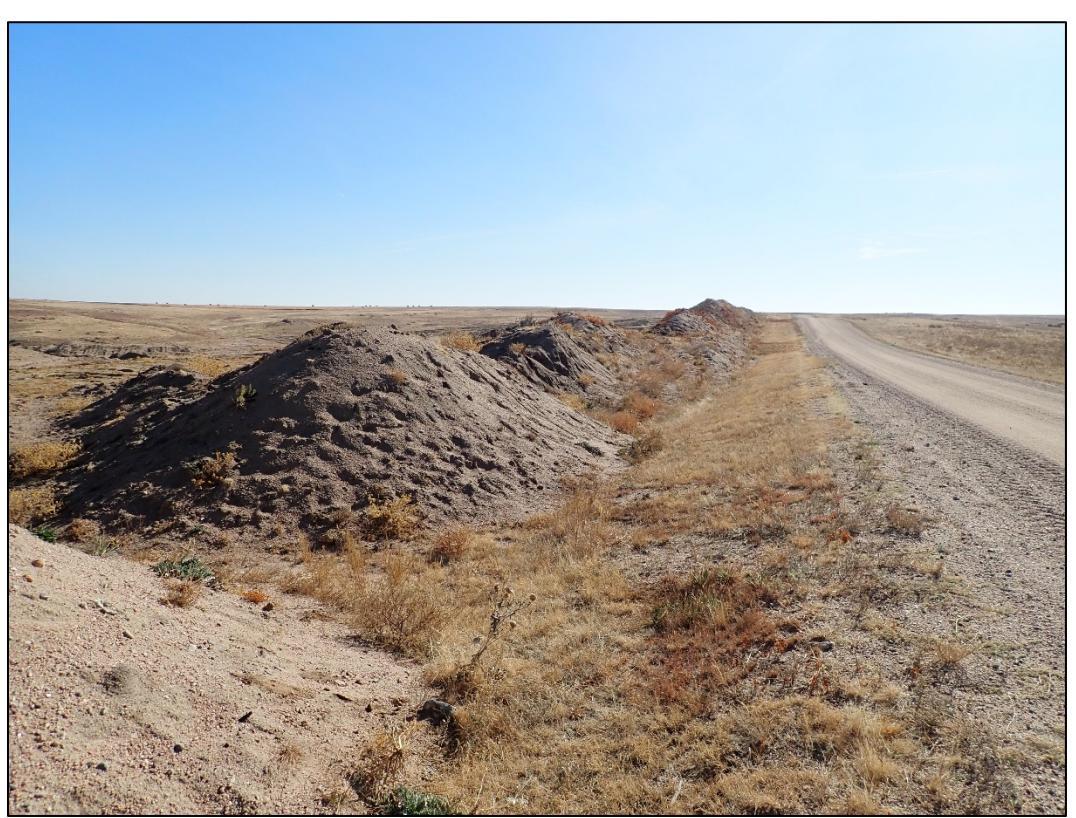
Photo 4. Topsoil stockpiled along County Road 6; looking southeast.

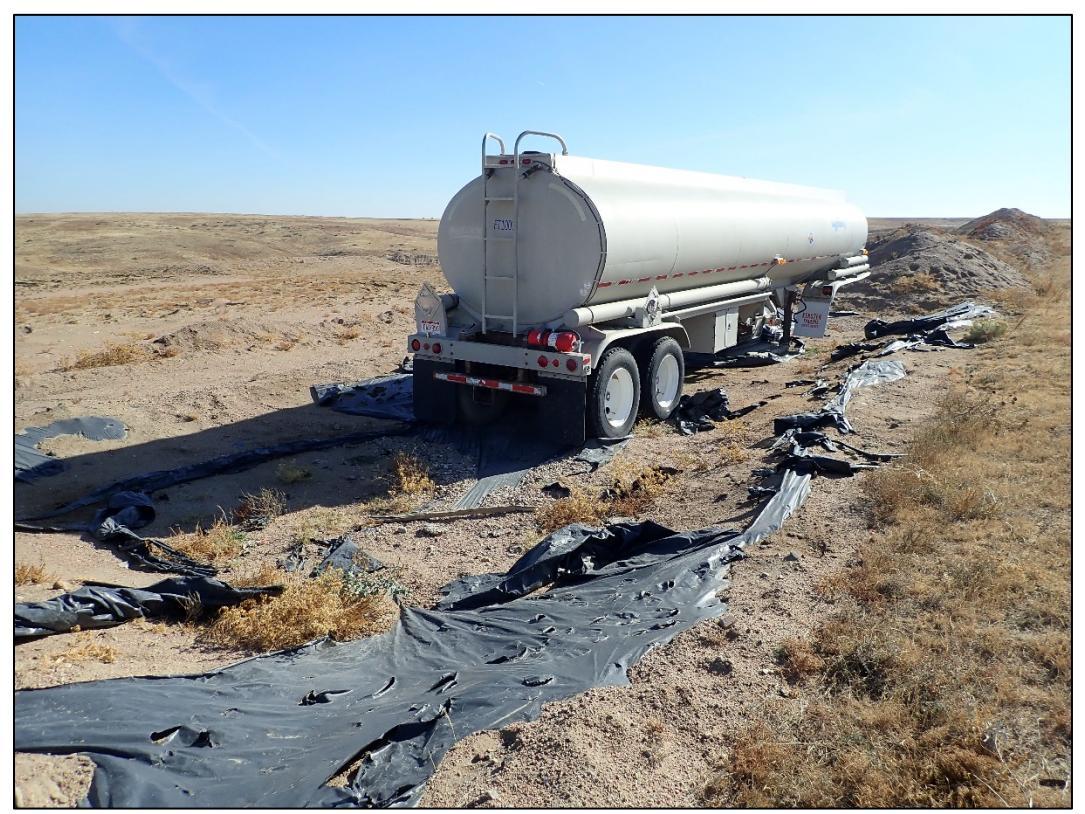
<u>Acid or Toxic Materials</u>: The fuel tanker on site is located within a secondary containment bermed and lined area. The liner was damaged and torn in multiple places. After the inspection, the Operator informed the Division that this tanker is empty and committed to replacing the liner prior to refilling it for reclamation activities.

Photo 5. Fuel tanker with damaged secondary containment liner; looking southeast.
