MINERALS PROGRAM INSPECTION REPORT PHONE: (303) 866-3567

MINE NAME:		MINE/PROSPECTING ID#:	MINERAL:	COUNTY:
Section 20 Gravel Mine		M-2022-001	Sand and gravel	Weld
INSPECTION TYPE:		INSPECTOR(S):	INSP. DATE:	INSP. TIME:
Monitoring		Peter Hays	June 22, 2022	10:00
OPERATOR:		OPERATOR REPRESENTATIVE:	TYPE OF OPERATION:	
Red Tierra Equities, L.L.C.		Kyle Regan, Brad Hagen	112c - Construction Regular Operation	
DEAGON FOR INCRECTION				
REASON FOR INSPECTION:		BOND CALCULATION TYPE:	BOND AMOUNT:	
Normal I&E Program			No Bond Held	
DATE OF COMPLAINT:		POST INSP. CONTACTS:	JOINT INSP. AGENCY:	
NA		None	None	
WEATHER:	INSPECTOR'S SIGNATURE:		SIGNATURE DAT	Е:
Clear	f.Any		July 20, 2022

PERMIT #: M-2022-001 INSPECTOR'S INITIALS: PSH INSPECTION DATE: June 22, 2022

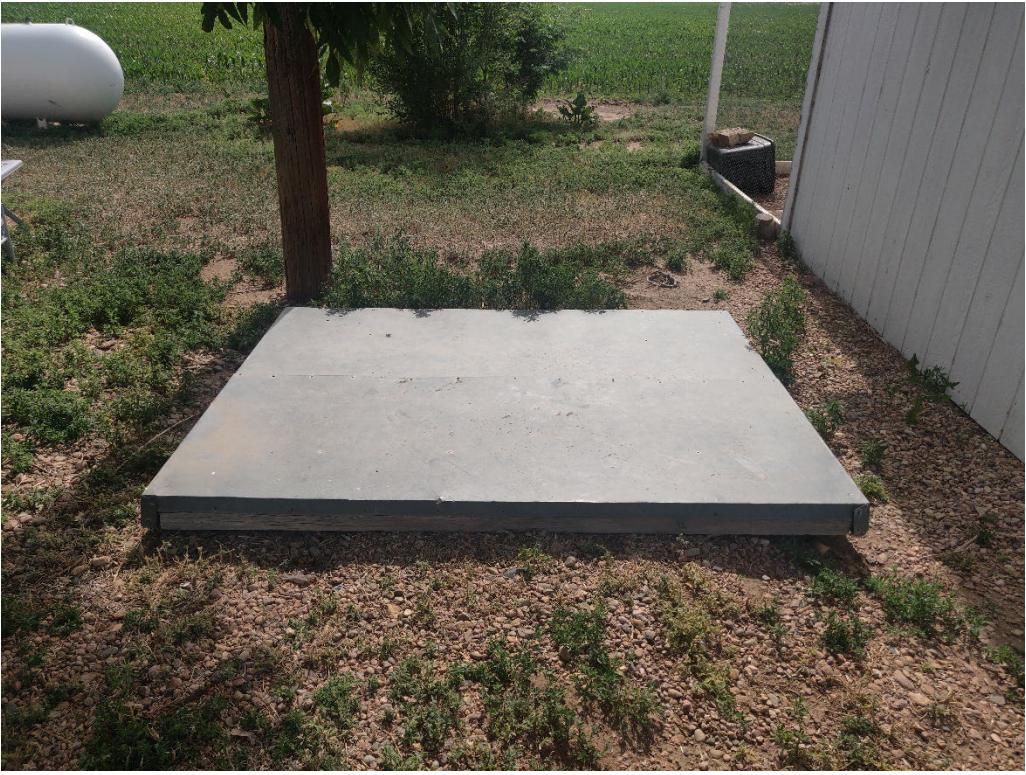
View of the outside of the Shimon well vault

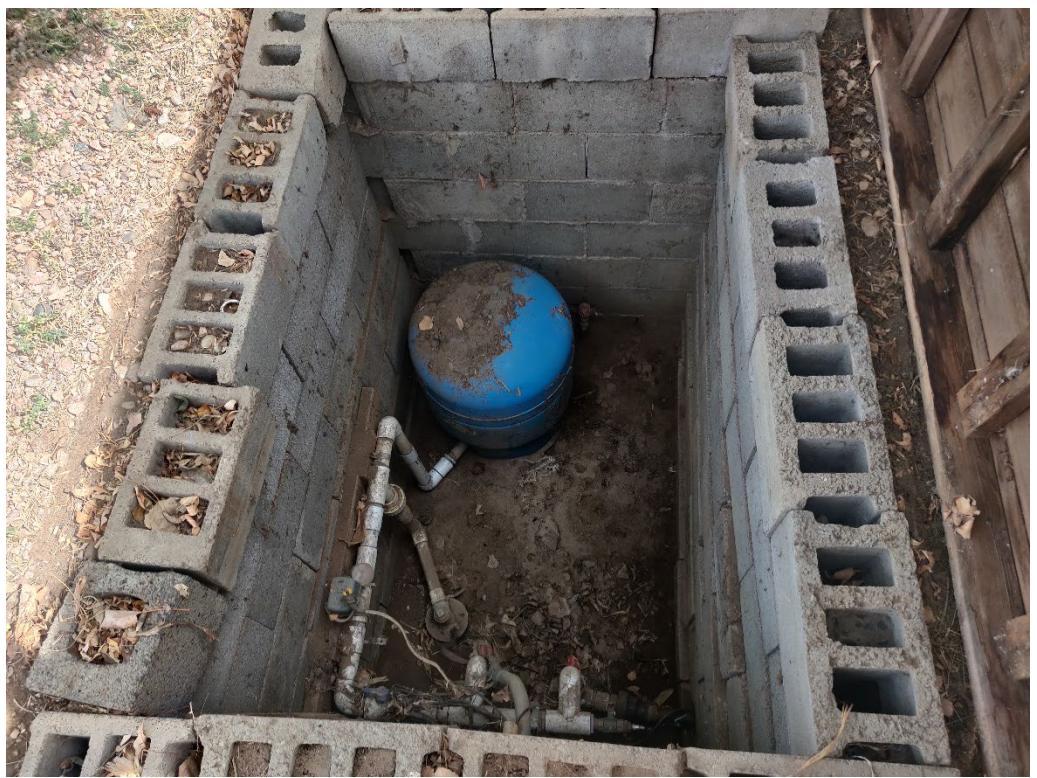
The consultant is completing a groundwater model to predict the goundwater mounding and shadowing associated with the planned slurry walls at the proposed mine site. The Shimon property is expected to be in the mounding area based on the anticipatied direction of groundwater flow. The mounding effect could increase the quantity of water in the Shimon well. The Shimon well was observed during the inspection, however the depth of the well and the level of water in the well could not be measured by the Division due to lack of an access port on the well.

View of the inside of the Shimon well vault
