MINERALS PROGRAM INSPECTION REPORT PHONE: (303) 866-3567

MINE NAME:		MINE/PROSPECTING ID#:	MINERAL:	COUNTY:	
Crowley Cnty Grav 2		M-1982-126	Sand and gravel	Crowley	
INSPECTION TYPE:		INSPECTOR(S):	INSP. DATE:	INSP. TIME:	
Monitoring		Patrick Lennberg	July 26, 2022	14:30	
OPERATOR:		OPERATOR REPRESENTATIVE:	TYPE OF OPERATION:		
Crowley County		Greg Sprosty	112c - Construction Regular Operation		
REASON FOR INSPECTION:		BOND CALCULATION TYPE:	BOND AMOUNT:		
Normal I&E Program		None	\$0.00		
DATE OF COMPLAINT:		POST INSP. CONTACTS:	JOINT INSP. AGENCY:		
NA		None	None		
WEATHER:	INSPECTOR'S SIGNATURE:		SIGNATURE DATE:		
Clear	Patrick La		August 3, 2022

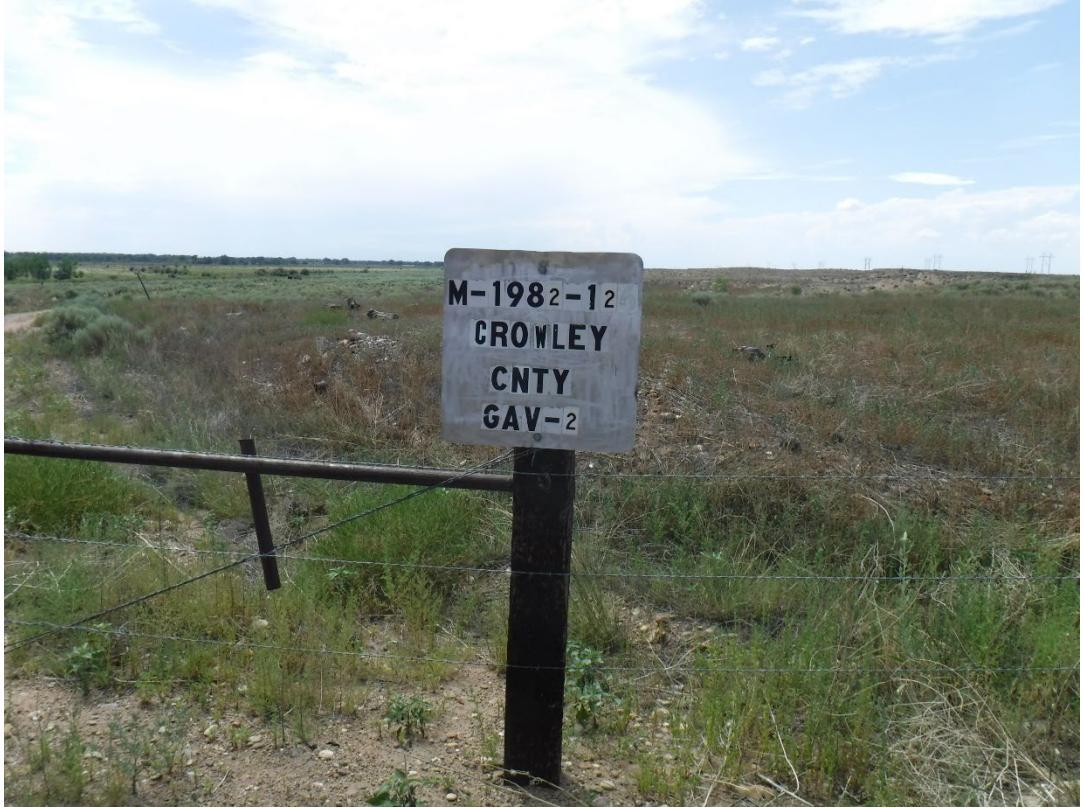
Photo 1: Mine sign at primary mine entrance

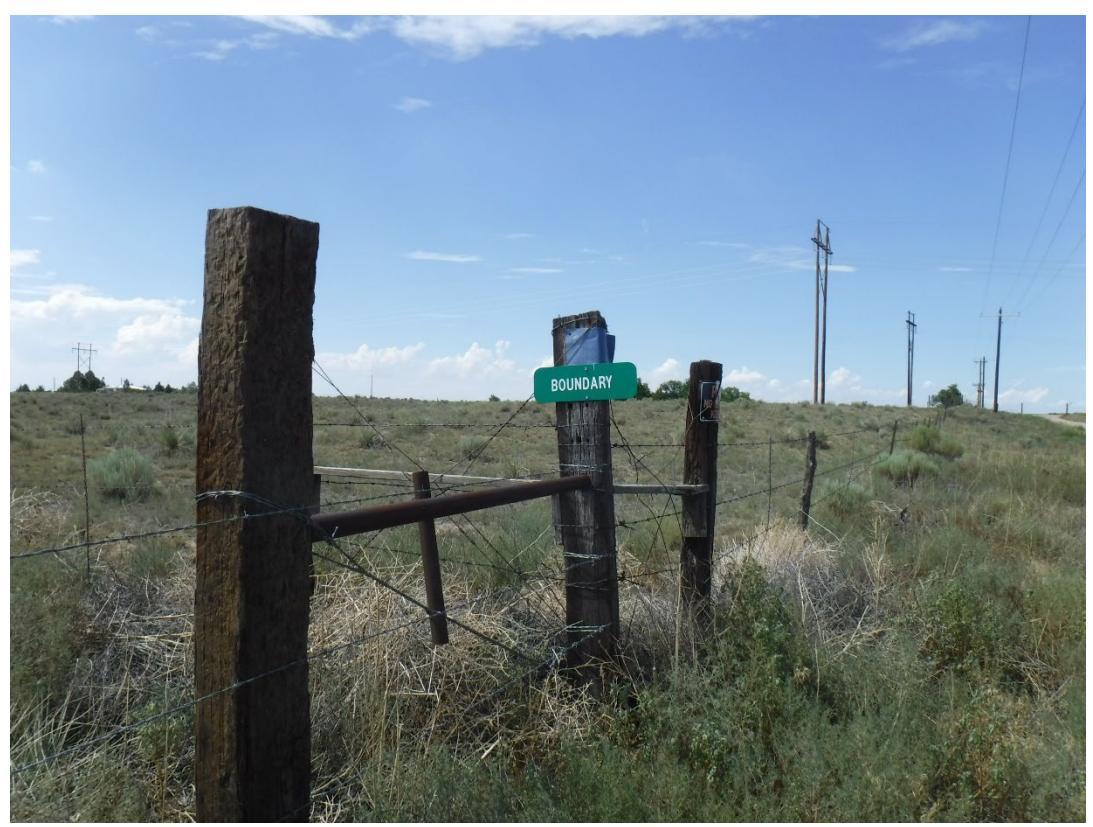
Photo 2: Typical permit boundary marker, NE corner marker pictured

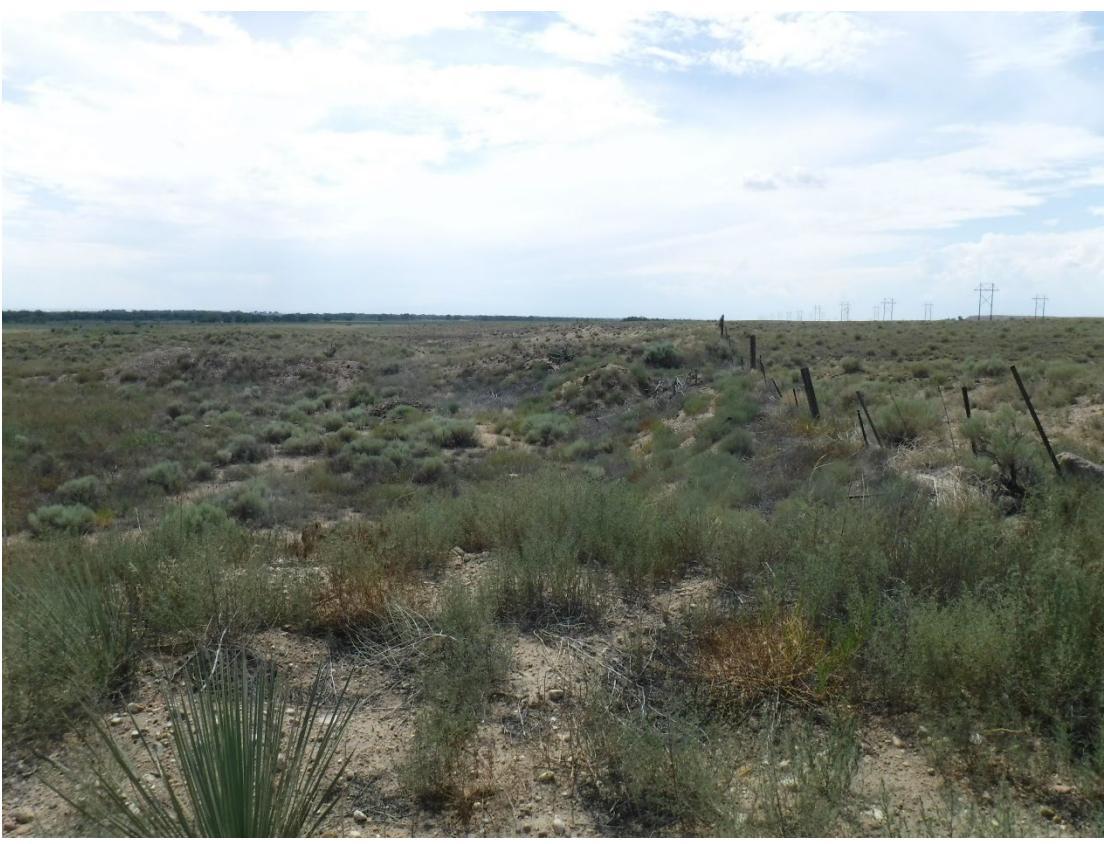
Photo 3: Looking west along the northern permit boundary, fence line marks boundary

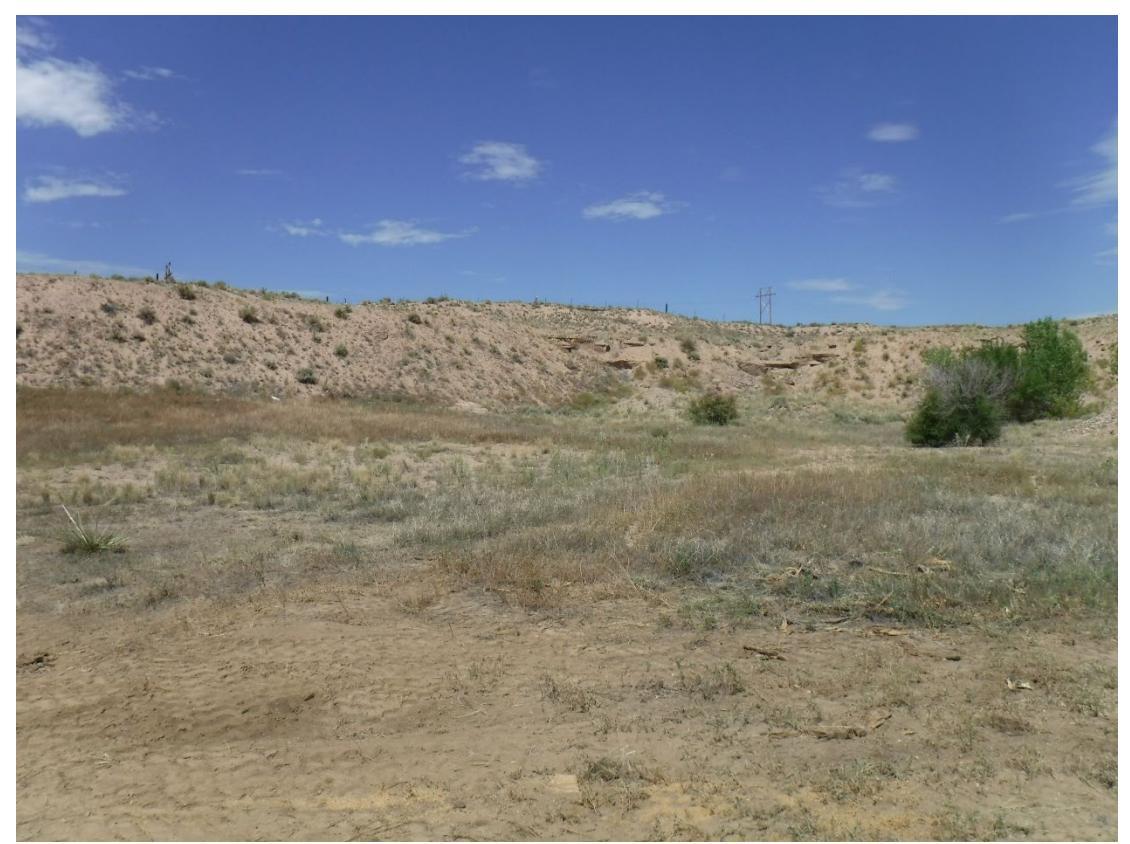
The post mining land use for the permit is rangeland and slopes are to be graded to 3H:1V or flatter. The remaining stockpiles can be graded into the slopes to help achieve the required slope configuration. Some material from the cleaning out of culverts and ditches is being spread on site to amend the topsoil and grade out the slopes. Topsoil is to be applied at a depth of five to six inches with crimped mulch. A copy of the Reclamation Plan Map is being included for reference.

Photo 4: Looking at the northwest corner of pit area that has highwalls that need to graded to 3H:1V slope

As stated earlier the site was not active at the time of inspection. During the last inspection the County verbally informed the Division that final reclamation of the site had begun. Pursuant to Rule 3.1.3 they had five years to complete reclamation beginning in December 2018. During this inspection the County informed the Division the dozer that was going to be used for reclamation broke down soon after the pandemic began. Due to supply chain problems replacement parts and repairs could not be made until recently. The County is planning on grading the pit area side slopes this winter. The Division encourages the County to grade the slopes and begin seeding as soon as practicable.

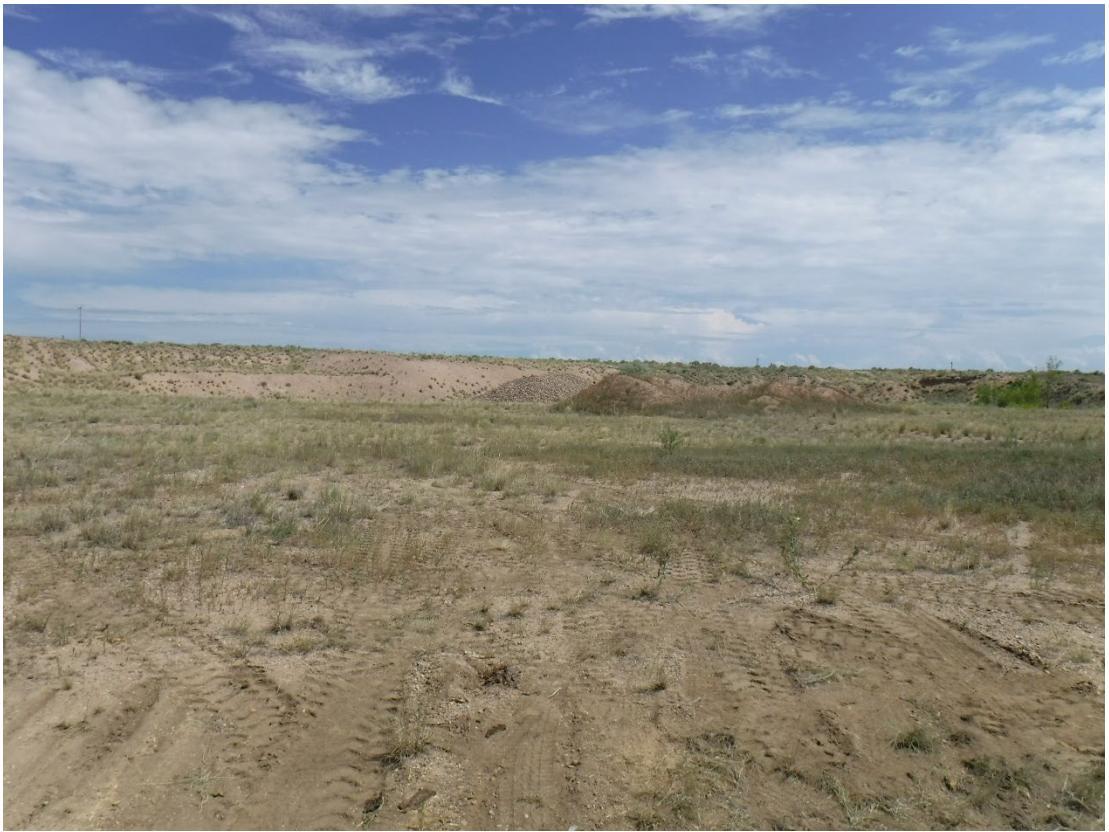
Photo 5: Looking east at the eastern pit wall, note stockpiles of material

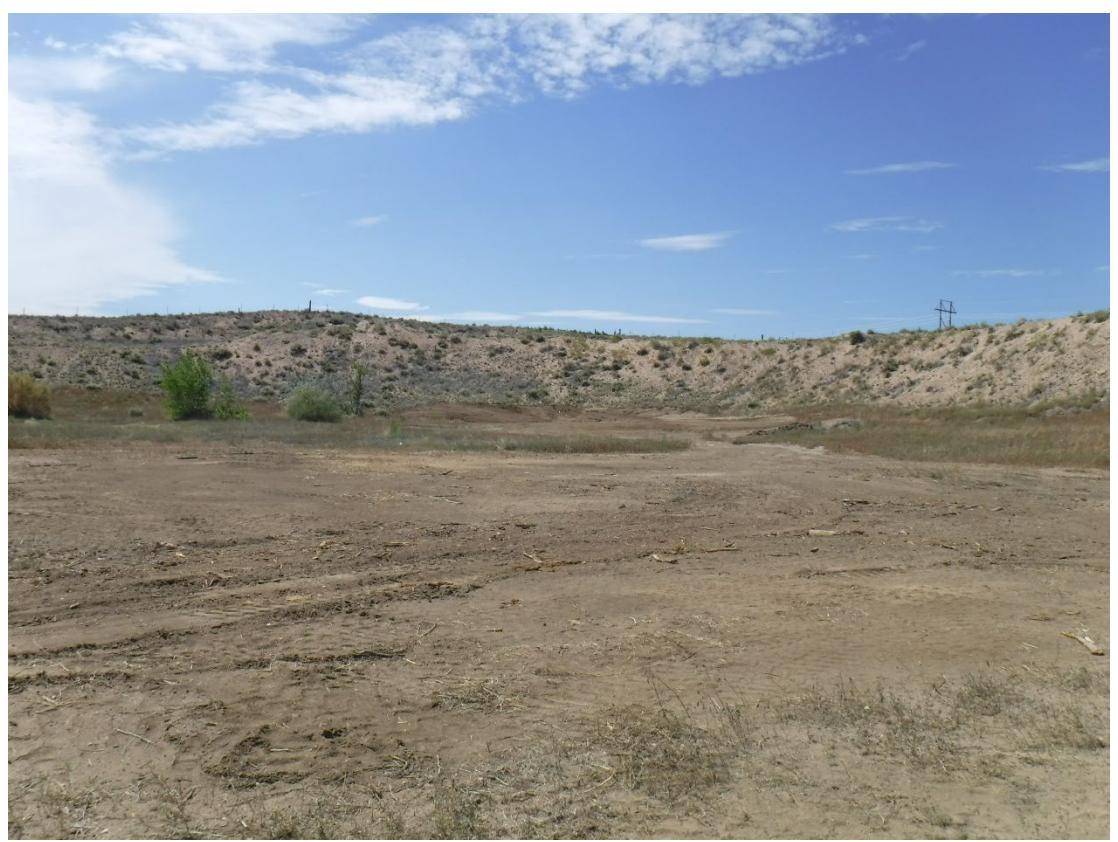
Photo 6: Looking northwest at the NW corner of pit area

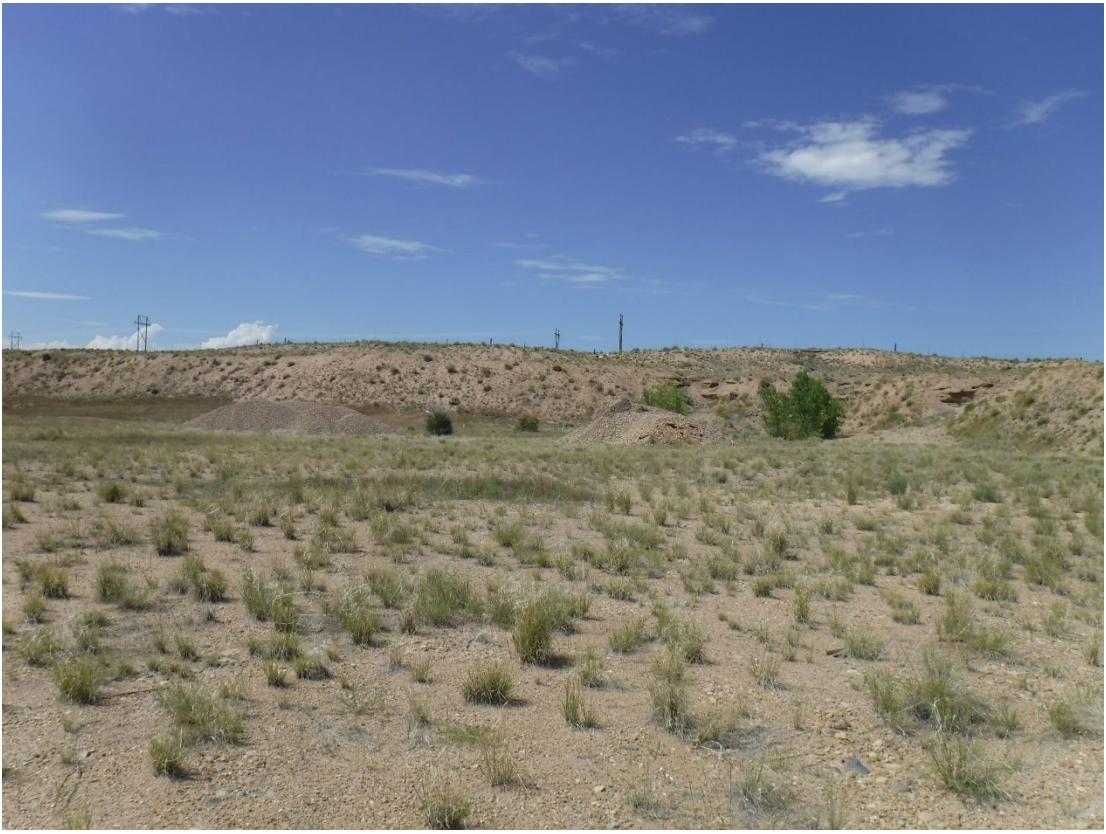
Photo 7: Looking north at the northern highwall of pit area

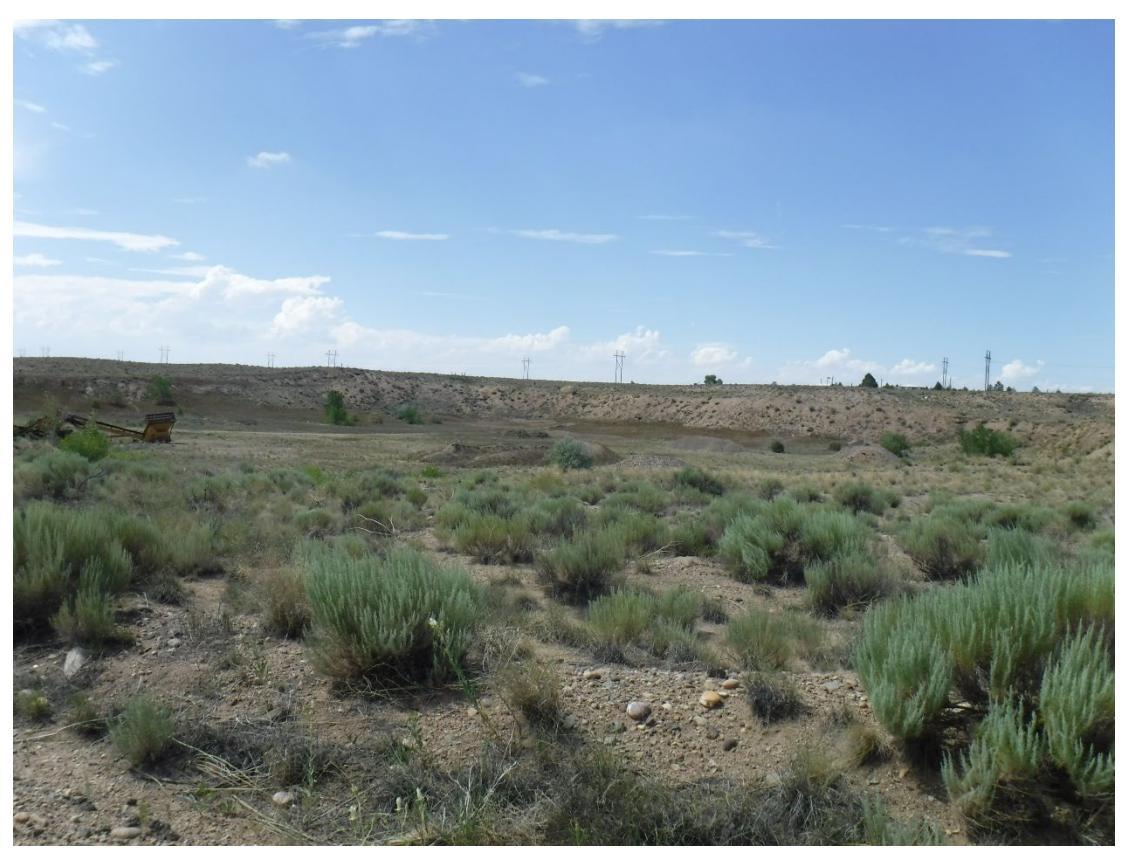
Photo 8: Looking northwest across pit area from access road
