# MINERALS PROGRAM INSPECTION REPORT PHONE: (303) 866-3567

MINE NAME:		MINE/PROSPECTING ID#:	MINERAL:	COUNTY:		
Achieve More Agricultural Complex Site		M-2021-024	Borrow material for	Weld		
INSPECTION TYPE:		INSPECTOR(S):	INSP. DATE:	INSP. TIME:		
Surety Release Inspection		Peter Hays	August 5, 2022	10:00		
OPERATOR:		<b>OPERATOR REPRESENTATIVE:</b>	TYPE OF OPERATION:			
New Vision Investments, LLC		Dan LaCoe	111(1)(b) - Special One-Time Incidental			
<b>REASON FOR INSPECTION:</b>		BOND CALCULATION TYPE:	BOND AMOUNT:			
Surety Release Requested		None	\$75,000.00			
DATE OF COMPLAINT:		POST INSP. CONTACTS:	JOINT INSP. AGENCY:			
NA		None	None			
WEATHER:	INSPECTOR'S SIGNATURE:		SIGNATURE DAT	E:		
Clear	$\Lambda_1 \downarrow$		August 12, 2022			
	f.Am

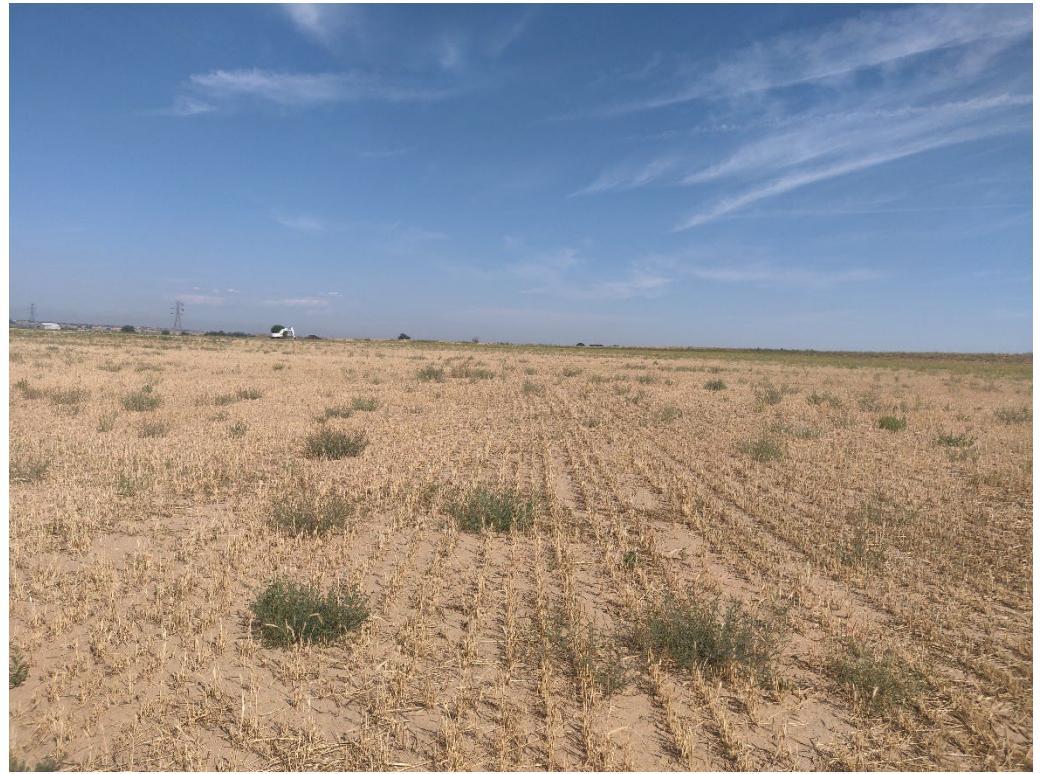
View of Mining Area "B" looking east

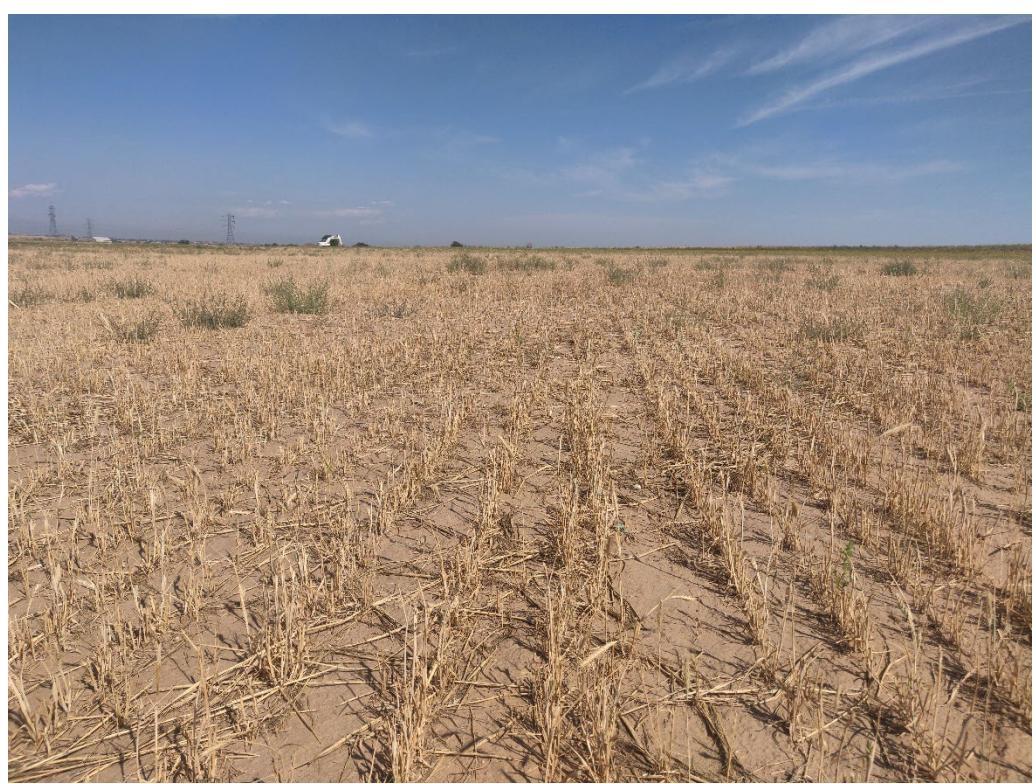
Drill rows and evidence of the grasses being cut for hay were observed during the inspection. Annual weeds including, kochia and a sunflower variety were observed during the inspection. No noxious weeds were observed during the inspection. The landowner stated the weeds would be sprayed as soon as possible to control the weeds. The site was stable and no evidence of erosion features were observed during the inspection of hay. Therefore, the site has achieved the approved post-mining land use of general agriculture.

View of the cut grasses in Mining Area "B"

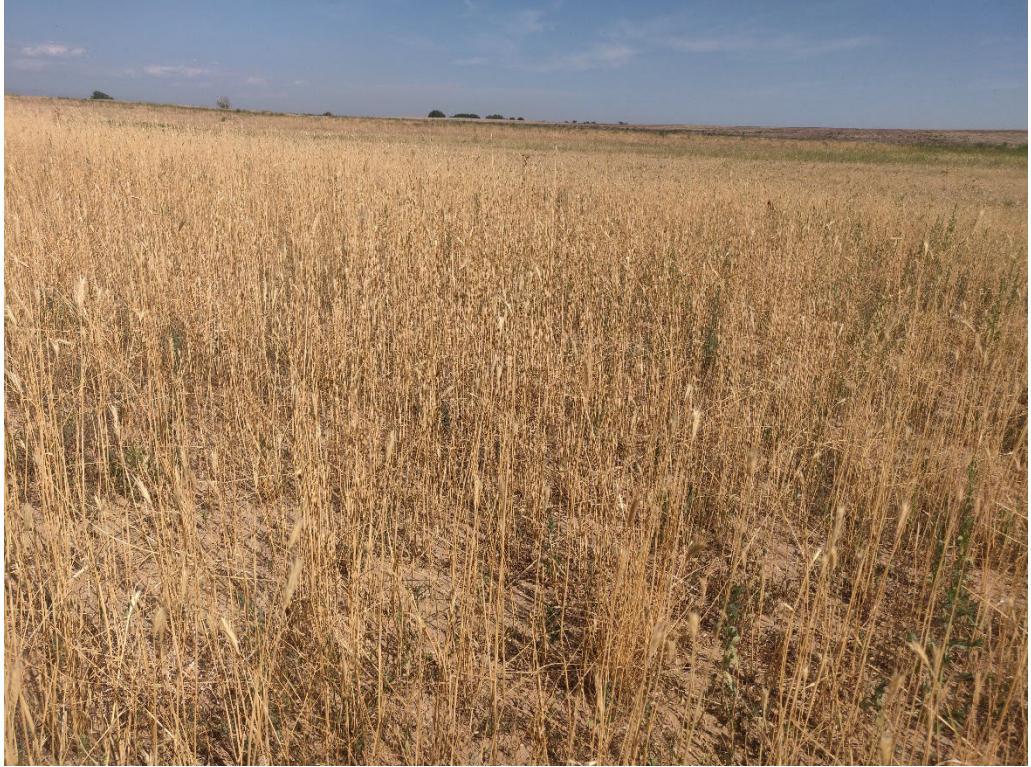
The approved post-mining land use for the site is general agriculture. The mining highwalls were graded to the required 3H:1V slope, topsoil was replaced at a depth of 4 to 6 inches and the areas were revegetated with the approved dryland quick establishment seed mixture.

View of the vegetation on the Mining Area "A" side slopes

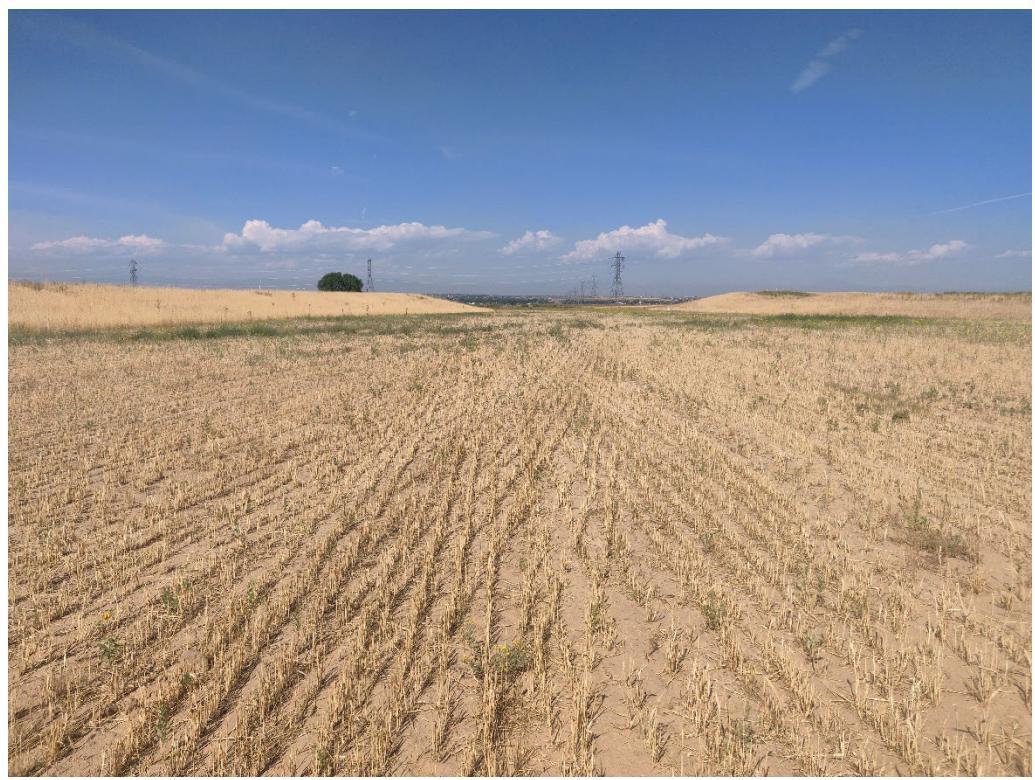
View of Mining Area "A" pit floor looking east
