MINERALS PROGRAM INSPECTION REPORT PHONE: (303) 866-3567

MINE NAME:		MINE/PROSPECTING ID#:	MINERAL:	COUNTY:
Schumacher Pit		M-1995-063	Sand and gravel	Logan
INSPECTION TYPE:		INSPECTOR(S):	INSP. DATE:	INSP. TIME:
Monitoring		Nikie Gagnon	August 4, 2022	10:30
OPERATOR:		OPERATOR REPRESENTATIVE:	TYPE OF OPERATION:	
Logan County		Jeff Reeves	112c - Construction Regular Operation	
REASON FOR INSPECTION:		BOND CALCULATION TYPE:	BOND AMOUNT:	
Normal I&E Program		None	\$0.00	
DATE OF COMPLAINT:		POST INSP. CONTACTS:	JOINT INSP. AGENCY:	
NA		None	None	
WEATHER:	INSPECTOR'S SIGNATURE:		SIGNATURE DATE:	
Clear	A		August 29, 2022	
	Yuku Dagnon		_	
	47			
		U

PERMIT #: M-1995-063 INSPECTOR'S INITIALS: NCG INSPECTION DATE: August 4, 2022

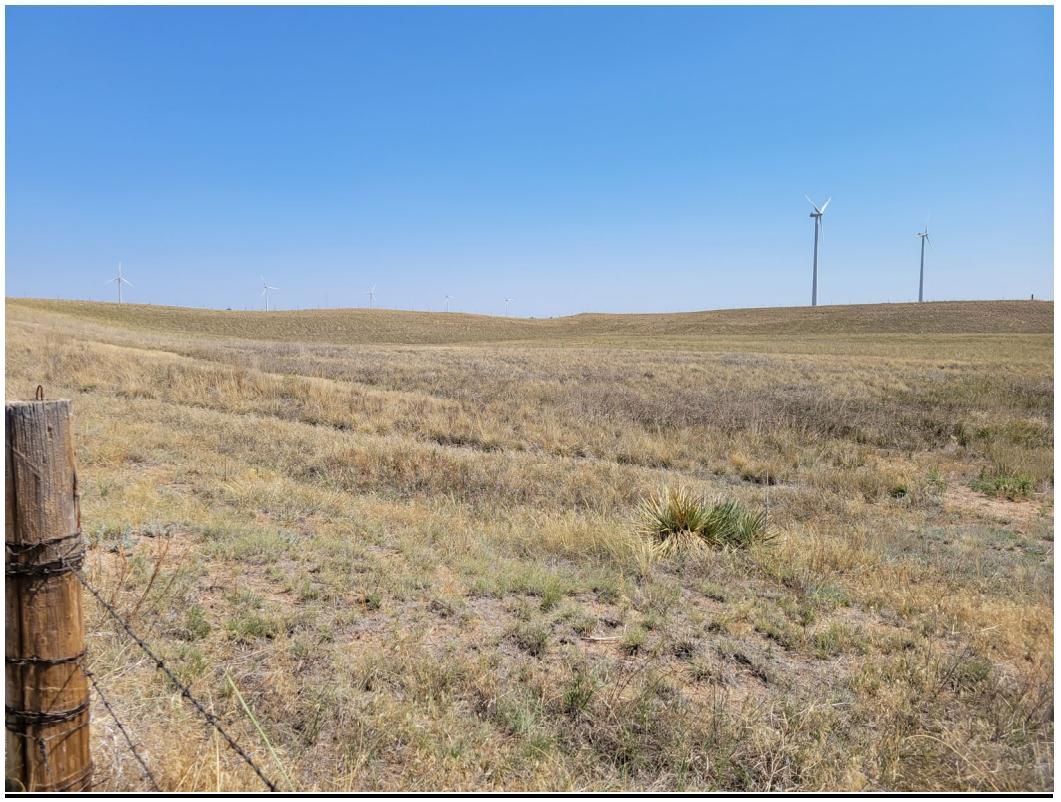
Reclamation is complete. The site has been backfilled and graded. The desired grassy vegetation is establishing uniformly throughout the site. Some annual weeds noted, however the native grasses are starting to thicken and spread across the slopes and in the bottom of the pit. The vegetation density is consistent with neighboring land. Bare patches of ground noted at the entrance to the site. No erosion rills were noted on the side slopes during the inspection.

Looking north across the reclaimed permit area.

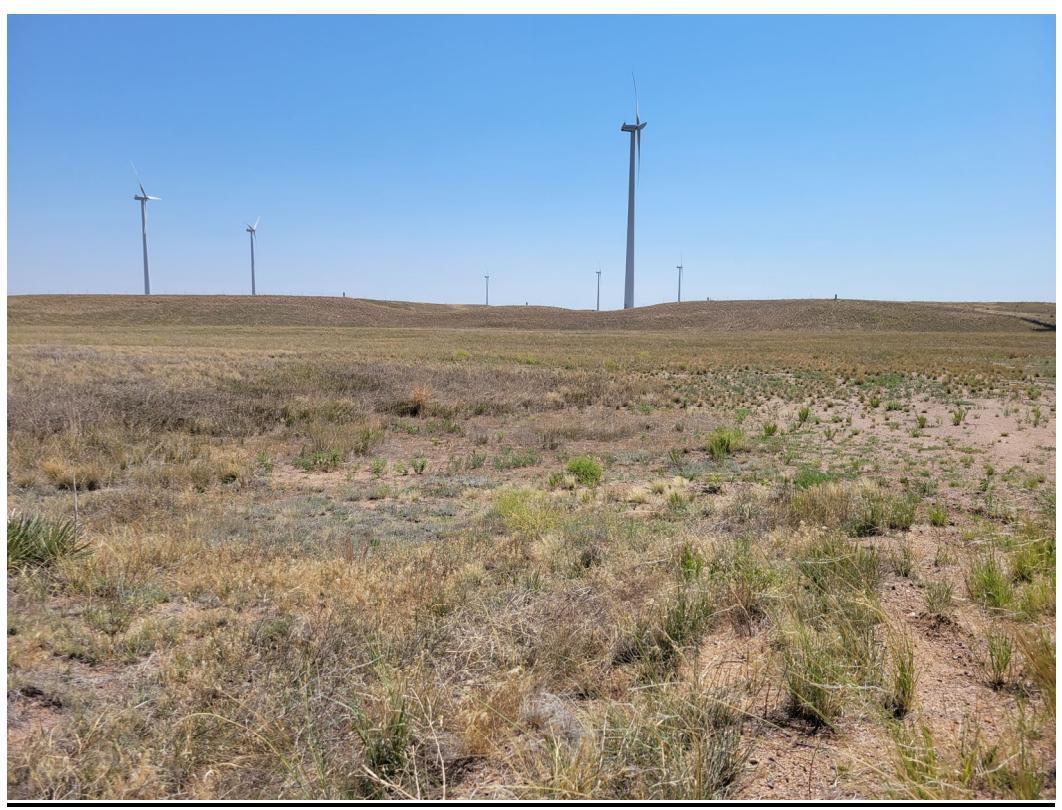
Looking east across the reclaimed permit area from the entrance to the pit.

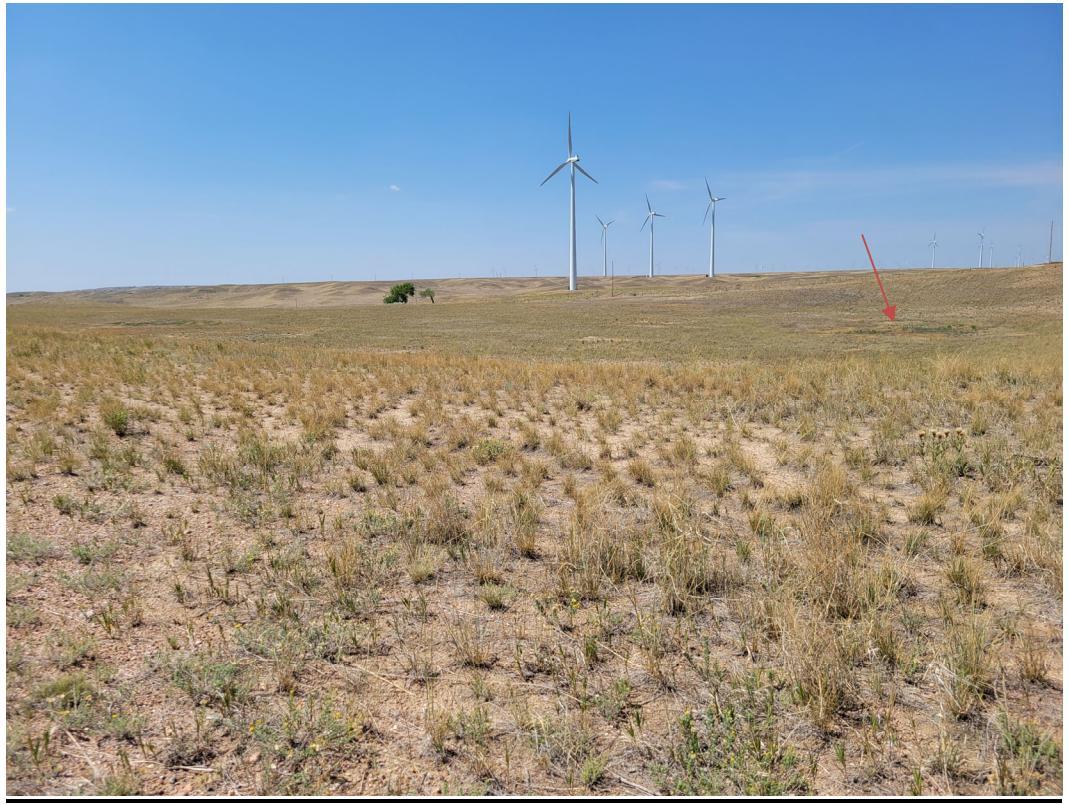
The pit was dry at the time of inspection. No evidence of water erosion was visible during the inspection.

Looking south from the northern boundary across the reclaimed pit. Arrow points to the bottom of the pit which was dry during the inspection.

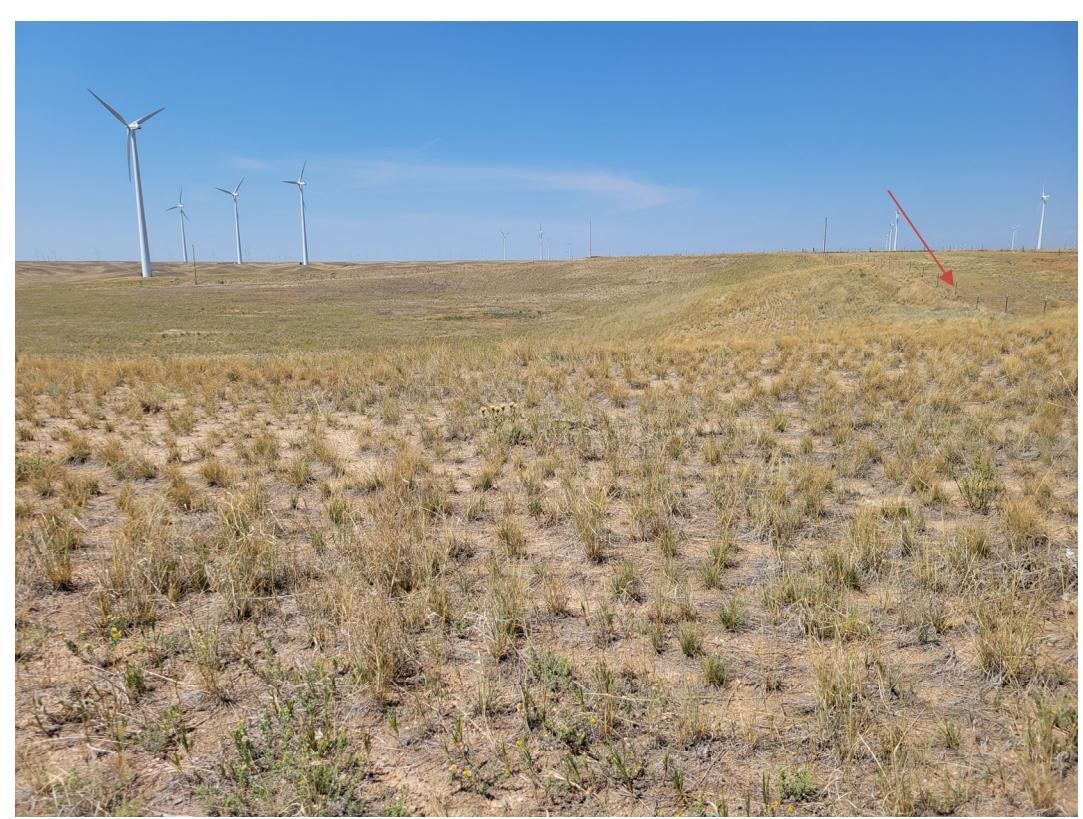
Looking west, along northern boundary, arrow points to fence line delineating northern edge of permit area.

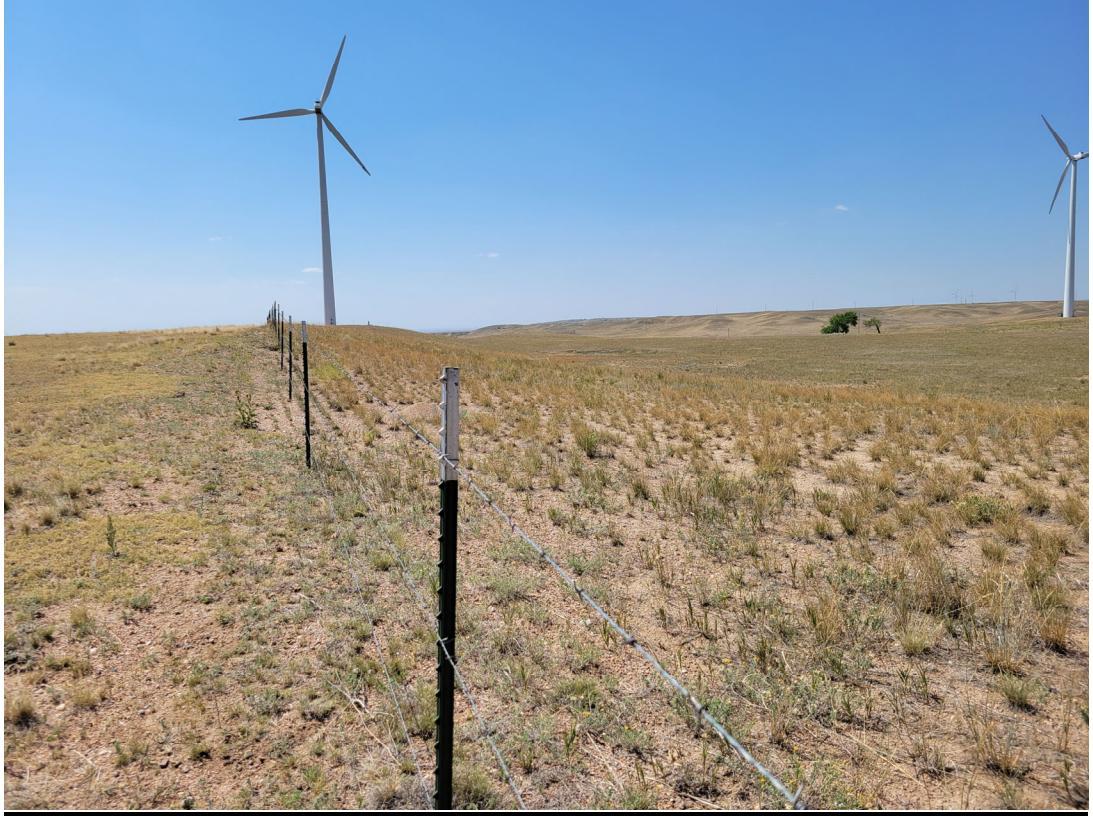
Looking south along eastern boundary, fence line delineates edge of permit area.

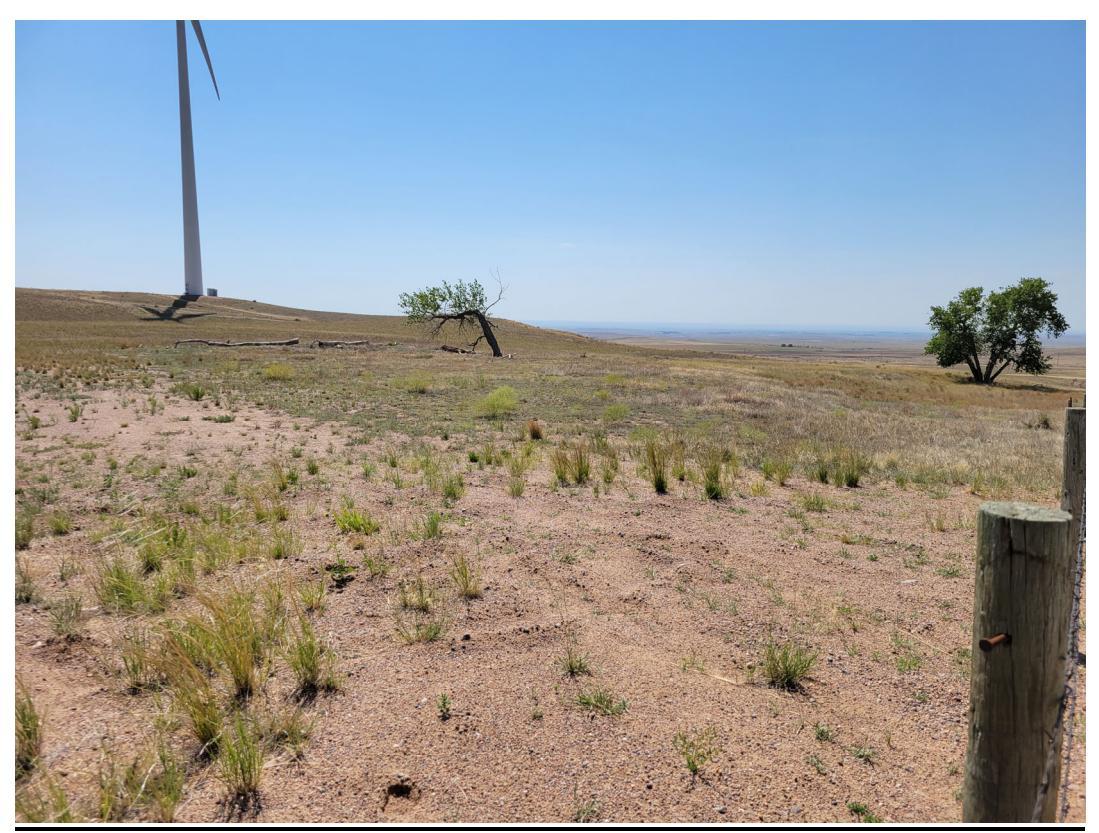
<u>Signs and Markers</u>: During the inspection a mine identification sign was not posted at the entrance and the entrance to the site had been closed with barbed wire. Jeff Schumacher, the landowner, stopped by while the Division was still on site and told us that he removed the sign and closed the entrance because he thought the permit had been released. A few days after the inspection, Mr. Schumacher posed the sign at the entrance and sent the Division a photograph of the sign in place. The permit boundary is delineated by a fence around the perimeter of the permit area.

Looking southeast from outside fence at the former gravel entrance to the site. A barbed wire fence was recently installed across the entrance.

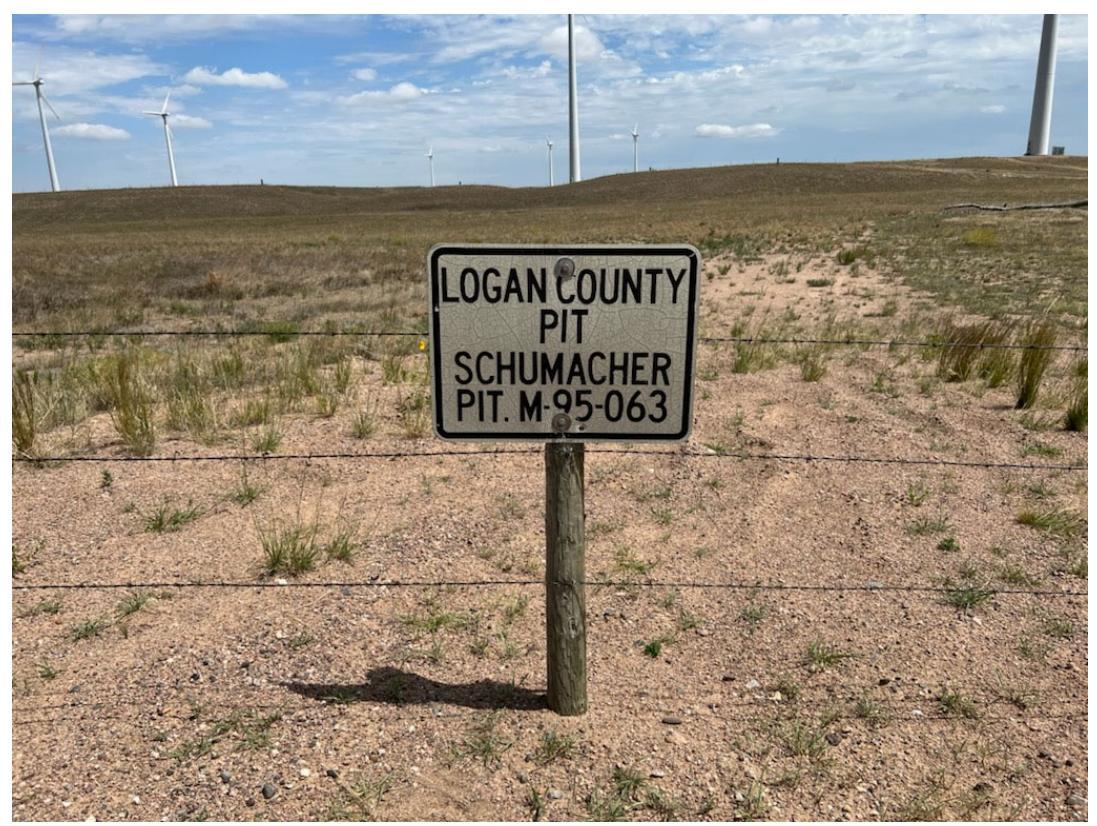
Permit sign in place at entrance to the site. Photo provided by landowner on August, 8 2022.
