RE: Colowyo Coal Company L.P. Permit No. C-1981-019 Technical Revision 156 (TR-156) Exhibit 23, Item 4

EXHIBIT 23, ITEM 4

THE ADEQUACY OF THE NATURAL SORTED SPOIL MATERIAL FOR THE PURPOSE OF A ROCK DRAIN IN LITTLE COLLOM DRAW

Re: The Adequacy of the Natural Sorted Spoil Material for the Purpose of a Rock Drain in Little Collom Draw

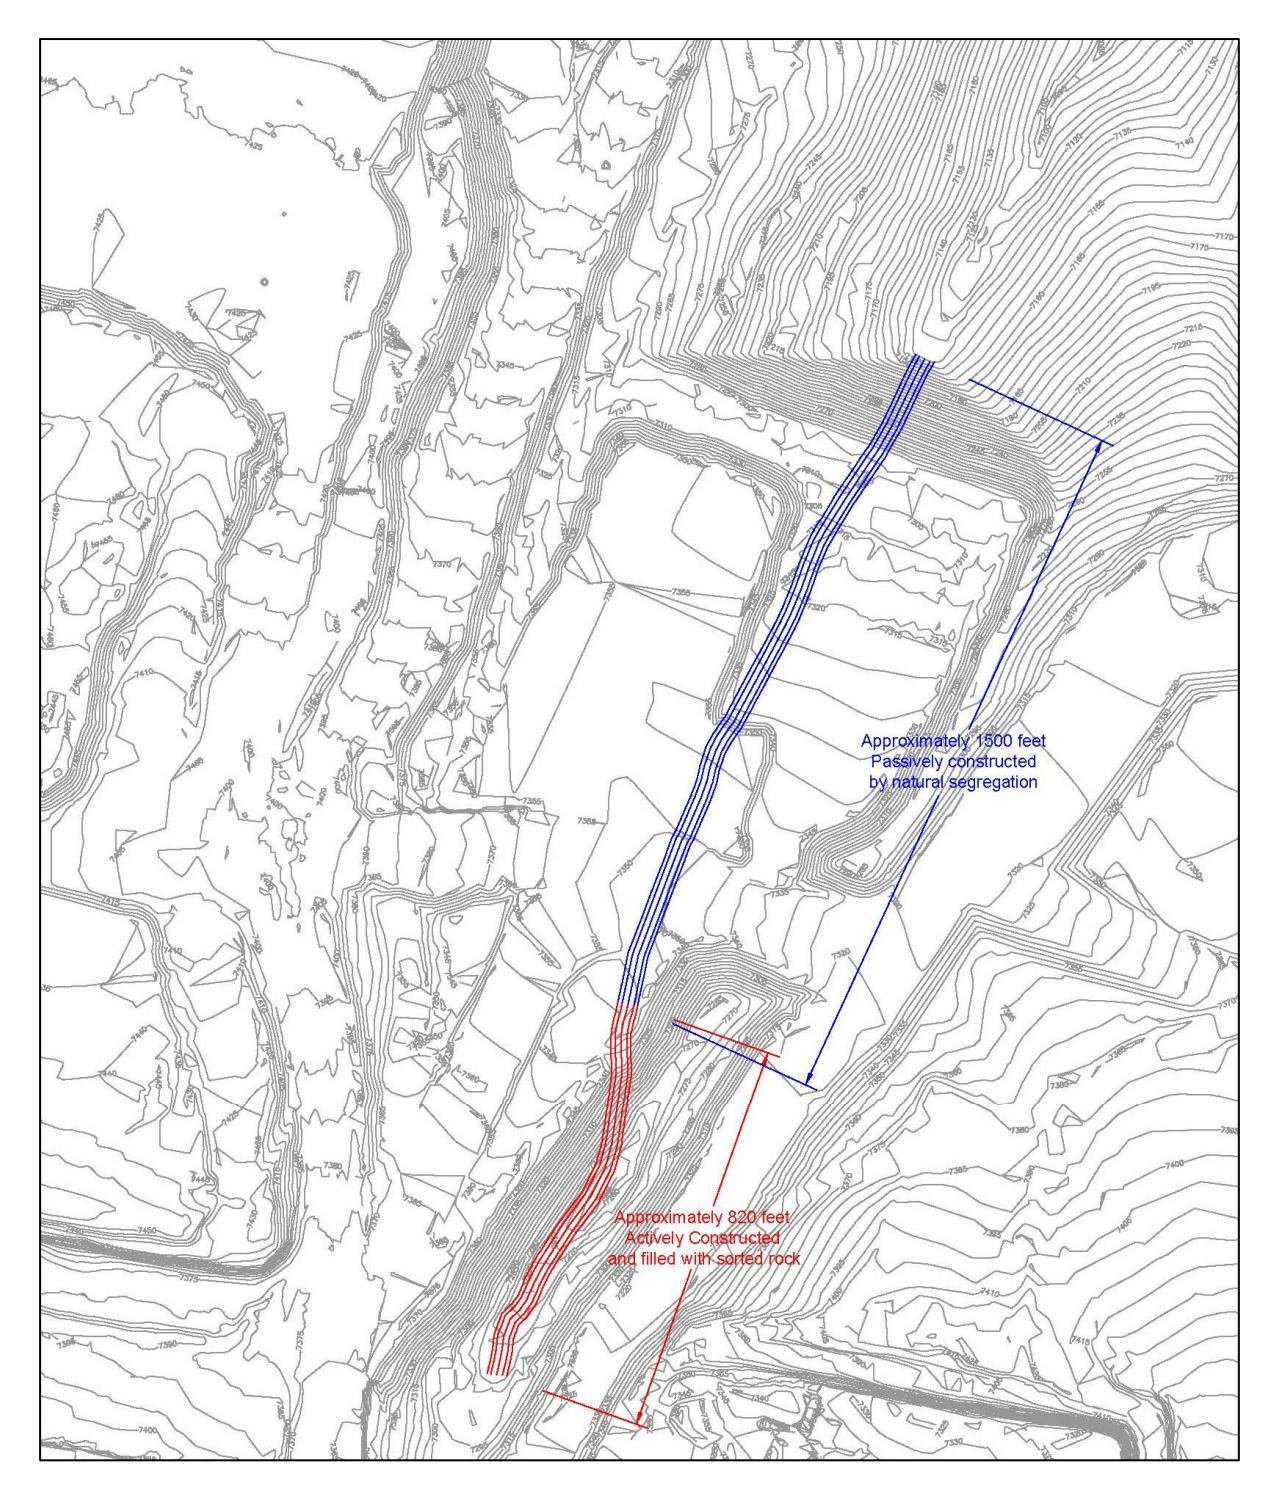
Colowyo Mine has indicated that prior to dumping spoil in the Little Collom Draw, the southernmost 820 feet (ft) of the draw had a 24-ft-wide rock drain constructed in 2021 (see Figure 1). The constructed drain was filled with large sandstone rock sorted on-site from existing spoil dumps. The sorted rock was placed in the drain with loaders and dozers. Following construction of the rock drain, excess spoil was end dumped into the draw and over the drain. This resulted in a dump height of approximately 130 ft above the valley floor at the north end of the draw.

Immediately north of the constructed rock drain, natural sorting from end dumping of the spoil material was utilized to create a rock drain for an additional 1,500 ft down the draw (see Figure 1). The cumulative volume of spoil dumped in the draw to date is estimated to be in the order of 4,200,000 cubic yards.

Figure 1. Drawing Showing the Location of the Valley Fill in Little Collom Draw Including the Constructed Underdrain and the Natural Sorted Rock Drain (Colowyo, August 8, 2022)

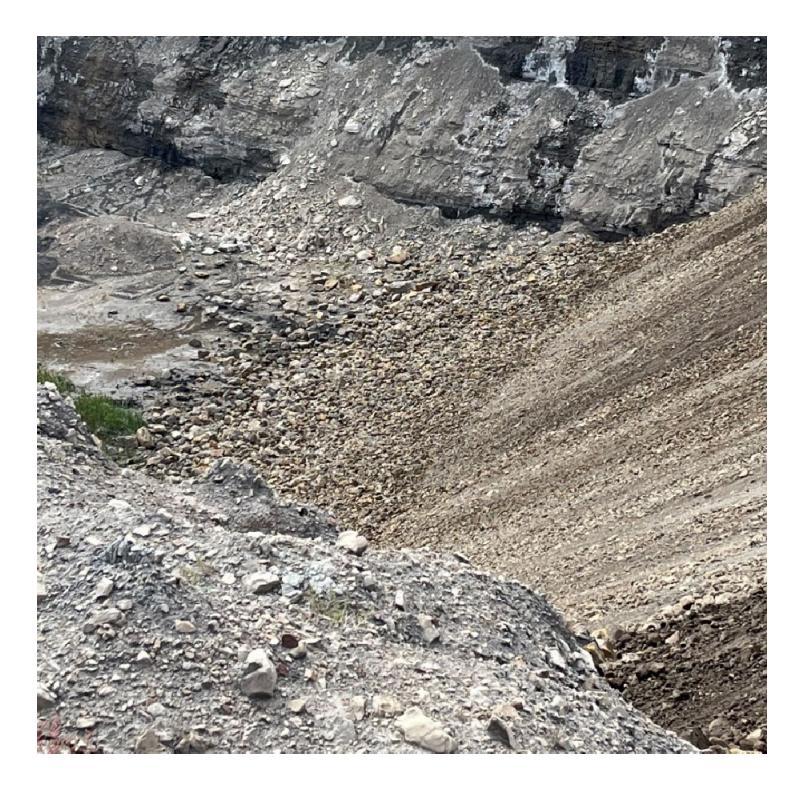
Agapito has also made several observations of natural sorting of spoil material from end dumping at the mine. At dump heights of greater than 100 ft, the toe of the slope is comprised of sandstone and siltstone cobbles (3 to 12 inches in diameter) and boulders (>12 inches in diameter), while the upper slope is dominated by finer sand and gravel material. The most recent example observed is shown in Figure 2, a photograph of active end dumping of spoil into West Pit at a height of greater than 100 ft.

Figure 2. Photograph Taken during the September 13, 2022, Site Visit Showing Natural Sorting of Spoil Material from End Dumping into West Pit

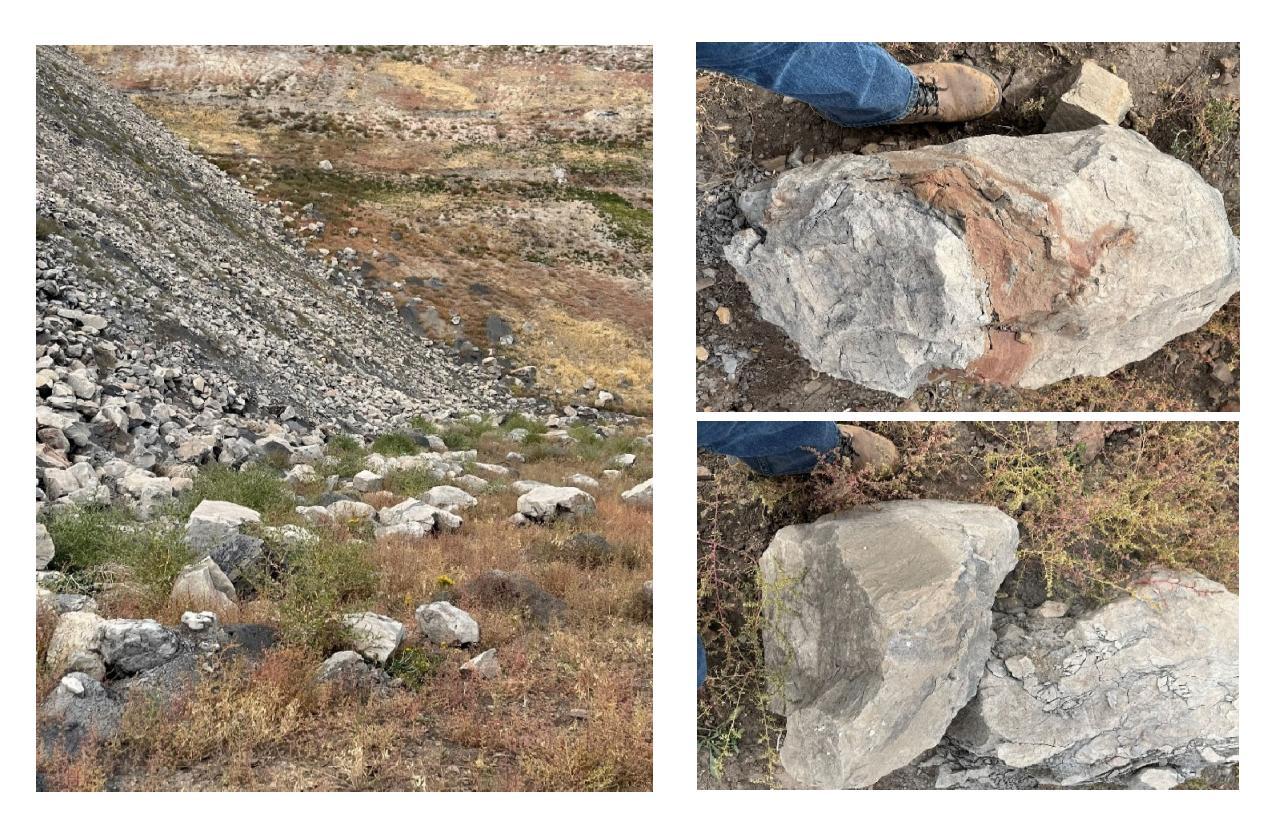
The spoil placed into Little Collom Draw consists of excavated bedrock composed of sandstone, siltstone, and mudstone from the Williams Fork Formation. Through the process of natural sorting, as shown in Figure 3, the base of the fill consists of sandstone and siltstone cobbles (3 to 12 inches in diameter) and boulders (>12 inches in diameter). Figure 4 shows the sorted spoil material at the northernmost end of the valley observed during the site inspection.

Figure 3. Photographs Taken during September 13, 2022, Site Visit Showing the Cobbles and Boulders Located along the Toe of the Lower Slope in Little Collom Draw

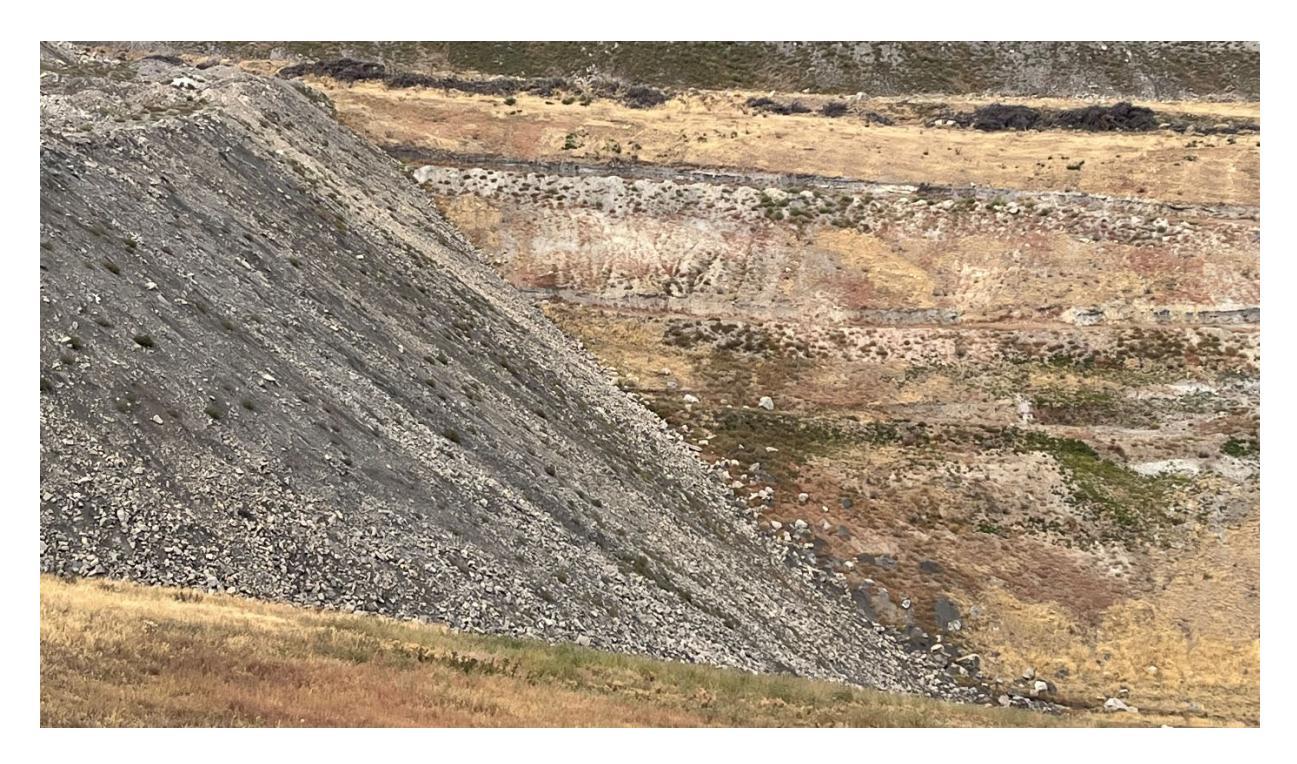
As the spoil has been end dumped from the crest of the fill, a height of greater than 100 ft, the natural sorting extends entirely across the valley floor, which would encompass any lateral drains present in the valley. This is shown in Figure 4, a photograph taken of the north end of the dump during the September 13, 2022, site inspection. Previous photos taken by the mine, see Figure 5, indicate that the natural sorting has taken place along the entire length of the valley fill in the draw.

Figure 4. Photograph Taken during September 13, 2022, Site Visit Showing Natural Sorting from End Dumping in Little Collom Draw

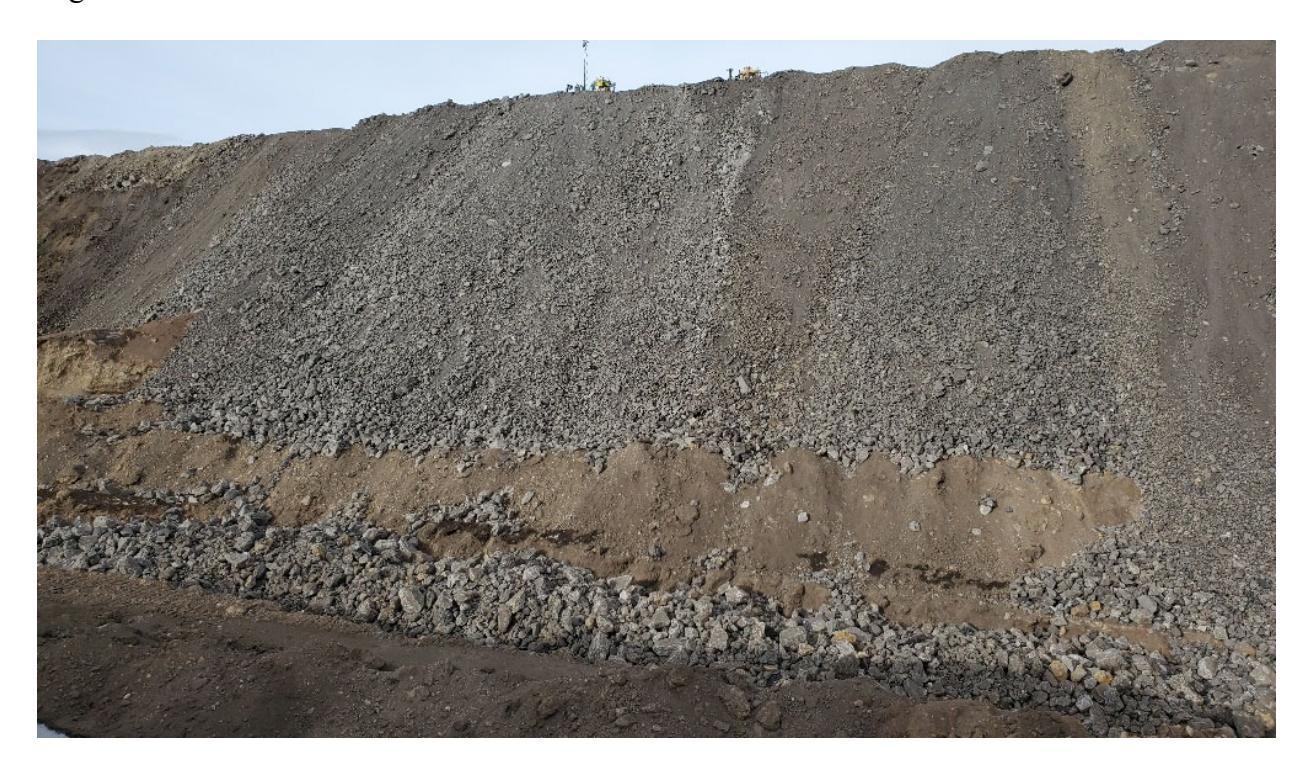
Figure 5. Photograph Taken during January 27, 2021, by Colowyo Showing the Constructed Underdrain and the Natural Sorting of Spoil Material Following End Dumping
