# **PERMIT INFORMATION**

Permit Number: C-1996-083 Mine Name: Bowie No. 2 Mine Operator: Bowie Resources, LLC Operator Address: Mr. Basil Bear P.O. Box 1488 Paonia, CO 81428 County: Delta Operation Type: Underground Permit Status: Active Ownership: Private

## **INSPECTION INFORMATION**

Inspection Start Date: September 29, 2022 Inspection Start Time: 11:10 Inspection End Date: September 29, 2022 Inspection End Time: 13:30			<b>Inspection Type:</b> Coal Parti <b>Inspection Reason:</b> Normal <b>Weather:</b> Clear	*
Joint Inspection Agency:		Joint Inspection Contacts:		
None				
Post Inspection Agency:		Post	Inspection Contacts:	
None				
Inspector(s):	Inspector's Signature:		gnature:	Signature Date:
Robert Zuber, P.E.	Phot	D.	21-	
				9/30/2022

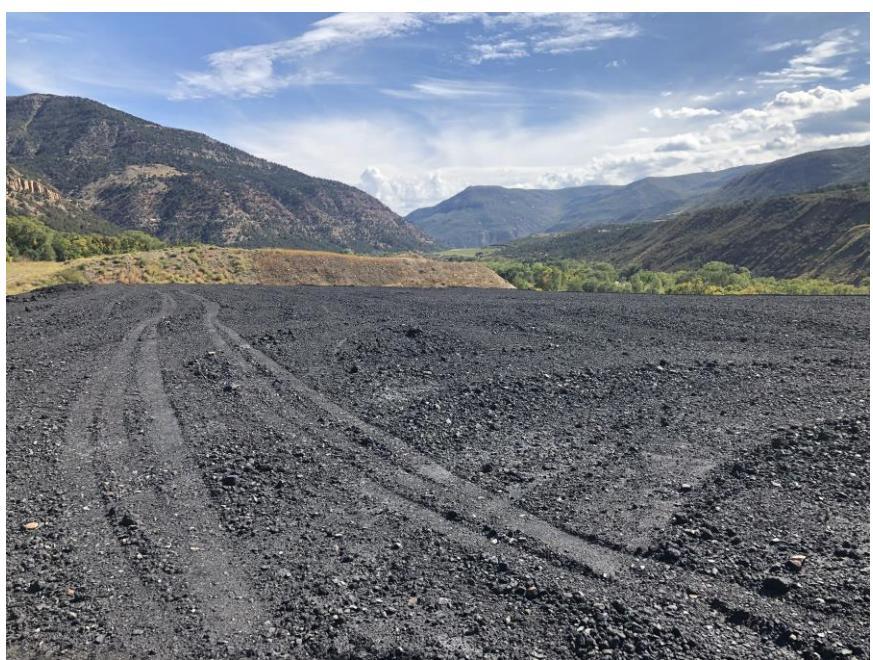
BRL continues to focus their efforts on Gob Pile #3, and it appears that this work is nearly complete. During the inspection, several piles of material had been placed on the east side of the pile. They were moved from the Coal Stockpile Pad. The majority of the site has a gentle grade to the south, and it appeared to be well compacted. The north side has approximately a 3H:1V grade.

Gob Pile #3, sloping to right (south)

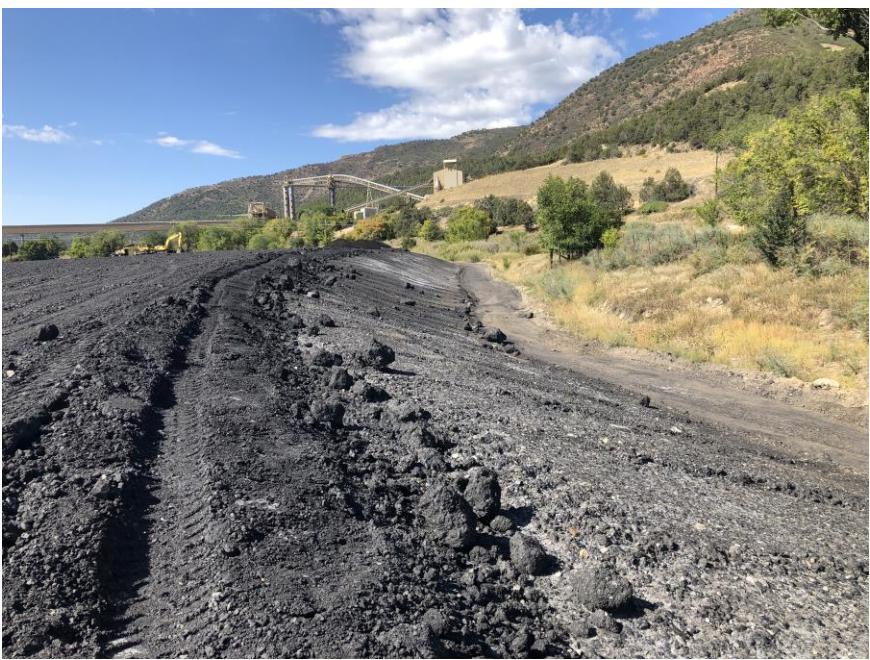
Gob Pile #3, slope on north side

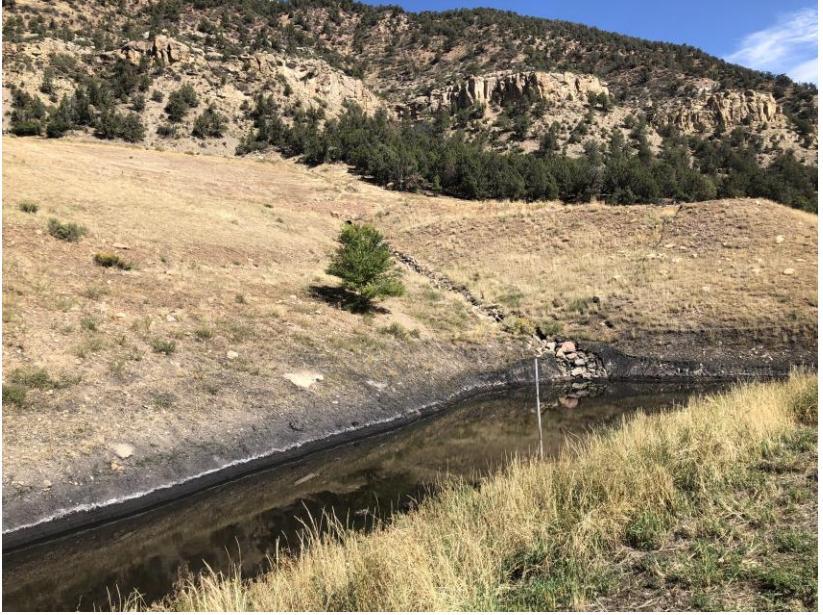
Pond F

Six sediment ponds were inspected: B, C, D, F, J, and K. None of the ponds were discharging. Most of the ponds contained water or the bottom is obscured with vegetation. Pond K, the exception, was dry. None of the ponds were close to full. No significant problems were identified with embankments, spillways, inlet channels, or other features of the ponds.

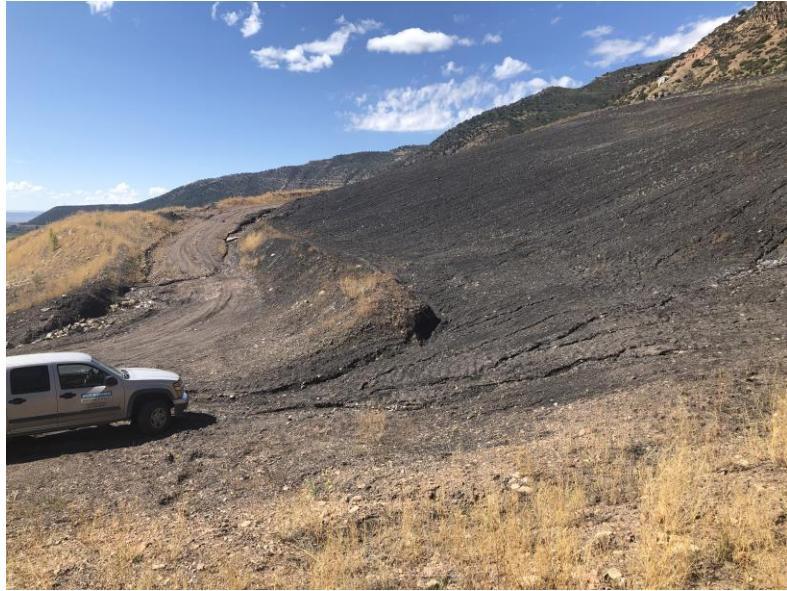
Rills were visible on the upper (bare) slopes of Gob Pile #2, but they are small.

Gob Pile #2 upper outslope

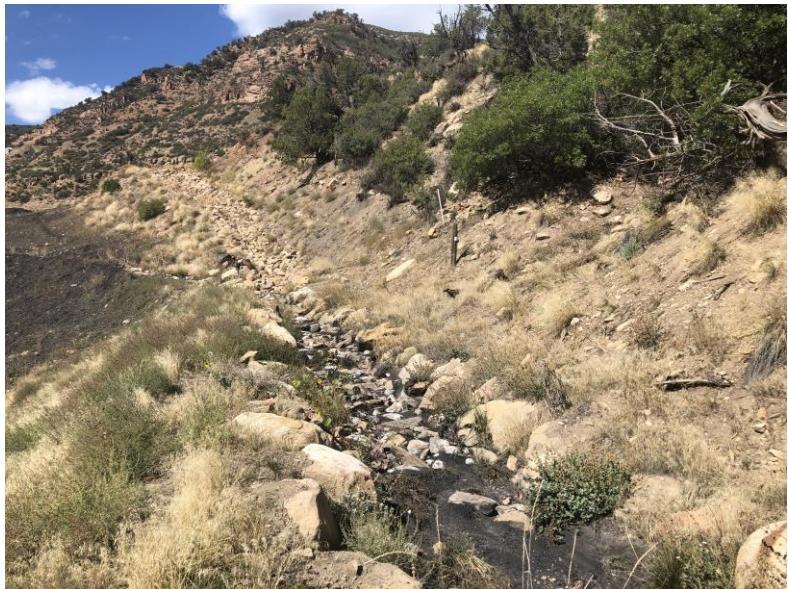
Ditch D-F4, east of Gob Pile #2

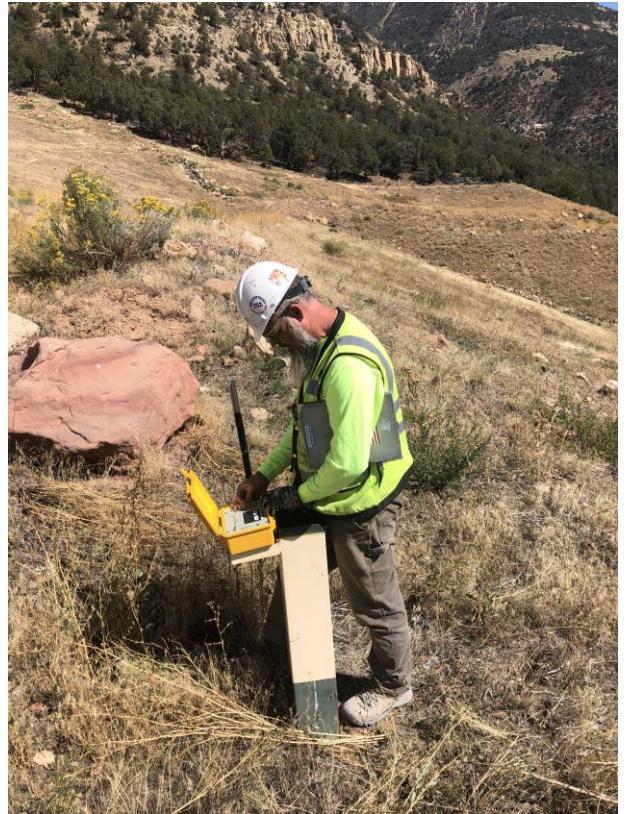
At Gob Pile #2, Jeremy Harshman of Buckhorn Engineering was collecting data from inclinometers and vibrating wire piezometers (VWPs). At VWP-10, only a slight change was detected from the last reading in June 2022.

Collecting data from VWP-10

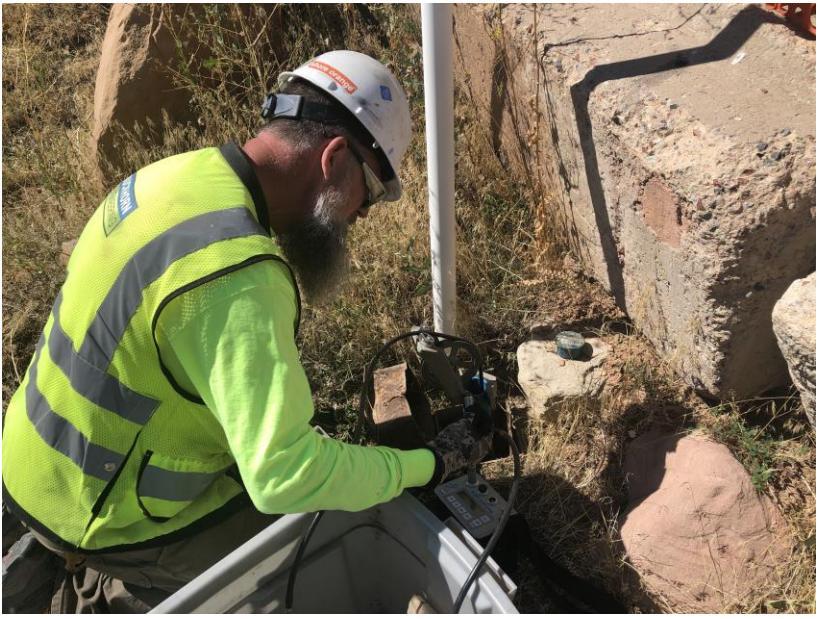
Collecting data from inclinometer, BGI 05-04

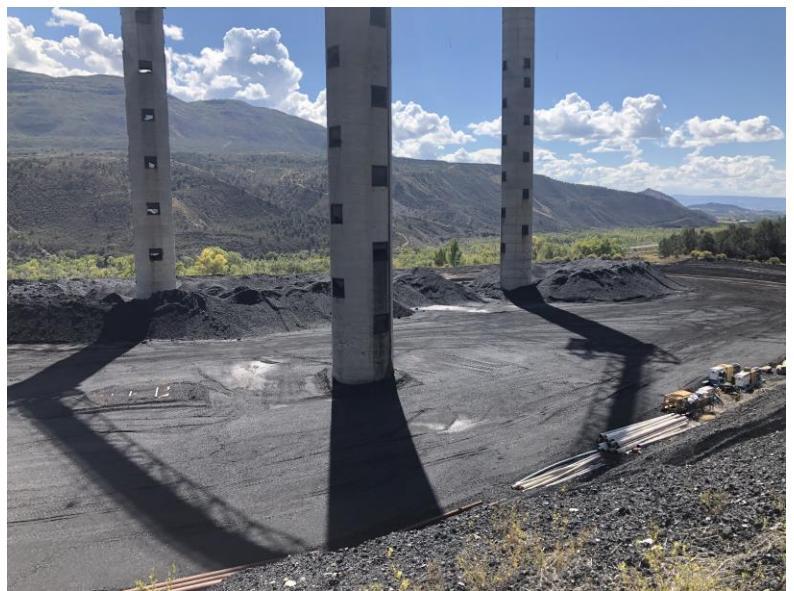
Gob on Coal Stockpile Pad

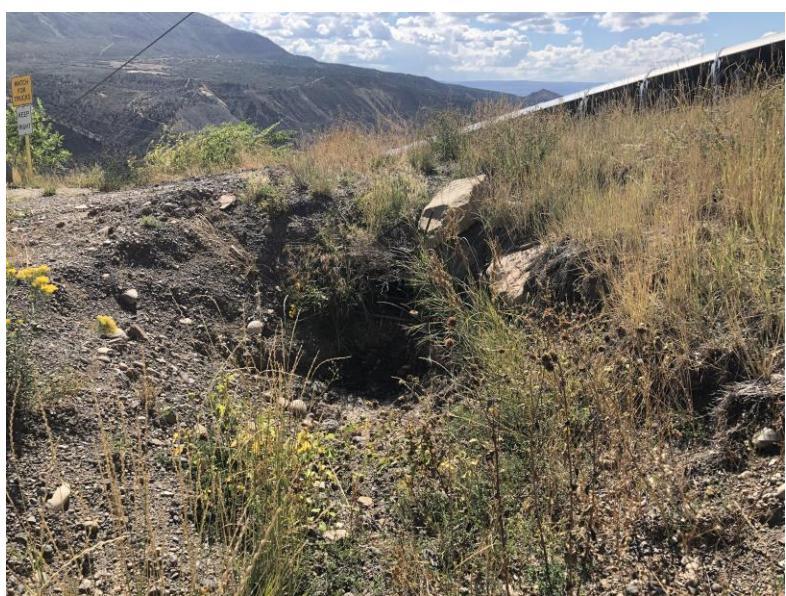
No issues were identified with most culverts or ditches. A culvert at Curve 5, however, was found to be approximately 80 percent clogged. BRL staff should identify if this structure is still a part of the surface water control system (perhaps culvert C-B9). If it is, it needs to be cleaned.

**Clogged culvert at Curve 5**
