MINERALS PROGRAM INSPECTION REPORT PHONE: (303) 866-3567

MINE NAME:		MINE/PROSPECTING ID#:	MINERAL:	COUNTY:
VIP Mine		M-2022-032	Gravel	Weld
INSPECTION TYPE:		WEATHER: Clear	INSP. DATE:	INSP. TIME:
Preoperation Inspection			October 5, 2022	12:00
OPERATOR:		OPERATOR REPRESENTATIVE:	TYPE OF OPERATION:	
Varra Buildings, Inc.		Nick Varra, Tony Evans	112c - Construction Regular Operation	
REASON FOR INSPECTION:		BOND CALCULATION TYPE:	BOND AMOUNT:	
Preoperation Inspection			No Bond Held	
DATE OF COMPLAINT:		POST INSP. CONTACTS:	JOINT INSP. AGENCY:	
NA		None	None	
INSPECTOR(S):	INSPECTOR'S SIGNATURE:		SIGNATURE DATE:	
Robert Zuber, P.E.			October 6, 2022	
	Phi	A. D. 24

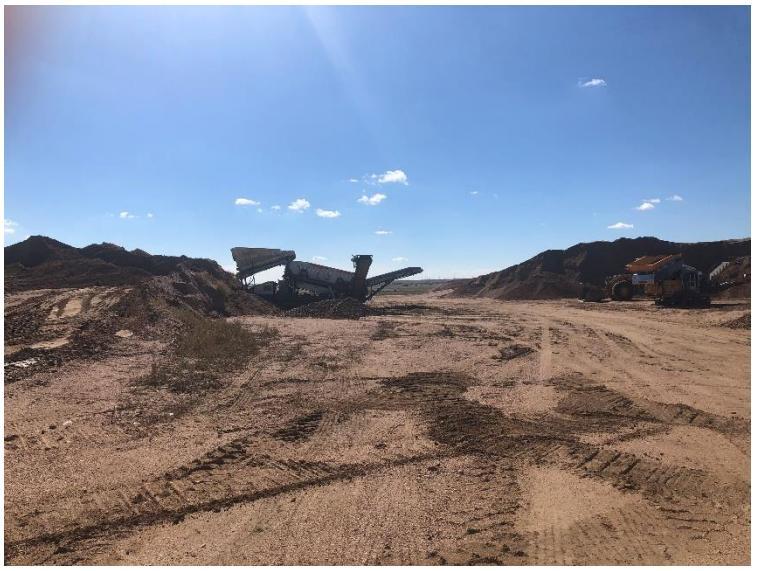
Some mining activities have been conducted at the site for road construction on the adjacent property (to become an industrial park), also owned by Nick Varra. There is no indication that material from the excavation was used off site. The size of the area is approximately 800' by 500' and 15 feet deep. Loaders, a truck, and equipment for processing material were on site but not in use. Piles of rock and soil were also in this area. Mr. Varra indicated that no more extraction will take place before a permit is obtained.

Material processing equipment

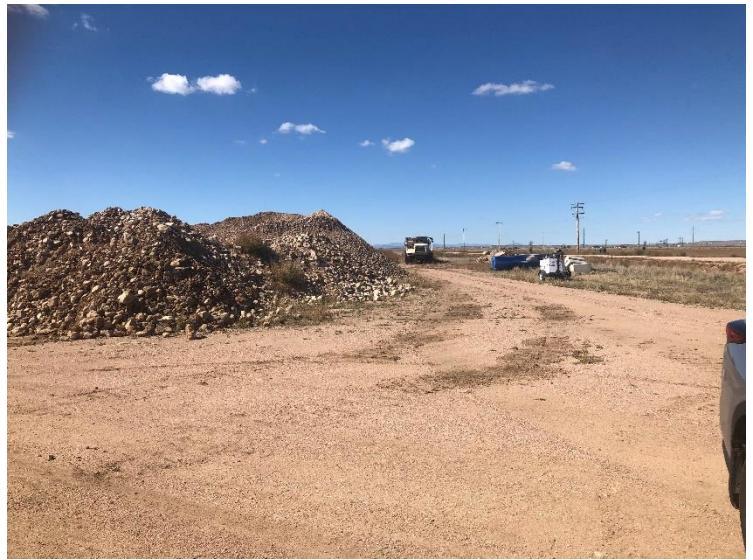
Material piles and a haul truck

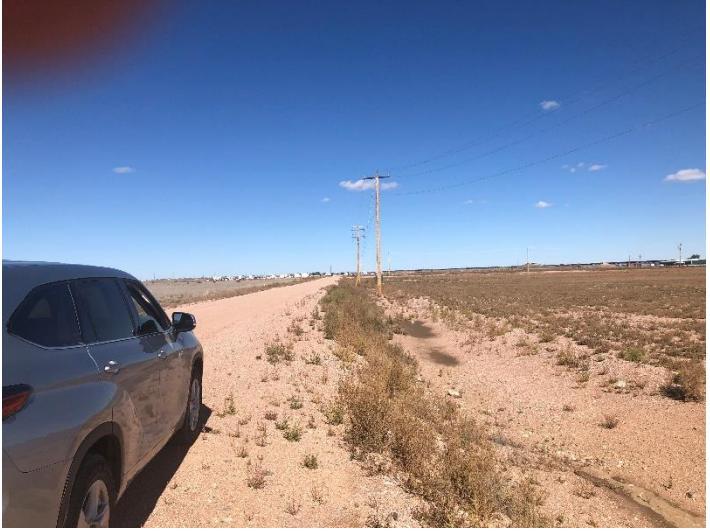
Signs of utilities on and close to the site include power lines and utility boxes, fire hydrants, and markers for gas lines. Mr. Varra indicated that:

*The power lines are active and power is supplied by Xcel Energy.

Power lines along the western portion of the site (looking north)

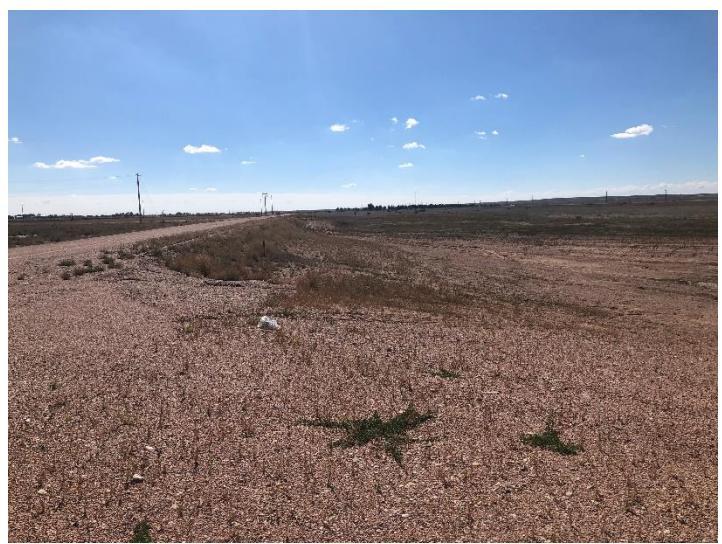
At the northwest corner, a small amount of disturbance (less than two acres) can be seen. This area was used on Varra property to fill low spots, per Mr. Varra.

Disturbance at the northwest portion of the site
