Permit Number: C-1996-083 Mine Name: Bowie No. 2 Mine Operator: Bowie Resources, LLC Operator Address: Mr. Basil Bear P.O. Box 1488 Paonia, CO 81428 County: Delta Operation Type: Underground Permit Status: Active Ownership: Private

Inspection Start Date: October 26, 2022 Inspection Start Time: 11:00 Inspection End Date: October 26, 2022 Inspection End Time: 12:45			Inspection Type: Coal Parti Inspection Reason: Normal Weather: Raining	
Joint Inspection Agency:		Joint Inspection Contacts:		
None				
Post Inspection Agency:		Post Inspection Contacts:		
None				
Inspector(s):	Inspecto	r's Sig	nature:	Signature Date:
Robert Zuber, P.E.	Phit	D.	2-	
				10/28/2022

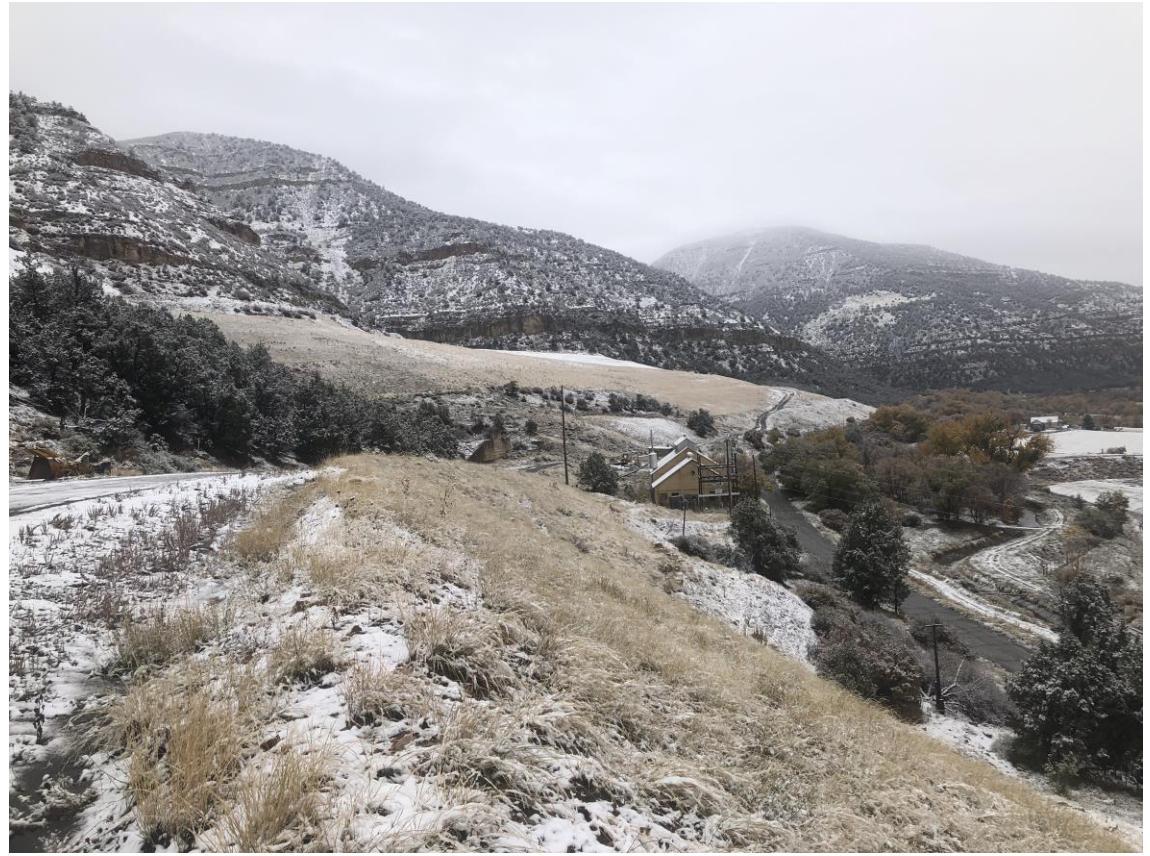
Overall the gob piles appeared stable. No large puddles or other significant problems were observed.

Gob Piles 1, 2, and 4 in background. Old Power Plant in middle of photo.

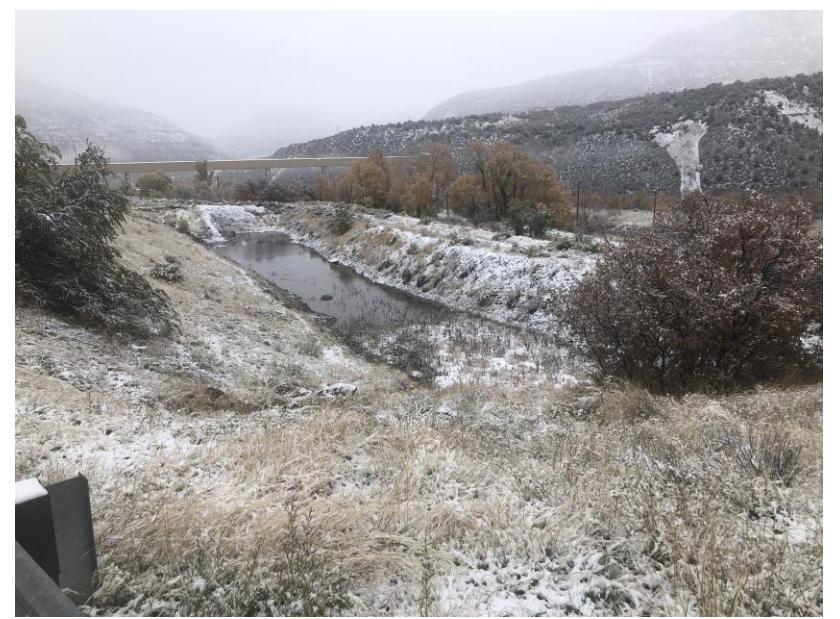
Pond B

Four sediment ponds were inspected: B, F, J, and K. None of the ponds were discharging. Most of the ponds contained water. Pond K, the exception, had a muddy bottom. None of the ponds were close to full. No significant problems were identified with embankments, spillways, inlet channels, or other features of the ponds.

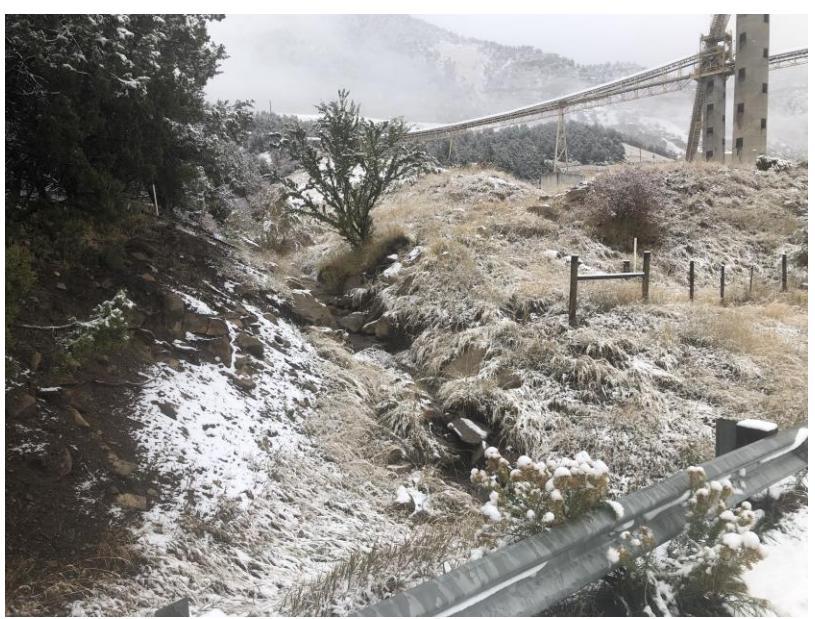
No issues were identified with culverts or ditches. A culvert at Curve 5, which appeared to be clogged in September, appeared to be clear of sediment during the October inspection (water flowing through the culvert prevented a thorough inspection).

Drainage west of Coal Stockpile Pad, above Pond B

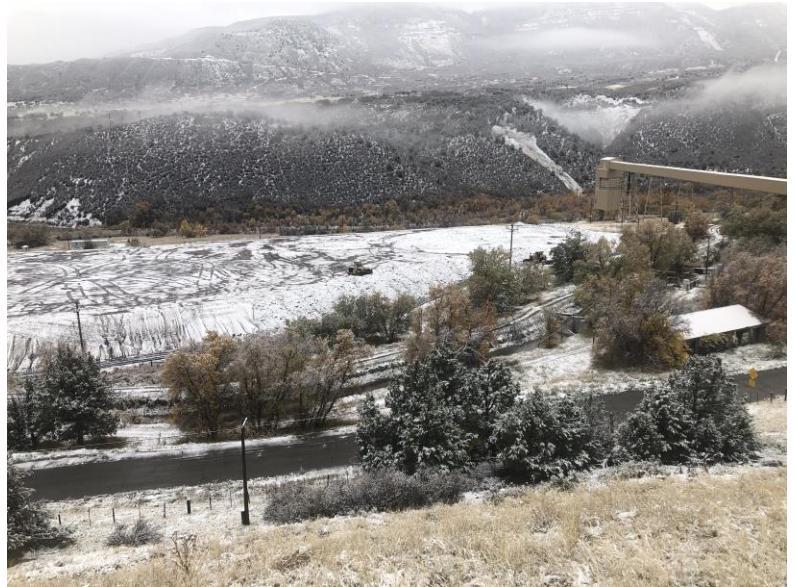
BRL continues to focus their efforts on Gob Pile #3, although weather precluded work during the day of the inspection. The grade on the north side of this pile is flatter than during the inspection in September.

Gob Pile #3, west side

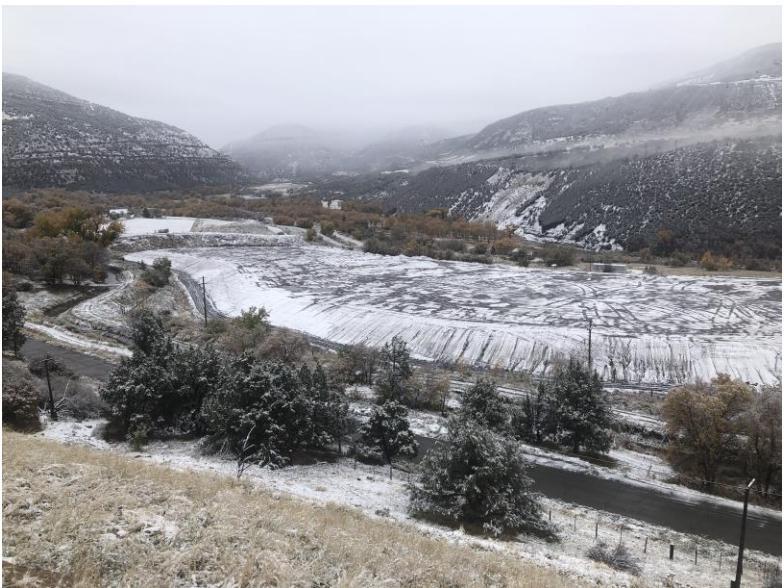
Gob Pile #3, east side
