# **DRMS Inspection Additional Information Requested**

October 31, 2022

# **Re:** Cresson Project, Permit No. M-1980-244; Monitoring of Mine Plan Response to Comments Regarding Corrective Action Submittal

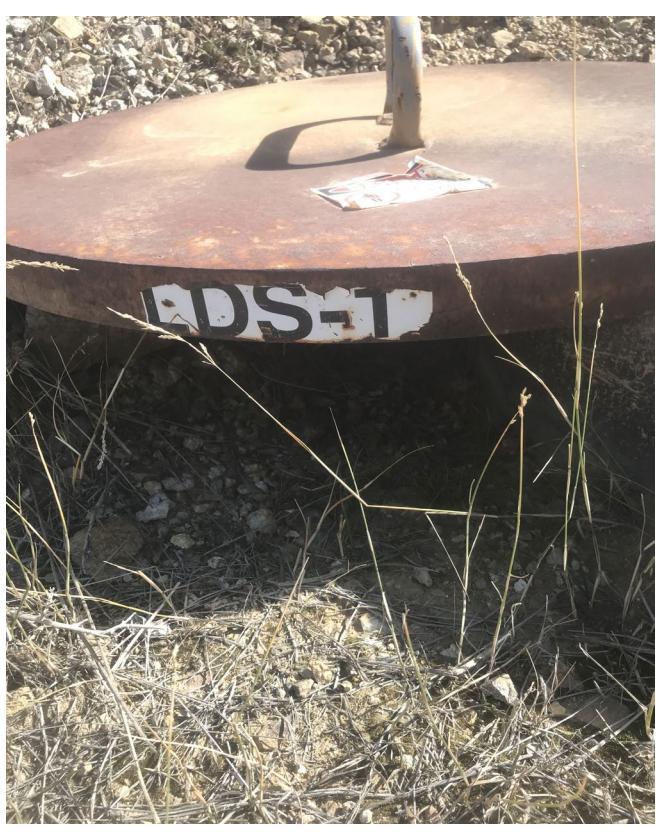
LDS-1 Photograph taken 10-26-22

Please see the attached photographs of LDS-1. This LD sump is a deep sump and does not allow for adequate lighting when taking photos. The visual marker is more apparent in field conditions.

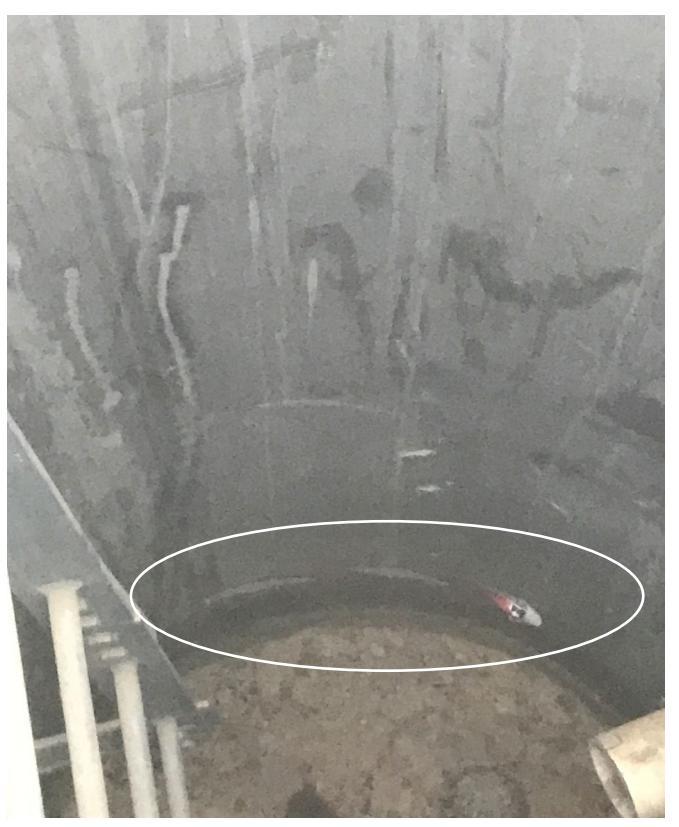
LDS - Visual marker. Marker is more apparent in the field

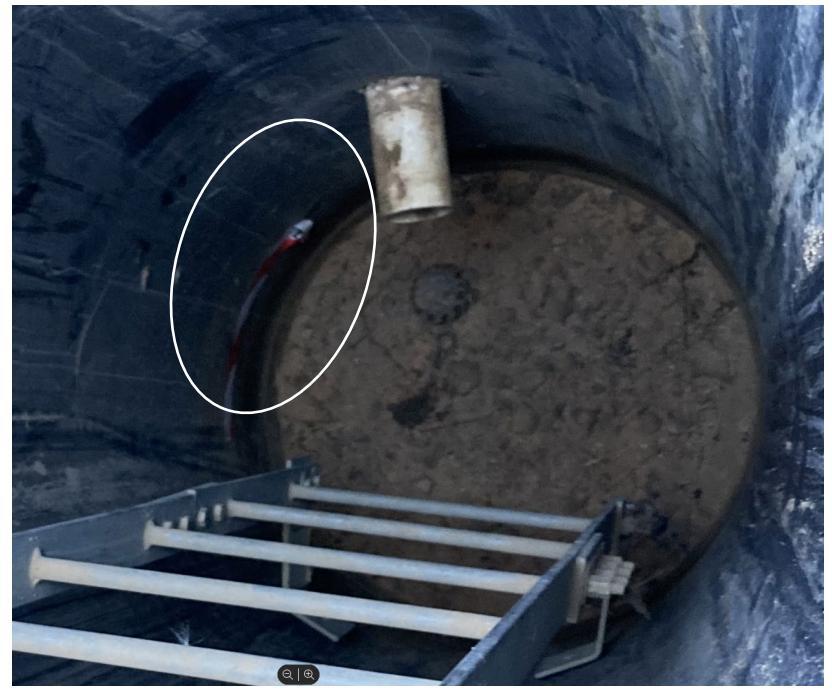
LDS-1 - Another view of the visual marker

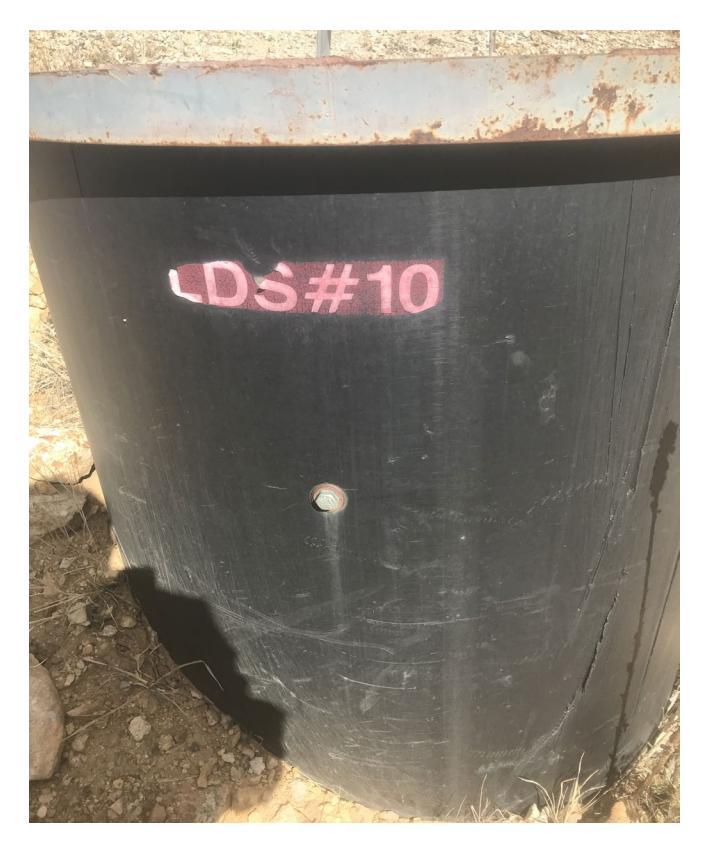
LDS-10, Photograph taken 10-26-22

- 2. The Division has the following question(s) regarding the photos provided to demonstrate the buckets have been removed from sumo inlet pipes:
  - a. The photo of LDS-10 only shows a portion of this sump, making it difficult to confirm the bucket has been removed from the inlet pipe. Please provide a photo that shows the entire sump bottom and inlet pipe.

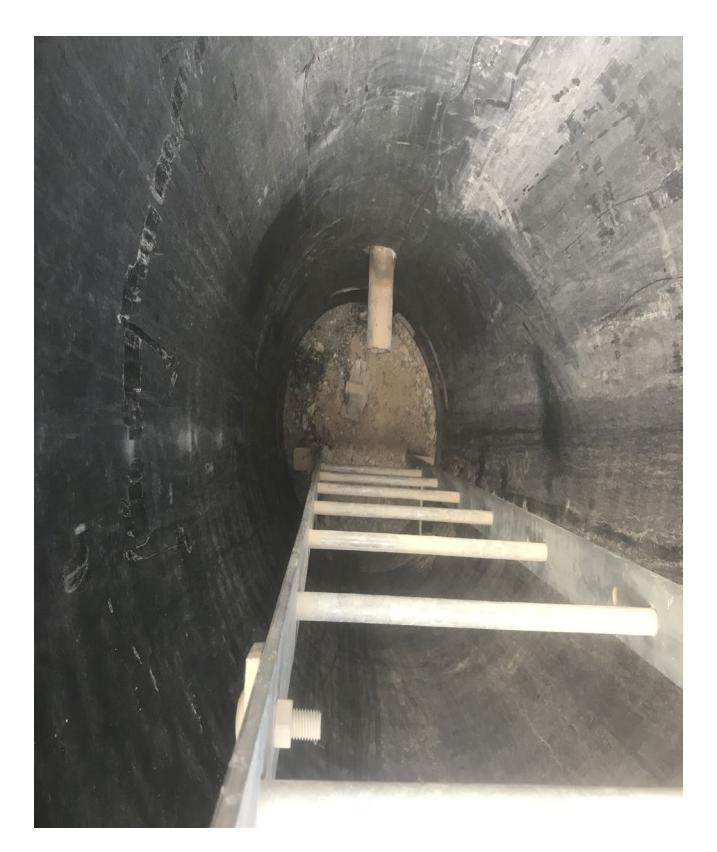
LDS-10 Photograph taken 10-26-22, showing bucket removed
