# MINERALS PROGRAM INSPECTION REPORT PHONE: (303) 866-3567

MINE/PROSPECTING ID#:	MINERAL:	COUNTY:
M-2013-018	Sand and gravel	Weld
WEATHER: Clear	INSP. DATE:	INSP. TIME:
	November 4, 2022	11:45
<b>OPERATOR REPRESENTATIVE:</b>	TYPE OF OPERATION:	
Dustin Gaspar	112c - Construction Regular Operation	
BOND CALCULATION TYPE:	BOND AMOUNT:	
None	\$61,267.33	
POST INSP. CONTACTS:	JOINT INSP. AGENCY:	
None	None	
SPECTOR'S SIGNATURE:	SIGNATURE DATE:	
	November 9, 2022	
What D Zh		
- · · · · ·		
	M-2013-018 WEATHER: Clear OPERATOR REPRESENTATIVE: Dustin Gaspar BOND CALCULATION TYPE: None POST INSP. CONTACTS:	M-2013-018 Sand and gravel   WEATHER: Clear INSP. DATE: November 4, 2022   OPERATOR REPRESENTATIVE: Dustin Gaspar TYPE OF OPERA' 112c - Construction   BOND CALCULATION TYPE: None BOND AMOUNT: \$61,267.33   POST INSP. CONTACTS: None JOINT INSP. AGE None   NSPECTOR'S SIGNATURE: SIGNATURE DAT November 9, 2022

The Harms Pit was inspected by Rob Zuber with the Division of Reclamation, Mining and Safety (Division/DRMS) as part of the Division's monitoring inspection program. Mr. Dustin Gaspar with Pine Bluffs Gravel & Excavating, Inc. was present during the inspection. The site was most recent

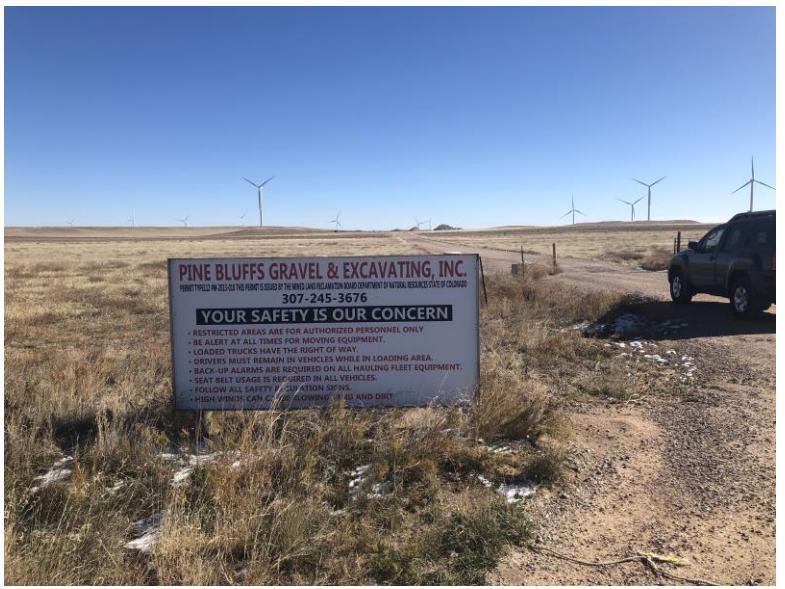
The mine identification sign, as required by Rule 3.1.12(1), was observed, and it contained the necessary information. Boundary markers were seen at the northeast and southeast corners. Some of the permit boundary markers have been knocked down by animals or removed (possibly by the landowner for a corn crop). Mr. Gaspar indicated that they will be replaced in the near future.

Entrance sing on CR 127

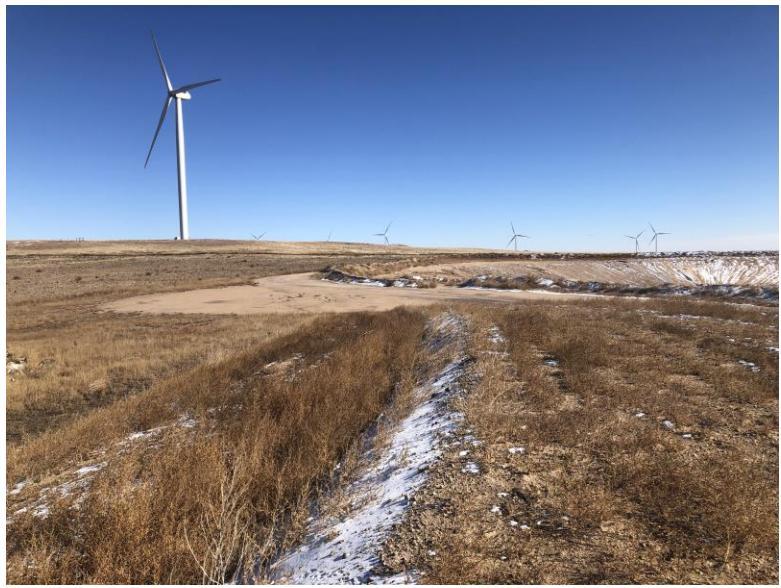
North side of disturbance, looking east

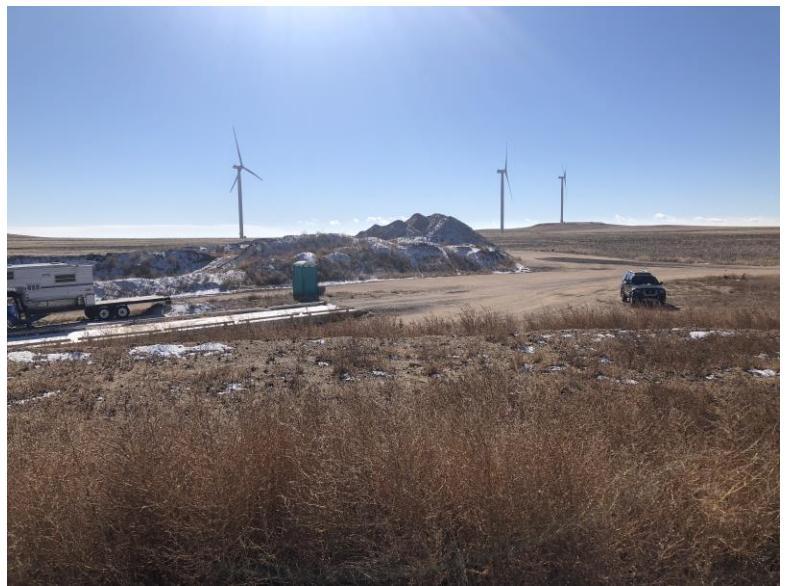
The processing plant has been removed. The fresh water pond, including the liner, has also been removed. The scale remains on the west side of the disturbance area.

West side of disturbance, including scale

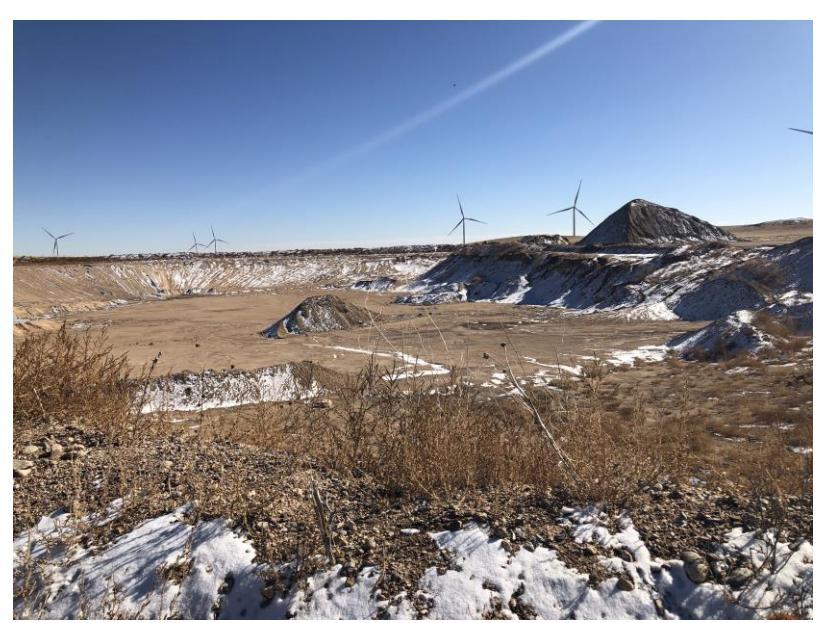
The site was inactive at the time of the inspection. The pit appears to be slightly larger than during past inspections, and the disturbance around the pit has expanded north and south. The pit and other disturbance, however, are still far from the permit boundary. The pit depth was estimated at 20 feet.

Pit, looking east

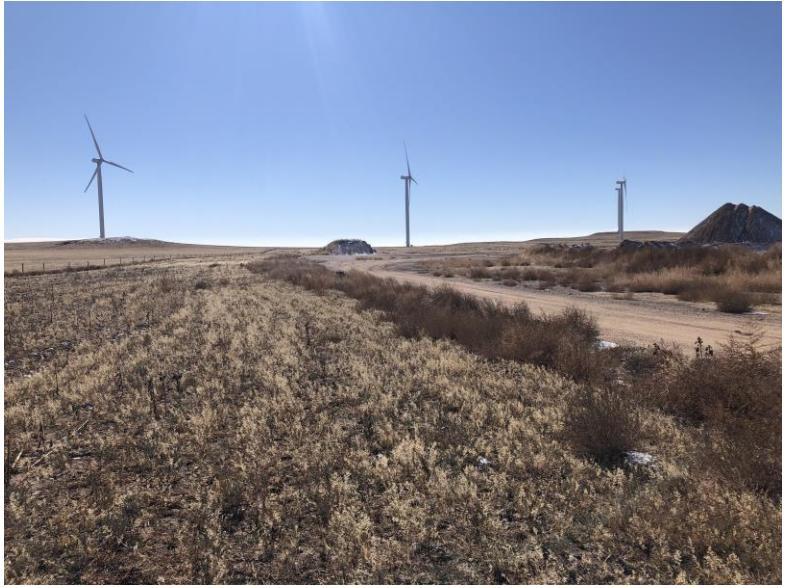
East side of disturbance, looking south

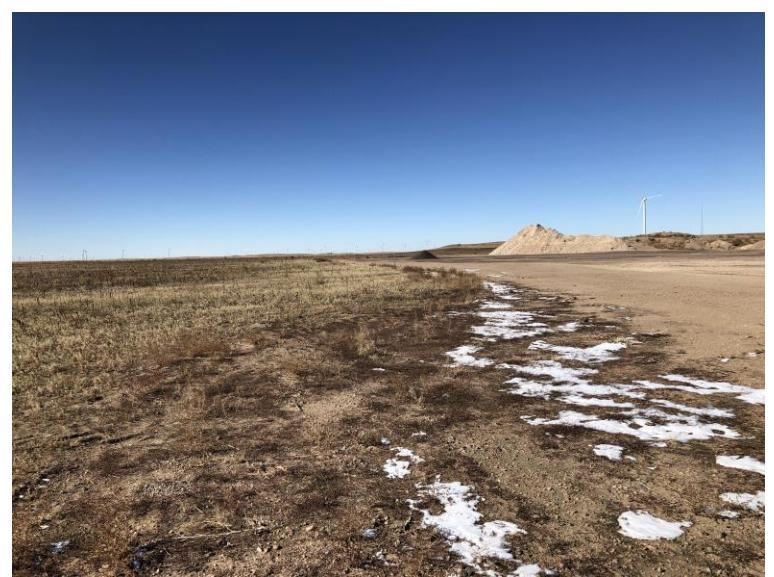
South side of disturbance, looking west
