PERMIT INFORMATION

Permit Number:C-1981-008CourseMine Name:New Horizon MineOpenOperator:Elk Ridge Mining and Reclamation,PermeLLCOwnOpenOperator Address:Mr Tony TennysonOpenP.O. Box 62827646 West 5th AvenueMindNucla, CO 81424

INSPECTION INFORMATION

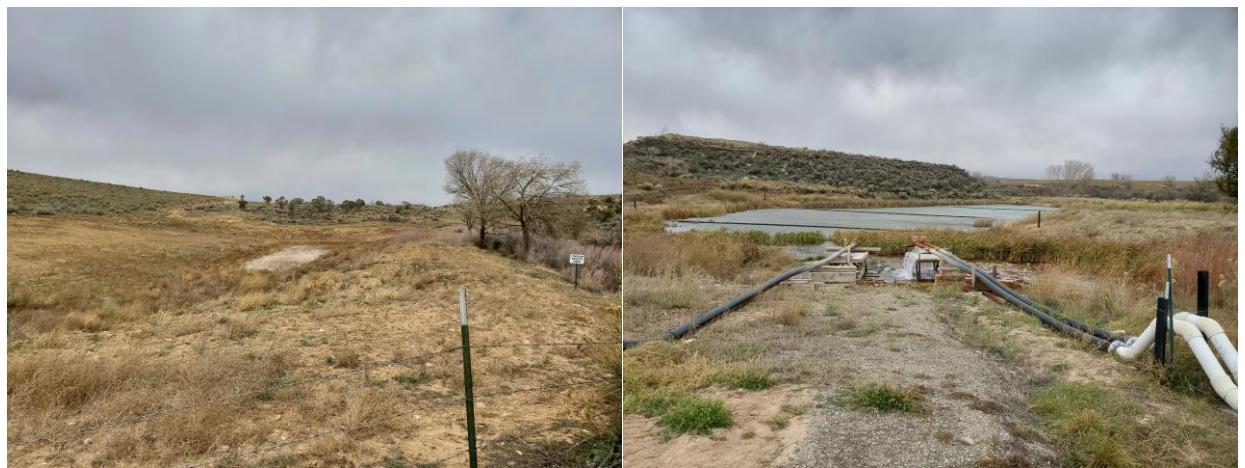
Photo 1: SP2

During the inspection portions of the mine site were damp. Mindy noted that the area had received some precipitation recently. SP2 pond was holding a shallow pool of water well below the discharge elevation. The inslopes were in good condition with the vegetation beginning to fill in. No concerns were noted with this stock tank.

Pond 13 was accessible. Mindy thought the inflow screen was due for a clean out soon. She estimated that it gets Number of <u>Partial</u> Inspection this Fiscal Year: 3 Number of <u>Complete</u> Inspections this Fiscal Year: 2

cleaned approximately once per month. The inflow rate was lower than the summer flow as irrigation water has been turned off for a while. Inflows were 285 gpm and 286 gpm= 571gpm on the two inflow pipe gauges. The baffles in the pond look secure and appear to be functioning.

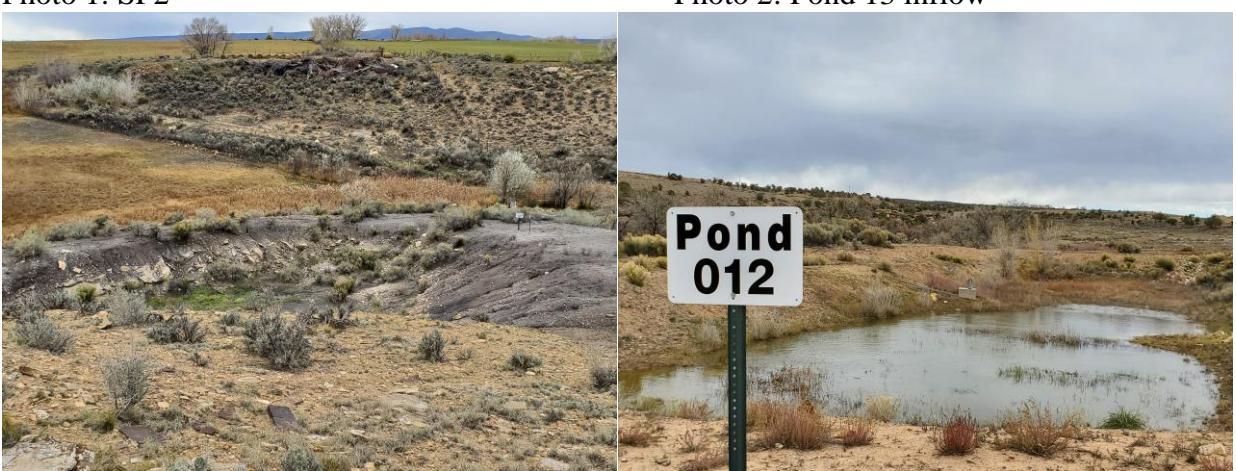
Photo 3: Pond 15

Pond 15 had a damp puddle in the bottom. No concerns were noted with this pond. The collection ditch to Pond 15 looked to be in good shape as well.

Pond 12 was visited and was holding a steady pool of water covering the bottom of the pond. The water elevation was several feet below the discharge elevation, and there was no evidence that the pond had discharged previously. The pond inslopes were well vegetated. No concerns were noted with this pond.

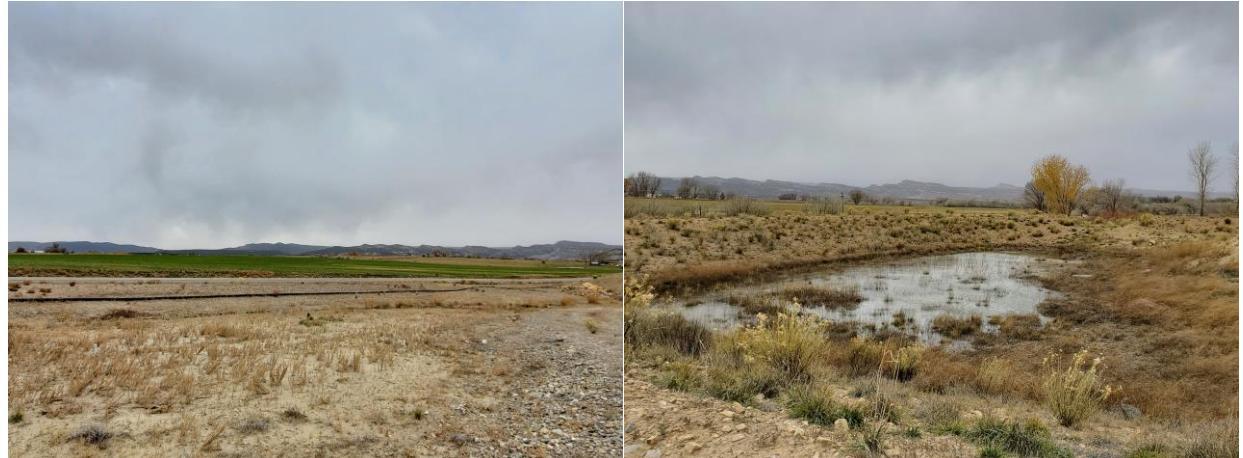
Photo 5: Irrigated Cropland across BB road

Pond 18 was holding a shallow pool of water at the southern end of the pond. Thee water elevation was feet below the discharge elevation. No discharge form this pond had occurred.

The Morgan property Irrigated Cropland was viewed for the hill on the north side of BB road. The IC1 field has been cut, hay bales removed and is still green. No obvious concerns were noted at this time. The Irrigated pasture Lloyd field was cut, still green and had no obvious concerns that were observed.

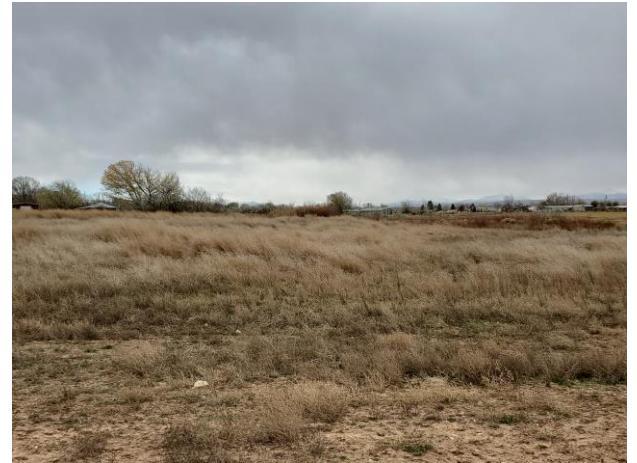
Photo 7: Topsoil stockpile E footprint

Topsoil stockpile footprint E still exhibits dry vegetation from this summer. The reclaimed pile is beginning to fill in with permanent vegetation. There was no evidence of rilling, gullies or soil blowing. The area appeared stable.
