RE: High Flume Gravel Pit, Permit # M-1990-093, Unresolved Problem(s) Noted in a Past Inspection Report

MINERALS PROGRAM INSPECTION REPORT PHONE: (303) 866-3567

MINE NAME:	MINE/PROSPECTING ID#:	MINERAL:	COUNTY:
High Flume Gravel Pit	M-1990-093	Gravel	La Plata
INSPECTION TYPE:	INSPECTOR(S):	INSP. DATE:	INSP. TIME:
Monitoring	Dustin Czapla	August 17, 2022	12:20
OPERATOR:	OPERATOR REPRESENTATIVE:	TYPE OF OPERATION:	
High Flume Gravel Pit, Inc.	None	112c - Construction Regular Operation

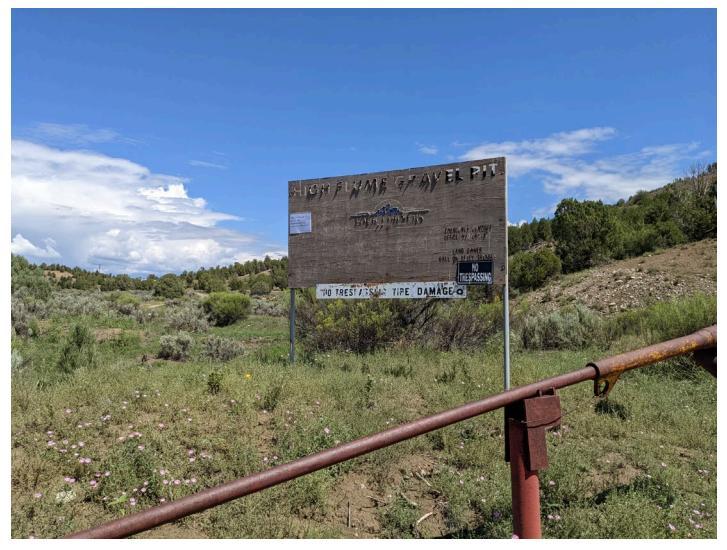
Adequate mine identification signage was noted at the entrance to the site.

Mine identification sign at entrance

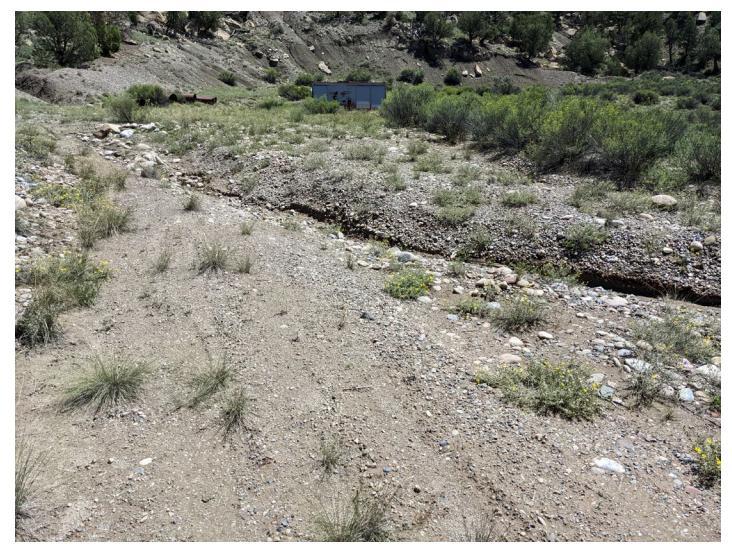
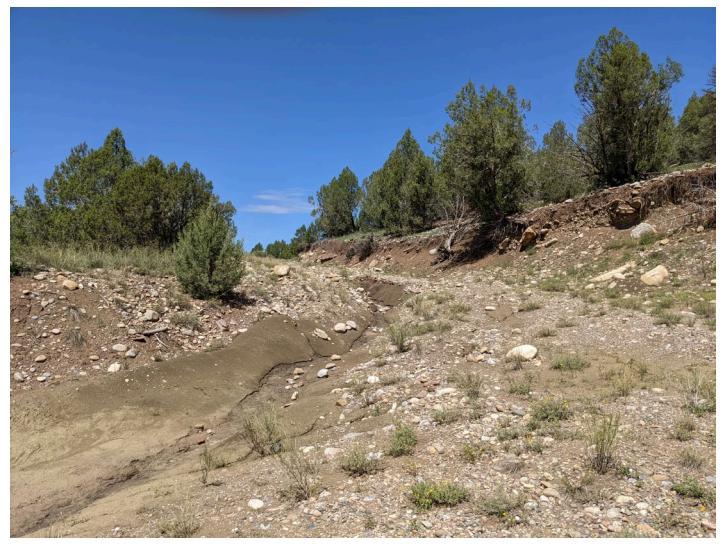
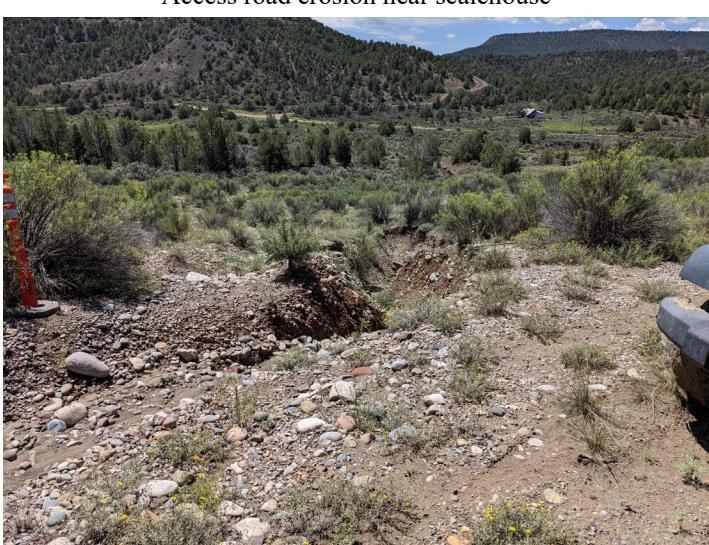
Mining has not occurred at this site since 2007. Consequently, the access road is extremely eroded. The inspector was unable to access the pit area due to the unpassable condition of the access road. Pursuant to Rule 1.13.5, an Operator must file a Notice of Temporary Cessation (TC) if the mining operation temporarily ceases production for 180 days or more. The Operator did not file a Notice of Temporary Cessation at the time production ceased. Pursuant to Rule 1.13.9, in no case can TC be continued for more than 10 years. Therefore, the Operator must commence final reclamation. Pursuant to Rule 3.1.3, all reclamation must be completed within 5 years. This has been noted as a problem on page one of this report.

Access road erosion near scalehouse

CORRECTIVE ACTIONS: Notify the Division, in writing, of the Operators proposed schedule for completing reclamation at the site. The schedule must comply with 5 year time limit pursuant to Rule 3.1.3.

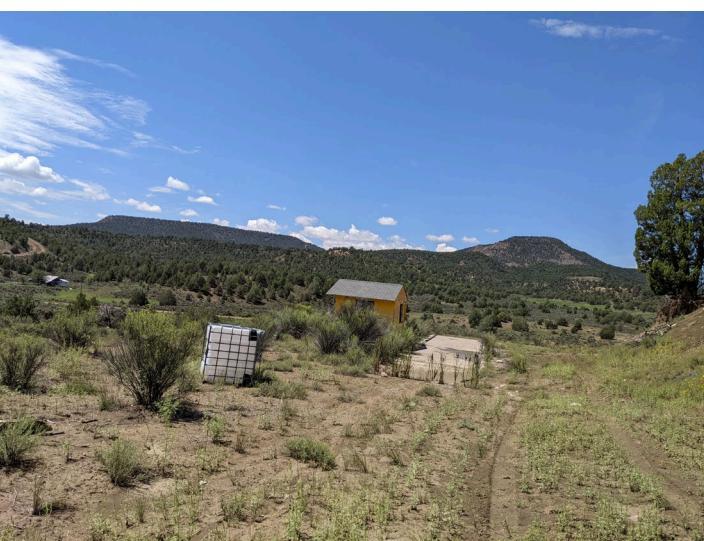
Most of the dilapidated equipment has been removed from the scalehouse area. The scale and scalehouse remain on site.

Scale and scalehouse
