MINERALS PROGRAM INSPECTION REPORT PHONE: (303) 866-3567

MINE NAME:	MINE/PROSPECTING ID#:	MINERAL:	COUNTY:
Virginia Acres	M-1990-021	Sand and gravel	Mesa
INSPECTION TYPE:	WEATHER: Cloudy	INSP. DATE:	INSP. TIME:
Monitoring		March 29, 2023	12:45
OPERATOR:	OPERATOR REPRESENTATIVE:	TYPE OF OPERATION:	
Oldcastle SW Group, Inc. dba United	Jason Burkey	112c - Construction Regular Operation	
Companies of Mesa County			
REASON FOR INSPECTION:	BOND CALCULATION TYPE:	BOND AMOUNT:	
Normal I&E Program	Complete Bond	\$30,000.00	
DATE OF COMPLAINT:	POST INSP. CONTACTS:	JOINT INSP. AGENCY:	
NA	DRMS	None	
INSPECTOR(S):	INSPECTOR'S SIGNATURE:	SIGNATURE DATE:	
Amy Yeldell	Amy Geldell	April 3, 2023

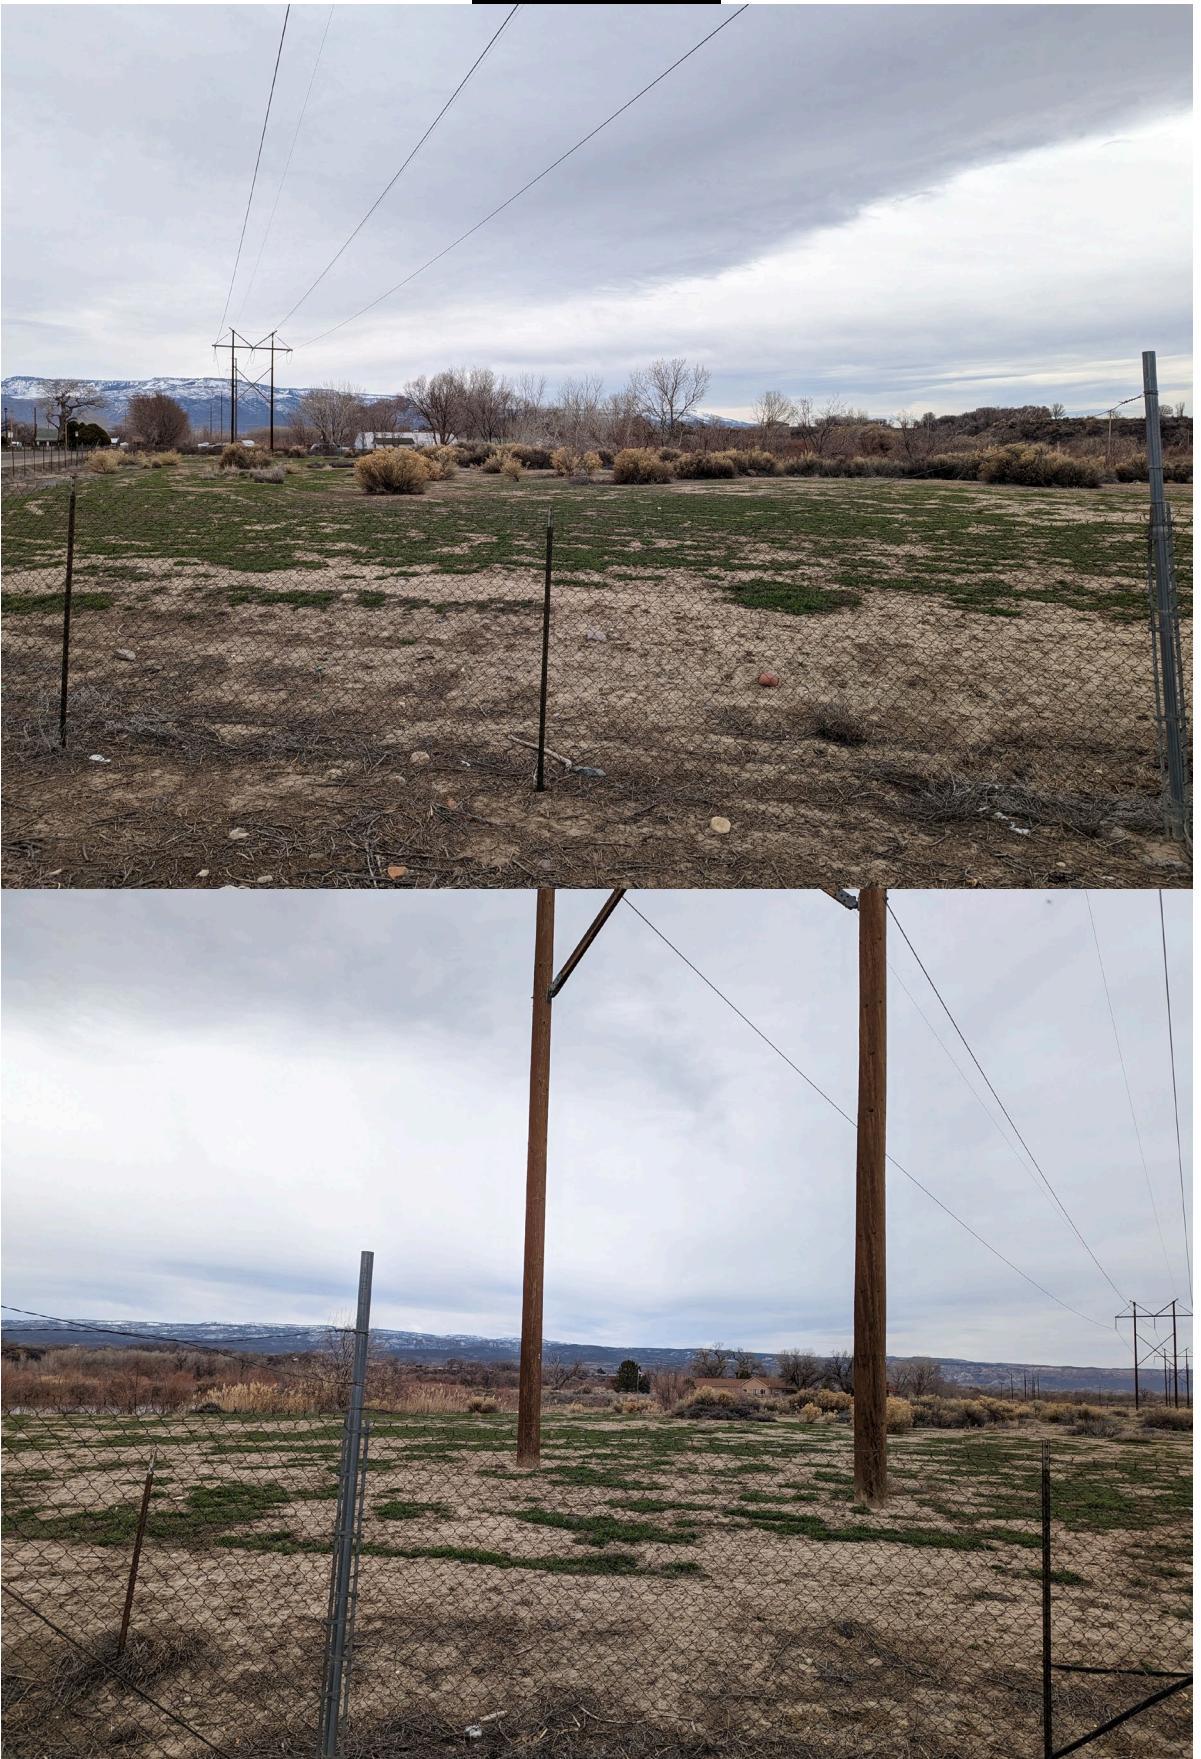
The site was inactive and in final reclamation at the time of the inspection. Mining concluded around 2000. No equipment, structures or mining related debris are on site. Since beginning final reclamation the operator has revised the seed mix and completed numerous reclamation efforts without site wide success. In 2018, the area around the lake, 14.33 acres, was released. The remaining permit area is the northern flat area which has struggled to establish sustainable, divers and desirable vegetation. The primary desirable species is rabbit brush, which occupies approximately 20% of the disturbed lands. Bare ground makes up approximately 30% of cover. And the remaining cover some plants have begun to germinate, however it is too early in the season to identify the species and to determine if it is weeds or desirable species.

The Division has reviewed the reclamation cost estimate and the current seed mix. The Current bond is sufficient. The upland seed mix used on this site could be better adapted for arid and alkali sites. If this current growing season proves poor the Division would suggest revising the seed mix to something more robust, site specific and better suited for the poor soils and high seasonal variability.
