Permit Number: C-1981-044 Mine Name: Williams Fork Mines Operator: Moffat County Mining, LLC Operator Address: Mrs Miranda Kawcak 29515 Routt County Road #27 Oak Creek, CO 80467 **County:** Moffat **Operation Type:** Underground **Permit Status:** Active **Ownership:** Private

INSPECTION INFORMATION

Inspection Topic Summary

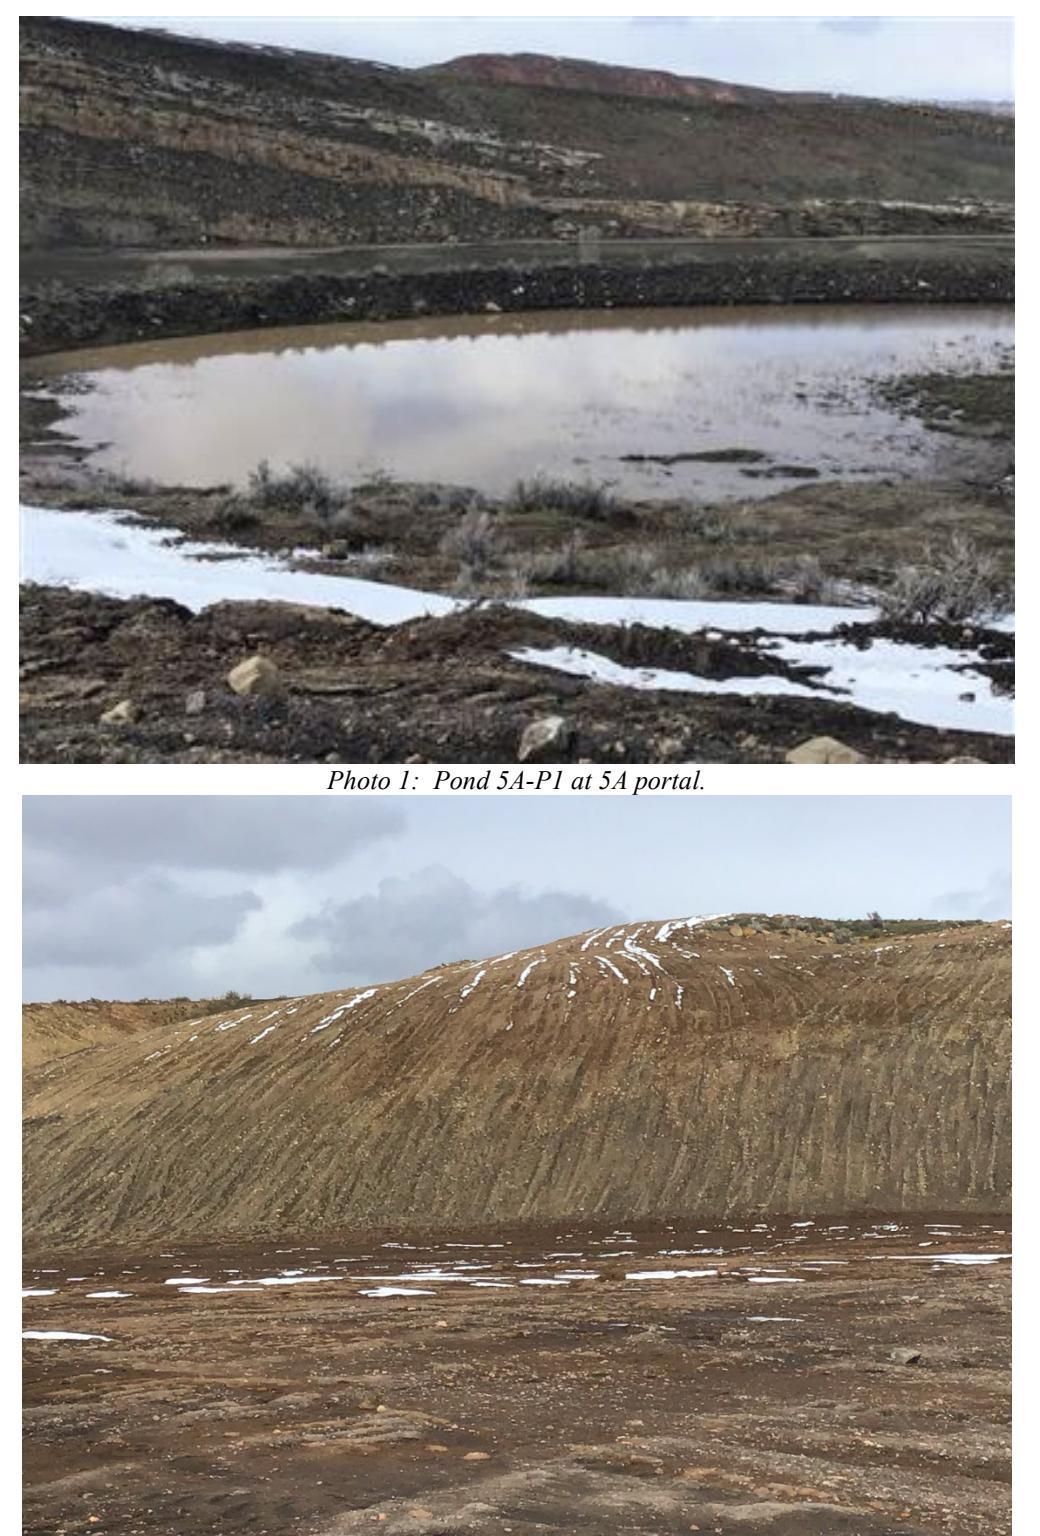
Backfilling and grading has been completed with the exception of grading some rilling at the 5A Portal resulting from rapid spring snowmelt.

Photo 2: North facing slope at 5A Portal.

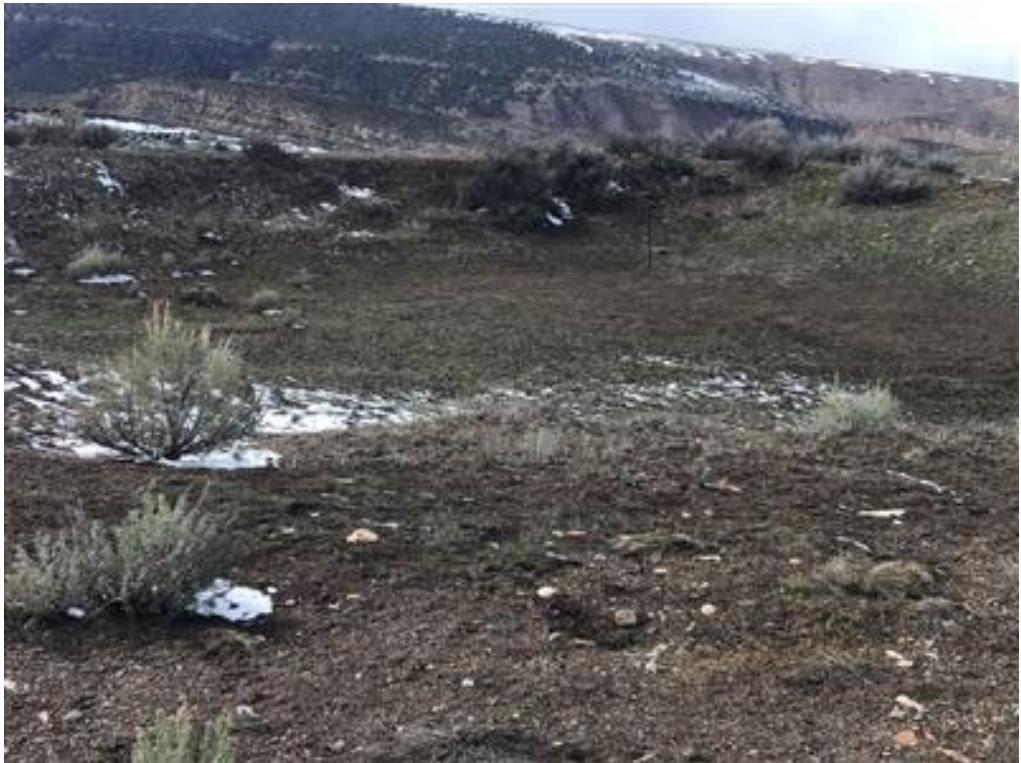
Photo 3: Pond SH-P2, not holding water/

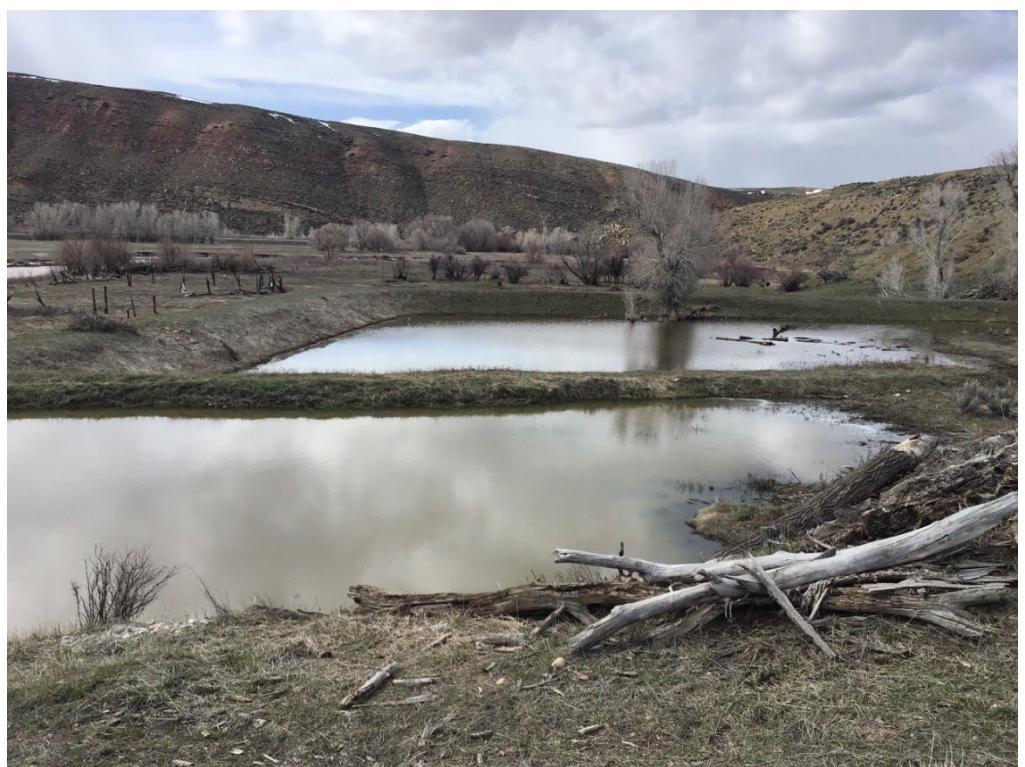
Photo 4: Ponds HR-P1a and HR-P1b located just east of bridge over the Williams Fork River.

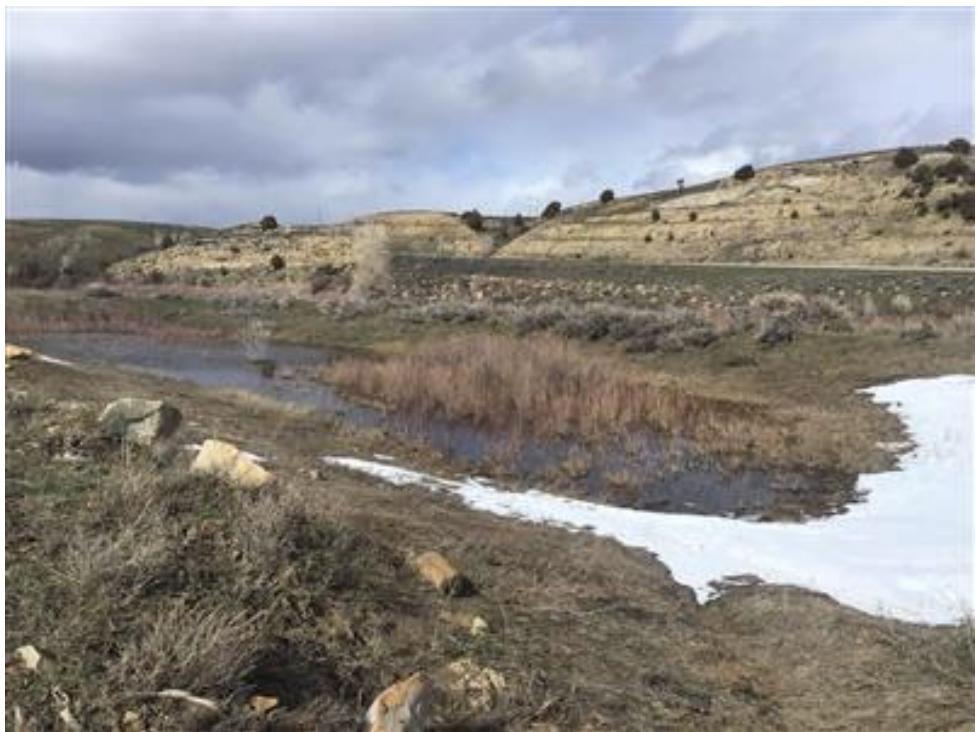
Photo 5: Main ditch in the Williams Fork Bottomlands.

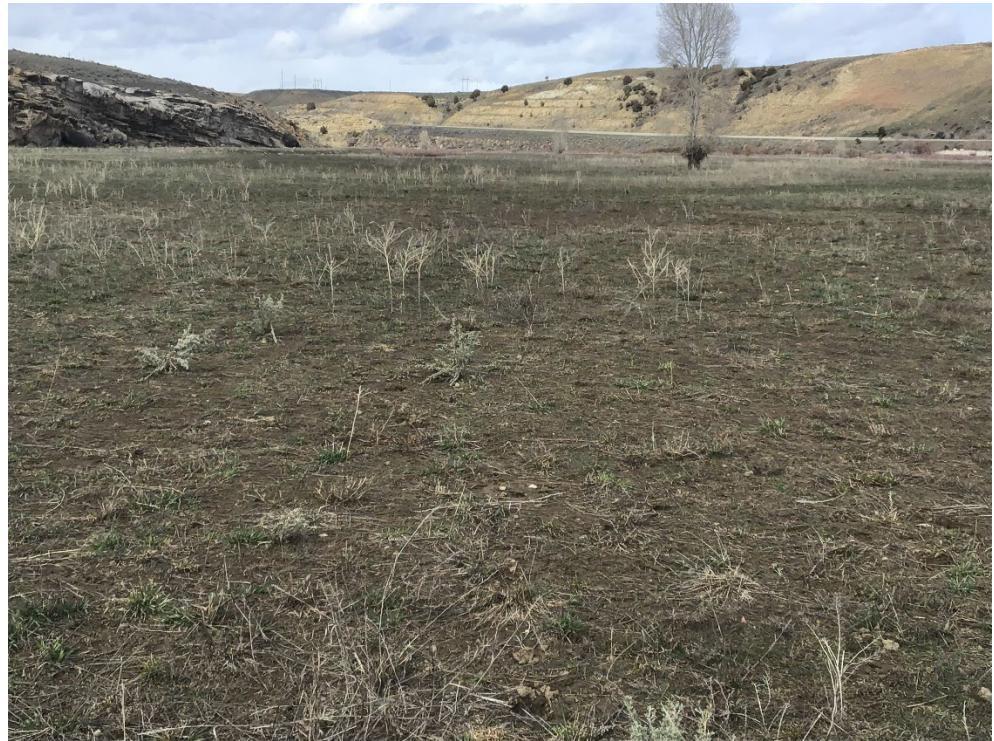
Photo 6: Williams Fork Bottomland where hay is cropped.
