MINERALS PROGRAM INSPECTION REPORT PHONE: (303) 866-3567

MINE NAME:		MINE/PROSPECTING ID#:	MINERAL:	COUNTY:
Mancos Gravel Pit		M-1985-031	Sand and gravel	Montezuma
INSPECTION TYPE:		WEATHER:	INSP. DATE:	INSP. TIME:
Surety Release Inspection		Clear	May 2, 2023	12:00
OPERATOR:		OPERATOR REPRESENTATIVE:	TYPE OF OPERATION:	
Montezuma County		Rob Englehart	112c - Construction Regular Operation	
REASON FOR INSPECTION:		BOND CALCULATION TYPE:	BOND AMOUNT:	
Surety Release Requested		None	\$0.00	
DATE OF COMPLAINT:		POST INSP. CONTACTS:	JOINT INSP. AGENCY:	
NA		None	None	
INSPECTOR(S):	INSPECTOR'S SIGNATURE:		SIGNATURE DATE:	
Todd Jesse			May 30, 2023	
	TARA			
	add Corre			
		000

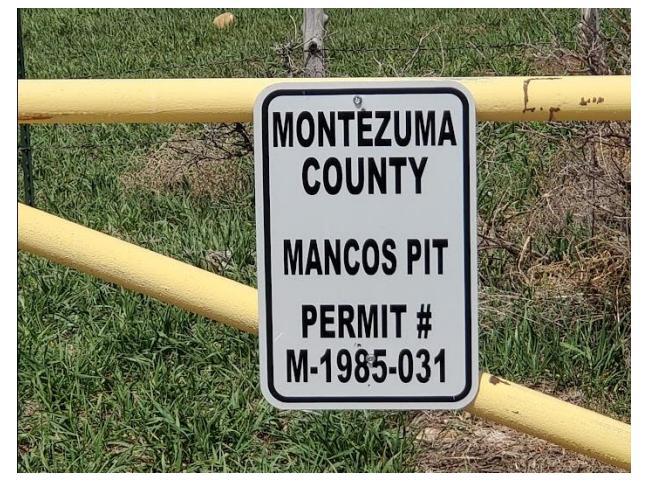
The mine identification sign and the affected area boundary markers are in place and in compliance with rule 3.1.12. The mine identification sign is located on the gate to the property off County Road 42. The portion of the permit that is being released was surveyed and survey stakes with orange flagging were left in place to mark the new permit boundary.

Sign at entrance to pit.

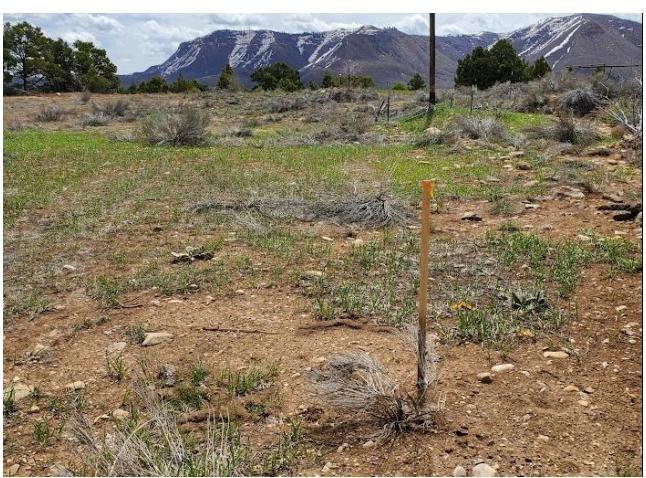
View to the southeast of survey stakes used as boundary markers.

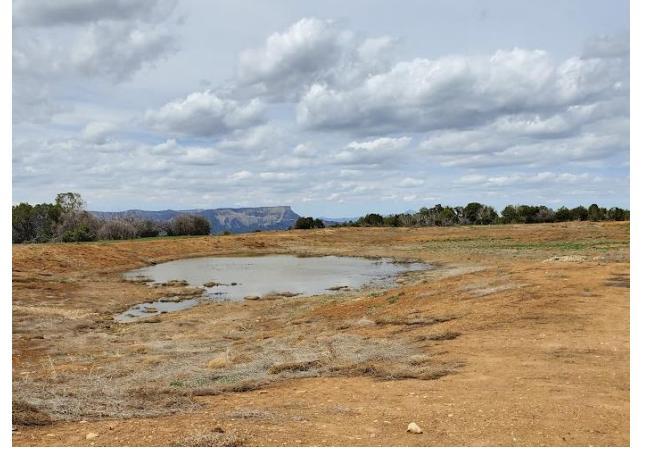
Meteoric water from snow melt was present in the release area. In addition to meteoric water there is also a spring in the release area that supports larger vegetation. Grasses are present in some areas of the release area, but since the post mine land use was changed to industrial under Technical Revision 3 revegetation is not required. No invasive species were observed during the inspection. The slopes in the release area are graded, stable, and show no signs of erosion or slumping.

View to the west of meteoric water in release area.

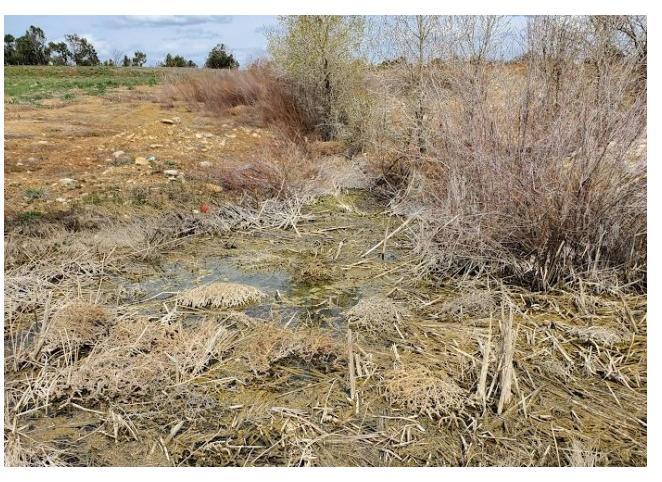
View to the northwest of the spring in the release area.

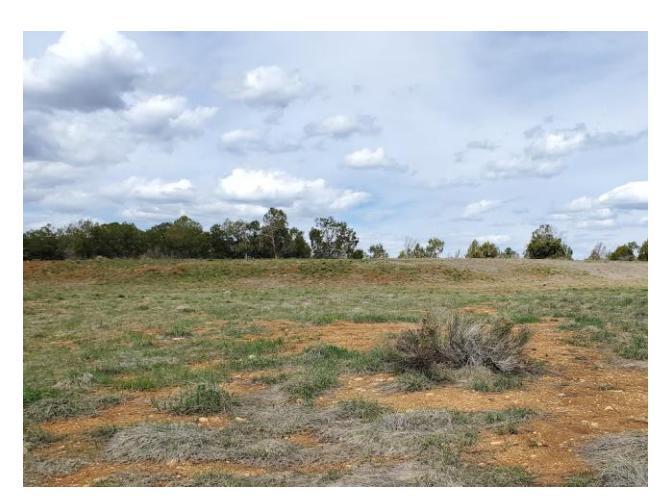
Vegetation cover with graded slope in the background. View to the west.

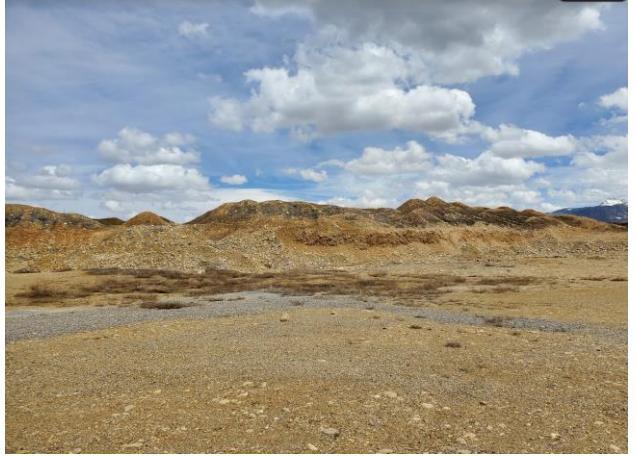
In the active area of the pit, a high wall approximately 15 feet high and 300 feet long was observed. There are multiple product material stockpiles in the pit. Material is used for county roads and material is also used on USFS roads. In addition to product stockpiles there are also topsoil and overburden stockpiles on site. The topsoil stockpile does have a minor amount of vegetation cover to protect the pile. A 950 Loader is the only piece of equipment on site, but was not in use at the time of the inspection. There are no onsite support facilities or hydrocarbons stored on site.

View to the north of the 15' high wall. Overburden stockpiles in the background.

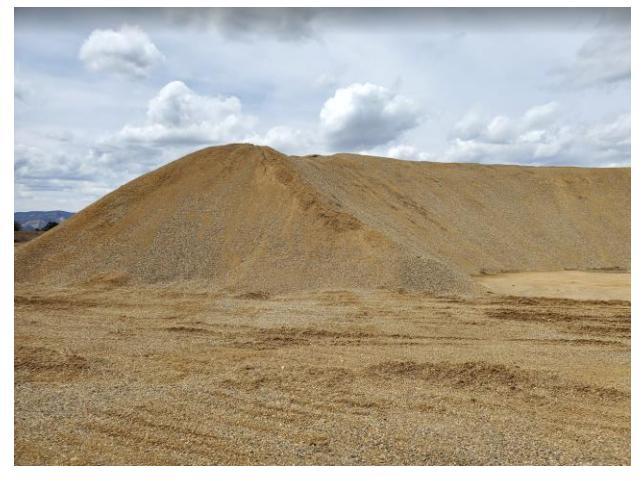
View to the west of principle product stockpile.

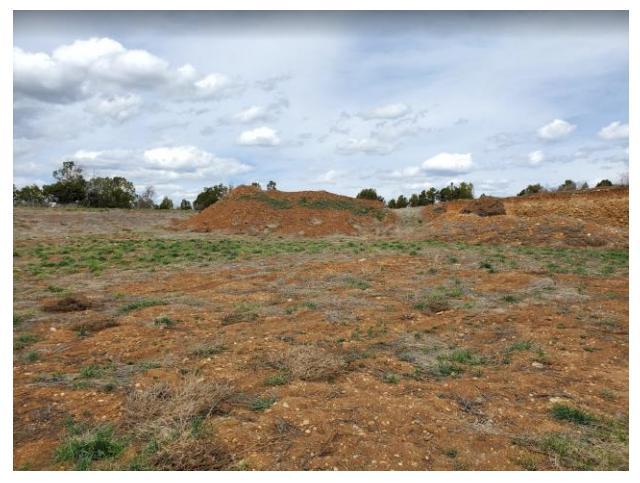
View to the northwest of topsoil stockpile.

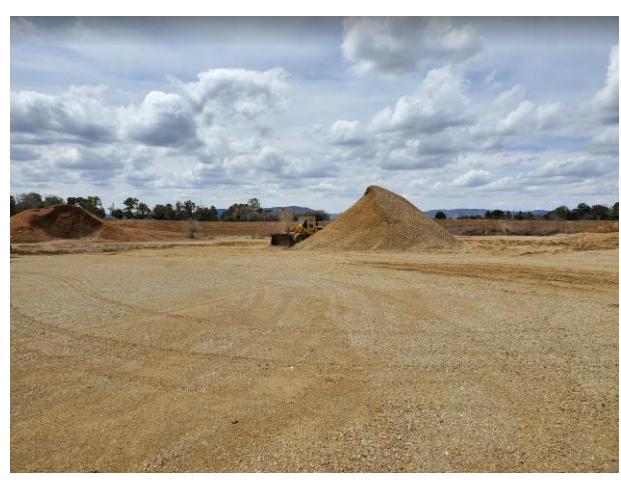
950 Loader next to product stockpile.
